SPECIFIC DEFECTS REPORT

Relating to the damp walls to hallway and kitchen

Terraced Property in London

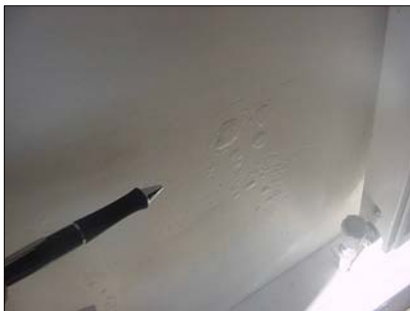
Blistering paintwork in hallway that has been damp proofed

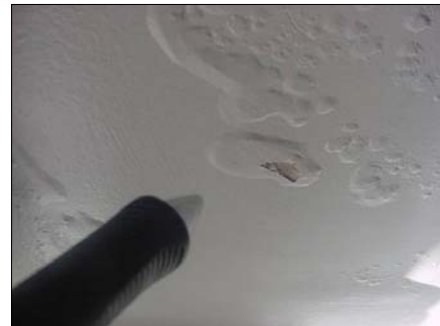
Close up view shows the plastering is starting to fail, as well as the paintwork

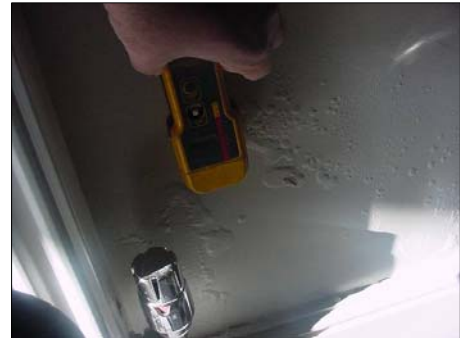
Protimeter damp readings

This indicates to us that there is dampness in the walls in excess of what we would normally expect to come from the ground below. We believe there may be another source or additional sources of the dampness. We feel that whilst adding a damp proof course treats the effect of the dampness it does not treat the cause.

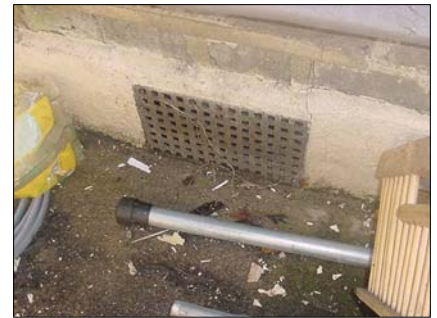
Your neighbour's air bricks

Before we leave the subject of airbricks, your neighbour has a good-sized airbrick, but unfortunately its location means it could effectively be acting like a gully for any rainwater or overflowing pipes. This is why we have recommended a French gully/drain.

Adding a French gully to stop the existing air grill from being used as a gutter and also lowering the ground level.

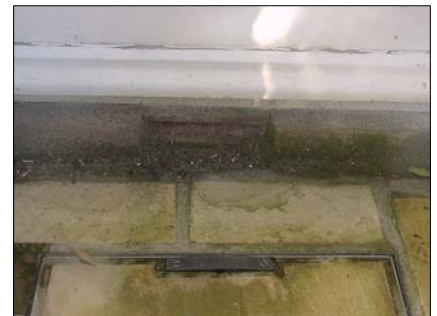
Your air bricks

Your metal vent has been replaced with a brick airbrick. As you are aware, this was blocked, as well as giving less ventilation.

ACTION REQUIRED: We would recommend unblocking airbrick and the adding of additional airbricks, or replacement with a larger metal airbrick, as your neighbour has.

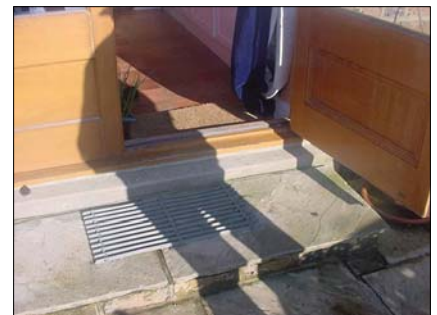
Your rear airbrick appears to have been blocked by the rear step.

ACTION REQUIRED: Add additional airbricks.

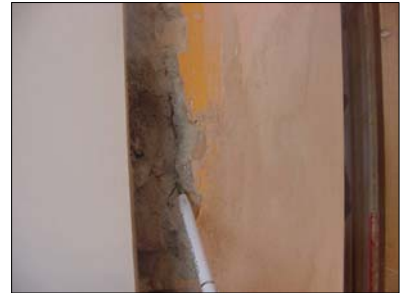
Kitchen

From our discussions with yourself and our visual inspection, we can see that in the kitchen the original plaster has been replaced with a cement based render, which has had a skim coat of gypsum plaster.

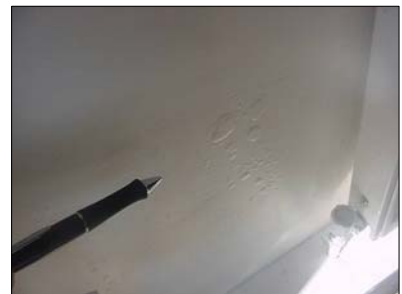
Hallway

This has a harder renovating style plaster, often cement based, with a waterproof agent applied to it and painted with a modern unbreathable paint.

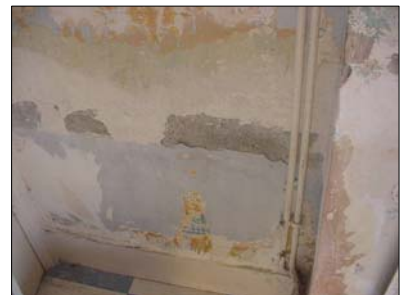
Unplastered finish in many areas. There has been a modern cement based plaster added in some areas and a skim coat with a water retarding agent in some areas.

Modern hard unbreathable
plaster/render

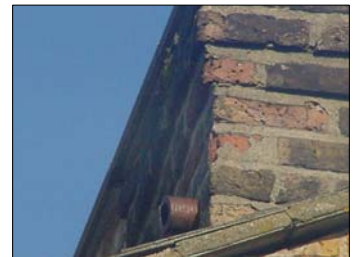
Close up of brickwork, in average condition
