RESIDENTIAL BUILDING SURVEY

**Dagenham,
Essex,
RM10 xxx**

INDEPENDENT CHARTERED SURVEYORS

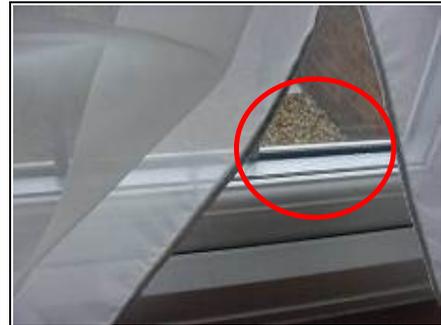
Also the single glazing to the rear of the property will tend to get condensation due to the humidity in the air.

Condensation on window
Hard to see in the photo

ACTION REQUIRED: Large humidity controlled extract fans to be added to the kitchen, bathroom and possibly the conservatory. If this is not carried out you may find black mould is occurring. We are still in the early days of discovering the health problems associated with this black mould.

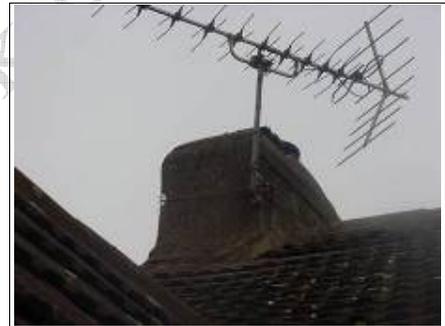
Chimney- front left

This chimney is rendered with a cement flashing and one chimney pot. From what we could see from ground level it looked in below average condition considering its age, type and style. The chimney is letting in dampness which may be via the cement render or via the flaunchings.

ACTION REQUIRED: Please see our comments in the Executive Summary regarding the chimney breast beneath it being removed.

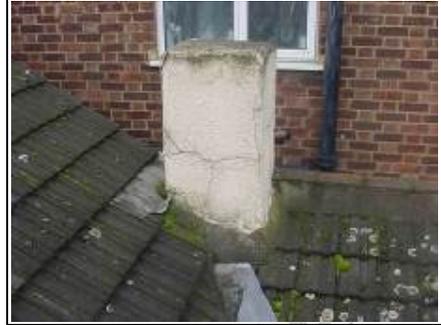
Chimney rear left

This chimney is finished in painted render and looks to have been sealed. There is a part lead and part cement flashing. We would comment that there is cracking visible to the render

ACTION REQUIRED: Add complete new flashings and redecorate. Please see our comments within the Executive Summary.

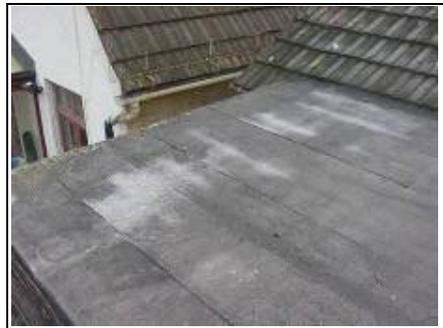
One has a bitumen finish which is crazing and cracking.

Rear flat roof with bitumen finish

ACTION REQUIRED: We would recommend this is replaced with an insulation cut to falls to take the water away.

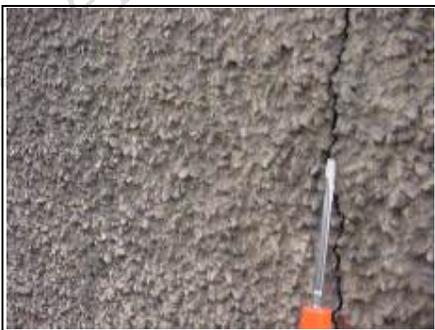
We noted cracking on the right hand neighbours building. This may indicate some leaks to the drainage. Older drains tend to be a push-fit type system that do leak.

Neighbours property also has cracking

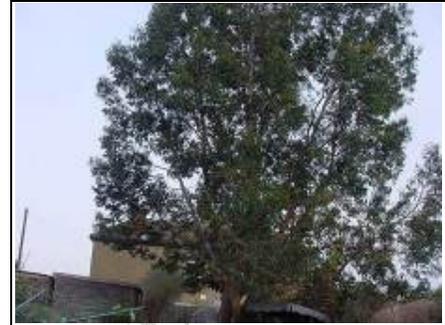
The tree is located to the rear of the property

ACTION REQUIRED: We would recommend an Arboriculturalist (not a tree surgeon) is asked to view the property and give a ten year plan for maintenance.

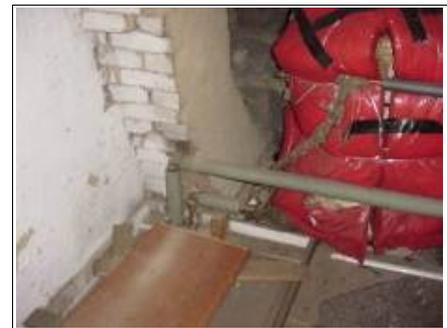
There is an older style hot water cylinder in the roof space which has an insulation jacket. This cylinder will therefore not have the same thermal properties as a modern factory insulated cylinder. The problem with these dated cylinders is they can just leak at any time.

Dated cylinder in roof space
