RESIDENTIAL BUILDING SURVEY

Shooters Hill, London,
SE18 xxxx

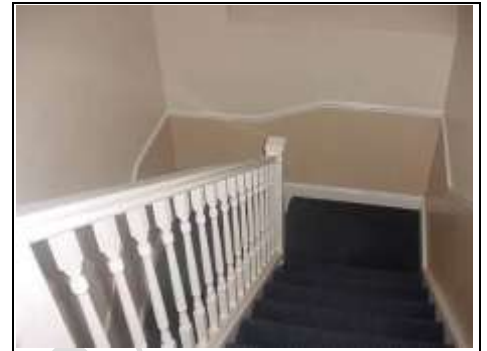
Communal stairwell
These would benefit from
re-decoration

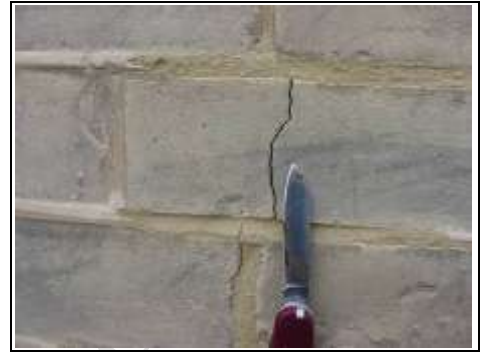
We can see vertical cracking in the bricks particularly to the right hand side wall. Internally there is also cracking particularly to the rear right hand bedroom.

Vertical crack in the brickwork

ANTICIPATED COST: Usually, if there are any problems, as stated above it will be limited to the excess of the policy. You do need to speak to the freeholder about this and inform them that your survey has identified that there has been/is movement in the property albeit minor at present; please obtain quotations.

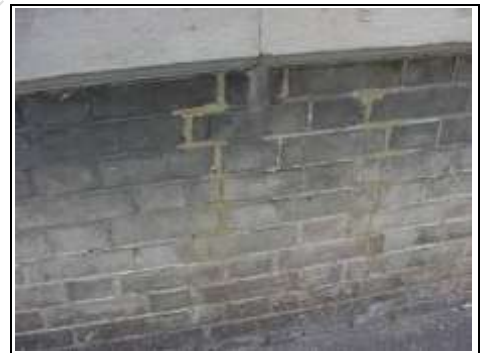
Repairs to cracking

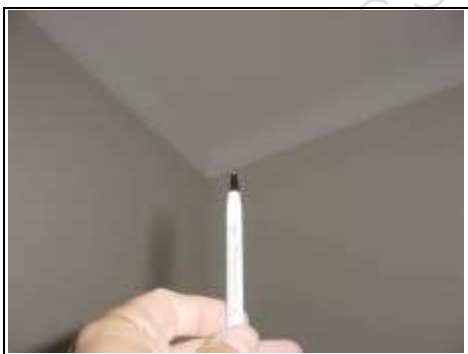
Internal cracking

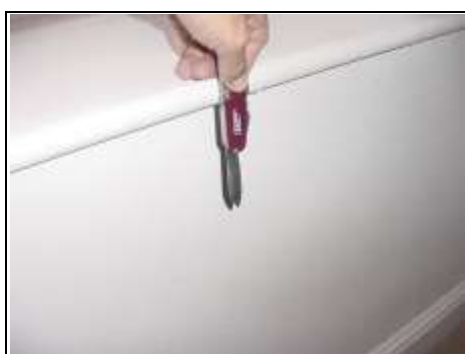
Cracking- lounge - front right

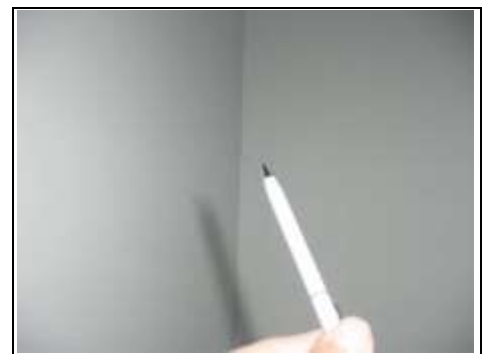
Cracking – rear right bedroom

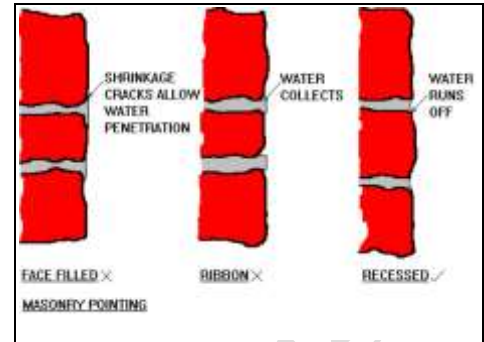
Unfortunately the cement re-pointing, whilst well meaning, is not appropriate for this type of construction. A cement mortar has been used rather than a lime based mortar. We recommend you use lime mortar in any future repairs regardless of what the builders say! Using lime mortar will limit further damage to the brickwork, which is almost impossible to repair successfully. However, we would add that many, if not most, of the properties that are re-pointed are re-pointed wrongly; it is only in recent years that we have discovered the problems that can occur from it.

Re-pointing

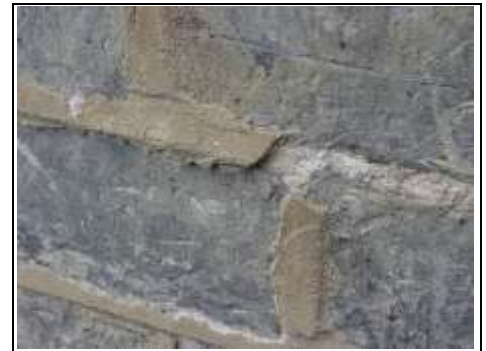
Poor re-pointing.
Just a skim coat we are amazed it has stayed on.

Re-pointing coming away

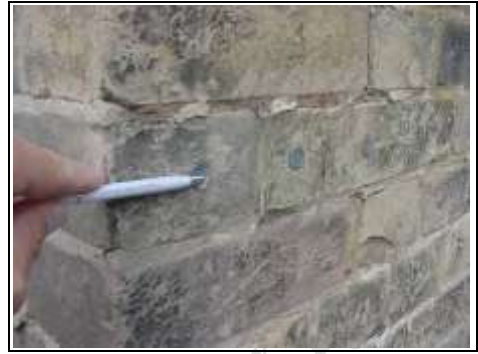
Damp proof course – right hand side of property

ACTION REQUIRED: We would recommend that you meet your downstairs neighbour for a cup of tea before you purchase the property to ask if they still suffer from any damp problems.

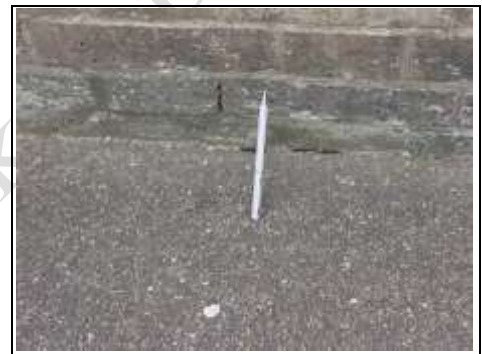
Damp proof course is too low for the ground level

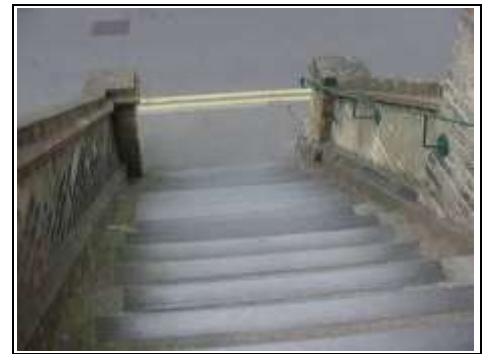
Dampness may be coming in via the stairs

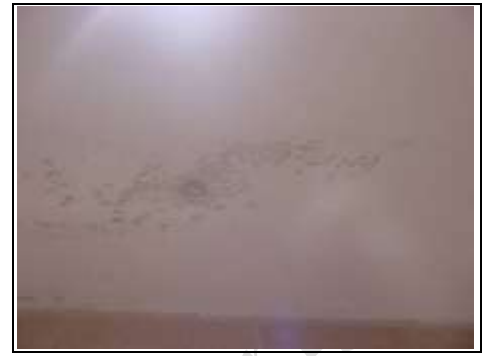
We noted mould in the internal bathroom. Whilst the mould and condensation may be partly due to the lifestyle of the previous occupant we would recommend that you install large humidity controlled extract fans. We would add that it will be a struggle to stop the problem of condensation altogether due to the design of the bathroom being internal and also the low ceiling height.

Mould in the bathroom

ACTION REQUIRED: Add large humidity controlled extract fans to the bathroom and ideally the kitchen. The beauty of humidity controlled extract fans is they switch on and off by themselves.

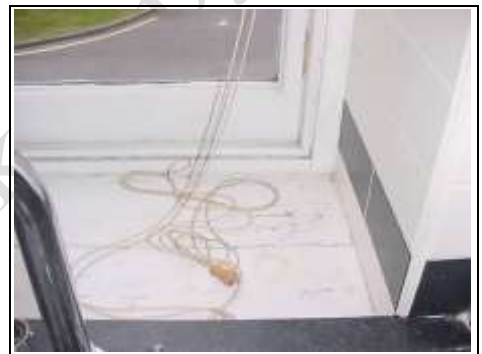
We can also see what looks like condensation to the sliding sash windows. This may be water ingress via wind driven rain. You may wish to think about a secondary glazing system assuming that the landlords and the local authority/ listed buildings planners give approval.

Kitchen window sill.
Signs of condensation.

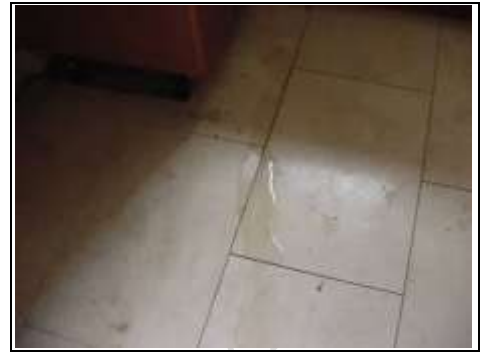
When we ran the tap water leaked onto the floor

ACTION REQUIRED: Check the plumbing under the sink. Ideally you should tile under the kitchen units so that there is not a drop in that area where water can get in. As previously mentioned you need to have a cup of tea meeting with your downstairs neighbours.

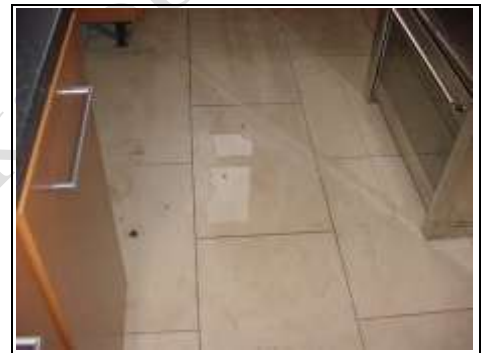
Leak in the kitchen

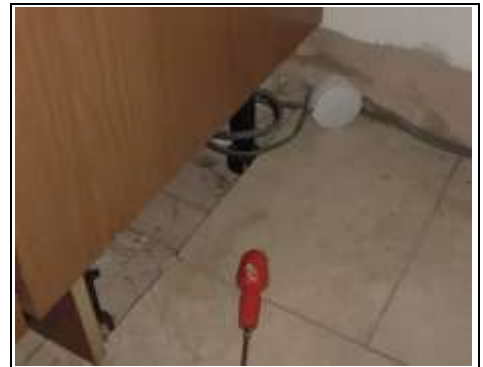
The kitchen floor has been laid on top of the old kitchen floor and has been cut around the units. In our experience this means that if there is any water that leaks (there was a leak at the time of our inspection) the water can get behind the units and under the floor causing the floor to blister (lose its grip) and also dampness can enter the apartment below.

Tiled floor has been laid on the old floor and cut around the units

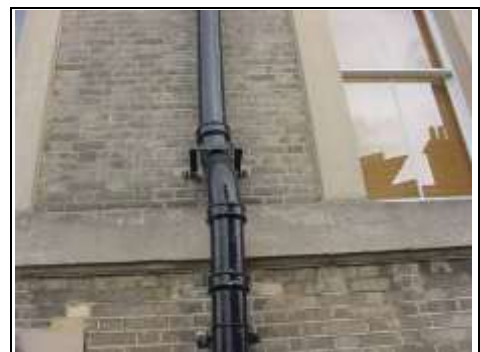
What we have noticed is that it looks like you have asbestos downpipes (we cannot be certain as they have been painted over many times. A good management

Possible asbestos downpipes

Our insurance company require us to advise we are not asbestos specialists. We recommend you have an asbestos survey carried out by a specialist asbestos company.

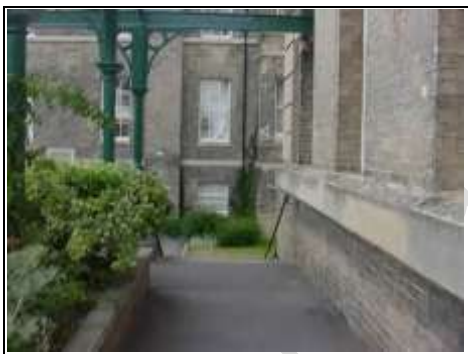
It was noted when we carried out the survey that other occupiers literally walk right past your window to the side of the property and to the rear. The entrance to the block of properties is at the rear. You need to revisit the property and make sure you are happy with this.

Passage way to the side of the property passes your windows

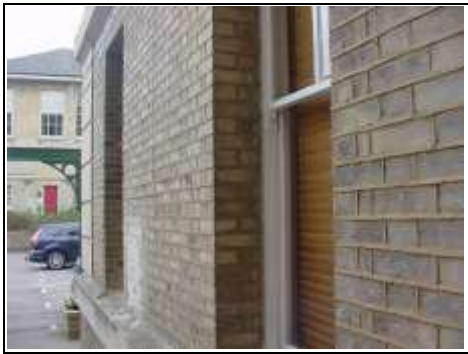
From what we can see, whoever carried out the re-pointing does not understand the usual process of working on a Listed building.

Re-pointing carried out in cement and not lime

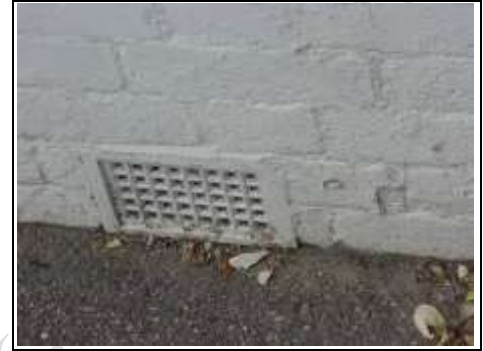
We smelled gas here. Is this the gas vent for the boiler in the property below.

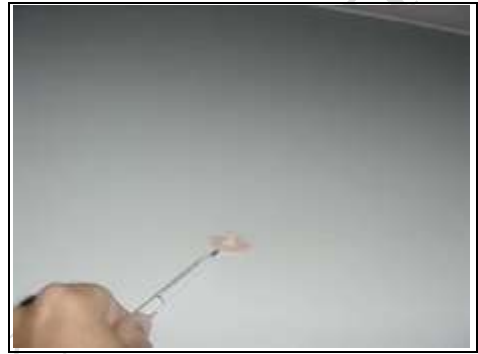
In some areas we can see popping which is where the plasterboard does not cover the nails sufficiently and has popped off.

Skim coat of plaster coming away

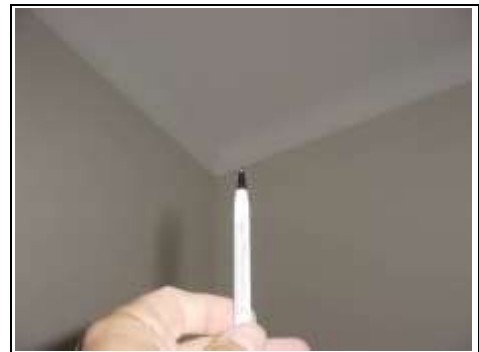
We noticed some cracking internally although it is quite difficult to see on the photos. The cracking internally and externally is a concern.

Cracking

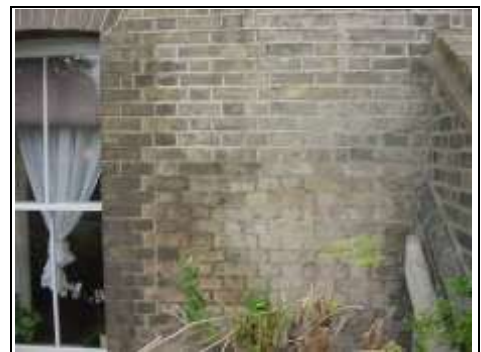
We noted that the downstairs neighbours flat, which is where the damp proof course was inserted, had what looked to be a wet area to the front of the property which may be from a leaking rainwater gutter at high level (check next time it rains heavily). Remember that this flat is partly underground and that it is directly under your property. We knocked on the door to ask about this but did not get an answer. Our concern is that this dampness may affect your property.

Wet area to flat below – right hand side of property

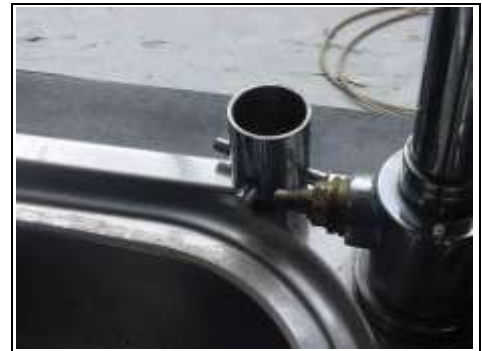
We found the kitchen in average condition, subject of course to some wear and tear as one would expect. Please note our comments with regard to the floor in the Executive Summary and the tap did come off in our hand.

Tap fell off in the kitchen

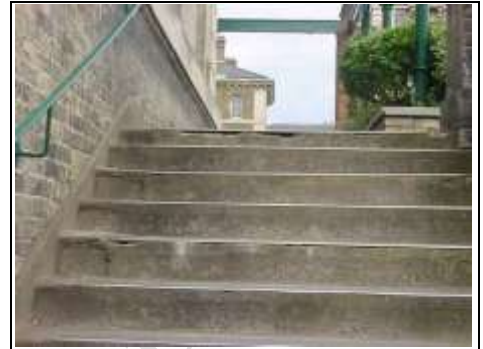
Stairs need repairing
