**RESIDENTIAL BUILDING SURVEY
OF
Warwickshire**

INTRODUCTION

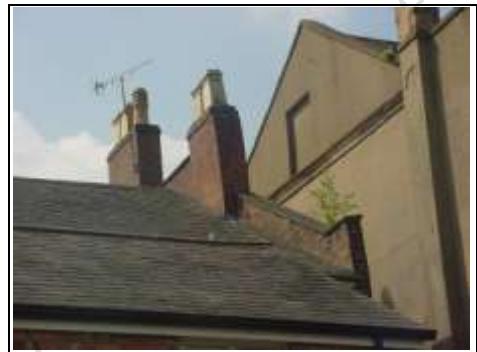
We note that the property has numerous chimneys and parapet walls, we noted that some of them where we could see them had cement flashings rather than lead flashings. This does ultimately lead to dampness getting into the property as the cement is brittle and breaks away whereas traditional lead flashings are more pliable and last longer.

ACTION REQUIRED: We therefore recommend that all the chimneys and parapet walls have work carried out on them to replace the cement flashings before the summer of 2010 ideally to ensure they are watertight for the winter. This work can be carried out in conjunction with the roof work. We do need to put this into perspective, we wouldn't be recommending this work so soon if work to the roof wasn't being proposed to be carried out.

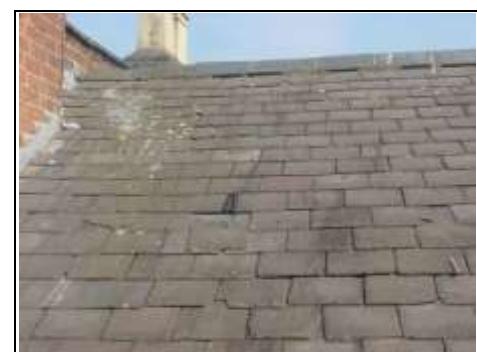
We had a limited view of the pitched roofs but we were able to access and view the front of the property very well. We would comment that the roof's days are numbered without a reasonable amount of repair. We can see some “DIY standard” repairs have been carried out to the roof. You can also see an above average number of tingles are holding the slates in place. We do however feel that the roof is saveable providing the work is started relatively soon. Most importantly it will

Slate roof to the front of the property

ACTION REQUIRED: It is so easy with the roof to glibly say that it all needs replacing. You need to obtain a selection of the right slates and good tradesmen . A good place for this and a good day out is a building reclaims yard such as Solar Park based near Cambridge (rumoured to be one of the biggest in the country). We propose a section by section repair and replacement of the slate. Whilst it is not the most economic way to carry out work (also the continuation of work that will allow you to get to know the roofer allowing him to understand the property) we feel it is probably the best option providing you have the right roofer carrying out the work. We would also suggest that you speak to the local council before you purchase the property to get a feel for the type of requirements that they will have (ensuring they are not too onerous before you purchase the property) and to ensure that you are happy to liaise with them or whether you wish to employ someone such as ourselves to carry this out for you. We would advise that we haven't been able to see the rear roof at all other than from ground level. It is very often rear roofs that are the bigger problem as they tend to use

As mentioned we would recommend a section by section approach to the repair and replacement of the roof. Whilst this is not the most economical way to carry out the work we feel that it is better to do some work rather than no work at all. This will also ensure that you get to know and understand your building better.

ANTICIPATED COST: We would expect costs to be in the region of £40,000 - £50,000 over several years (no more than three years). We would also add the caveat that as mentioned we have been unable to see the back of the front roof properly so this needs a close examination as soon as possible. You also need to establish a safe way of accessing that rear roof which may in itself be very costly, sometimes the scaffolding can cost as much if not more than the actual work. We would recommend three quotations from companies experienced in this type of work.

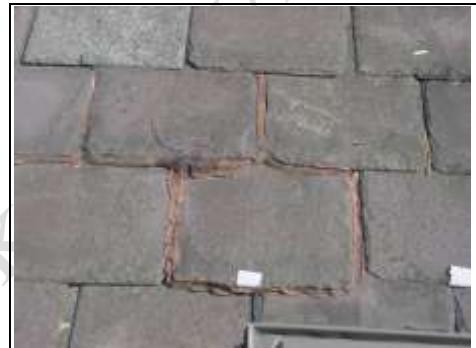
Mastic repair to roof slates

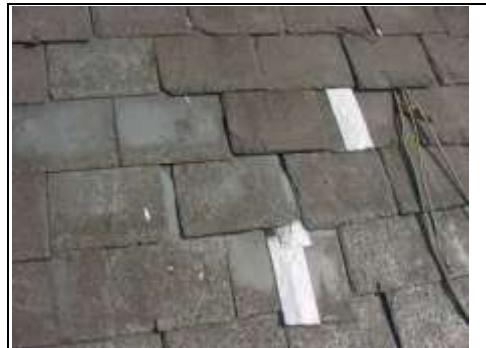
Flash band repairs

Flashband is a sticky backed felt which is best used for temporary repairs only.

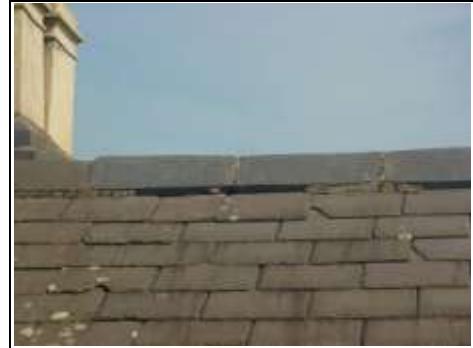
You will also need to repoint the ridge of the roof

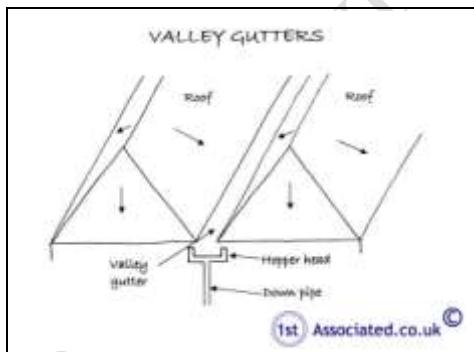
Valley gutter

This is not exactly as your roof detail as there is a wall rather than a second roof, we hope it gives you an indication of how valley gutters work. You can see on our sketch that there is a large hopper head which is what you need.

ACTION REQUIRED: Regular maintenance of these areas needs to take place to ensure that they don't block. Sometimes out of sight out of mind is not good! We would also recommend that another access is added to the rear roof in the form of a roof light so there is another area where you can view the condition of the roof. You would need to obtain Local Authority approval for this.

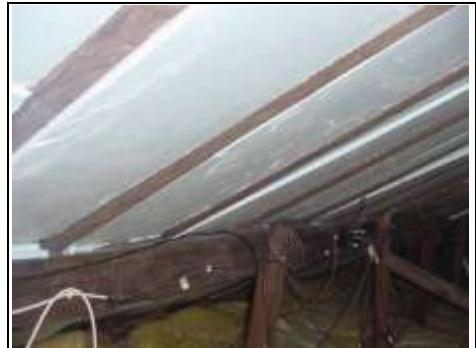
Unfortunately thermal efficiency and condensation go hand in hand with older properties. Within the roof there has been a lot of insulation added, some is what is known as solid core insulation which is between the rafters and some is a more traditional fibreglass type insulation between the ceiling joists. Our concern is that so much insulation has been added in this type of property it could cause condensation. Unfortunately it is very difficult to tell the difference between condensation and a roof leaking in lots of instances.

We have moved some sections of the insulation to check (although we are aware this probably only represents less than one percent of the entire roof structure) but didn't find anything untoward however this is certainly a risk so we therefore recommend that when you do have the roof work carried out you add quite a number of vents. We particularly noticed condensation/dampness in the rear roof and as mentioned we were not able to view this so it could be either.

Roof insulation

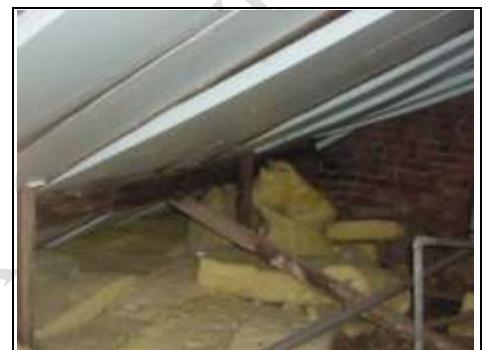
Condensation and possibly damp coming in on the rear roof

ACTION REQUIRED: We recommend to reduce the risk of deterioration of the roof from condensation that air vents are added to the gable ends where possible and within the roofs at both high and low level where not possible. Again Local Authority approval/opinion will need to be obtained. You have to be so careful with older properties when you mix old and new materials/technologies. I would say that we still don't fully understand the implications of what we are doing with regards to adding additional insulation to properties.

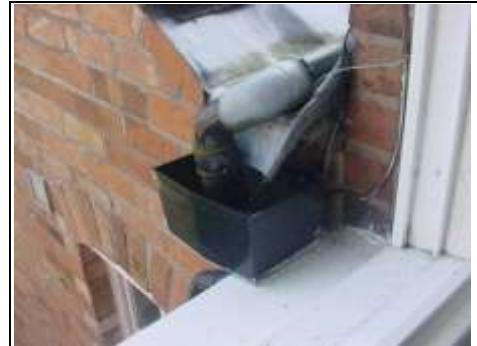
We think there needs to be a general overhaul of the gutters and downpipes. Whilst we didn't see the property when it was raining we suspect for example that the hopper heads to the rear left hand side are too small and will overflow during not too heavy a downpour of rain.

Hopper heads are too small and should be increased in size

ACTION REQUIRED: We recommend a larger hopper head along with an overflow discharge on it in case it gets blocked with leaves, etc.

ANTICIPATED COST: This will be fairly expensive, we would estimate costs to be in the region of £2,000 - £5,000, this would include such things as repairing and redecorating cast iron pipes, checking and positioning of clips, etc. quotations required. Finally we would add that we would not use plastic guttering on this age of property but use an aluminium or more appropriate cast iron. Although these have initial more expensive capital cost in the long run reports show that they last longer.

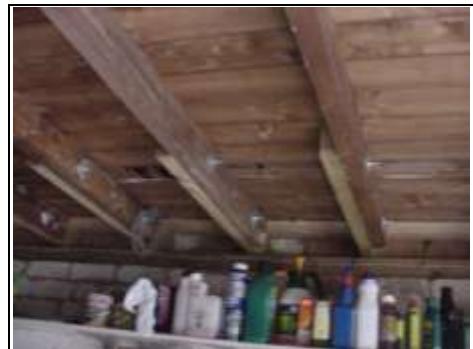
We noted that the ceiling joists have rotted and new timbers have been put in place and bolted through (sometimes known as back to backing) into the new timber. However the rotting of the timbers is likely to be the effect rather than the cause.

New timbers added into the ceiling joists in the garage

ACTION REQUIRED: You do need to inspect this flat roof next time it rains heavily to see if the rainwater is travelling off it or sitting on it otherwise the original problem will just be recreated.

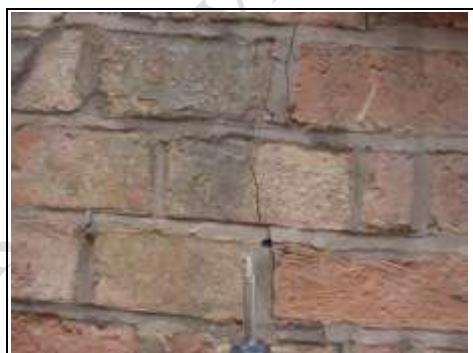
We noted some hairline cracking to the right hand side (all directions given as you face the front of the property) which is the drainage side of the property. We often find that where the cracking is on the drainage side it is due to minor leaks and drains and causing additional settlement in the ground below. Having said that in this instance unfortunately we were unable to have a comparable look at the left hand side due to our view/access being limited in this area. We thought it best to record the hairline crack. As you can see there have been repairs previously.

Cracking to brickwork

ACTION REQUIRED: Your solicitor to specifically ask the existing owners if they have had any problems with subsidence and movement in the property and also to ask them to place an insurance claim with regards to the cracking as a safety measure as this then would limit any liability and the excess of the insurance assuming that you take on the same insurance company.

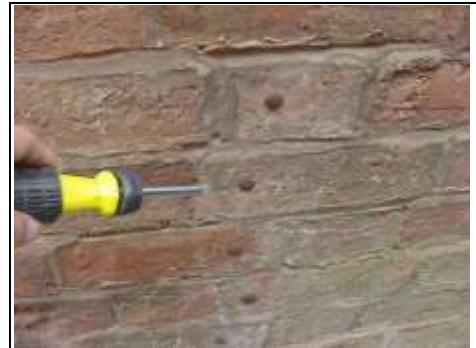
We found dampness to the rear of the property. We feel you may well be able to live with this so we suggest that you do live with it for a while. If however you are unhappy with this we would then suggest a French gulley is placed around the property to reduce the dampness.

Plastic caps indicate a liquid damp proof course has been inserted which we generally find don't work

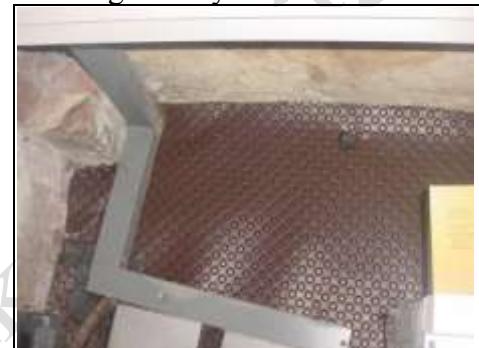
With regards to the basement you do need to accept that dampness is coming in as you are below ground and ground water table level and presently you have false walls that are hiding the dampness. We noted radiators were on when we went into the basement/lower ground floor and therefore suspect that there is dampness in the area and remember we are looking at selling at the best time of year, ie. during the drier summer months, things can only get worse!

Damp proof membrane photographed within the basement area

ACTION REQUIRED: We spoke to you about how you intended to use this area. You mentioned a gym. If this is the case then you do need to have some form of air circulation and ultimately you may need to replace some of the dry lining which we personally have done to properties we have owned in the past.

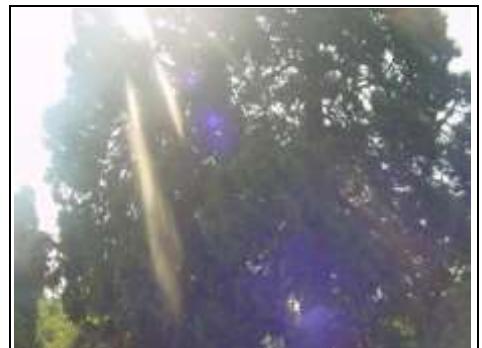
Large trees to front of property taken from the roof of your property

ACTION REQUIRED: For the trees that are not on your land your solicitor needs to make further investigation as to how they are maintained, whether you have a shared liability, etc. In the meantime we would suggest not parking underneath them due to the branches that could fall off them!

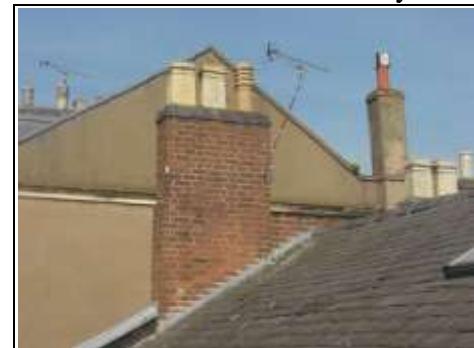
Chimney One

A brick built chimney with chimney pots and a lead flashing in reasonable condition requiring some minor repointing. This is mainly a preventative measure.

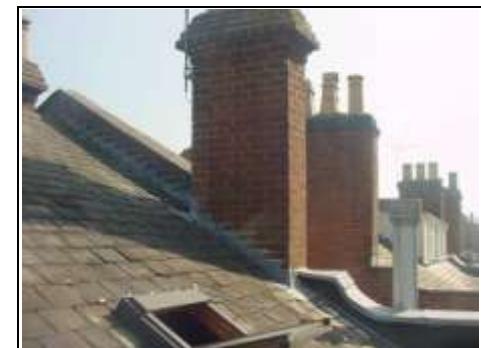
Chimney two

Again, a brick built chimney with chimney pots and a lead flashing in reasonable condition requiring some minor repointing.

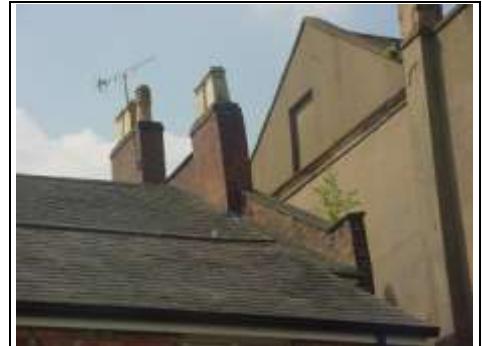
Chimney three

Brick built with a cement flashing which we recommend is replaced with lead as we do on the parapet wall. You can see the tree growing out of the end of the parapet wall.

We think it is well worth carrying out work to the chimneys to replace the cement fillet flashings with a lead flashing to the rear chimneys. The difficulty is accessing this area. We think it can probably be carried out on crawler boards although you do need to get roofing contractor quotations as soon as possible. Please see our comments in the Executive Summary.

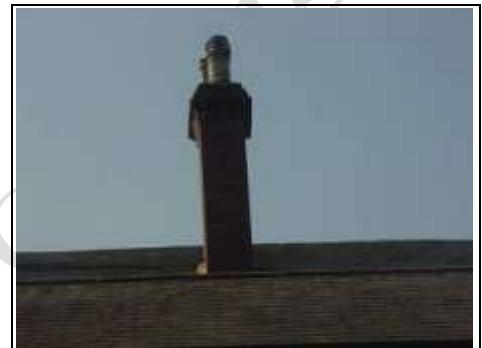
Brick built in reasonable condition, again it looks to have a cement flashing.

Central chimney – cement flashing needs replacing

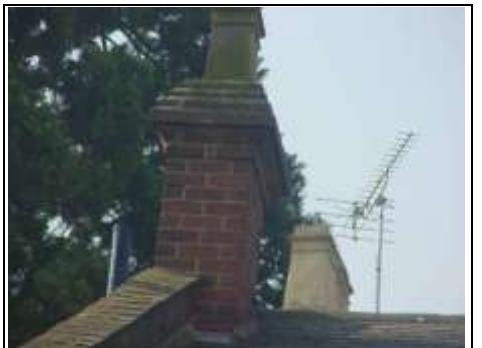
Chimney Five

A difficult chimney to see. From what we can see of the other chimneys we would recommend a closer inspection.

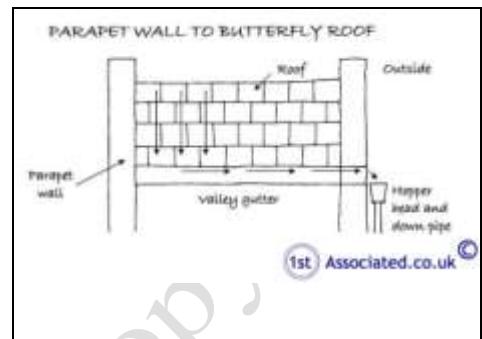
The rear parapet wall running on the right and left hand side is brick built but unfortunately has a cement flashing and also the coping stone is not particularly good as you can see with the tree growing out of it.

ACTION REQUIRED: We therefore recommend replacing the cement flashing with a lead flashing and overcladding coping stones. This is likely to need local authority approval for this work.

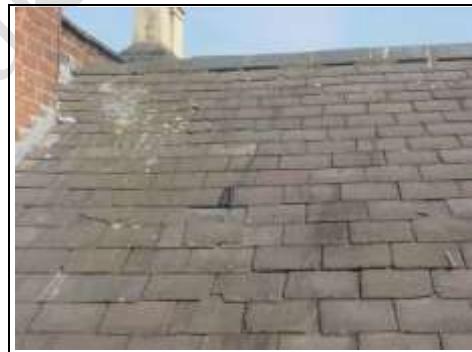
This is a slate finished roof. We can see it has been repaired many different times in many different ways.

Front slate roof

ACTION REQUIRED: The roof needs now repairing systematically and properly. Please see our comments in the Executive Summary.

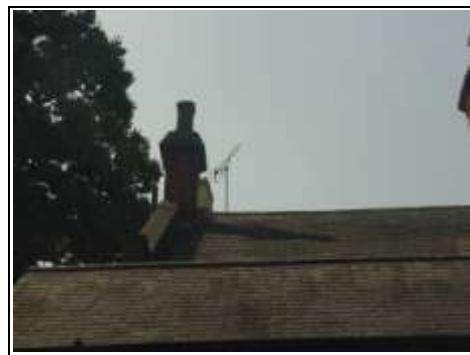
This is also a slate roof, we were able to view both roofs relatively closely and feel they are in average condition for their age, type and style but nevertheless we would recommend they are checked.

Rear roof

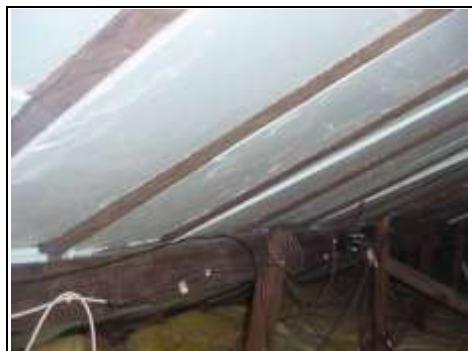
We were able to access both the front and the rear roofs. The front roof was hidden with insulation, this is where we have our concerns about the amount of insulation. Please see our comments in the Executive Summary.

Insulation in front roof

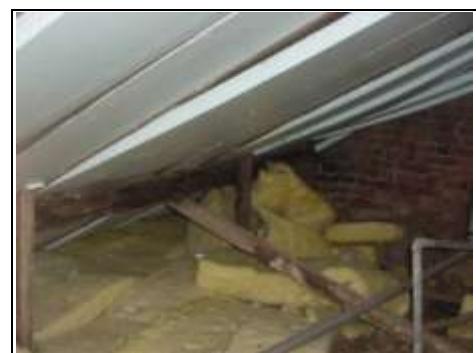
Condensation and possibly damp coming in on the rear roof 40

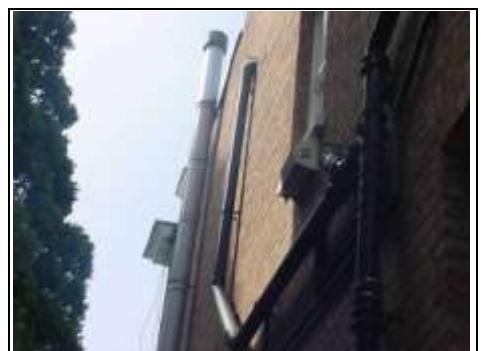
The property has a mixture of the original cast iron soil and vent pipes and the more modern replacement plastic strapped together. What we found were in typical condition for this mixture of materials. There is often some leaks, there is some corrosion of the cast iron, however we feel that most people could live with this. Some of the waste pipes have a torturous route which is not surprising with all the en suite bathrooms/shower rooms that have been added over the years.

Some of the waste pipes have a torturous route

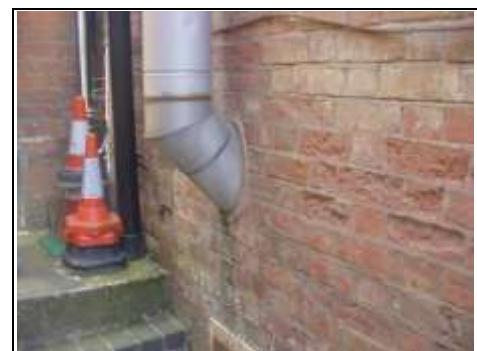
The side and the rear walls are built in brickwork of varying ages. There is Flemish bond to the front of the property which was originally lime bedded but has now been repointed in cement and mortar. Unfortunately we find in many cases this then leads to the spalling of the brickwork that you can see in this photo.

Flemish bond brickwork

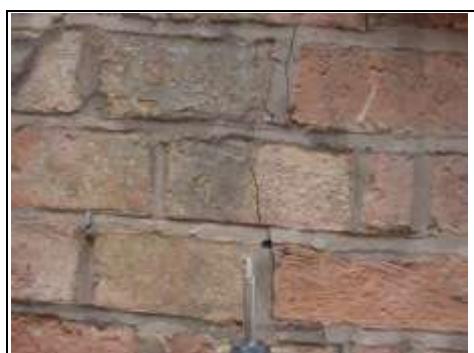
Cracking to brickwork

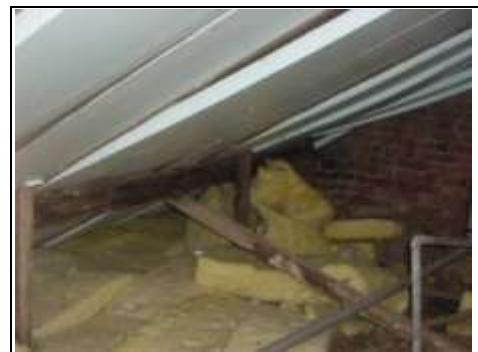
Condensation and possibly damp coming in on the rear roof

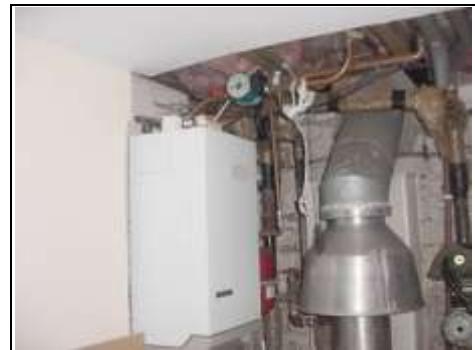
Unmarked boiler and factory lagged cylinder

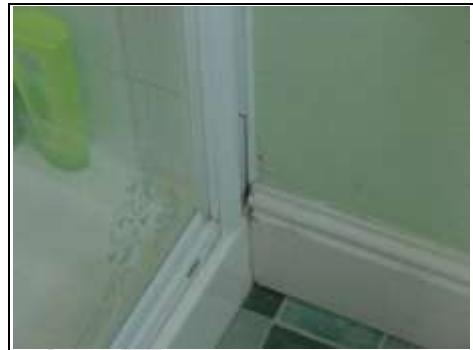
Leak to shower room
