RESIDENTIAL BUILDING SURVEY

London Borough of Merton

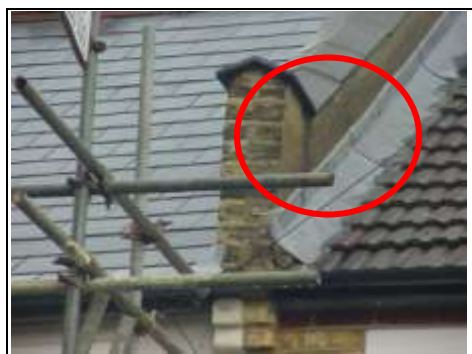
There are problems with the parapet walls which have allowed dampness into the property. This is caused by the lead work being incorrectly detailed to the left hand side and a tile on edge being used on the right hand side. Both of which typically have problems where dampness comes into the property.

Left hand parapet wall with original tile on edge and then lead over the top

ACTION REQUIRED: You need high level replacements of lead flashing and tile on edge flashing.

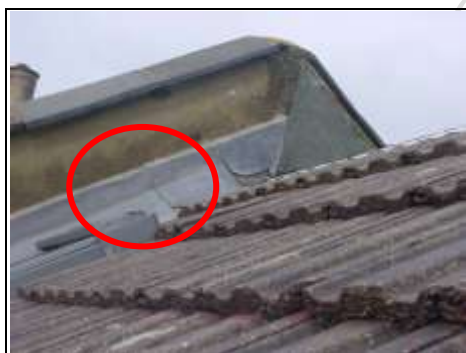
Close up of flashings (tile on edge with a covering of lead)

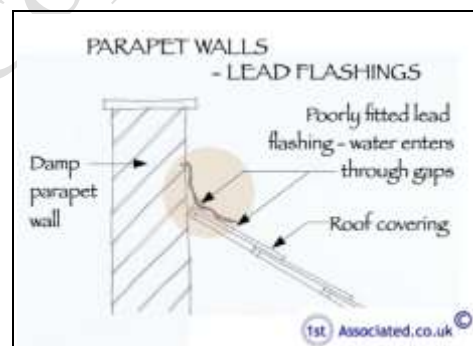
Lead flashing to left hand parapet wall.

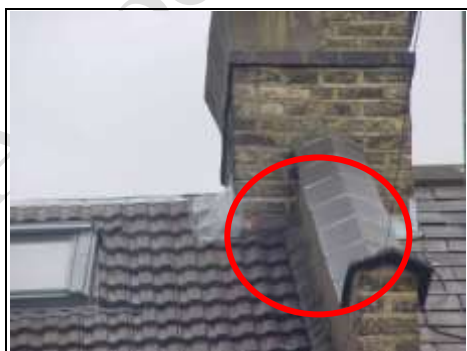
Right hand parapet wall tile on edge

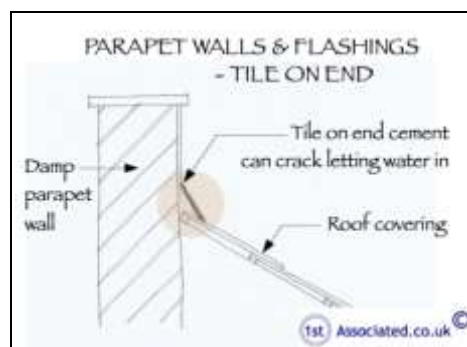
Tile on end to right hand parapet wall

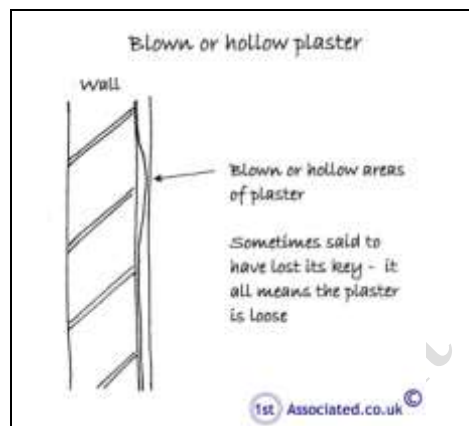
This has then resulted in blown and hollow plaster to the left hand side of the property where there is also staining visible.

Blown or hollow plaster

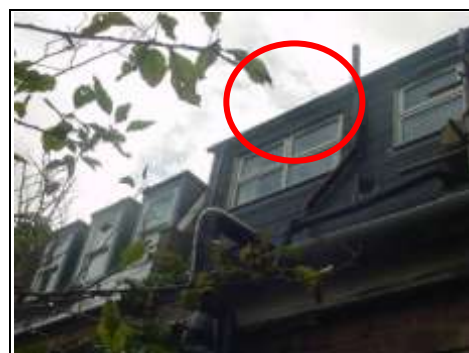
The property has had a loft conversion and part of this incorporates a flat roof section that is not visible from ground level other than very small areas. From what we can see it looks like a felt flashing has been used (they certainly weren't very good at flashings on this project); these need to be replaced with a proper lead flashing.

Flat roof

ACTION REQUIRED: Replace with lead flashings.

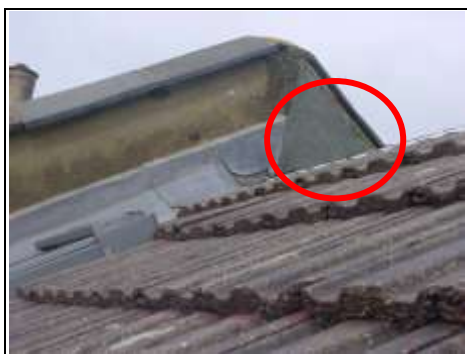
These flashings are problems waiting to happen. You will have enough concerns over high level flat roofs to a property such as this without poor quality work.

Felt flashing

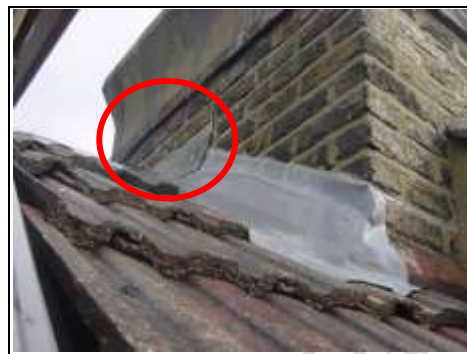
Felt flashing

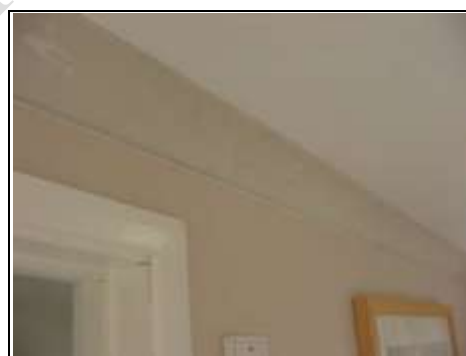
As mentioned the property has a flat roof on the roof extension, we couldn't view this other than the flashings that we have mentioned above. We have concerns over the quality of workmanship of the roofing in general. We need to gain access to this flat roof. Our concerns are highlighted as within the loft conversion bedroom a coving has been added but not decorated.

Coving to top bedroom indicating there may be dampness getting in via the flat roof

ACTION REQUIRED: We would recommend that an access hatch is formed in the flat roof to allow inspection.

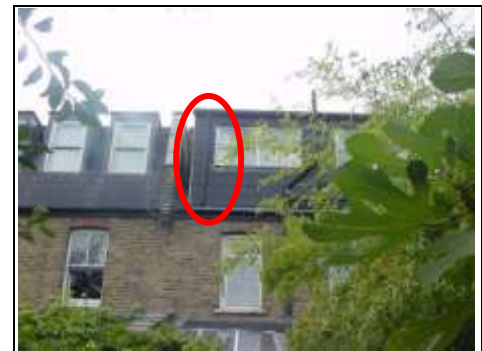
The flat roof rainwater downpipe discharges onto the rear gutter. This looks like it will overflow and in turn cause dampness to the rear of the property.

Downpipe to rear of property

ACTION REQUIRED: Replace guttering with a deep flow guttering and possibly add a hopper head detail. Unfortunately this is a very difficult area to access. This work should really have been carried out when the extension was carried out as it has been on neighbouring properties.

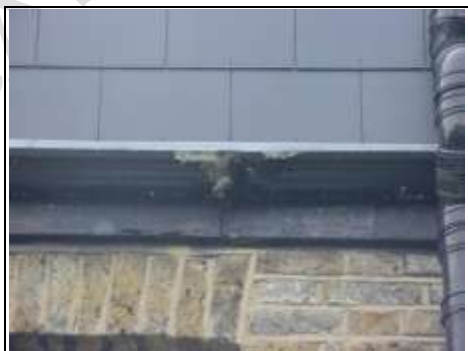
Gutter to rear which isn't coping, looks to be cast iron

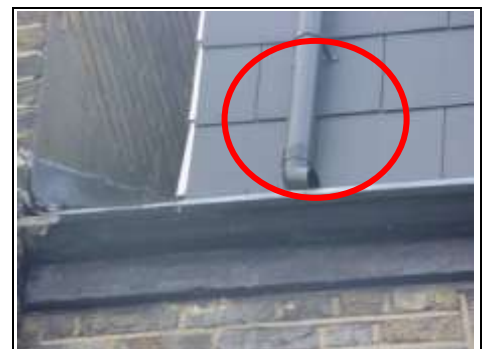
Downpipe causing overflow

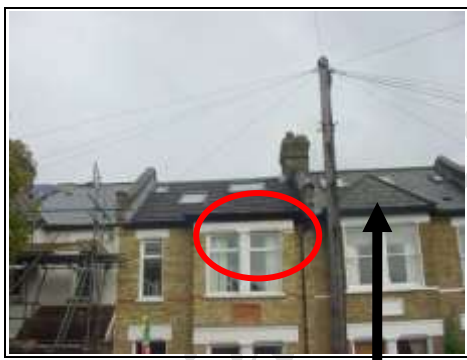
The box bay to the front has a flat felt roof which has ponding and needs replacing.

Flat roof to front box bay – you can see pitched roof to adjacent property

ACTION REQUIRED: Ideally this should be rebuilt to match the original box bay pitched roof as per the adjacent property and the rest of the street. If this isn't possible we would recommend stripping back all the felt, checking the decking which does look like it is in poor condition because of the way the ponding is occurring, probably replacing this and adding a lead roof covering with rolled joints would be most appropriate.

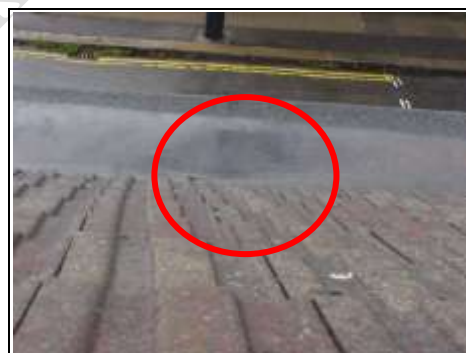
Ponding to bay window roof

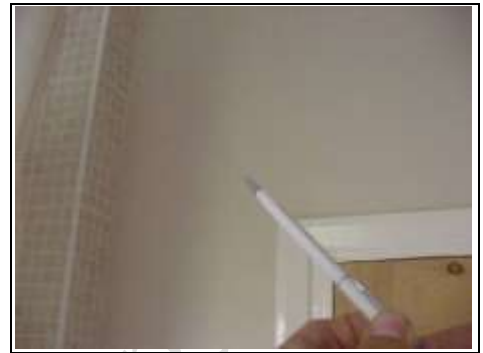
The mortgage company's valuation identified the property has had movement. We would say this is evident in distortions in door frames and diagonal cracking. We believe the work being carried out by the adjoining neighbour (left hand side) will open up these weaknesses in the structure and we also believe that signs of movement, even if it is not progressive (the only way to be 100% certain is to monitor the property for a year) does affect value. You need to be very aware of this. If you recall we discussed two identical hypothetical properties, one that has had structural problems that have been resolved and one that hasn't. Generally in our experience of valuation (we are a regulated valuer) can affect value.

Diagonal crack in bathroom which is a structural crack

ACTION REQUIRED: To be 100% certain that there aren't any problems you would need to monitor. We appreciate that this isn't a practical option; we would therefore be looking for the existing owner to either make an insurance claim based upon the hairline cracking in the property and you to then take over the insurance claim and their insurance which all needs to be in writing. We do consider there to be a low risk with regard to permanent progressive movement in the property but we cannot be certain without carrying out the monitoring for this period of time. We certainly believe it is a factor in your negotiations with regard to the value of this property which should not be overlooked, as it is a risk you are being asked to take on it should have a value attached to it.

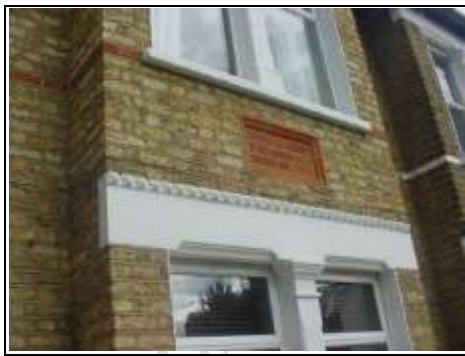
Brickwork to front was previously rendered

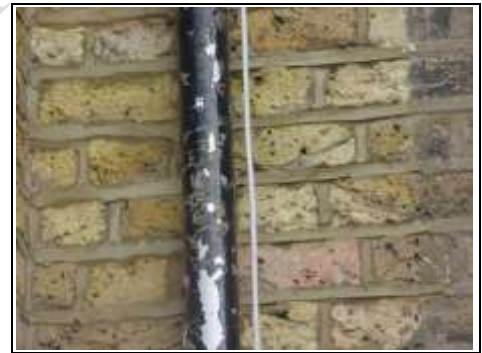
Surface of bricks sanded or sand blasted, possibly damaged when the render was taken off which means they will deteriorate more quickly

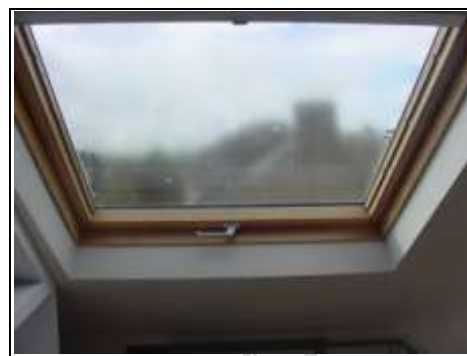
The double glazed windows have misted. You advised that you had been told that the windows had been installed in 2002 (we hope we remembered the date correctly). We generally consider that double glazing does last for around ten to twenty years. This deterioration could be due to the quality of the original windows or alternatively it could be due to minor movement in the property.

Misting of roof window

ACTION REQUIRED: You may be able to live with the misted up windows, you may not. We noticed the windows in the kitchen in particular which are more visible as these are a feature of the kitchen area. We would recommend replacement

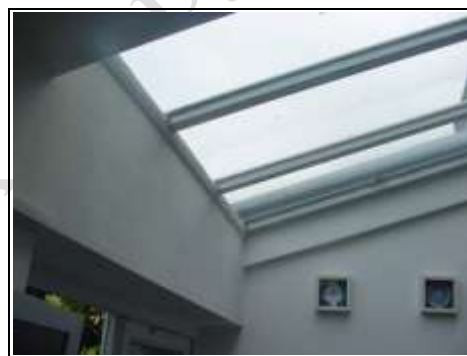
Roof windows in kitchen area misted

ANTICIPATED COST: In the region of £2,500 to £5,000, again it is the access that is the issue. Please obtain quotations.

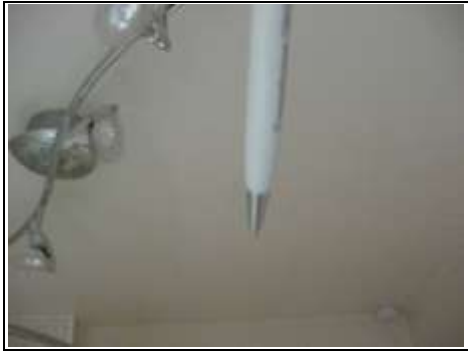
There is general hairline cracking throughout the property both to the ceilings and the walls. We believe this is due to the deterioration of the lath and plaster. We can see areas where it looks as if plasterboard has been tacked over the lath and plaster.

Straight line crack to bathroom ceiling

ACTION REQUIRED: We would recommend in any humid areas the cracks are sealed with a mastic or some other flexible material and lining paper with a skim coat of plaster in other areas that are not affected by humidity. We would also recommend putting in large humidity controlled extract fans.

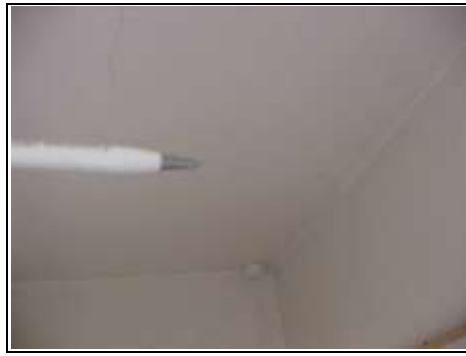
Other straight line crack to bathroom ceiling

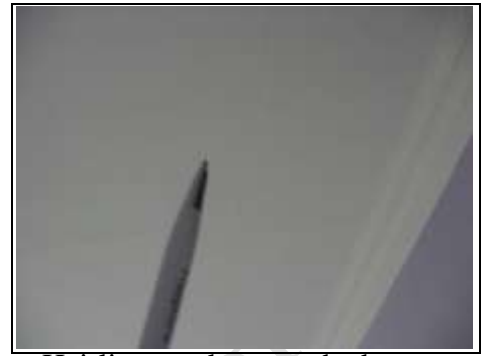
Hairline crack to rear bedroom

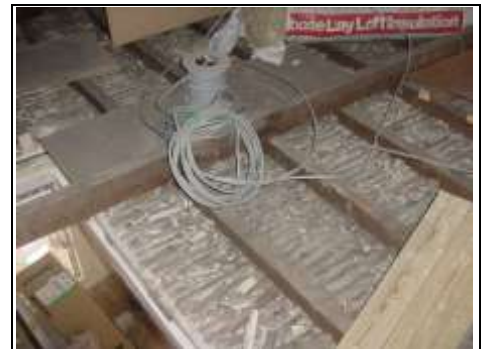
Broken laths to next doors ceiling

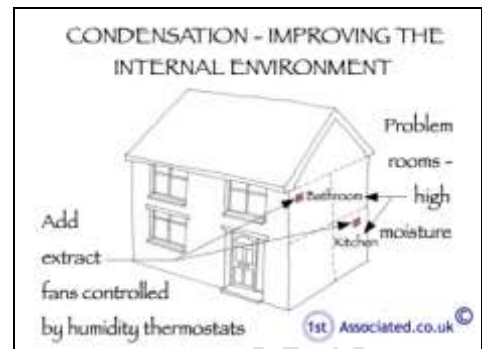
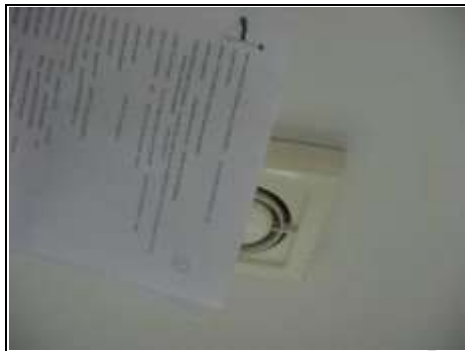
We noticed in the kitchen and bathroom, both of which are humidity creating areas, there were no appropriate extracts.

Next to no draw on the extract fan

ACTION REQUIRED: We would recommend large humidity controlled extract fans are added to the kitchen and the bathrooms.

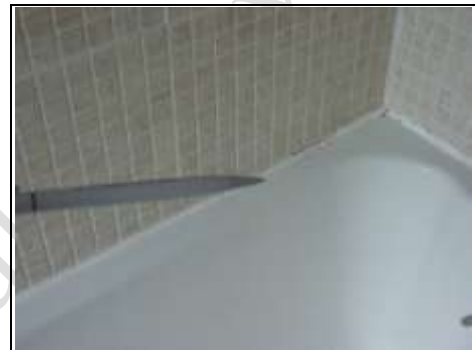
Mould to bath

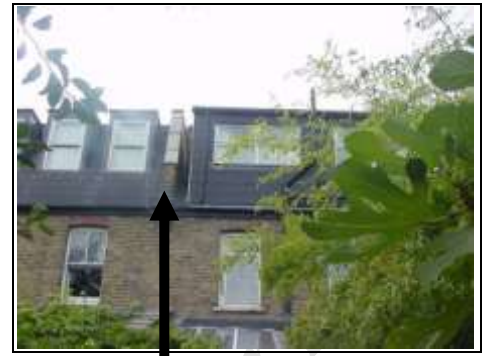
We noted the party wall to right hand side (all directions given as you face the front of the property) that the roof extension doesn't go up to the party wall, we assume because there is no party wall agreement.

Party wall

ACTION REQUIRED: Your legal advisor needs to provide copies of all party wall agreements that have been carried out on this property. We note that your neighbour on the left hand side is carrying out work which we feel would normally form part of a party wall agreement.

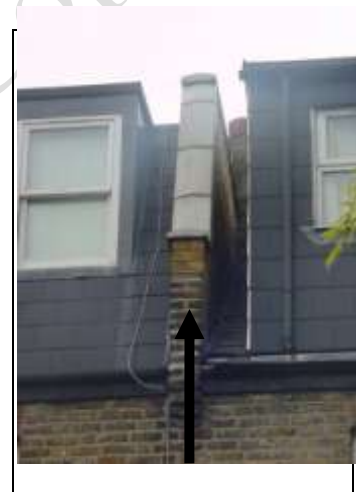
Close up of Party wall

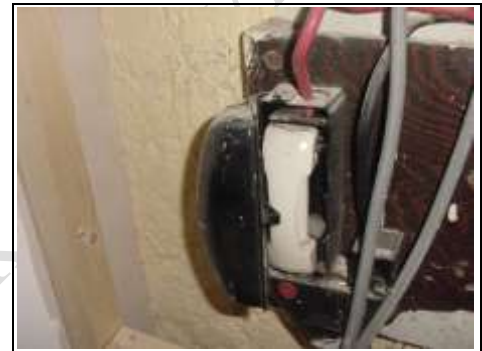
The electric unit in the cloakroom is very old with a porcelain transformer but interestingly there was a more modern fuse board under the stairs. We need a better understanding of why there are two fuse boards.

Porcelain fuse which is why we believe a re-wire is likely

ACTION REQUIRED: We would either recommend an Institute of Electrical Engineers standards (IEE) test to confirm this installation is safe or a report carried out by an NICEIC registered and approved electrical contractor or equivalent. We would anticipate there is a lot of old and dated wiring within the property. We were surprised this has been left in during upgrading of the property.

ANTICIPATED COST: £250 - £500 to have a thorough investigation. Re-wiring would cost in the region of £4,000 - £6,000 if required; please obtain quotations.

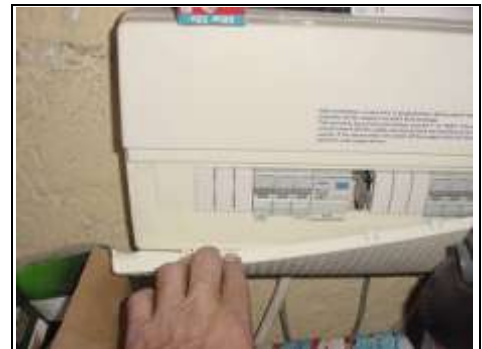
More modern fuse board – not sure which one is being used

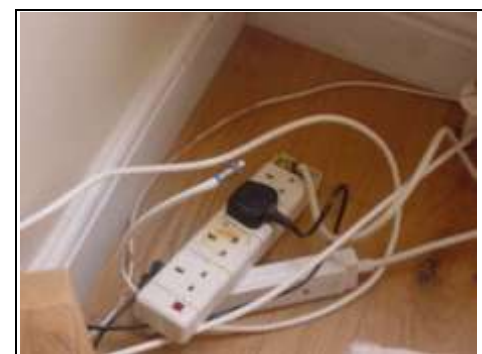
Extension leads were noted, more electric points required 25
