# RESIDENTIAL BUILDING SURVEY

**XXXXX**  
**Radlett**  
**Hertfordshire**  
**WD7 XXX**

**Mr and Mrs M X**

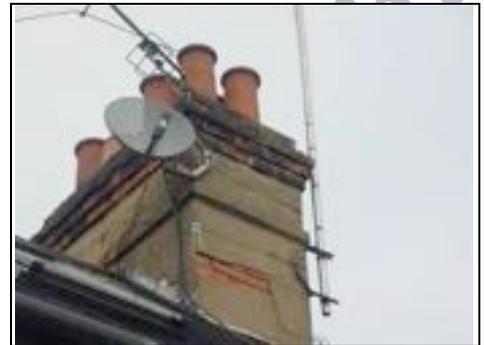
The left chimney (as you face the property) requires render repair and general making good to stop dampness getting in.

Render coming off chimney

**ACTION REQUIRED:** General repairs to both chimneys within the next few years; sooner rather than later.

**ANTICIPATED COST:** Few hundred pounds for chimney repairs; please obtain quotations.

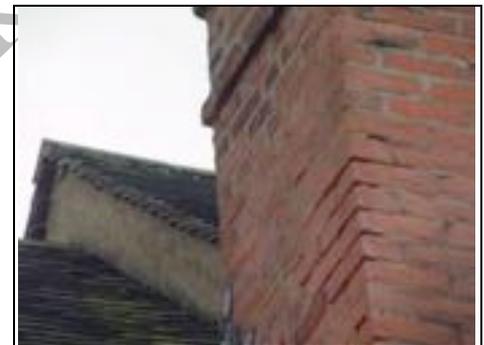
Brickwork needs repointing to rear right chimney

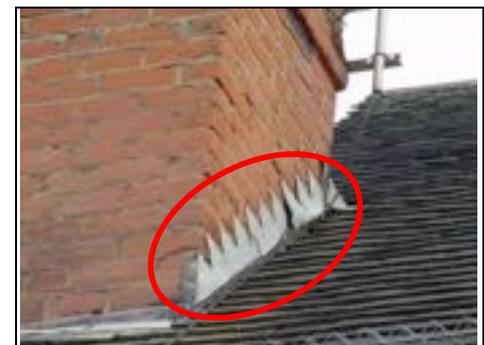
Flashing coming away

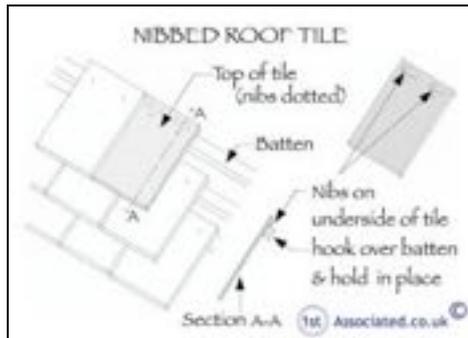
This is a pitched tiled roof. Some of the tiles have become displaced. They are likely to be nibbed tiles as there is a close boarded roof beneath, although we cannot be certain of this. Deterioration can be caused by water getting underneath these tiles (wind driven rain) and spalling occurring to the nibs. Unfortunately with this construction of roof (close boarded) there is no way of being able to check exactly what is going on.

Nibbed tiles

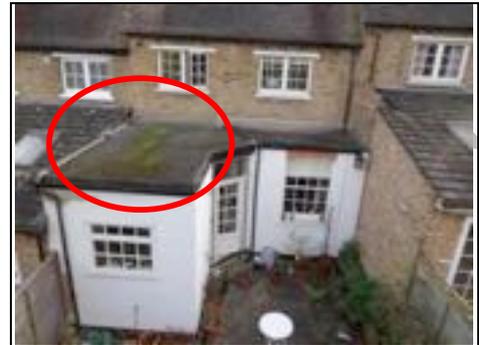
In this particular case we can see moss is sitting on the roof and the roof and we would term this as a flat, flat roof and as such we would ultimately recommend that it is re-roofed, although we consider that patch repairs can take place for some time, although you do need to bear in mind it can be hard to find problems on roofs covered with chippings.

Rear left flat roof  
Aerial view – 360 photo

**ACTION REQUIRED:** Budget for a roof replacement with a warm roof.

**ANTICIPATED COST:** In the region of £2,500 to £5,000, depending upon how the roof is detailed and if it is insulated. We would also add a lead flashing. Please obtain quotes.

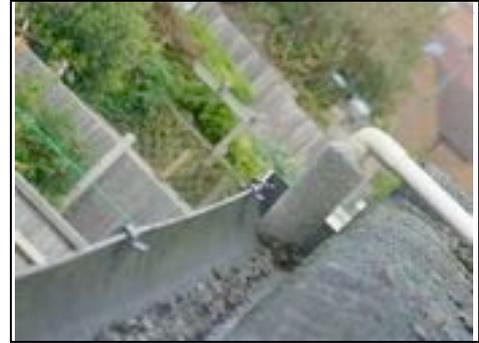
Condensing pipe going into  
downpipe. We have known there to  
be problems with these freezing as  
it's a condensing pipe from a boiler

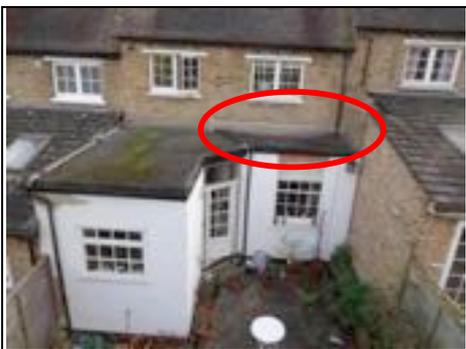
It was noted the downpipe from the main roof discharges onto this roof. Often it is best to put a slate underneath the base of the downpipe to reduce wear or to extend the downpipe so it crossed the roof further. This can be an area of surcharging where the guttering overflows when it rains heavily, which seem to be more common with our weather conditions.

Rear right flat roof  
Aerial view – 360 photo

**ANTICIPATED COST:** In the region of £500 to a few hundred pounds to repair the asphalt and improve the downpipe; please obtain quotations.

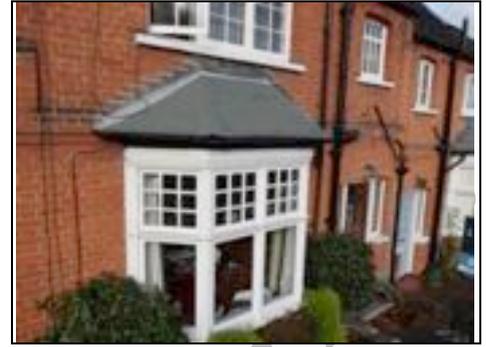
The front bay window roof is covered with mineral felt, rather than a tile covering. There has been some minor movement in the bay, as can be seen by the hairline cracking in the lath and plaster and old style textured paint ceiling internally.

Front bay window  
Aerial view – 360 photo

**ACTION REQUIRED:** We recommend re-roofing with a matching tile. This will also give the opportunity to have a store of tiles should there be any that become loose on the main roof.

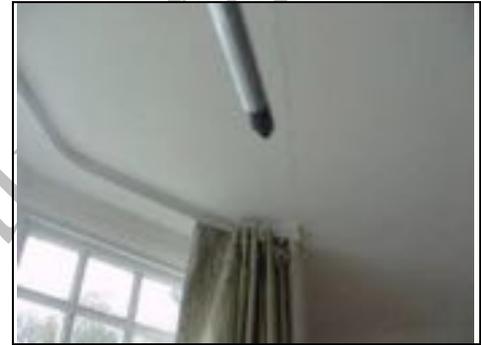
Crack in ceiling to bay window

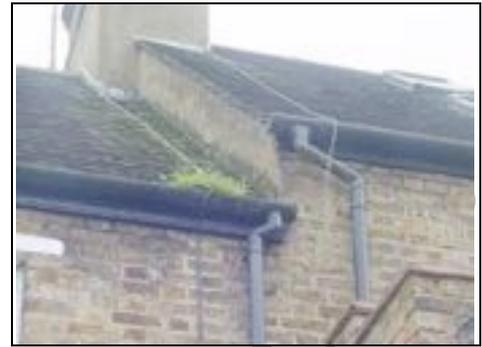
Grass growing from gutter

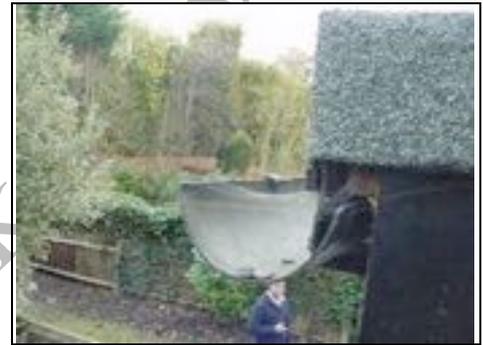
There are also other things such as the end cap missing on the rear guttering and, as mentioned earlier, the downpipe from the main roof discharging on the rear right corner of the flat roof.

Missing end cap  
(and next door neighbour!)

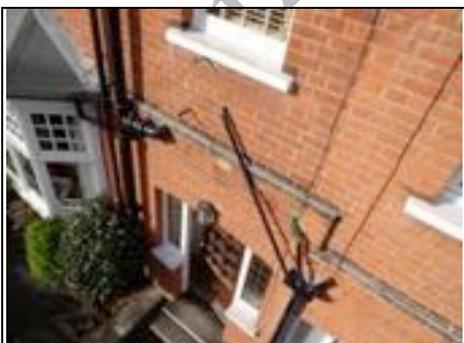
The hopper head on next door's property is overflowing and this may cause problems with dampness getting into your property. It should also be noted that the hopper head takes waste water from your bathroom.

Soil and vent pipe  
and next door's hopper head  
Aerial view – 360 photo

**ACTION REQUIRED:** We recommend you discuss this with the neighbour as it could well be worthwhile you relocating your waste pipes into your own soil and vent pipe.

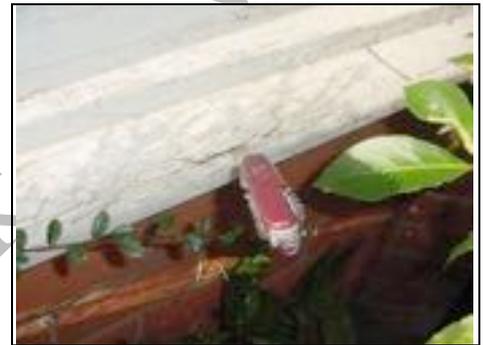
There are painted timber, single glazed windows. There are some signs of wet rot to the rear of the property particularly to the base of the kitchen door. You may want to replace the entire door for a more secure door.

Minor wet rot in timber window frames

**ACTION REQUIRED:** Repair and redecorate the entire external joinery. You may wish to replace the kitchen door as it is not particularly secure glazed door.

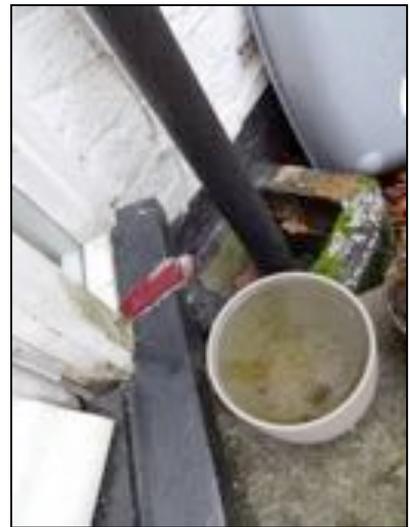
Rot to base of rear kitchen door

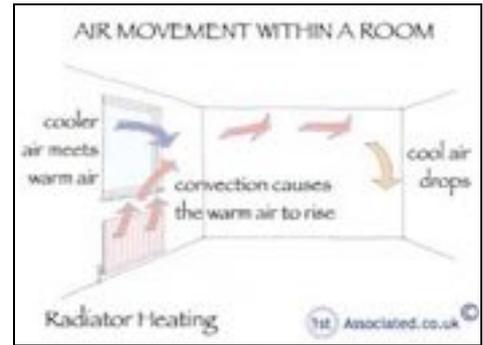
Air movement from radiator under window

We recommend radiators are repositioned under windows for better air flow.

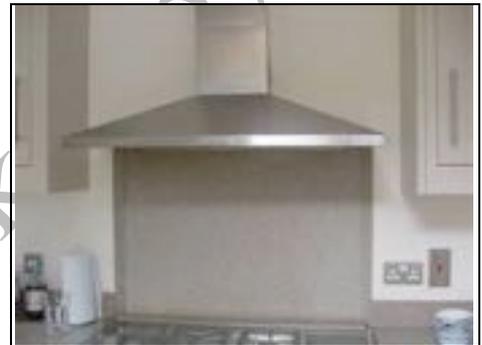
Filter over cooker – not an extract fan

**ACTION REQUIRED:** We would recommend good quality large humidity controlled extract fans in all humidity generating areas, such as the kitchen, bathroom and any areas used for drying clothes. You may also wish to make the filter above the cooker into a proper extract.

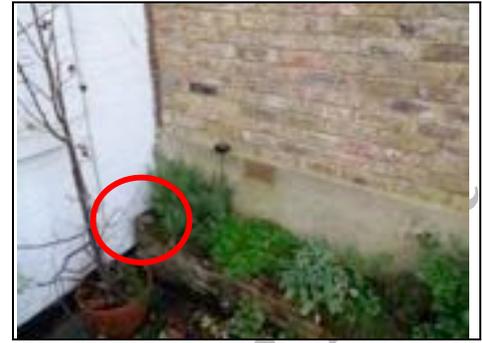
There were high damp readings to the rear left corner. This could again relate to the sloping site running from left to right and could also relate to what the next door property has within their property. It may relate in part to the brick bed planter to the rear of the property, although this did look quite low when we reviewed it in our photographs.

Planter bed to rear left side, maybe causing dampness internally

**ACTION REQUIRED:** We would recommend you meet with next door to see what is happening on their side of the property and whether they have dampness, and as mentioned we would also live in the property to see if dampness occurs.

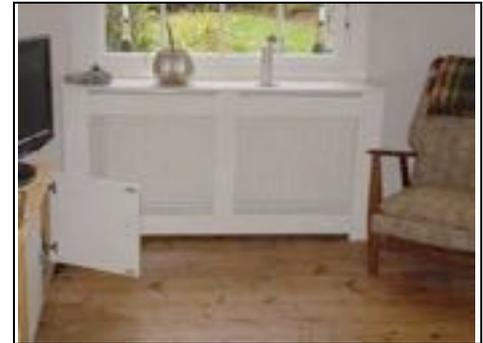
As mentioned some of the radiators are internal and ideally they should be positioned under the windows. The radiators also have radiator covers on them. We have found in the past that rusting radiators occur beneath. We did not open up any of the covers in this particular instance.

Covered radiator

**ACTION REQUIRED:** Relocate all radiators under windows and check condition of radiators.

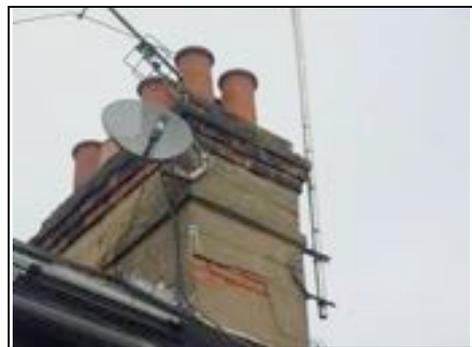
This chimney is covered with render, with a lead flashing and numerous chimney pots. From what we could see from ground level it looked in slightly below average condition considering its age, type and style. Areas of render are coming away.

We noted an aerial attached to the chimney, which we are not keen on as it cuts into the render rather like a cheese wire cutting into cheese.

Render deteriorating

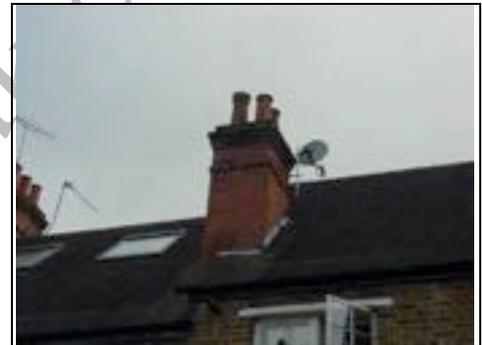
Rear right chimney

This chimney is built in a soft red brick with a lead flashing and four chimney pots. It is in below average condition for its age, type and style. We would comment that it needs repair and repointing.

This chimney has a satellite dish and an aerial, which can be held in place with wires which cut into the brickwork.

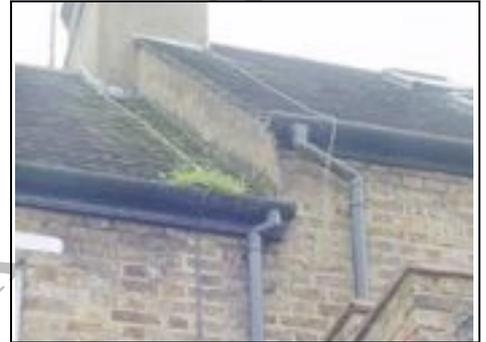
Grass growing out of rear gutter

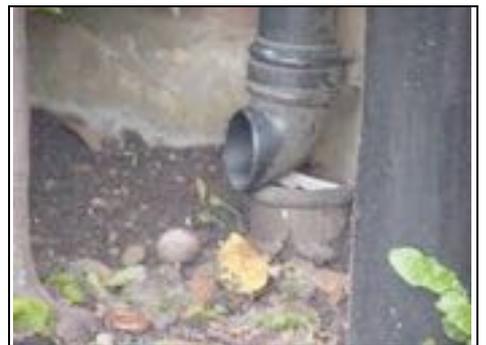
Downpipe discharges onto ground, which could cause dampness

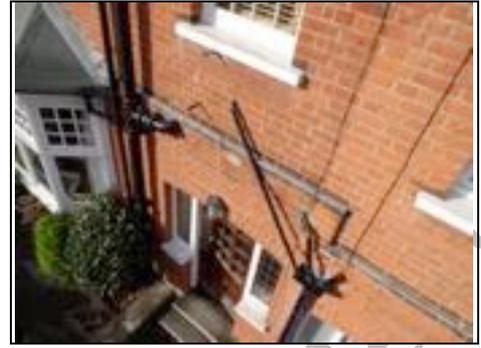
Soil and vent pipe discharging into next door's hopper head

**ACTION REQUIRED:** Please see our comments in the Executive Summary.

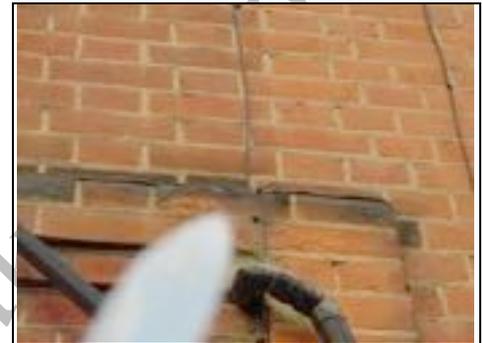
Soft red brickwork spalling

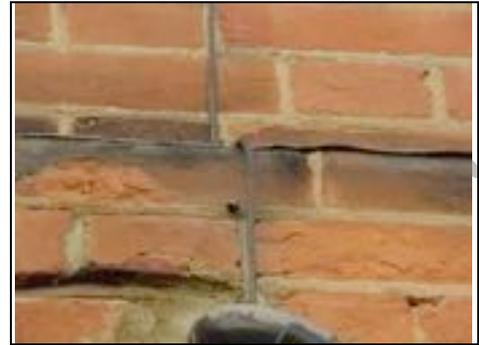
In this case a cement mortar has been used replacing the original lime mortar.

Close up of cement mortar and spalling brickwork

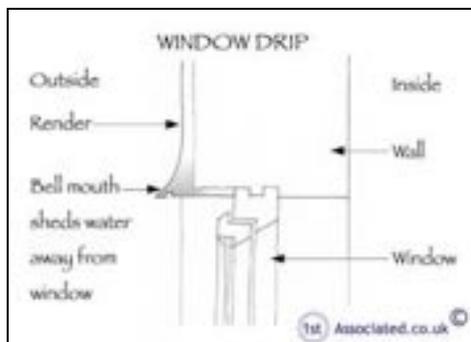
In this case we found no drip detail to the window.

Window drip

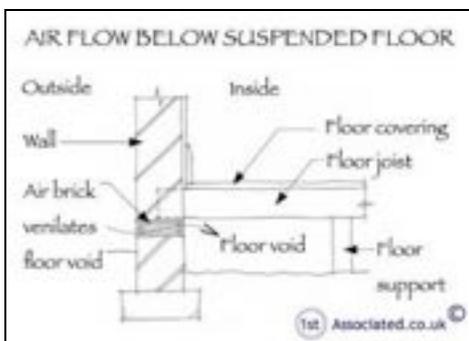
Air bricks are essential to have a through flow of air as this helps to reduce the chances of wet rot, dry rot and woodworm. In this case the bushes need removing / cutting back to the front to expose the air bricks. You may need to add additional air bricks to the rear.

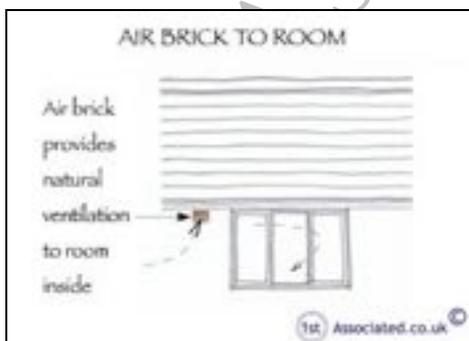
There is a high level to the rear and we recommend this is changed to a mechanical extract fan. To the front there looks to be a blocked up air vent to the bathroom.

High level air vents

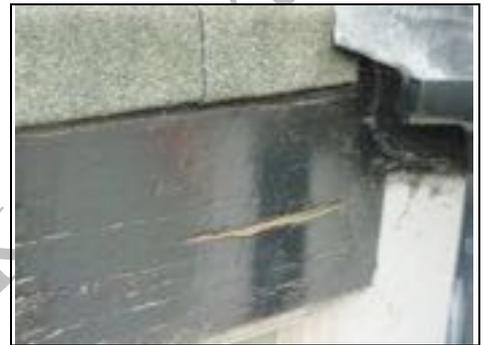
Fascia board needs redecorating

**ACTION REQUIRED:** Redecorate once the repairs to the gutters and downpipes have been carried out.

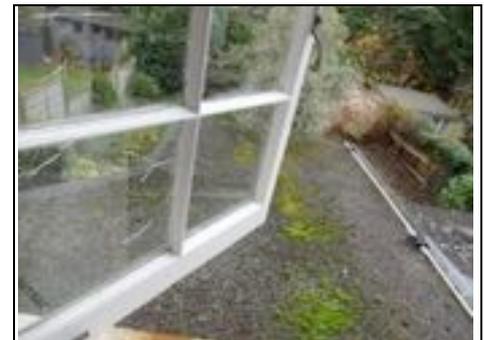
The property has single glazed timber windows. We would specifically comment that they have wet rot in some of the windows. There is secondary glazing in some of the rooms.

Broken window, moss on roof and condensing pipe from boiler

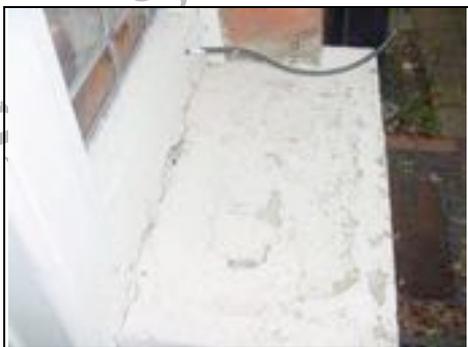
Window sill needs painting

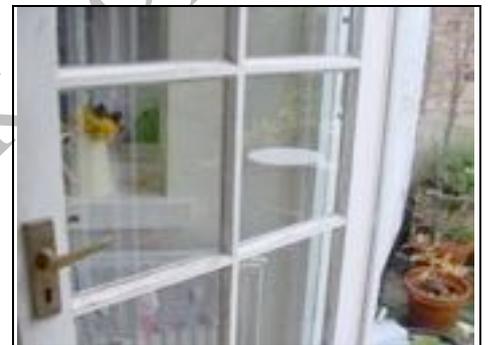
The glazed single door does not offer much security and you may wish to replace this.

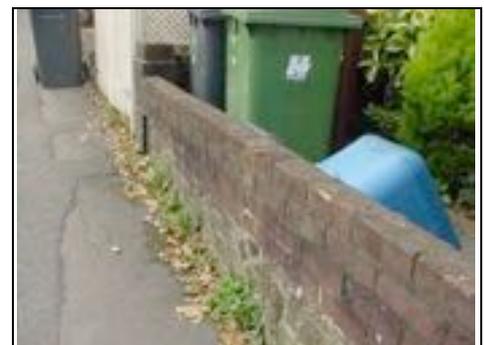
Crack to front wall

**ACTION REQUIRED:** Cut back bushes and repair front wall.

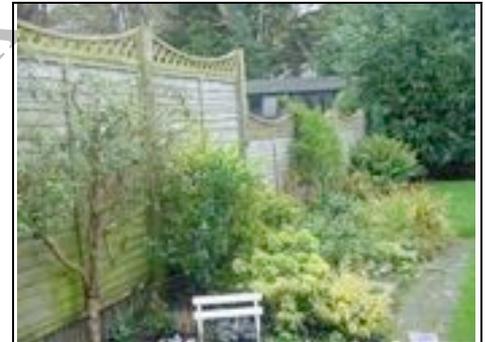
Fence to left side needs re-staining

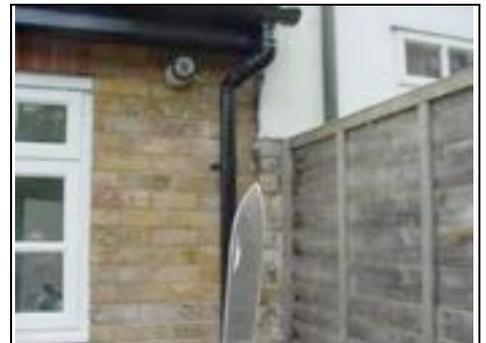
We went into next door's property and noticed that the fence boundary and wall boundary differed.

What is the correct boundary?

**ACTION REQUIRED:** Please see our comments in the Executive Summary.
