RESIDENTIAL BUILDING SURVEY

Kingston Upon Thames

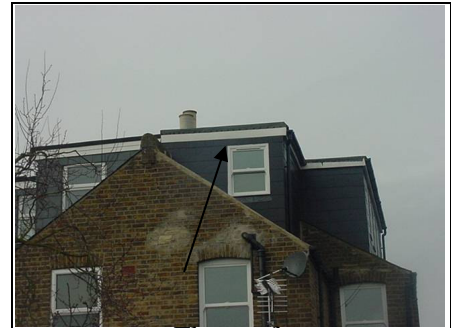
There are two flat roofs to this property, one to the loft conversion, which is not visible (we can only see about five percent of it), and one to the rear of the property. However what we can see gives us cause for concern. We can also see the rear flat roof which has been nailed in places, a practice that we don't believe is best practice.

Flat roof

ACTION REQUIRED: It is likely the roof will be okay for years to come as it is relatively new. We would however recommend a roof window or roof opening is added to the main roof to give access to the roof and to view it. We would be more than happy to comment on any photos that you take.

We would also recommend ultimately that you add insulation to the flat roof areas and a high performance felt.

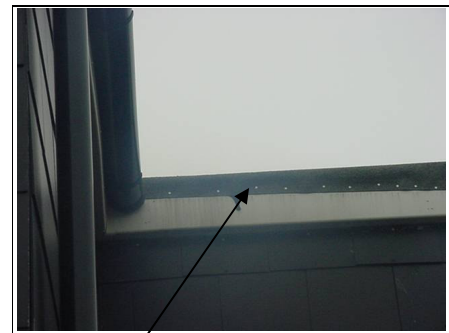
Nailing of main flat roof

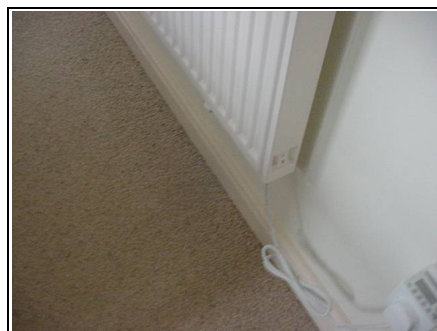
If you recall, the heater in the rear bedroom was electric and there was no heating in the front bedrooms as far as we could see (you can't just add radiators onto the existing system at this height as a property of this height often requires a fair amount of alteration, amendment and possibly pressurising to the system.

Electric radiator on top floor

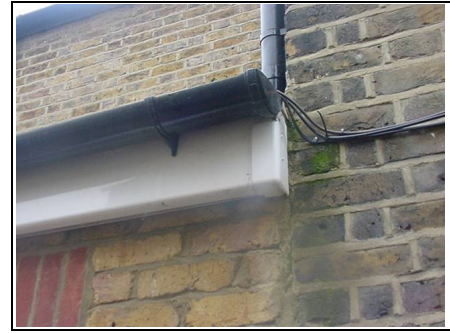
We often find that where properties have been altered and extended such as this one, that not enough thought is given to the gutters and downpipes and they need attention. We can see an overflowing gutter to the rear left hand side. There is also to the front left hand side a downpipe that is not fixed properly which is possibly the cause of the dampness in the front bedroom to the ceiling although alternatively it could be wind driven rain. We could also see a downpipe to the side porch extension that discharges on the ground rather than a soakaway, (a cost saving measure that often occurs these days).

Overflowing gutter

ACTION REQUIRED: Stand outside the property next time it rains heavily and see how the property deals with the rainwater. We would recommend this is carried out by the summer of 2012.

ANTICIPATED COST: Some of these problems are very expensive to resolve such as adding a soakaway so you may be better with an alternative such as a water butt and water being discharged away from the property to stop dampness. In other areas larger guttering such as a deep flow guttering replacing the existing guttering may well work. Please obtain quotations.

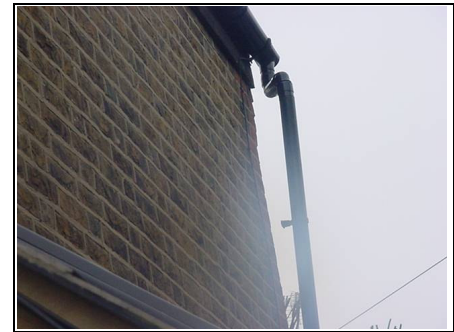
Unfixed downpipe

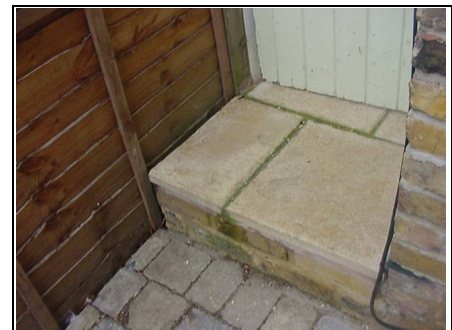
Water staining on the steps due to a leaking/surcharging gutter

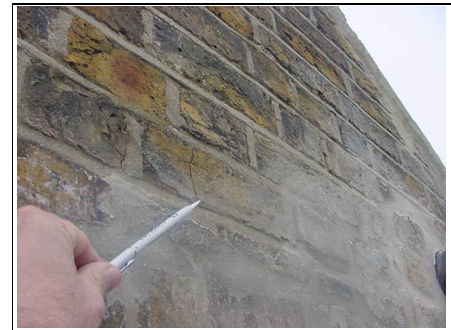
Hairline cracking to rear of prop
above bathroom window

As discussed it would be better to repoint in a lime mortar (lime every time) as this would give a breathability to the walls which would reduce/remove the dampness. However an older property will never be absolutely free of dampness in the walls as it was constructed to have some dampness in it.

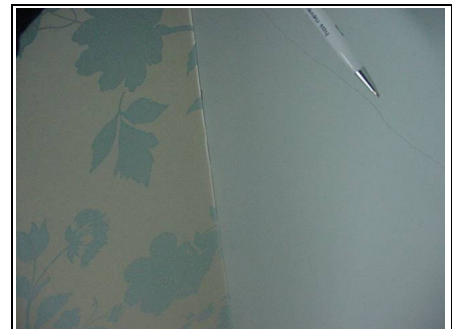
Hairline cracking to plaster

ACTION REQUIRED: You need to understand this is a characteristic of the property and as such there may be hairline cracking to the walls and to some of the ceilings where these have had a gypsum plaster skim coat.

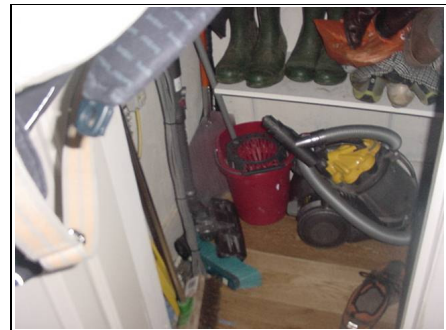
Just a reminder that the laminate floor is quite springy – you may wish to have this re-laid particularly in the kitchen/dining room area.

Laminate floors everywhere, even under the stairs so we weren't able to see the real floor boarding

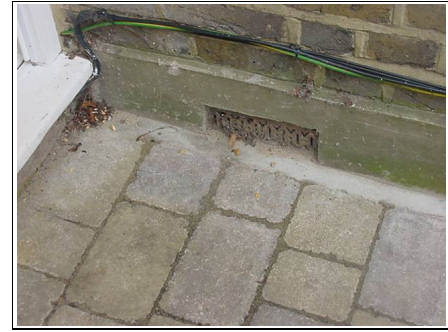
Airbricks are so important to allow an airflow underneath the property and they help reduce/lower the chances of wet rot, woodworm and dry rot. If you recall, we showed you the airbrick near the front door that looked to be acting as a gutter although it is on a slight fall.

Airbrick acting as a gutter next to the door

ACTION REQUIRED: All the airbricks need checking, particularly the one near the door, next time it rains heavily (you will already be outside in the rain looking at the gutters so also make sure you look at the airbricks). If it is acting as a gutter then it will need protecting (please see the above sketch). We would reiterate you also need to check the other airbricks are clear and allowing a through flow of air. Where a property has been extended such as this it can actually block up the airflow.

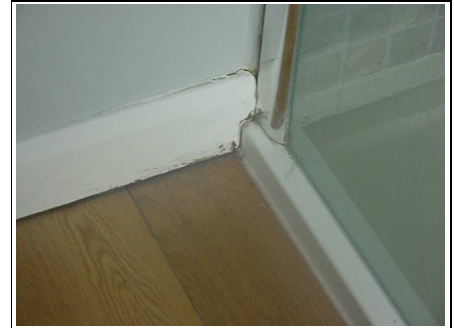
We believe there has been a leak from the top floor shower judging by the skirting board.

Leaking shower

ACTION REQUIRED: We would initially re-mastic the area. You need to be very aware of whether it leaks when you have showers and don't forget to add the extract fan in the shower area.

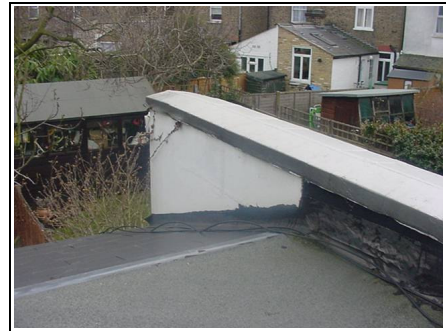
In this case there are parapet walls built from brick and are covered with flashband which is a product which we consider to be temporary (like a sticky backed metal). We have known it to last for ages, but equally we have known it to allow water in quite quickly.

Flashband on parapet wall which is not ideal

ACTION REQUIRED: The whole of the parapet detail needs looking at. This should be carried out in conjunction with your neighbour. We did knock on the neighbour's door but unfortunately no-one was in at the time of our survey. We would recommend that you speak to them prior to purchasing the property as we wouldn't be at all surprised if dampness is getting in this area. We would recommend lead flashings and the rebuilding of the parapet wall to a higher level and proper coping stones being added.

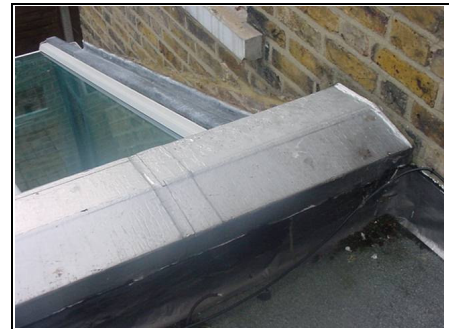
The original coping stone has been completely covered in a flashband.

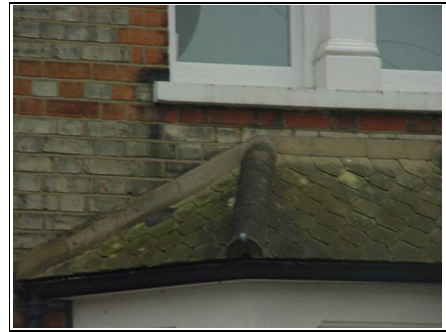
To the front bay window there is a pitched roof. This is probably the original tile. We noted it has cement flashings, which we are not particularly keen on and prefer to see lead. However we made a visual inspection internally and couldn't see any dampness coming through but this situation of course will change over the years.

Roof over front bay window

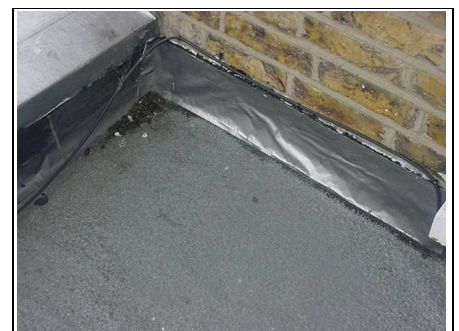
Flashband to rear flat roof

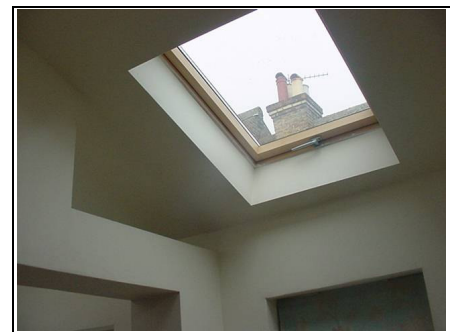
The property has a number of roof windows in the rear extension. Whilst they are a modern factory made unit, they are in an awkward location as the roof is relatively shallow and within the kitchen you can get fairly high levels of condensation. We noted there was some moss around then. Whilst a nice design feature there may be problems in years to come.

Roof lights in the kitchen that may get condensation

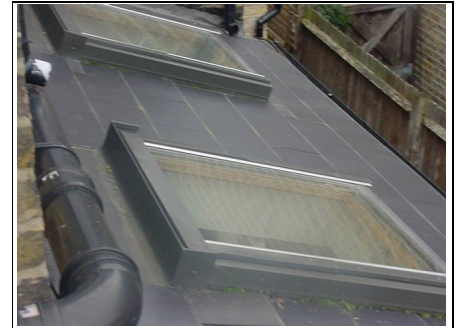
The property has plastic soil and vent pipes. There is a very awkward run of soil and vent pipes, which includes blocking up the extract from the bathroom and then runs all the way along the length above the kitchen at roof level. In our experience this would be prone to blockages.

Awkward soil and vent pipe

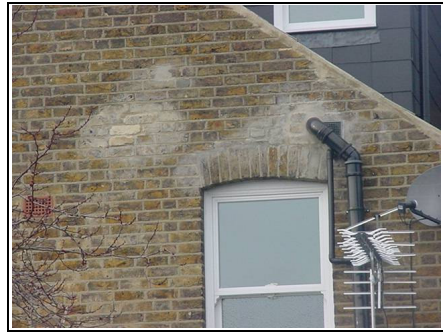
We would draw your attention to the cement mortar re-pointing that has been carried out on the exterior of the property. Whilst we find it on the majority of properties that we look at, it is no longer considered the most appropriate way to re-point on this age of property. Originally it would have been built in a Lime Mortar and this is what should be used for any re-pointing in the future. Luckily (or unluckily) the cement mortar does tend to come away on its own with the assistance of a stiff brush.

Repair work to rear wall

The use of cement mortar causes deterioration to brickwork and does lead to the face of the bricks deteriorating, which in turn leads to dampness. This is a very important point.

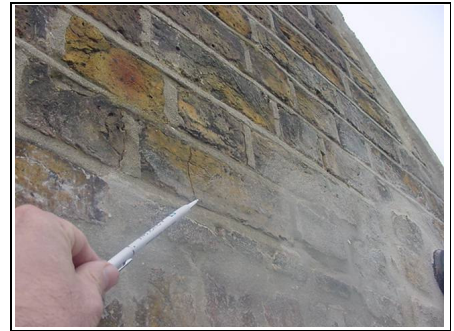
Cracking to the rear

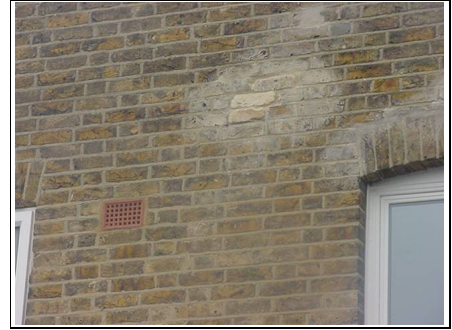
Next doors air vent and you air vent covered up

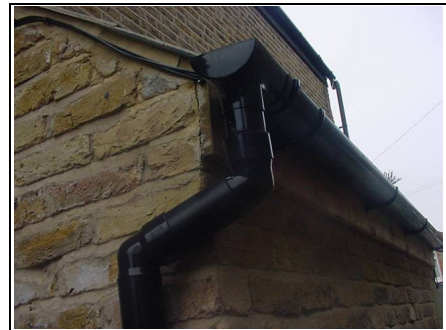
Fascias and soffits not painted to the left hand side

ACTION REQUIRED: Once you have carried out the work to the gutters and downpipes you then need to look at the fascias and soffits.

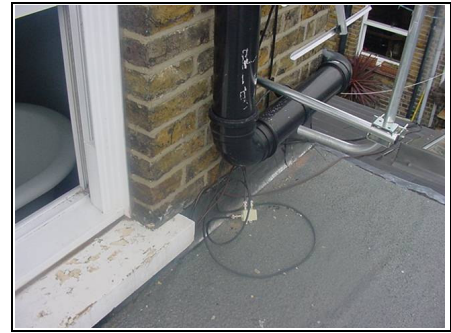
The window sills would benefit from redecoration and the fascias and soffits.

Window sills need redecorating

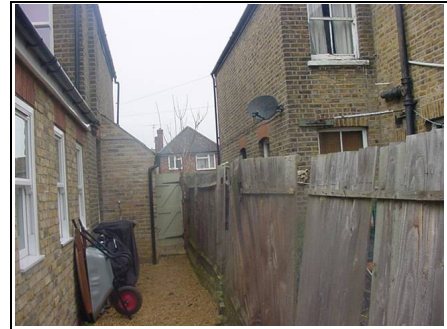
Left hand fence that needs repair –
likely to be your fence
