RESIDENTIAL BUILDING SURVEY

Shooters Hill,
SE18

FOR
Ms A

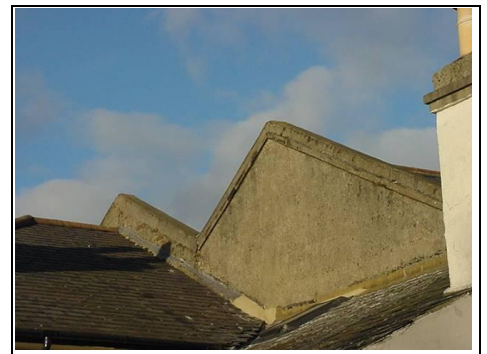
Parapet Wall

Flashband is a sticky backed felt which is best used for temporary repairs only.

ACTION REQUIRED: We would estimate the sum of £5,000-£10,000 (five thousand – ten thousand pounds) to carry out this work. However until you get onto the actual roof you will not be able to estimate the cost of this properly. Our concern is that you may

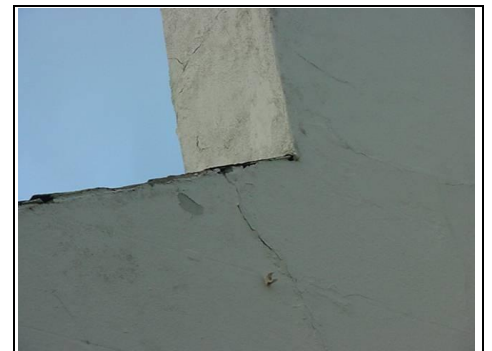
Cracked render

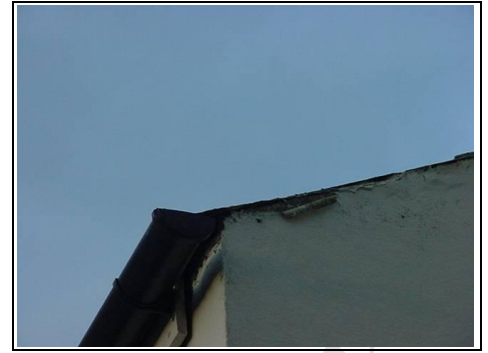
Cracked render

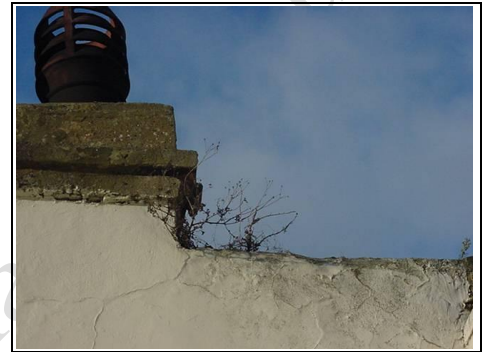
Vegetation growing on wall

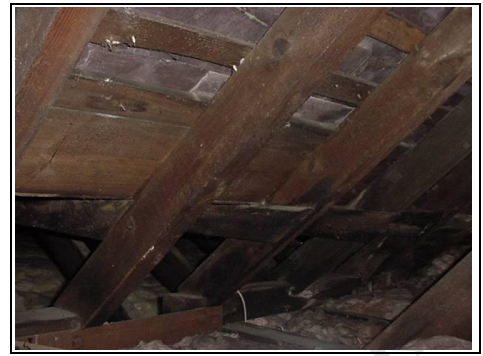
We could see the dampness in the timber that could ultimately lead to rot.

Close up of the valley gutter showing dampness in the timbers

By short term we mean in the next one to three years. For a long term solution most people will be looking at removing the slate roof and re-roofing which would cost in the region of £10,000 - £20,000 (ten thousand – twenty thousand pounds) depending upon scaffolding requirements and temporary roofing requirements. Please obtain quotations before you commit to purchase.

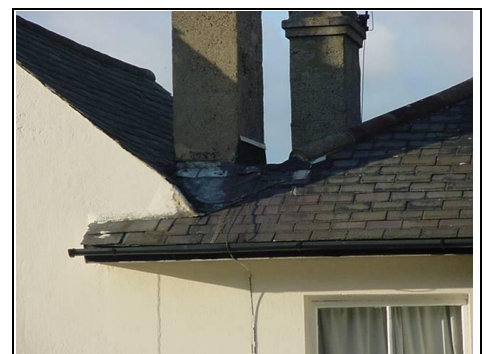
There is a valley gutter to the property that cannot be seen properly from the front but can be seen from the rear and in the roof space. These are generally considered problematic areas and we think that dampness is getting in which will lead to rot on the roof structure.

Hidden valley gutter

ACTION REQUIRED: We recommend that a roof light or access panel of some sort is put into the pitch of the roof so that the valley gutter can be seen, accessed and cleaned. Please note we did not gain access to the valley gutter and our view within the roof was limited due to the mass of insulation. Please note you may need local authority approval to add a roof light/access panel.

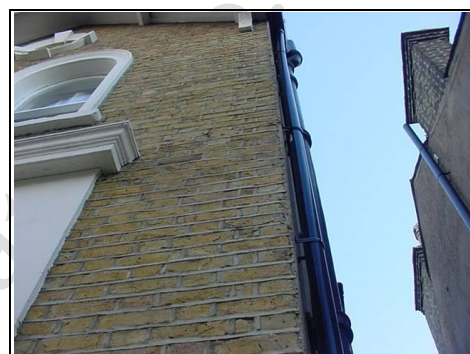
Unfortunately the brickwork has been re-pointed in a cement mortar rather than a lime mortar. It has also been proud pointed which means that ultimately it will cause damage and deterioration to the brickwork which is unfortunate. It should be lime mortar every time as this allows the buildings to breathe.

Cement mortar wrongly used instead of lime

ACTION REQUIRED: We would recommend a programme over the next few years of gradually removing the cement mortar and replacing it with lime mortar to allow the property to breathe again.

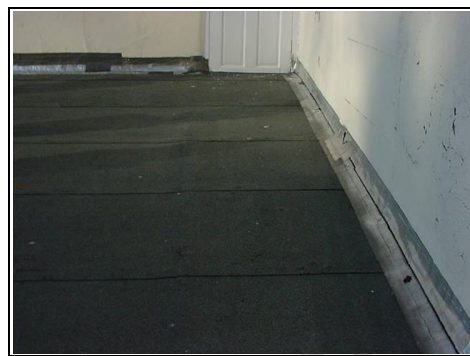
The whole concept of having a concrete roof within the kitchen of a residential property is not ideal as condensation can occur and cause what is known as cold bridging (please see the article in the appendices) Ideally we would much prefer a standard roof construction of timber. However you do have to be careful as it may somewhere be connected to your adjoining neighbours property.

General view of the kitchen roof

ACTION REQUIRED: Further investigation is required. Have a “cup of tea meeting” with your next door neighbour on the left hand side to check the construction of their rear area and to see if they have altered or amended their roof. We would also have an asbestos check on this roof to see if there is any asbestos content. You also need at the very least to use a ‘rust stop’ agent to stop the rusting that we can see.

ANTICIPATED COST: This is very difficult for us to comment on other than to say thousands of pounds will be needed to put this right. We feel the best bet is to completely open up the kitchen roof to see what is there. Then carry out

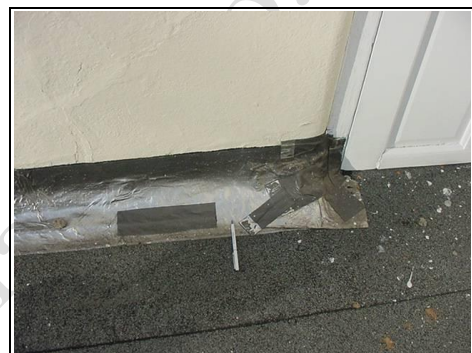
reasonable condition although where there is Flashband flashing around the roof we would much prefer to see this replaced with lead as generally Flashband is considered a temporary repair material.

Close up Flashband repairs with concrete roof in view

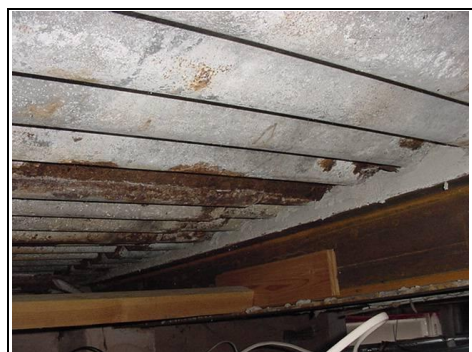
Possible asbestos in concrete
This needs checking

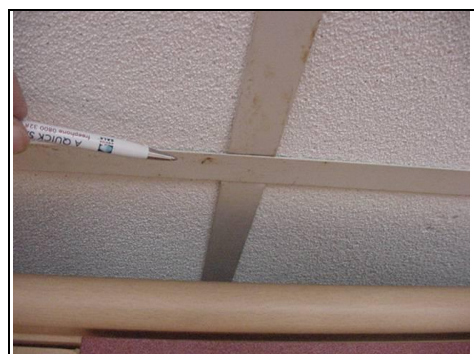
Dampness has come through as shown by the rust on the suspended ceiling system

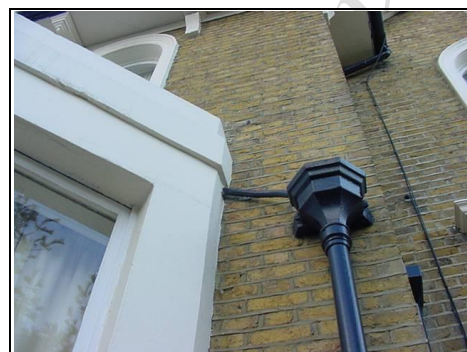
Small downpipe from bay window.

Often problems are caused for example over the bay window where there is only a small downpipe. This then backs up and over flows and allows dampness to get into the structure.

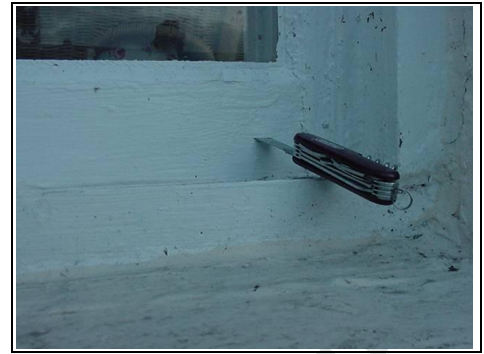
Rotten timber knife test

ACTION REQUIRED: Repair by splicing in new timber. We would always recommend saving as much of the old timber as possible as it was better quality than today's timber.

ANTICIPATED COST: As you are likely to need to scaffold the area to give a protective roof layer so that the kitchen is not damaged we would say £10,000 - £15,000 (ten thousand – fifteen thousand pounds) ; please obtain quotations.

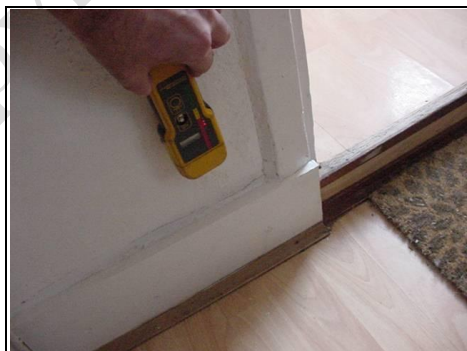
Dampness was found particularly to the rear of the property. We noted the high ground levels.

Dampness found in dining room due to the ground levels

ACTION REQUIRED: We would recommend lowering the ground level and ideally adding a French drain.

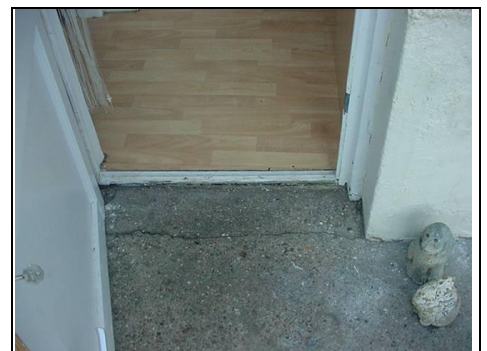
High ground levels

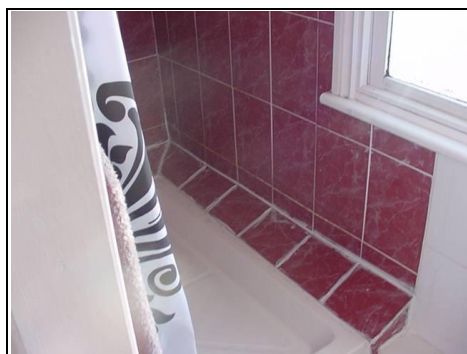
It does look as if the shower has been repaired several times indicating that it leaks.

Leaking Shower room

ACTION REQUIRED: We would recommend that you re-seal this area as one of the first tasks you carry out.

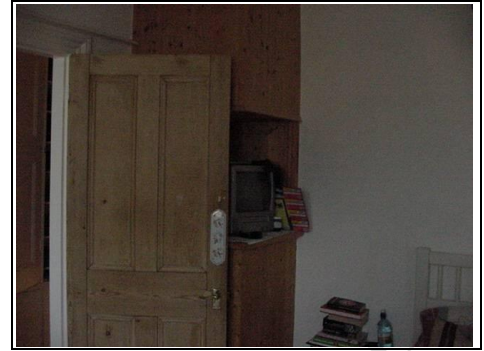
Boxed in old boiler

ACTION REQUIRED: Open up area to check its condition and see if the boiler and pipe work needs removing.

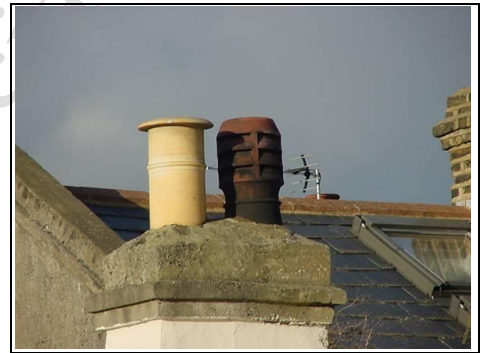
Rear left hand side chimney

This chimney is render finished with a cement flashing and two chimney pots. From what we could see we believe there may be problems with the render as we can see vegetation growing which normally means there is dampness in the render.

ACTION REQUIRED: Please see our comments in the Executive Summary with regard to repairs to all the chimneys.

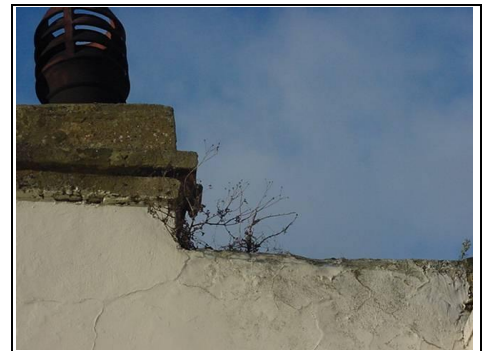
Vegetation growing in render

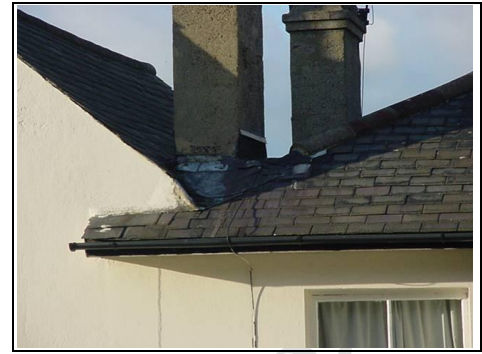
It is the base of the chimneys that concerns us as they sit in a valley gutter. It looks from the outside that there have been various repairs including re-tarring of the valley gutter. Within the roof we can see that dampness is getting in.

The two centre chimneys sitting in the valley gutter

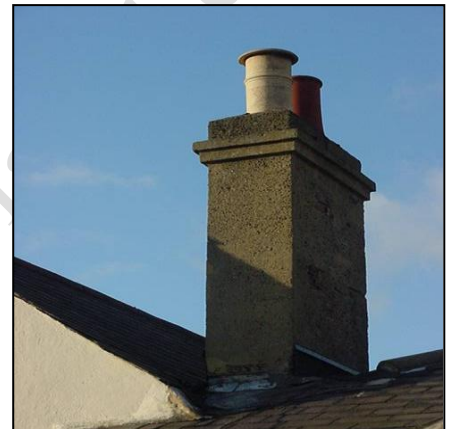
To Chimney three (the rear chimney) the render looks weathered. This is the stage that it starts to deteriorate and dampness gets in and frost can damage it considerably.

Weathered render on chimney

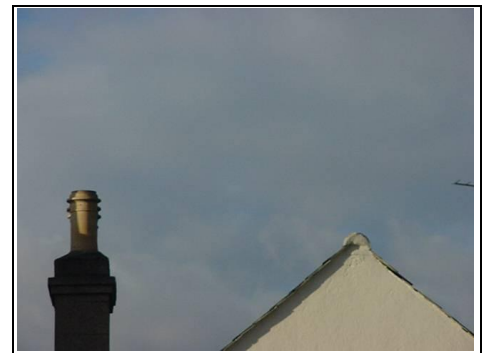
Right hand side chimney

This is the chimney we had the poorest view of and is the greatest concern. This is a large fairly slender chimney that needs a close inspection. We would recommend the summer of 2012 for this.

ACTION REQUIRED: We have concerns about all the chimneys. Please see our comments in the Executive Summary. We have recommended that a roof light is put in the valley gutter roofs. This is a roof window in the valley gutter that will give access to the central chimneys but will also give a better view of the other chimneys. This work should be carried out first and you would be better able to assess the work required to the chimneys.

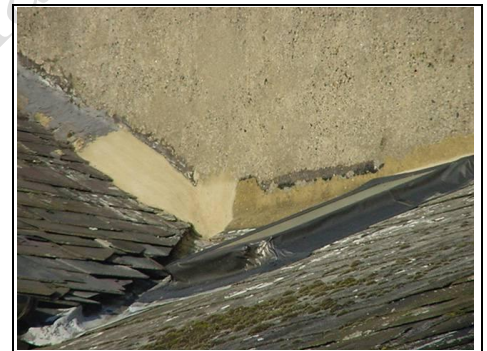
There are some awkward junctions to the rear of this roof and unfortunately the flashing looks to have deteriorated which in turn will mean dampness will get in. We could not gain access to the rear roof properly and we were very limited on our movements within the main roof due to the mass of insulation (we would not recommend this amount of insulation in this age of property).

Awkward junction

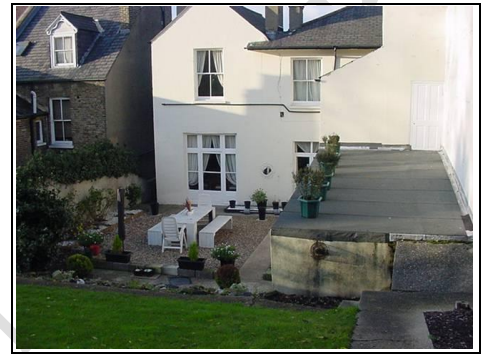
Flat Roof on kitchen

Flat roof with no gutter

ACTION REQUIRED: The detailing needs to be improved with the addition of guttering and the flashings need to be replaced with lead flashing.

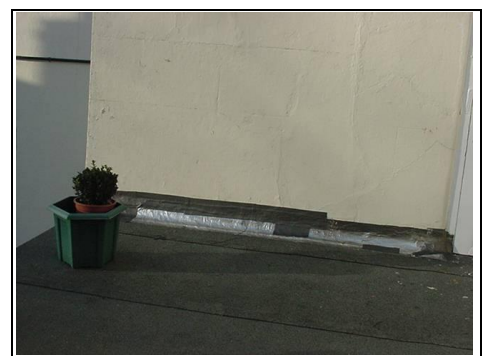
Repaired flashing

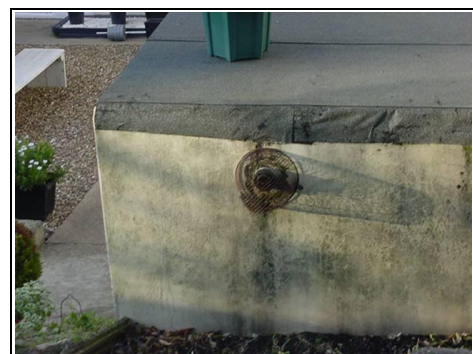
No guttering to the rear of the kitchen roof

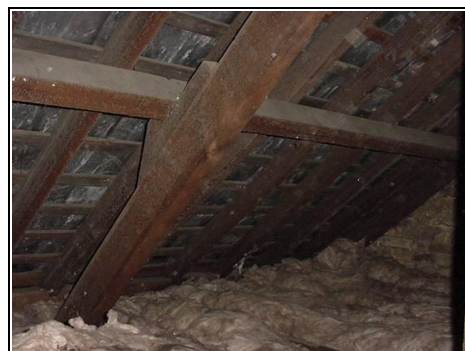
Looking at the roof to the right hand side with mould on the timbers.

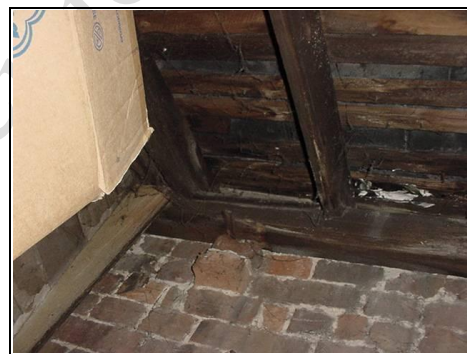
Rear Left hand side roof showing damp getting in.

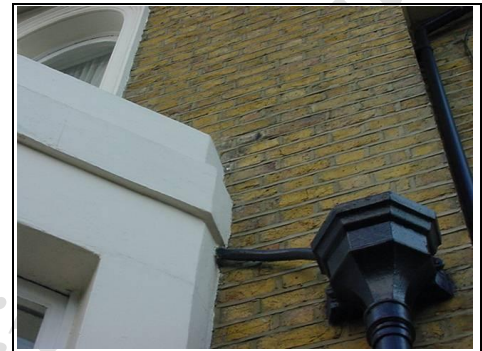
These looked in average condition apart from there being no guttering at all to the kitchen area. Also the canted bay window to the front of the property has the traditional 50mm piping which always becomes blocked

Small pipe outlet from the canted bay window that will leak and these always get blocked.

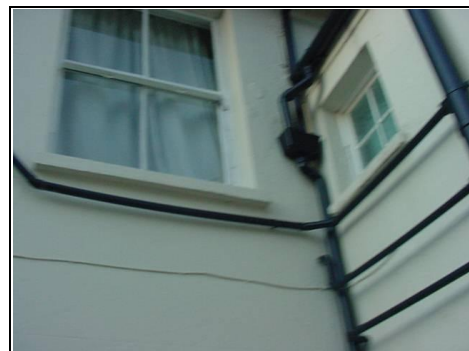
One of these runs from the far right hand rear bedroom to the soil pipe at the rear which we think is a blockage waiting to happen.

Long run of Soil and vent pipe

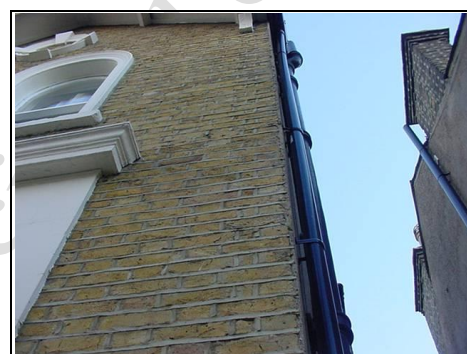
Re-pointing to the cement mortar to the front of the property

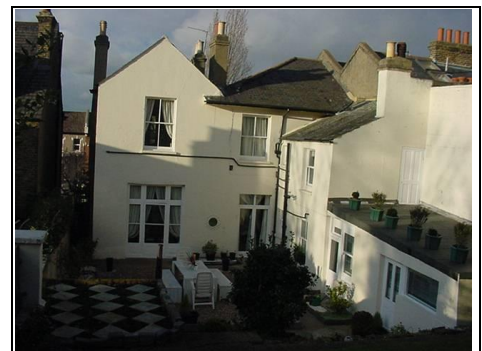
In this particular case we believe it is part of the original aesthetics and we would consider the render to be in average to below average condition.

Painted render to rear walls

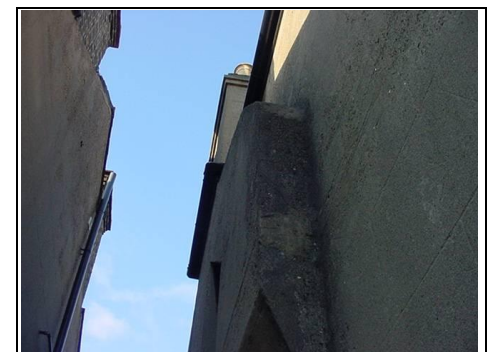
The render on the right hand side is unpainted and has a stucco effect which is lining of the plaster to make it look like stone. This area does not get much light and will be susceptible to dampness which means you need to keep the render in top condition to prevent this.

Render to right side wall

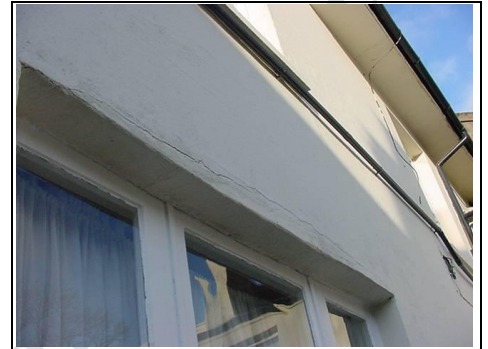
In this case we found no drip detail to the windows but we can see there is deterioration and cracking over the window. Please see our comments on Lintels in the Executive Summary

No drip over window

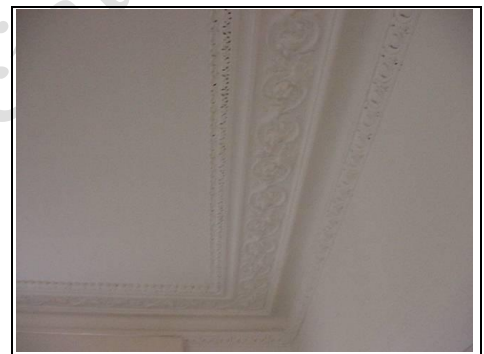
Unfortunately the cornicing has been painted rather than lime washed. This does mean that the detail of the cornicing has been lost over the years. Extensive repair work will be required to make the features fully visible

Painted Cornicing

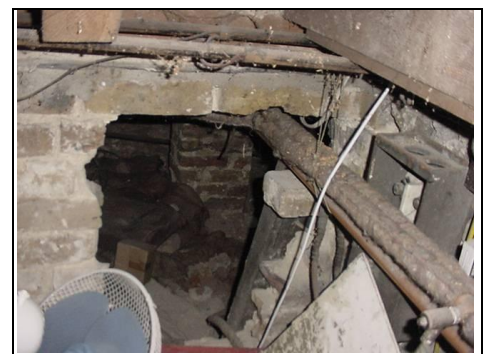
Stored items in cellar

ACTION REQUIRED: the whole cellar area needs clearing out to give us proper access before you legally commit to purchase the property.

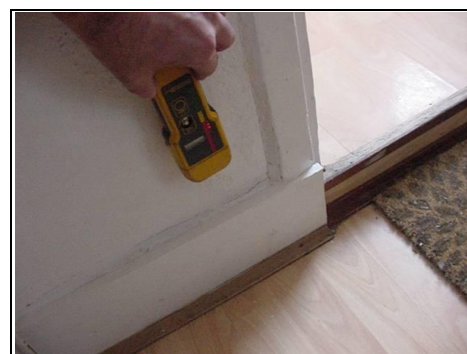
A random visual inspection and tests with a moisture meter have been taken to the perimeter walls and some internal walls. In this particular case we have found rising damp and we would comment as follows.

Testing and finding rising damp
