# RESIDENTIAL BUILDING SURVEY

London  
South East

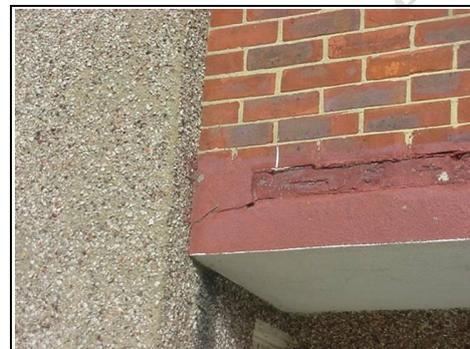
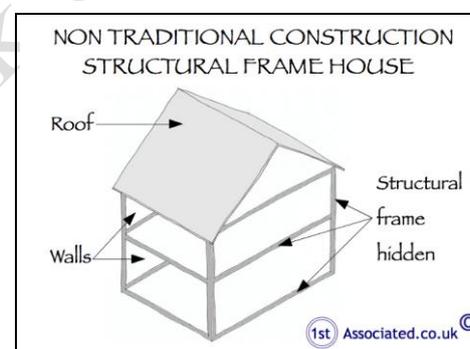
Deterioration to concrete frame

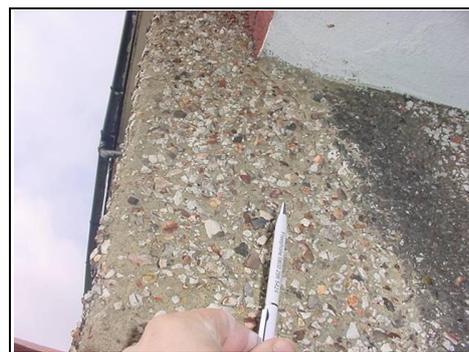
Vertical hairline cracking  
to the structure which is almost invisible unless the structure is closely viewed.

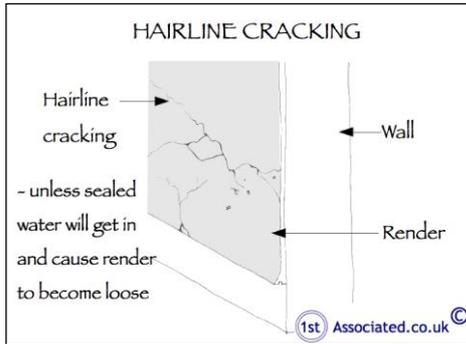
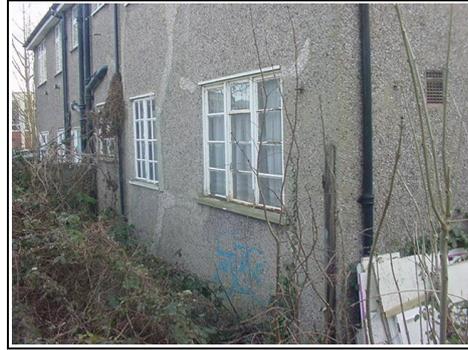
Cracking to render to rear of property

**ACTION REQUIRED:** We would recommend the entirety of the rear of the property is re-rendered once you have established if there is any movement in the property and resolve this if there is.

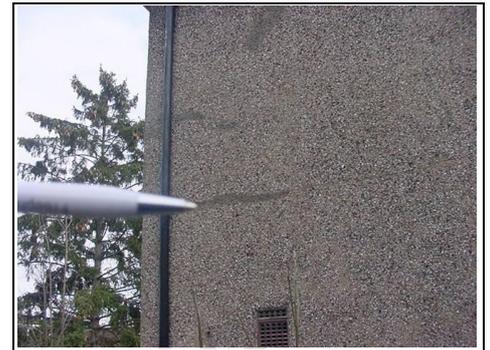
Horizontal cracking

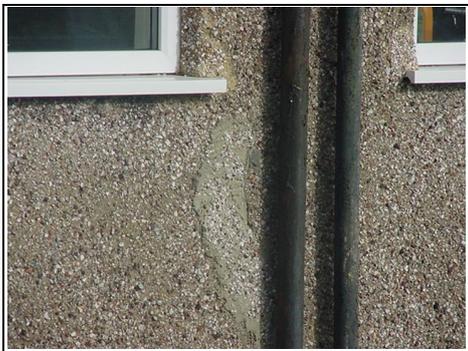
Bad pea shingle repair

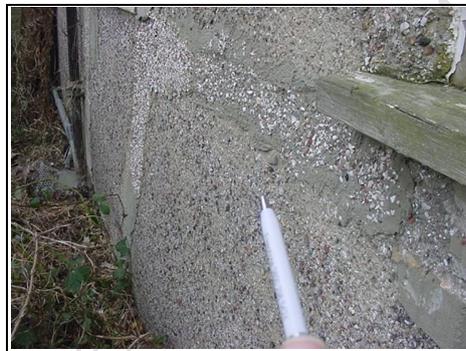
Repair to render

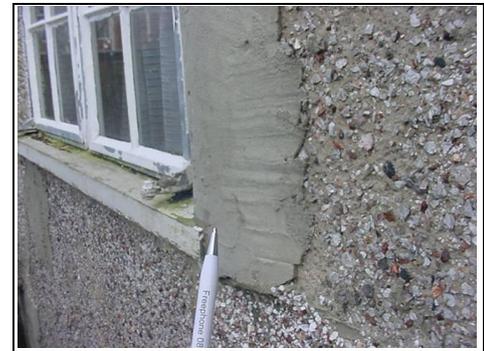
Repair to render

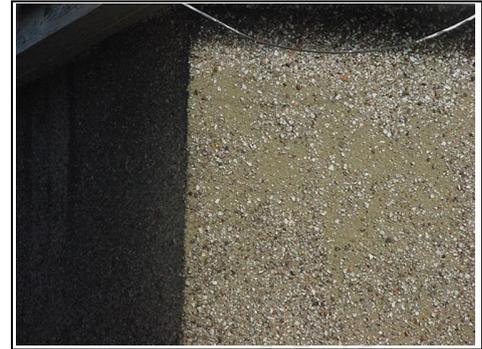
There are also areas where the render has weathered, indicating that there is leaking gutters and that the render is now of an age where it is starting to deteriorate. Unfortunately it is very hard to patch repair render without it being very visible as you can see in the repairs that have been carried out to the cracking.

Render weathering

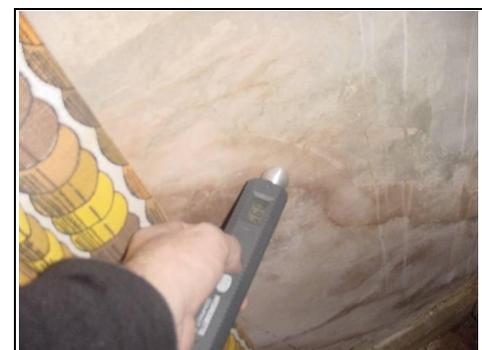
We found dampness to the property, particularly to the rear. This we believe relates to the cracking externally which is allowing water in. We have had a range of readings from the mid to late thirties and early forties that we would expect almost double in some areas, particularly to the rear of the property. This shows dampness

Dampness

is getting in through the render which means that the render repairs that have been carried out aren't sufficient.

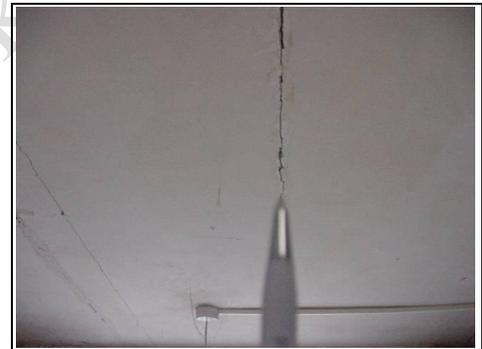
We can see a range of cracks internally. Most of these are due to the structure as a whole moving as explained earlier in this report. There is also ceiling movement at a different rate so you have ceiling board cracking as well. Finally, you also have the cracks associated with the new additions to the electrics. We believe there may also have been a skim-coat of plaster applied to the ceilings.

Cracking to ceiling

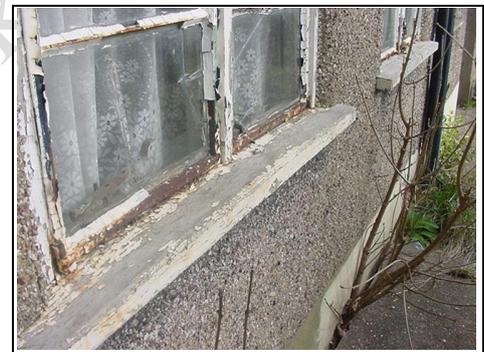
It was common in this Era to have single glazed metal windows. These windows rust and warp and allow condensation as they have in this instance. The windows have many cracked panes as is common with metal windows that are warping and deteriorating.

Rusting to metal windows

**ACTION REQUIRED:** We would recommend you budget for new double glazed windows.

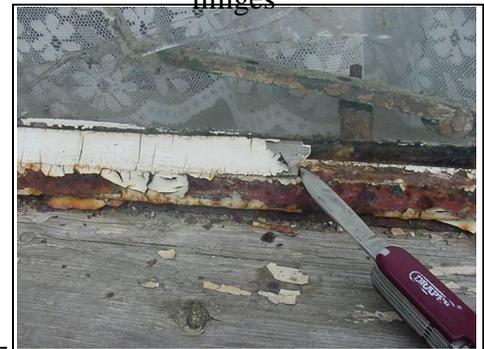
Close up of rusting to windows

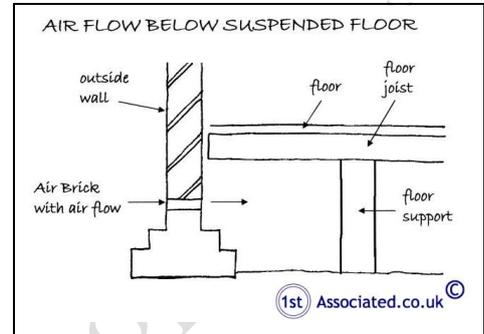
The ground floor is a suspended timber floor. With the dampness in the structure there may be some deterioration to the flooring. It didn't feel to deflect that much during the course of our inspection under our impact test (literally jumping up and down).

**ACTION REQUIRED:** The only way to be certain is to open it up and check.

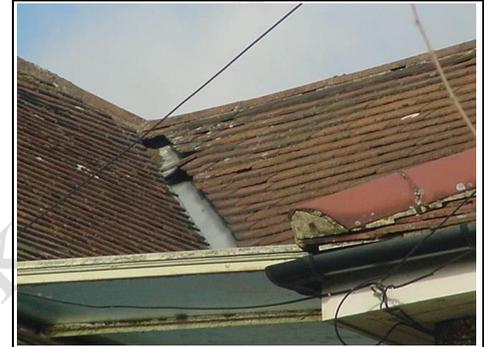
There is some deterioration to the roof tiles to the front of the property. We haven't been able to gain access to the roof (number 13 and number 14 were not in at the time of our inspection) however we did note a nearby property in a similar style have had their roof replaced. You could have a shared cost towards replacing this in years to come.

Slipped tile to hipped roof

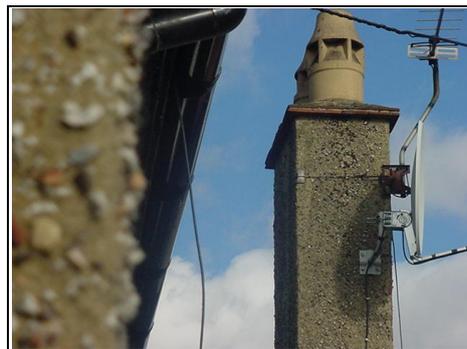
Chimney

There is a chimney to the left hand side, we assume it is shared. We can see the render on this is deteriorating (the pebbledash surface). We anticipate work will be required in the next few years to stop dampness from getting in. Whilst this may not directly affect your property, but would affect the top floor property, you may have a shared liability for this.

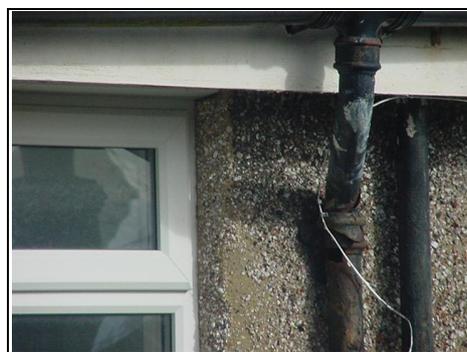
We can see a mixture of plastic and cast iron. Some of the plastic has twisted and is allowing water to discharge down the front of the property. We can see areas where the cast iron has rusted.

Cast iron downpipe rusted

**ACTION REQUIRED:**  
Repair/replace all the gutters and downpipes.

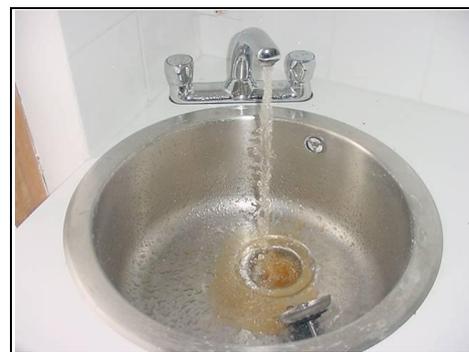
We noted rust when we first ran the kitchen tap. You may have old pipework.

Rust staining from taps

**ACTION REQUIRED:** You may need to remove old rusting pipes.

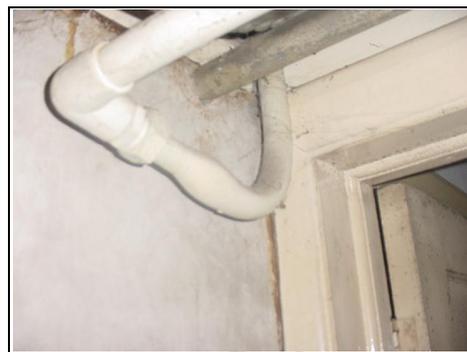
There is danger in older properties of having a lead water supply; we would recommend that you speak to the water company to ask them if they have carried out such replacement, as you will be re-piping much of the water used in the building it gives an ideal opportunity to also check for any remaining lead pipes.

Lead pipe

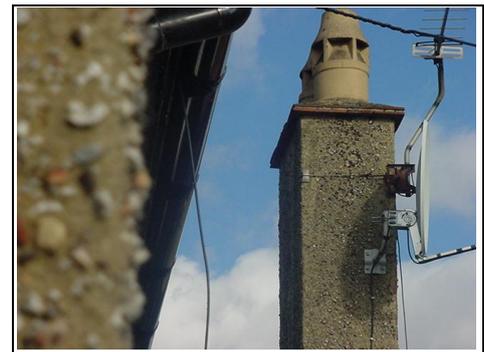
Chimney

This chimney is finished in a pebbledash render. It was difficult to see whether there was a proper flashing. Often with a render chimney the flashings are hidden by the render (we would recommend a lead flashing if there isn't one). From what we could see the chimney looked in slightly below average condition considering its age, type and style.

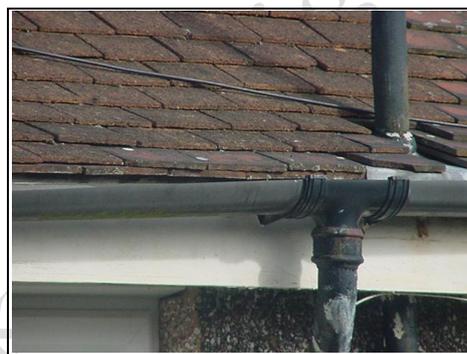
The property has a mixture of the original cast iron and plastic gutters and downpipes. The cast iron is in a poor condition and needs major repair or replacement. The plastic guttering is of the older style which is starting to weather and discolour. It was also sagging in areas indicating they didn't have enough brackets or it was a poor quality gutter.

Cast iron to plastic guttering

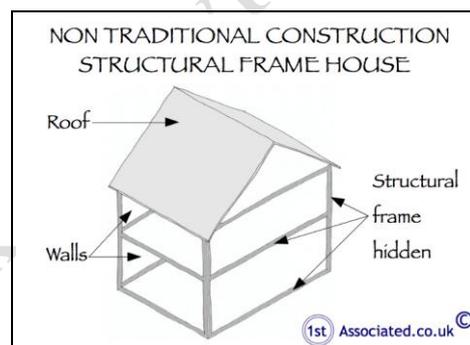
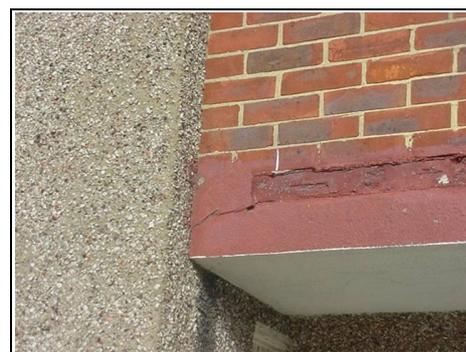
Just to reiterate our earlier comments in the Executive Summary, this is a concrete frame built house. We would normally be able to establish/confirm most of our information from looking in the roof which we have not been able to do in this instance. However we can see some areas which we believe are part of the concrete frame such as in the photo opposite where we can see some repair work has been carried out and also the side of the steps are concrete. However, other than this our view has been very limited.

Deterioration to concrete frame

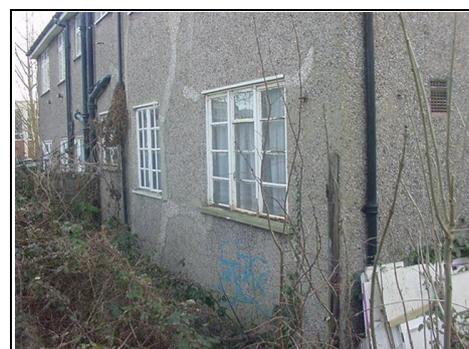
Cracks to rear of property

We would divide this into structural cracking and hairline cracking. We feel that the cracking to the rear of the property has potential to be structural cracking however there is also hairline cracking which needs to be sealed as soon as possible to stop dampness and water getting in causing sections of the render to need to be re-rendered.

We would recommend that the entirety of the rear elevation is re-rendered once the cracks have been filled in. We would also recommend that you put in a movement joint to the rear elevation and use a mastic.

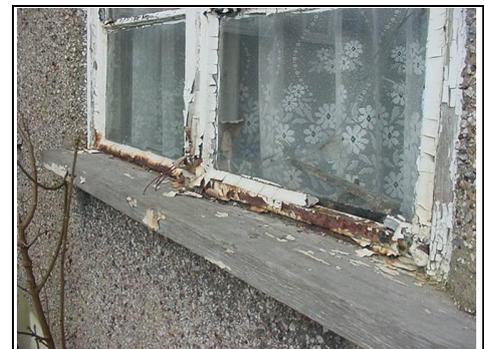
The property has metal windows, some are in timber frames. Metal windows are often known by their generic name of Crittal windows which was one of the main manufacturers. Typically these windows warp and rust and become difficult to close which in turn makes them draughty. In this instance there is lots of rusting and warping to the frames together with cracking of the glass.

Rusting to metal windows

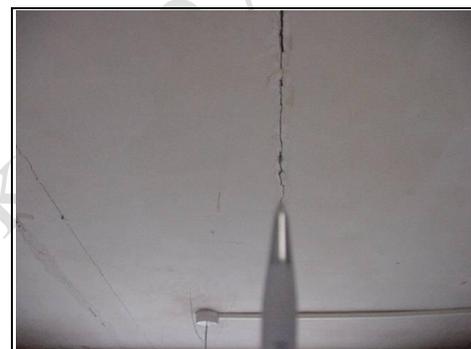
Cracking to ceiling

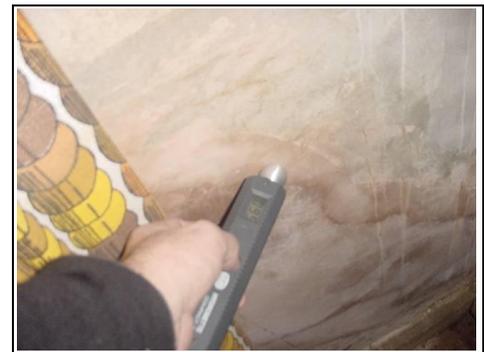
A random visual inspection and tests with a moisture meter have been taken to the perimeter walls. In this particular case we have found rising damp.

Testing for rising damp

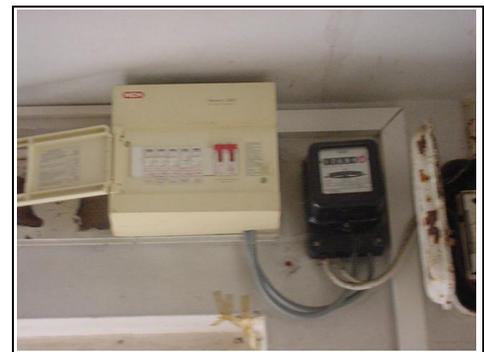
The electric fuses and consumer units were located in the hallway. The fuse board looked dated and better are now available. In multi occupied properties a defective fuse board can be particularly dangerous.

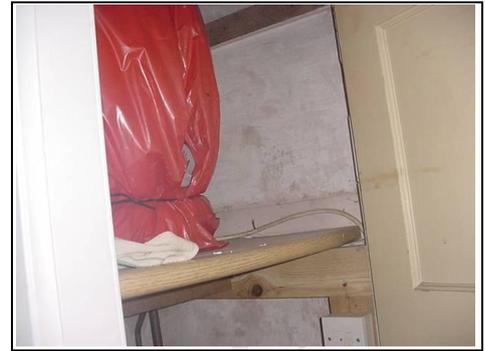
Hot water cylinder

The hot water cylinder is located within the bathroom. This is an older style cylinder which has a separate insulation jacket. Unfortunately this type of cylinder, due to its age, can leak without warning.
