JOB REFERENCE: XXXX

RESIDENTIAL BUILDING SURVEY

XXXX
Braintree
Essex
CM7 XXX

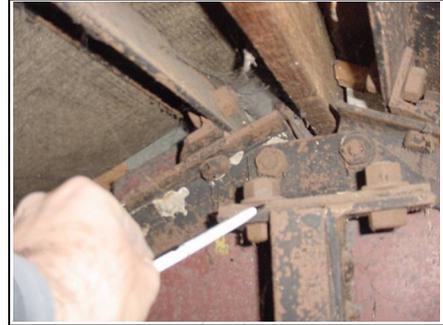
As with all these types of non traditional buildings without opening them up our investigation is limited very much to the roof space area. Within the roof in this instance we found rust to a higher level than we would normally find it to the metal roof and we also found elements of the roof that had been replaced.

We can see that fairly extensive work has been carried out to the roof in the form of re-roofing, new timbers and a sarking felt; our concern is the rust on the metal frame that we could see and furthermore the rust on the metal frame of the building that we cannot see.

Rusting metal frame

ACTION REQUIRED: Whilst we do recommend a rust stop agent or equivalent to the roof structure we would classify this property as being an above average level of risk and recommend that opening up is carried out to the base of the property where the steels are bolted into the floor as this is often the most likely place for the most severe corrosion to have occurred.

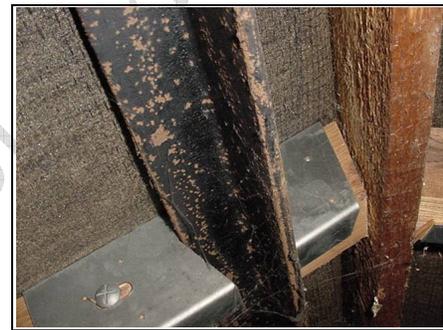
Replacement metal section

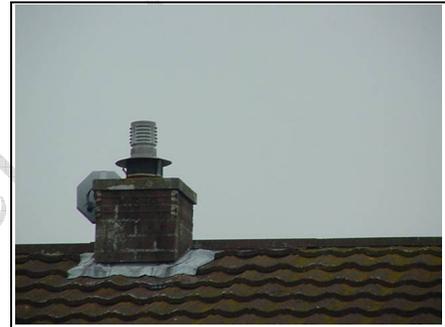
Chimney

We could see some asbestos had been left in where the chimney had been replaced (this can be seen from within the roof). It is very likely that there is other asbestos left in for example the fascias and soffit boards where we can now see a new plastic board but there may be an asbestos one behind it.

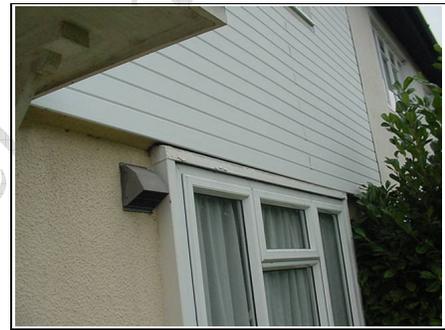
There is a mixture of things that combined together to give the higher risk of condensation than usual. These range from some of the radiators being internal on the ground floor to a lack of trickle vents to the windows to the extract from the humidity generating bathroom and kitchens being too small.

No trickle vents to window

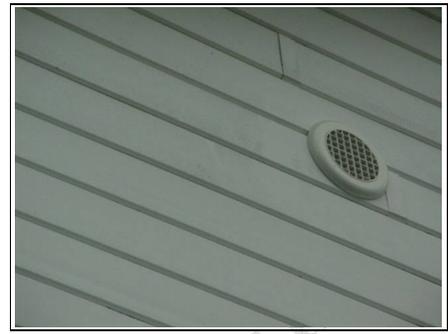
Outside vent on small extractor from bathroom

ACTION REQUIRED: Increase the size of the extract fan in the bathroom and kitchen and make them humidity controlled.

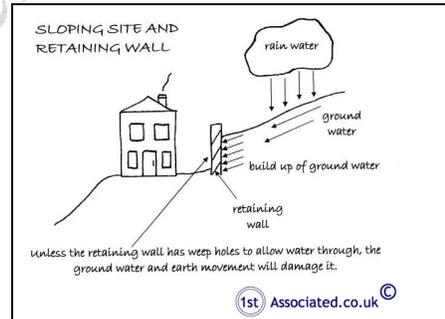
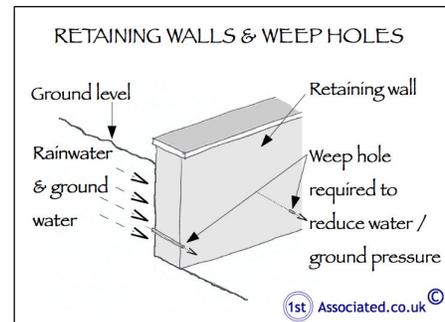
Whilst the retaining walls in your garden have weep holes we noted that the retaining walls to the left hand side (all directions given as you face the property) to your neighbours did not and the wall had suffered.

ACTION REQUIRED: Weep holes need to be added to the left hand side retaining wall and really should be a joint cost with your neighbour and will be well worth having a cup of tea meeting to discuss this.

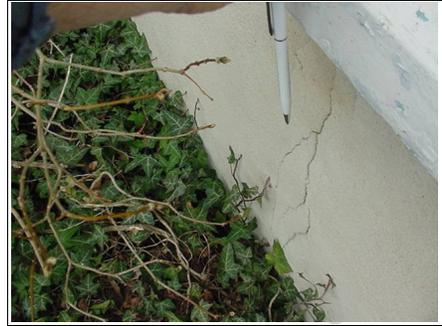
To the rear of the property there is a crack to the smooth render that has been added. This could be for a number of reasons, we feel the most likely is that there is too much cement in the render mix or the applied render is too thin. Or finally, and it is something we do need to make you very aware of, the cracking could relate to problems within the metal structure.

Crack to render at the rear of the property

ACTION REQUIRED: As mentioned earlier in this report we would recommend opening up to examine the base of the columns in the structure at the existing owners cost.

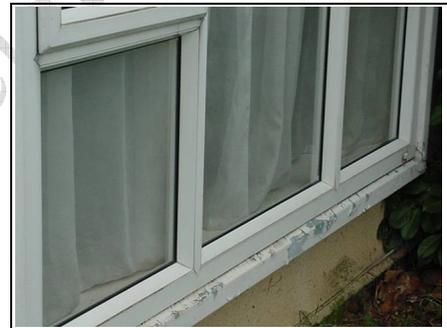
One characteristic of the property is a metal frame around the windows which will cause cold bridging, possibly condensation and will be in need of re-painting regularly.

Metal surrounds to windows

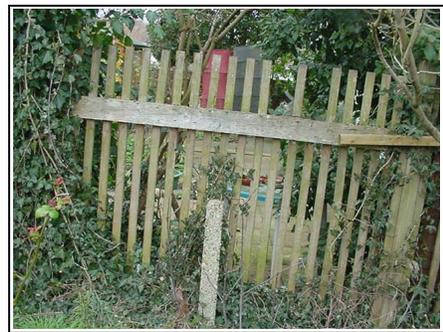
Garden boundary to right hand side with concrete posts and wooden fence – where is the boundary?

ACTION REQUIRED: You do need to check where exactly the boundary is located.

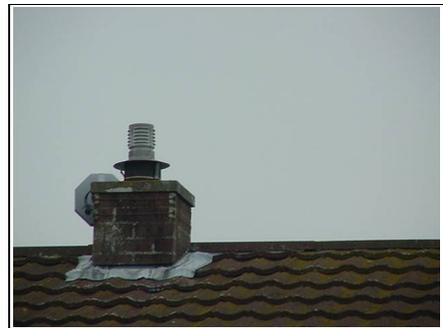
Chimney

We are uncertain as to what this chimney is made out of, we know that originally they were lined with asbestos and this is what we can see when we are in the roof. Fairly typical on upgrades such as in this property to amend the chimney we can see that it has had a lead flashing added which we consider the best type of flashing provided it is of course fitted correctly. From what we could see from ground level it looked in average condition considering its age, type and style. Unfortunately we were unable to see the top of the chimney known as the flaunching, we therefore cannot comment upon them.

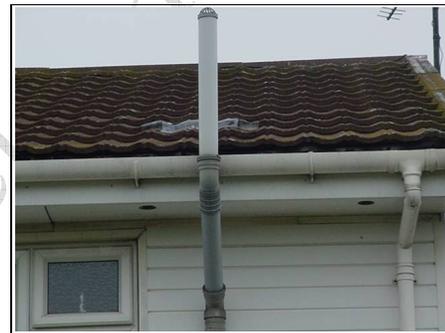
Main roof

The main roof is pitched and clad with a concrete tile, originally it would probably have been an asbestos roof covering. From ground level, the tiles look in average condition considering the roofs age type and style. We noted that the soil and vent pipe had been moved and can still see the lead flashings; sometimes there can be problems in these areas. With this age of roof there can be a few missing or displaced tiles, this is nothing unusual.

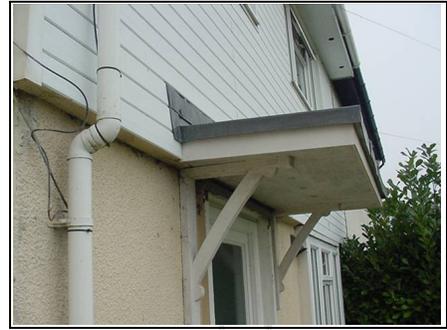
Front canopy

There is a small lead covered front canopy, sometimes there is concrete beneath these, we once read about a problem when a window cleaner stood on one when it unfortunately could not take the window cleaners weight! Please be aware of this when you get your windows cleaned.

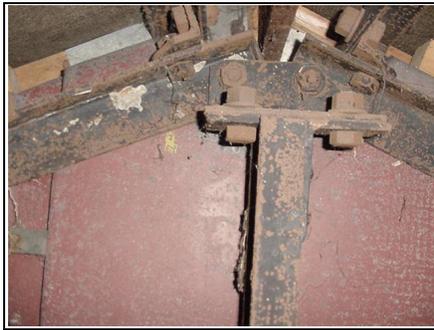
Close up showing roof bolts with more rust than we would like to see

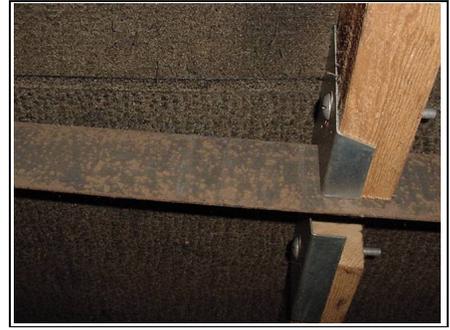
Some fixing have been replaced

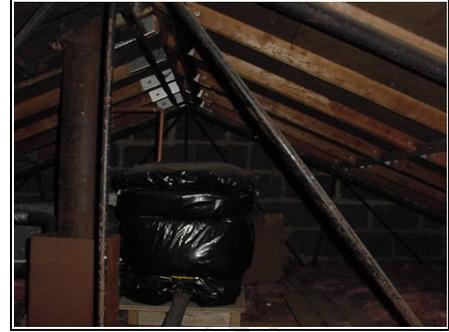
Water tank

The water tanks were found to be plastic (many of the original water tanks would have been asbestos).

We would always recommend that water tanks be drained down and cleared of any debris etc. (we have seen dead birds and other unmentionable things in these tanks). As you are often cleaning your teeth with this water it is best that it is as clean as possible!

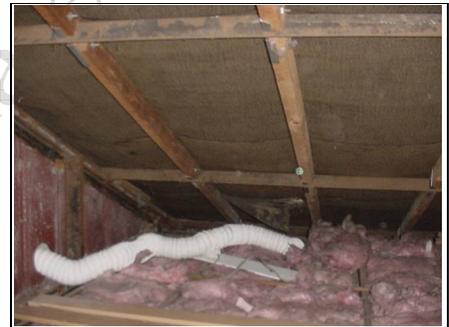
Extract vent to outside often discharges into roof which is essential that this does not happen in this type of roof

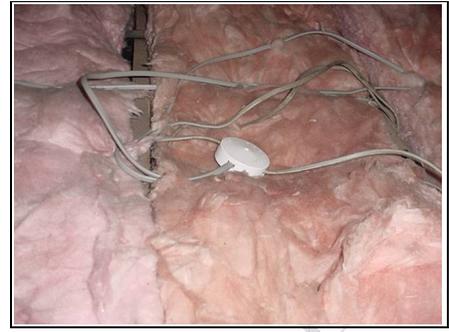
We can often identify the age of an electrical installation by the age of wiring found in the roof. In this case surprisingly we found electrics sitting on top of the insulation which is not often the case so enquiries should be made whether there have been some relatively recent additions to the electric wiring (which there should be certificates for this electrical work).

Electrics sitting on top of the insulation

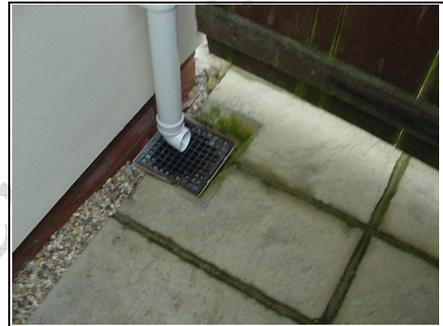
Overflowing downpipe assumed due to green moss

ACTION REQUIRED: We would always recommend you stand outside the property next time it rains heavily and see how well the drains cope with the rainwater particularly looking at the guttering and the joints. We would always recommend that the gutters and downpipes are cleaned out, the joints are checked and the alignment checked to ensure that the gutters fall towards the downpipes.

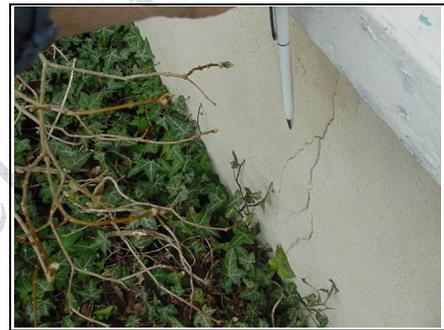
Cracking to render at rear

ACTION REQUIRED: Please see our comments in the Executive Summary.

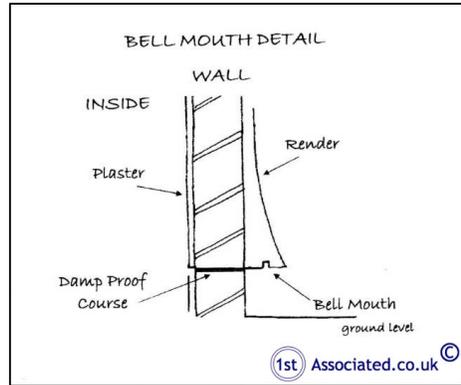
To the base of the render to the new section there was a good bell mouth detail. To the majority of the property it is not as pronounced and also there is a slight problem with regard to ground level heights as the ground level should be approximately 100-200mm from the bell mouth and it is less than this in most cases.

ACTION REQUIRED: Lower the ground slightly.

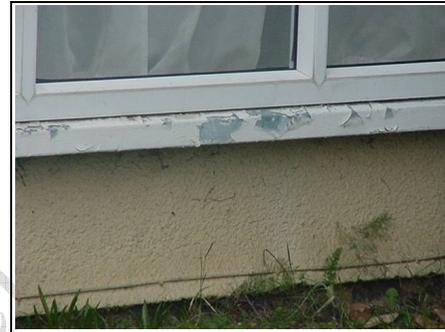
All modern properties should incorporate a damp proof course (DPC) and good building practice dictates that a differential of 150mm (6 inches) should be maintained between the damp proof course and ground levels. In this case cannot see a DPC to the original building we can see one to the extension.

No DPC visible.

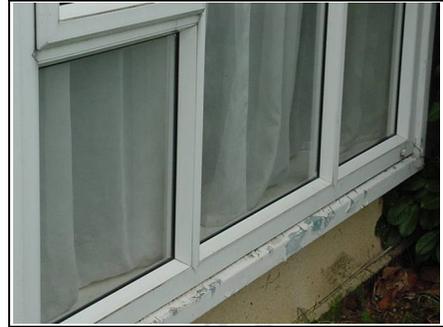
The property has plastic double glazed windows with a metal surround without trickle vents (with the exception of the extension windows which do not have the metal surrounds) which generally look to be of a average quality although better are now available. We would draw your attention to the fact that sealed double glazed units can fail, particularly as a result of poor workmanship during installation. Failure of the seal leads to condensation between the two panes of glass and simply replacing the affected units may not provide a satisfactory long-term solution.

Window with metal surround

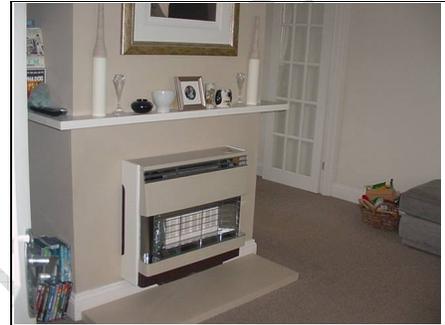
At the time of the survey no chimneys were in use and indeed this could not be used for a fire as it has a back boiler within it which was the latest invention back in the 1960s.

Chimney breast with Baxi Back boiler

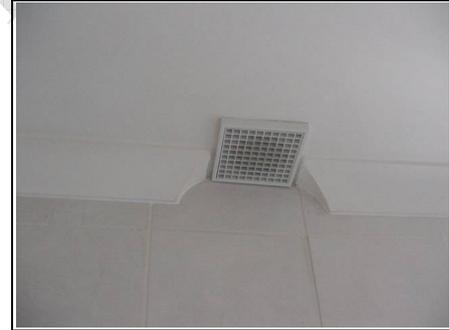
Small extract fan in bathroom

ACTION REQUIRED: We would recommend humidity controlled extract fans be added to kitchens and bathrooms.

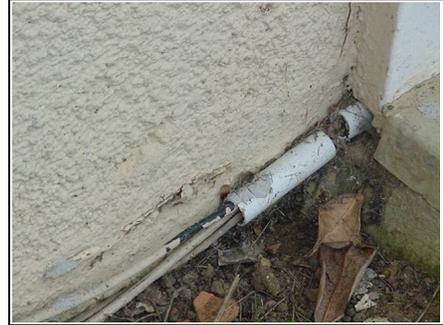
Also we noted some wiring that was sitting on top of the insulation indicating that the electrical work has been carried out relatively recently.

Electrics should be underground
