# RESIDENTIAL BUILDING SURVEY

Tenbury Wells,  
Worcestershire  
WR15 XXX

FOR

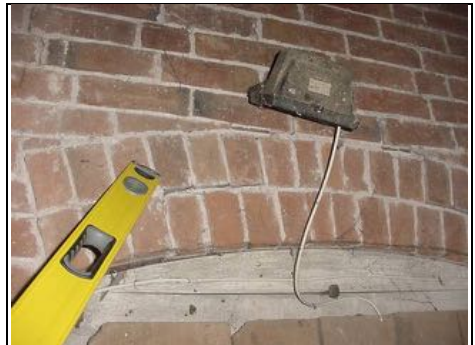
Crack to gable of house visible within the barn

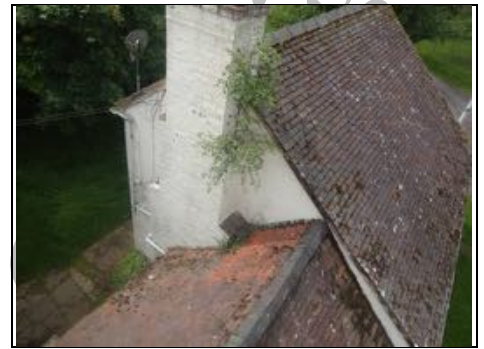
The chimney has suffered from a lack of maintenance, there is vegetation and plants growing out of it. It no doubt will require some repointing and repair work.

Plants growing out of chimney

**ACTION REQUIRED:** Remove plant/vegetation, repoint and repair.

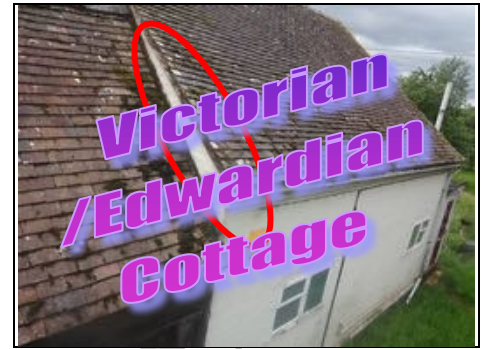
This is an area where often dampness gets in. A cement flashing has been used; we would much prefer a lead flashing.

No lead flashing between barn and main building

**ACTION REQUIRED:** We would recommend the moss is cleared with a soft brush and carry out ad hoc repairs to the roofs. The main repairs are required to the barn. Add lead flashing between the main house roof and the barn roof. Care needs to be taken when on the barn roof until the structure is stable.

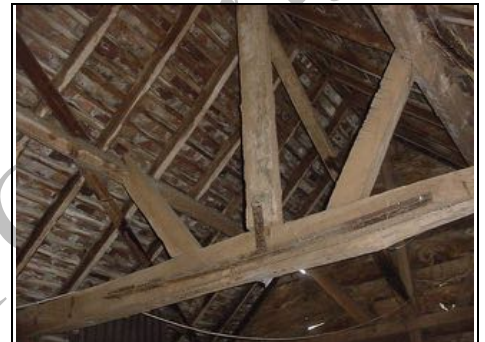
Barn has medieval style kingpost truss of sorts stabilised with a metal brace

We spoke about having an exposed roof in the barn and possibly one for the first floor. If this is the case, we would recommend adding additional timbers possibly additional Kingposts. We would recommend making the two structures separate to each other; at present the barn seems to sit against the main building.

**ACTION REQUIRED:** Repair work required to both roof structures.

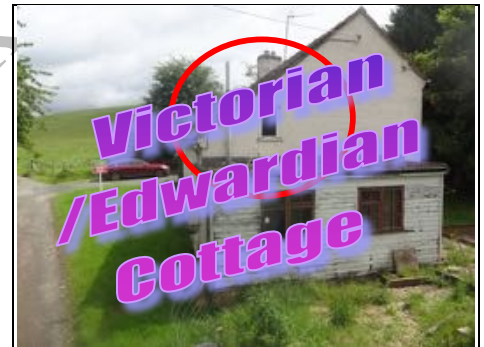
Dampness coming through painted walls

**ACTION REQUIRED:** Repoint and repair the gable end walls and stop the dampness getting in with repairs to the roof. Monitor the woodworm using woodworm traps whilst you live in the house with the heating on!

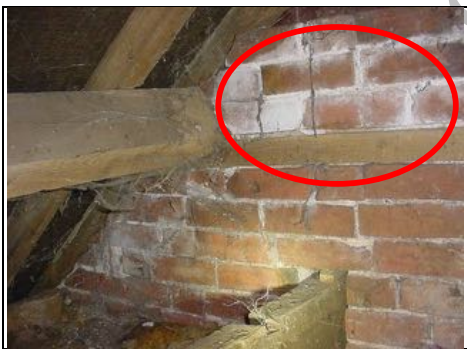
Dampness coming in through walls

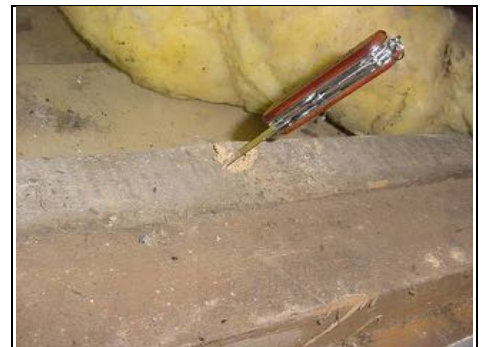
The roof area is slightly damp and we noted woodworm. It is very difficult to confirm whether it is still active, we would air on the side of it not being active as we could see some new timbers in the roof that do not seem to have woodworm.

Woodworm

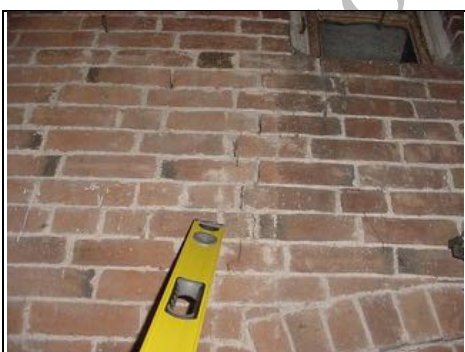
We believe that where the door is and the window on the left gable of the main house is a weak area. The barn is also taking support off this wall in the form of point loads from the purlins. This combination, we believe, has caused movement in the main property.

Crack to left gable of main house

**ACTION REQUIRED:** Ideally, we would recommend the existing owners take out an insurance claim, advising that the cracking has been noted by a

We believe the work needed will be to separate the barn to make it a self-supporting structure although obviously, it has stood the test of time as it is. Once this has been carried out, carry out repairs to the wall structure to re-bond it together.

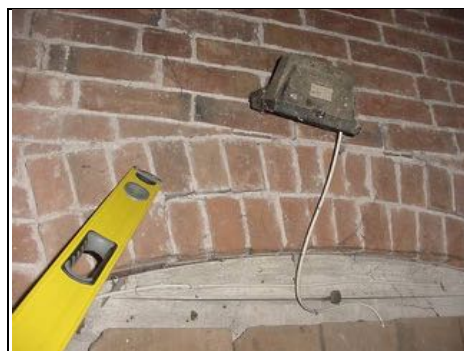
Crack to left gable

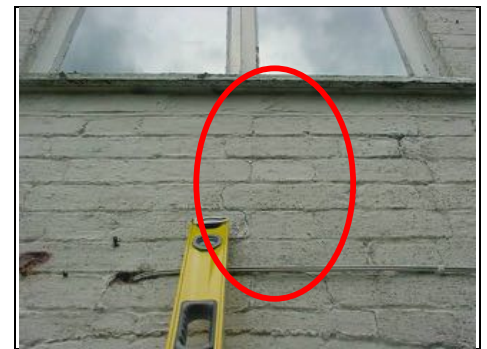
Vertical crack which follows line of mortar

**ACTION REQUIRED:** If you wish to be on the safe side then an insurance claim placed by the existing owners would be the best way of limiting your future liability.

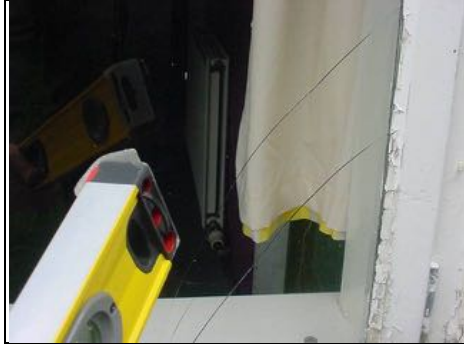
Cracked glass possibly indicating there is movement in the property

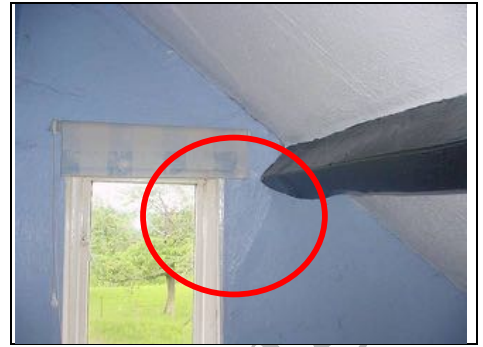
Movement around front window likely to be due to the timber lintel

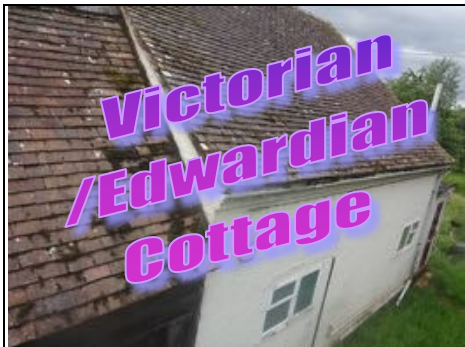
Front guttering needs checking

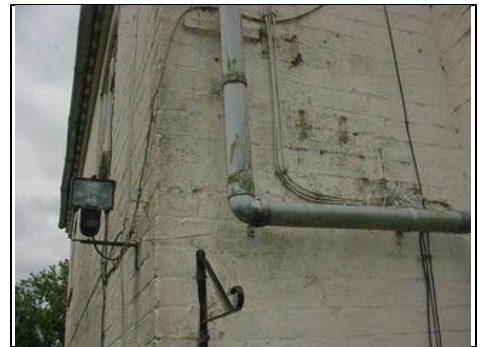
Awkward downpipes to rear left of main house

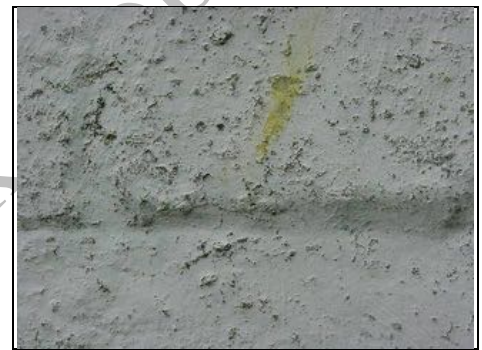
The walls to the main house are paint finish onto a red brick (relatively soft) in a Flemish bond brickwork. We can see moss has been painted over to the rear of the building. This could be misalignment of gutters (as mentioned) and also the surrounding trees.

Painted over moss and mould

**ACTION REQUIRED:** There is a lot of work required to the walls once you have stopped the water discharging down them by mending the gutters and get them back to a state where they are breathing again. Gently and gradually remove the modern paint that has been painted over the lime with a soft brush ensuring the brickwork is not damaged and then repoint and redecorate using a lime wash or modern microporous paint. This is likely to take several summer months (sunny days). We would anticipate this work to be carried out over a few years. Within it we would also incorporate repairs to the timber lintels and also underneath the windows which look to have been repaired in some areas with a modern cement rather than a lime plaster.

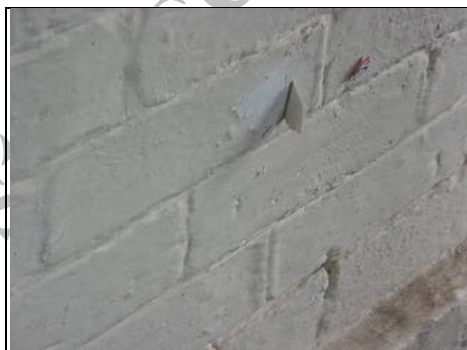
A wrong type of modern paint has been used which has painted over a lime wash. Luckily the lime is rejecting the modern paint so it is starting to peel away. You need the walls to breathe.

Paint flaking revealing lime wash behind

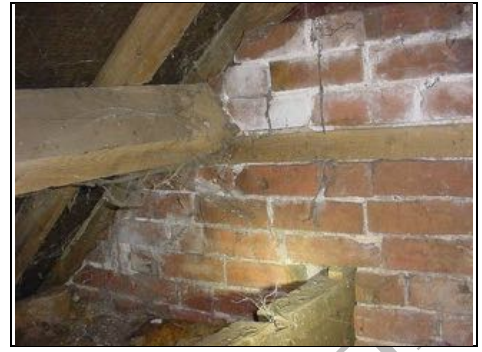
The dampness, we believe, is getting in through the joints and can be seen in the form of efflorescence in the roof.

Efflorescence, bonding timber will be affected by dampness

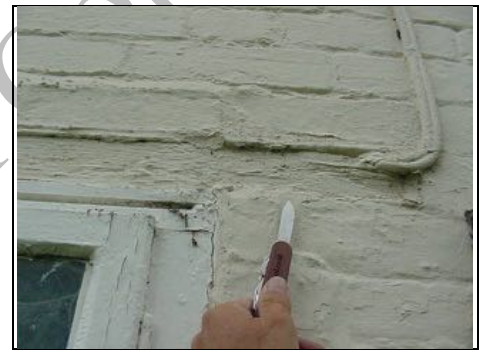
Timber lintel over front window

To the front of the property there are timber lintels. It may well be worth taking these out completely. You can replace them with a timber lintel or with a metal lintel.

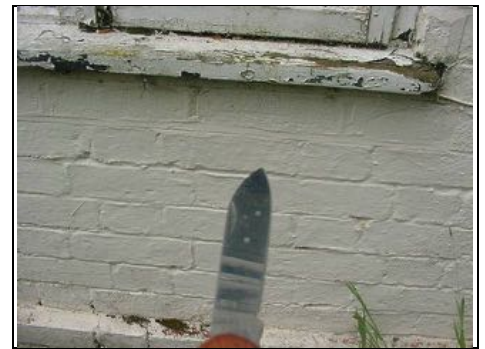
Damage under windows

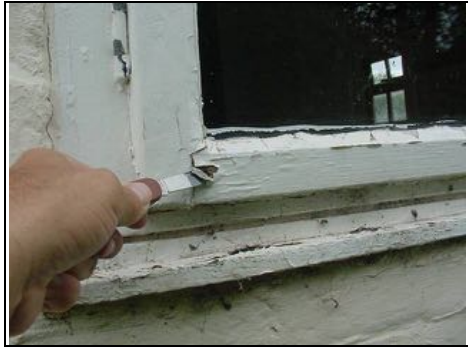
The external windows are in a poor state.

Rot to windows

**ACTION REQUIRED:** We would normally recommend you splice in new timber however these windows are relatively modern and it may be better to replace them with a good quality timber window. We suggest that the new windows are set back slightly to allow a drip detail so that the rainwater from the walls does not go impact the timber as much.

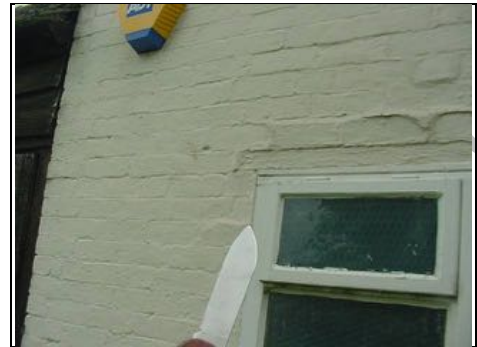
Window put in flush and timber lintel above

At the same time as carrying out repairs to the windows you will also need to check the lintels above them as we have already mentioned. Many of them are timber and may need replacing/repair.

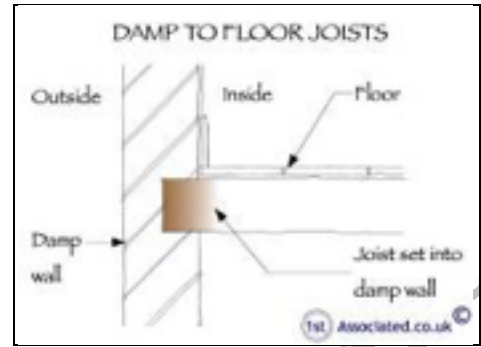
Damp to floor joists

**ACTION REQUIRED:** Add additional timbers in although there is an exposed floor structure so it may not be possible without covering this area over.

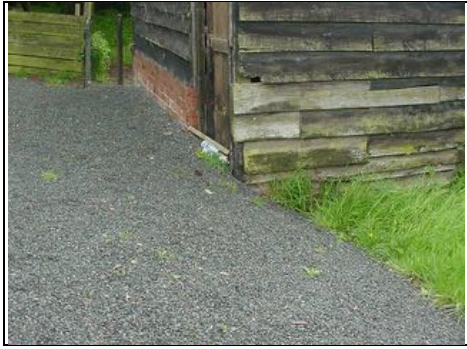
Both the house and the barn sit on a sloping site and to some extent suffers from a high ground level. There has been a build up to the area where the parking is and there is also concrete added around the building to form a pathway. All of this also allows dampness to get into the building.

High ground level

**ACTION REQUIRED:** We would recommend that you reduce the ground level around the building wherever possible and add a drain around the building in the form of a French drain, traditionally approximately a shovel width by two shovels deep and in more recent times it has a perforated pipe at the base of it to take the water away to a drainage system.

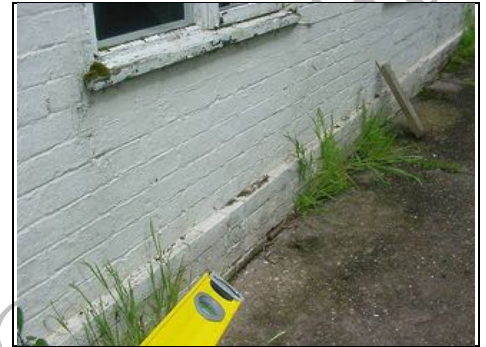
Grass growing against property/dampness

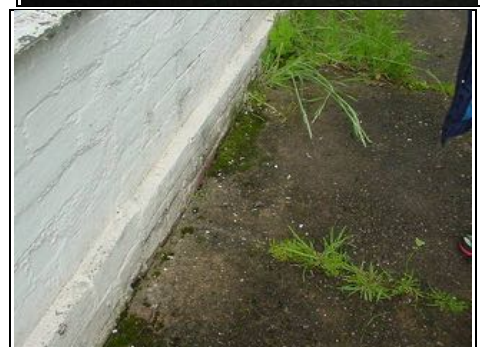
You need to look for the cause of the plaster losing its bond which we believe is dampness in the property. The deteriorating plaster (losing its key) is being caused partly by dampness coming through the walls, probably old age in the plaster in this particular instance but mainly dampness. We would refer you to our earlier comments about walls needing to breathe and removing the existing modern paintwork and repointing and also reducing the high ground level around the property.

Dampness/grass growing at base of property

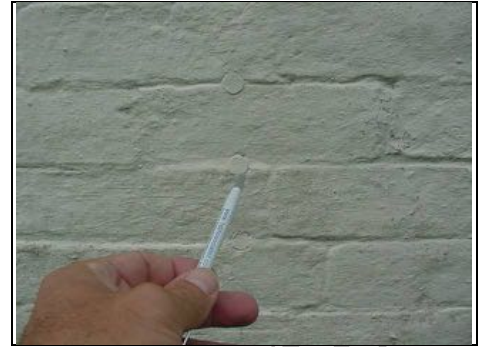
We can also see that the previous owners did not understand/were wrongly advised with regards to this property as we can see where the modern chemical damp proof course has been added horizontally and vertically which is not the way to resolve dampness in this particular property in our opinion.

Chemical damp proofing

**ACTION REQUIRED:** Once the work externally has been carried out to help the property dry internally the best way is to remove the wallpaper and this would then allow some of the plaster that has not lost its key to remain and dry. You could patch repair other areas. If and when you remove the plaster the walls are still very damp then it may be necessary to remove all of the plaster. In some cases, expose the brickwork to allow it to dry out.

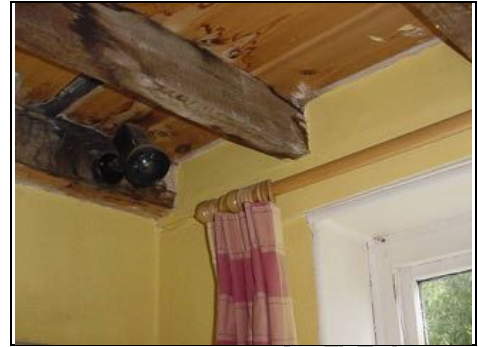
Dampness to timbers in rear lounge

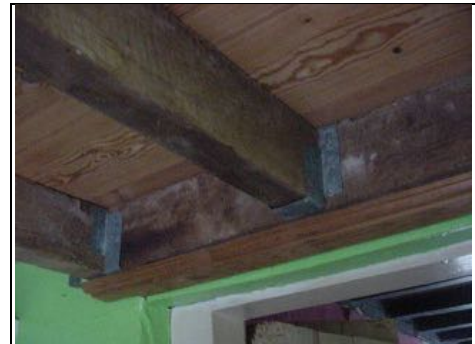
Black mould to timbers

**ACTION REQUIRED:** We would recommend large good quality humidity controlled extract fans are added to the kitchen, the bathroom and any areas that are used for drying clothes internally during winter months (we would assume that clothes will be dried externally during the warmer months). By large extract fans we mean 150mm.

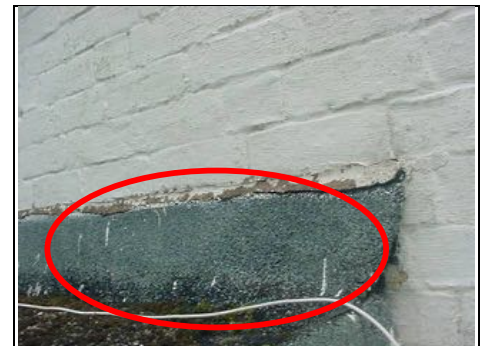
Flashing starting to come away from wall

**ACTION REQUIRED:** We would suggest you clear the roof to see its condition and it is probably best if you put a layer of felt over the top of it and check the flashings. Also, add guttering. Ultimately, we would recommend that you put a pitched roof on this.

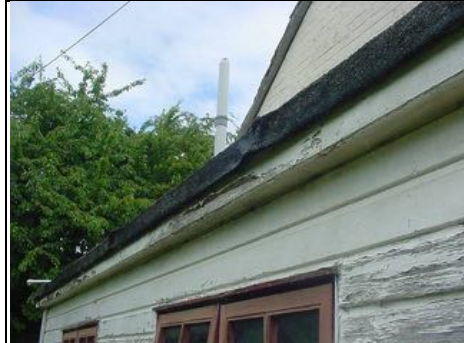
No gutters

**ACTION REQUIRED:** We recommend stripping back all of the shiplap boarding, adding insulation between the timber frame and then putting new shiplap boarding on the entire structure and redecorating. There would be some associated repairs with this around the windows and doors as well as adding the guttering of course.

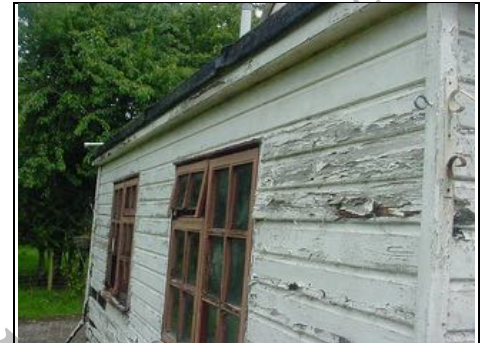
Rotten timber

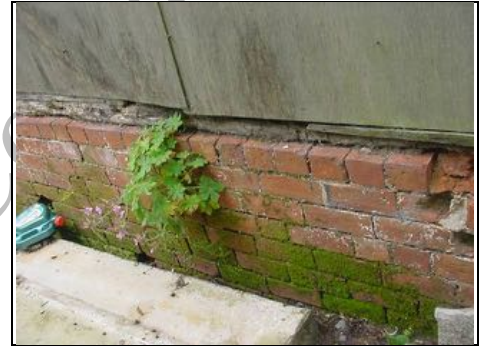
Dampness to rear base of barn due to not having gutters

Guttering needs to be added to the barn. Once you have added gutters you then need to replace the shiplap boarding to the side and to the gable end, you may well be able to re-use some of the cladding. By adding guttering to the building will make it a lot better.

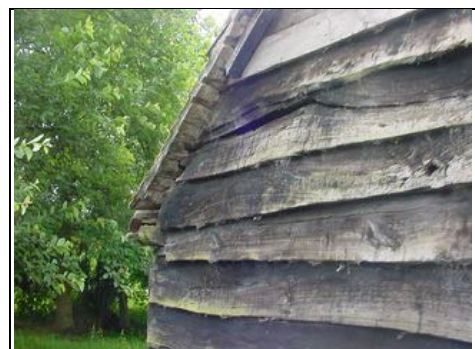
Deterioration to boarding on gable end

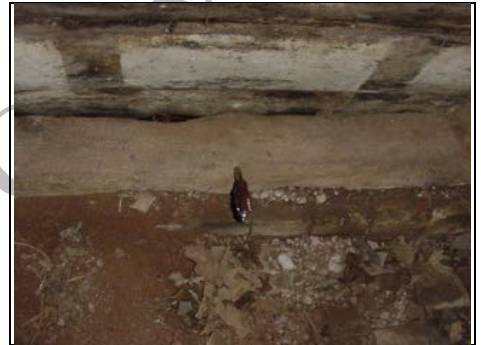
Rot to sole plate

**ACTION REQUIRED:** The timber that we knife tested is not doing too badly. We would suggest extra timbers are added in between the existing timbers and that repairs are carried out to some of the existing timbers including the sole plate that had some wet rot in it. There was not an excessive amount considering it was a sole plate.

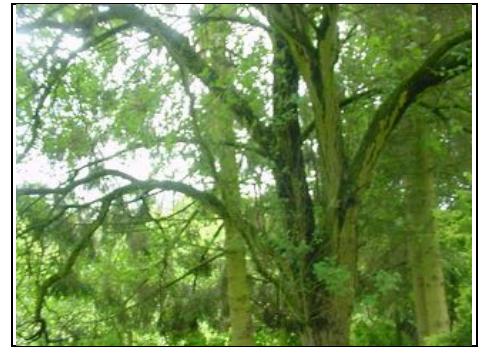
Trees need cutting back

**ACTION REQUIRED:** We believe that all of the trees need maintenance around the property and cut back to appropriate size for this property which we believe is much smaller. We would recommend an arboriculturalist (not a tree surgeon) is asked to view the property and give a ten-year plan for maintenance. There was a lot of tree cutting taking place on the day of our survey around the electrical lines.

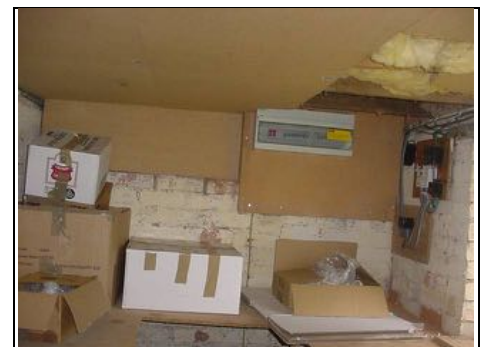
Whilst the fuse board is newer than we would expect the electrics within the house were dated with single socket points noted and older switch points.

Fuse board

**ACTION REQUIRED:** We would recommend a complete re-wiring of the property to be carried out by an NICEIC registered and approved electrical contractor or equivalent.

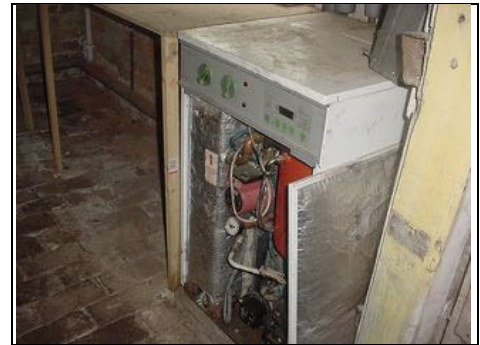
The property has a Worcester floor mounted boiler. This may or may not work; it was not working on the day of our survey. It would be great if you could get it to work as to replace it would be costly.

Boiler

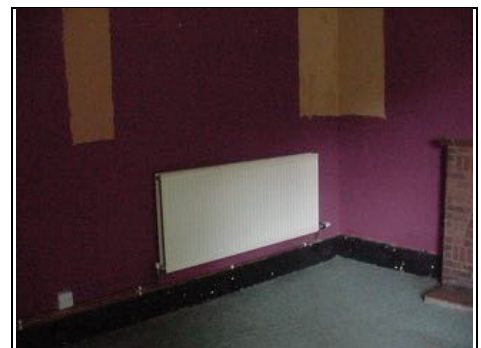
We noted the radiators are internal in some areas. This is often carried out on cheaper central heating systems to save the labour and piping costs of positioning the radiators underneath the windows. However, it then reduces the air movement in the room, which can lead to black mould.

Internal radiators

**ANTICIPATED COST:** For a new heating system including radiators, etc expect costs in the region of £3,000 - £5,000 assuming the oil supply from the tank is usable; please obtain quotations.
