JOB REFERENCE: EX41963/RBSG2E/MH/MB2

## RESIDENTIAL BUILDING SURVEY

XXXXXX  
Northampton  
XXX XXX

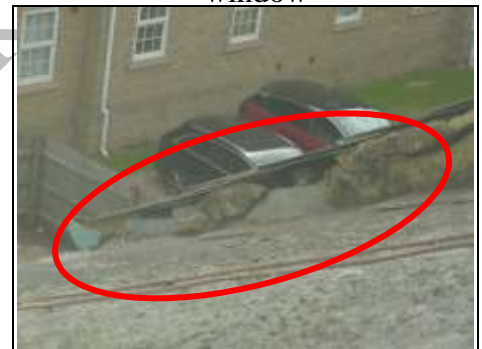
There is a step in the roof which needs repair. We spoke to the owners about this who advised they thought it was next doors cost. We knocked on the neighbour's door at the time of the survey to discuss this however there was no response. The work certainly needs doing, we would have said it is a shared cost as it is on what is known as the party wall which is a shared element of the property.

Step in roof viewed from rear window

**ACTION REQUIRED:** Before you commit to purchase the property speak to next door right hand side and check and confirm their view with regard to the roof repair as ultimately it will affect both of you.

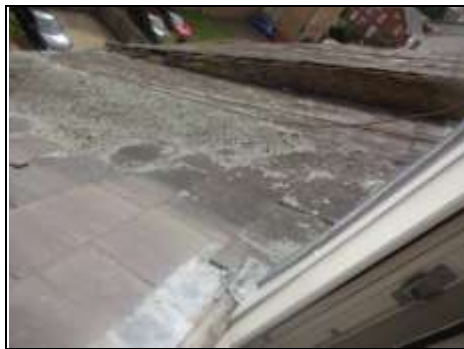
The roof is clad with a slate; some of these slates look to be suffering. It looks like the nails are starting to rust from a phenomenon known as nail sickness. Generally, it is the nails that are the weakest part of a slate roof where they rust away over the years. Unfortunately, we have no way of seeing the underside of the slates as the roof access areas are lined and there was a room formed within the roof. We can however see that lead tingles have been used. Lead tingles are used where the nails have rusted away as it is very difficult to replace individual slates and costly on a high level roof such as this.

Deteriorating slates to right

**ACTION REQUIRED:** We would look at doing one lot of high level work which includes the upstand mentioned earlier and also slate repairs and also check the dormer roofs which we could not see properly.

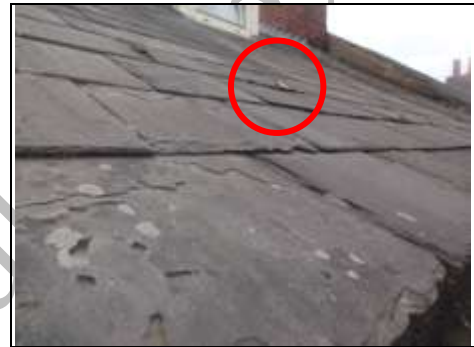
Deteriorating slates (tingle circled)

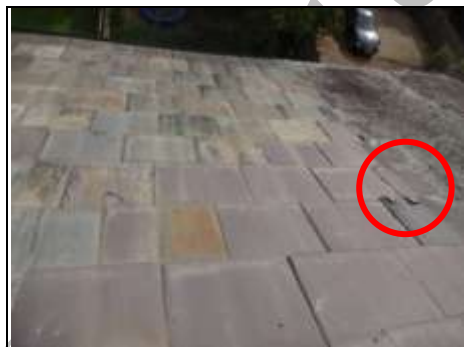
Tingles

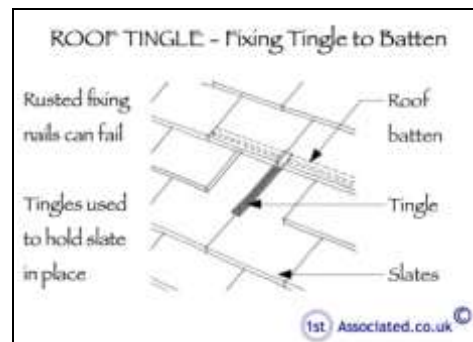
Tingles

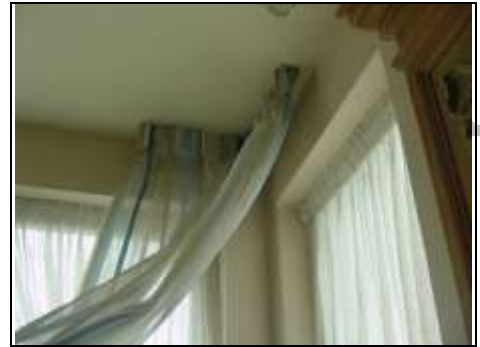
There is a mixture of timber windows and metal windows. We noted staining around some of the windows. We spoke to the owners about the staining around the metal windows to the rear and they advised that they thought they were leaks from when the windows were first carried out and no longer leaked.

Staining to windows

We were wondering whether this could also be condensation as this often occurs with metal windows particularly where there is a mixture of different types of windows (in this case timber and metal) particularly with a modern central heating system which has made the property far warmer than it ever was originally with coal fires.

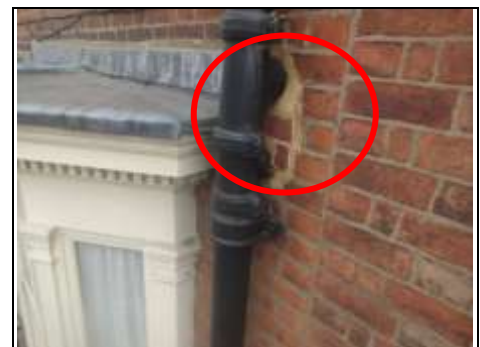
With older properties, you will hear a lot about the use of lime mortar and cement mortar. We tend to find a lot of properties that have been wrongly repointed in a cement mortar however the idea behind lime mortar is now better understood and generally listed properties are moving towards lime mortar. We can see in this property that there have been some cement repairs to the outside of the property. This causes a smothering effect of the property so it cannot breathe and let the dampness out. Over time you need to replace the cement mortar.

Cement repair

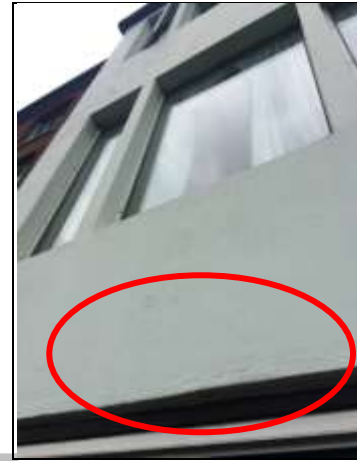
To the rear of the property there is a large area of painted render which looks like it has been finished in a harder cement mortar. We could also see cracking in it and what looks like cement mortar repairs as well. We would prefer a bell mouth detail here.

Repair

**ACTION REQUIRED:** Interestingly, if you look to add drip details on this we would discuss it with the Listed Building Officer before you do it. Although it is a defect it may be considered part of the style of this property.

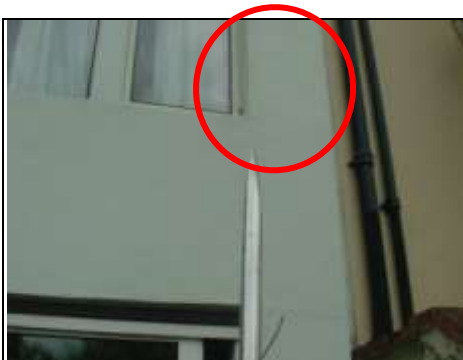
Vertical cracking

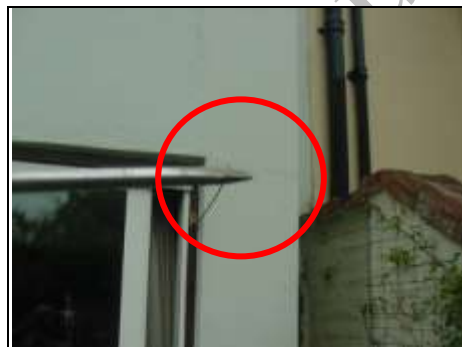
Horizontal cracking

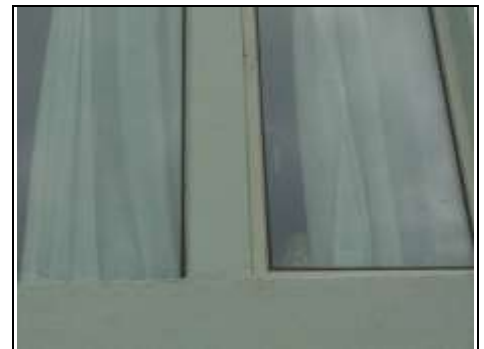
Repair around window area

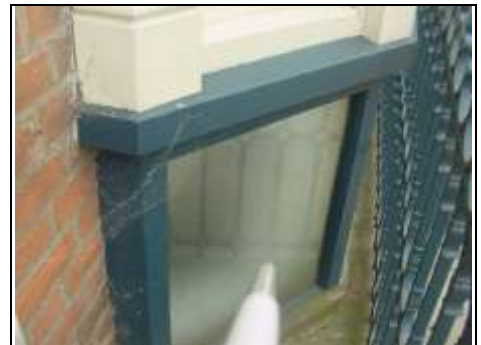
Glazed window to front not to listed building standard

**ACTION REQUIRED:** We would recommend legal advisors obtain a full list from the present owners as to what they have and have not done and what they consider previous owners have not done. Then arrange an informal 'cup of tea' meeting with the Listed Building Officer and show them the list and ask if they have a photographic record of the property as many local authorities do have. We noted it was originally listed on

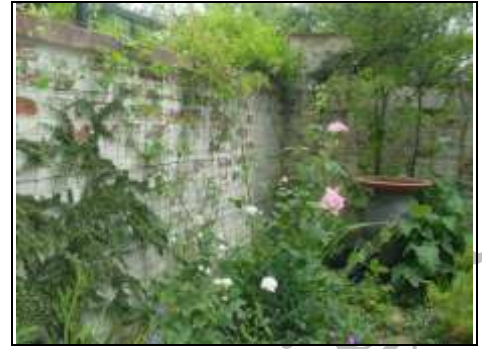
The rear garden wall is slightly unsafe and worse for wear. We could see it is built in a red brick which is starting to deteriorate and also some of the capping is not ideal, possibly because of the conifers and trees nearby. We tend to find that garden walls are built without proper foundations.

Garden wall

**ANTICIPATED COST:** We recommend you set aside the sum of £500 to £1,000 (five hundred pounds to one thousand pounds) assuming that the adjoining owners will also pay some money.

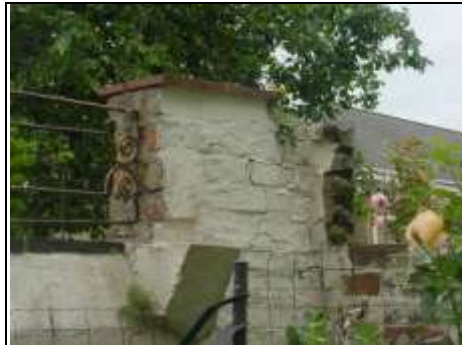
Cracking to wall

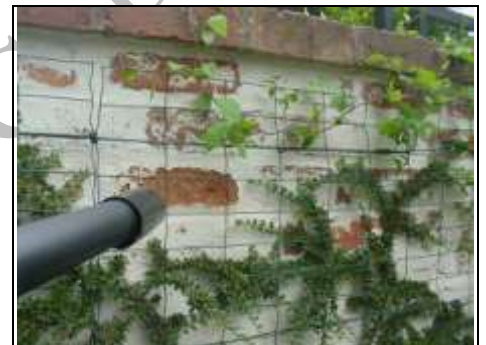
Spalling brickwork

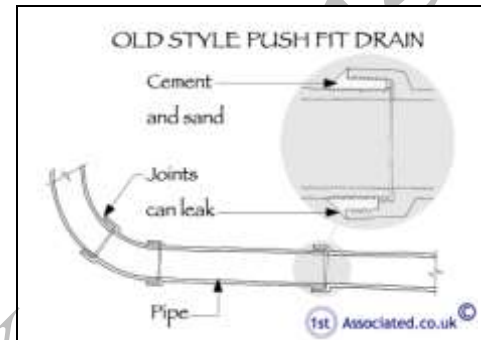
In older properties, such as this, drainage was often push fitted together rather than bonded together which means that they may leak over the years. Whilst we ran the tap for 15 minutes without any build up or blockages the only way to be 100% certain of the condition of the drains is to have a closed circuit TV camera report.

Push fit drain

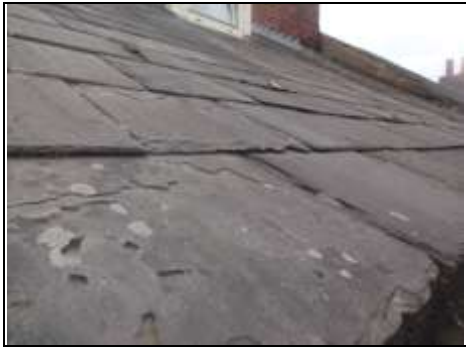
Deteriorating slates

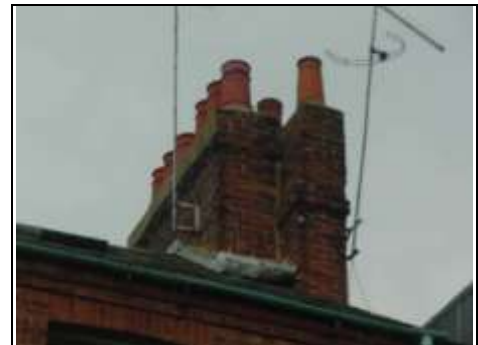
This is a large brick chimney with a lead flashing and numerous chimney pots. From what we could see from ground level we noted some deterioration to the soft red brick.

We noted aials attached to the chimney which we are not keen on as it cuts into the brickwork rather like a cheese wire cutting into cheese.

Chimney

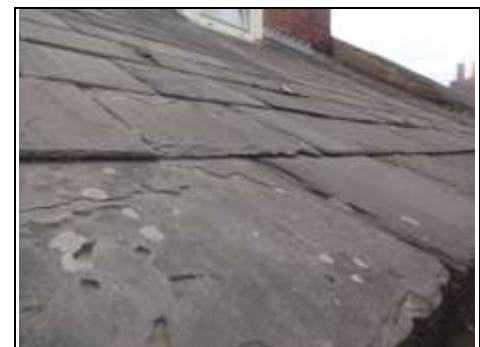
The main roof is pitched and clad with slates and, from ground level, this looks in below average condition considering the roofs age type and style.

Deteriorating slates

**ACTION REQUIRED:** Please see our comments in the Executive Summary.

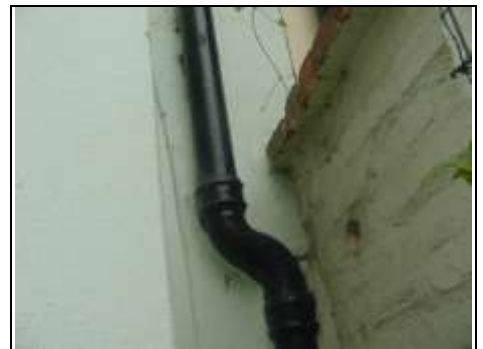
Possible rusting to cast iron

We also recommend that the gutters and downpipes are cleaned out, the joints are checked and the alignment checked to ensure that the gutters fall towards the downpipes.

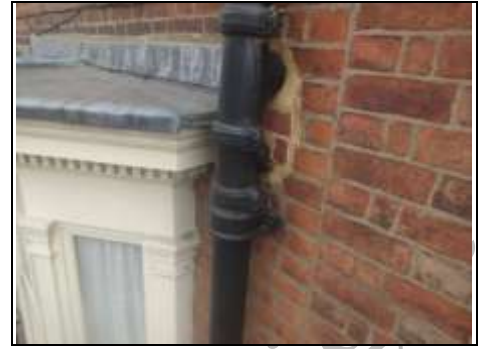
Generally Flemish Bond brickwork is liable to penetrating dampness internally, dependent upon the condition of the brickwork and the exposure to the weather. It is essential that external faces be kept in good condition. In this case we noted cement mortar repairs.

Cement mortar repairs

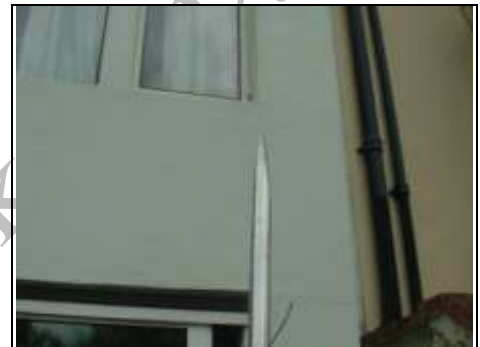
Hairline cracking to rear box bay indicating that render has got too high a cement content

**ACTION REQUIRED:** Please see our comments in the Executive Summary.

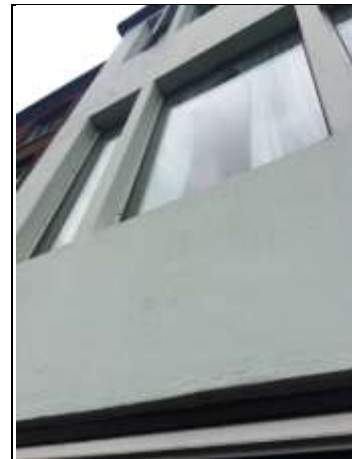
To the base of the render there was no bell mouth detail.

Repairs to render  
We would prefer a bell mouth detail here.

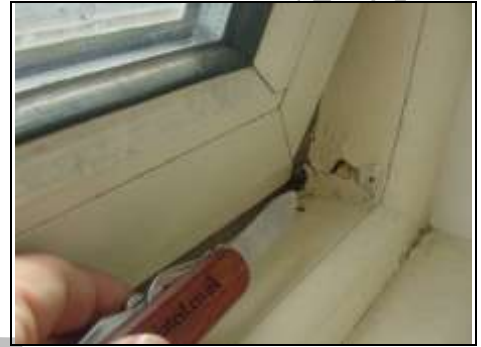
Rot to rear window

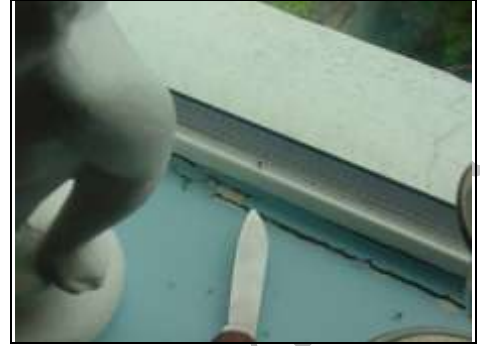
To the rear the property has modern double glazed metal framed windows without trickle vents. Generally, they look to be of an average quality for their age, type and style. In this case we noted cracking to the sill on the first floor box bay window.

Cracking to box bay window sill on first floor rear window

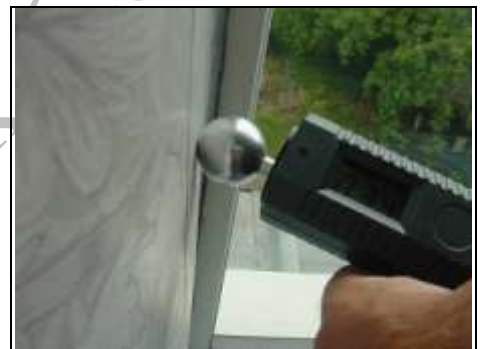
Lateral dampness in window reveal

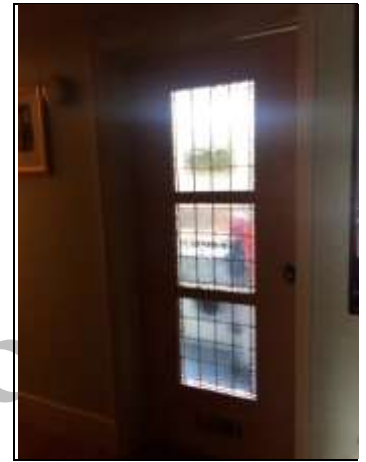
The property has some quite unique doors with glazing. Care has to be taken with older glass as it tends to shatter and break differently to a modern safety glass. In fact, if the building was not listed we would recommend removing and replacing the doors with safety glass.

Glazed door

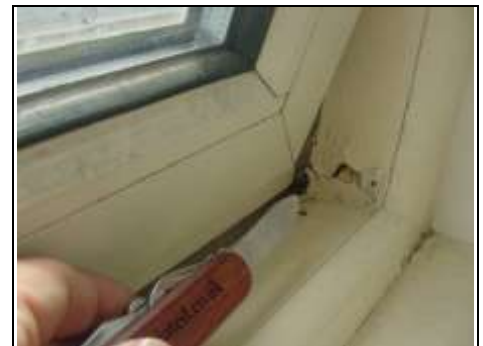
Rot to rear window

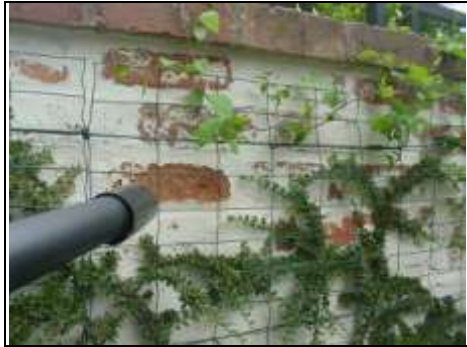
Spalling brickwork to rear garden wall

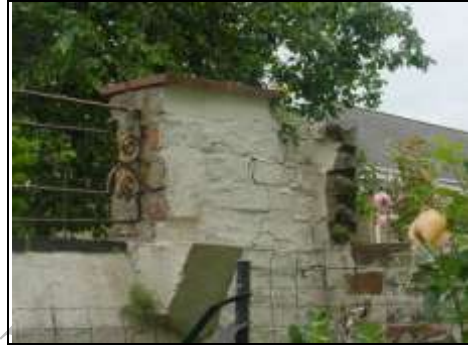
Rear right corner of garden wall needs repair
