JOB REFERENCE: EX41963/RBSG2E/MH/MB2

# RESIDENTIAL BUILDING SURVEY

**XXXXXX**  
**Northampton**  
**XXX XXX**

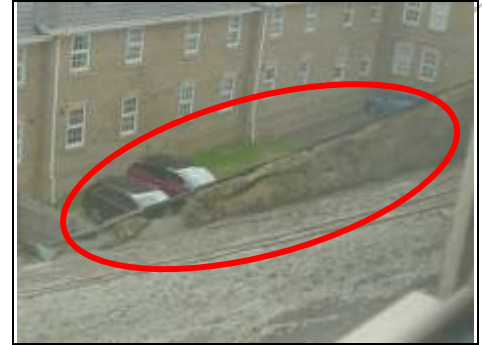
There is a step in the roof which needs repair. We spoke to the owners about this who advised they thought it was next doors cost. We knocked on the neighbour's door at the time of the survey to discuss this however there was no response. The work certainly needs doing, we would have said it is a shared cost as it is on what is known as the party wall which is a shared element of the property.

Step in roof viewed from rear window

**ACTION REQUIRED:** Before you commit to purchase the property speak to next door right hand side and check and confirm their view with regard to the roof repair as ultimately it will affect both of you.

**ANTICIPATED COST:** This is high level work therefore will need scaffolding to access it. We would anticipate the work to cost in the region of a few hundred pounds and the scaffolding to be in the region of a thousand pounds; please obtain quotations.

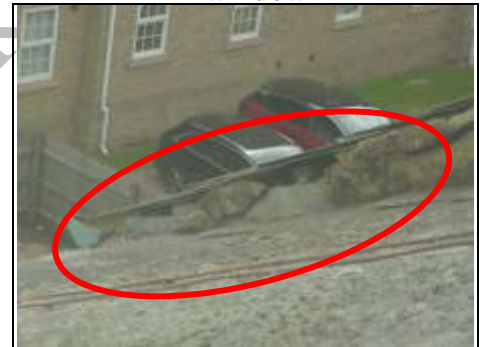
Close up

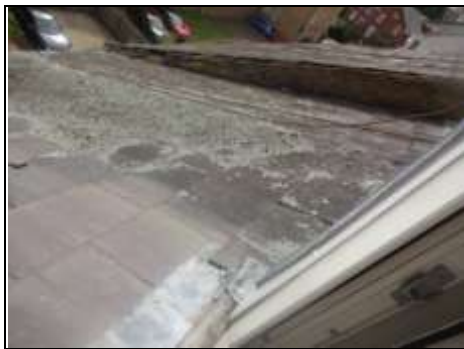
The roof is clad with a slate; some of these slates look to be suffering. It looks like the nails are starting to rust from a phenomenon known as nail sickness. Generally, it is the nails that are the weakest part of a slate roof where they rust away over the years. Unfortunately, we have no way of seeing the underside of the slates as the roof access areas are lined and there was a room formed within the roof. We can however see that lead tingles have been used. Lead tingles are used where the nails have rusted away as it is very difficult to replace individual slates and costly on a high level roof such as this.

Deteriorating slates to right

**ACTION REQUIRED:** We would look at doing one lot of high level work which includes the upstand mentioned earlier and also slate repairs and also check the dormer roofs which we could not see properly.

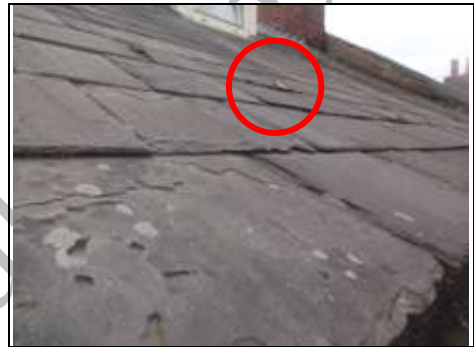
Deteriorating slates (tingle circled)

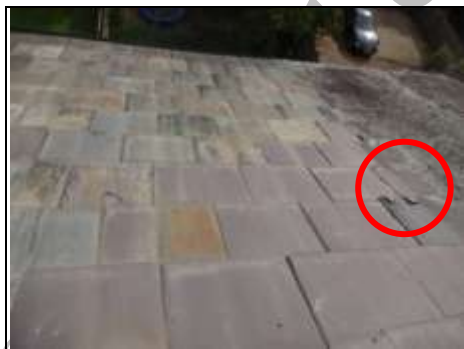
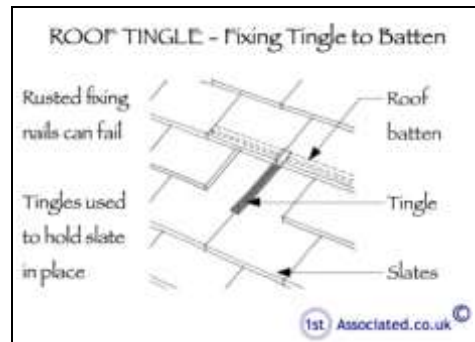
Tingles

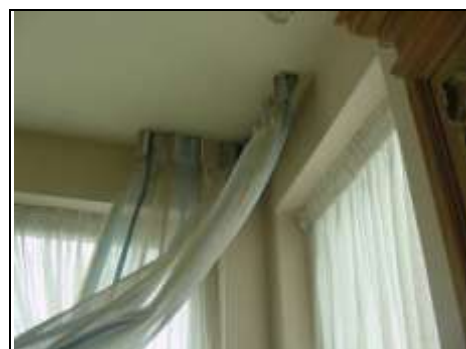
There is a mixture of timber windows and metal windows. We noted staining around some of the windows. We spoke to the owners about the staining around the metal windows to the rear and they advised that they thought they were leaks from when the windows were first carried out and no longer leaked.

Staining to windows

We were wondering whether this could also be condensation as this often occurs with metal windows particularly where there is a mixture of different types of windows (in this case timber and metal) particularly with a modern central heating system which has made the property far warmer than it ever was originally with coal fires.

**ACTION REQUIRED:** You need to ensure there is a balance between heating, coolness and air movement and ventilation in the property to minimise condensation. However, we have been involved with some properties where there has been particularly bad condensation and the way you live in the property will be different to the way the existing owners live in the property so this condensation may appear.

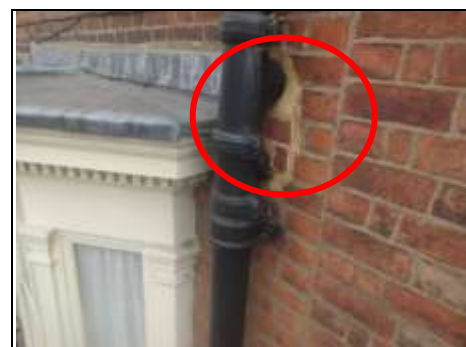
With older properties, you will hear a lot about the use of lime mortar and cement mortar. We tend to find a lot of properties that have been wrongly repointed in a cement mortar however the idea behind lime mortar is now better understood and generally listed properties are moving towards lime mortar. We can see in this property that there have been some cement repairs to the outside of the property. This causes a smothering effect of the property so it cannot breathe and let the dampness out. Over time you need to replace the cement mortar.

Cement repair

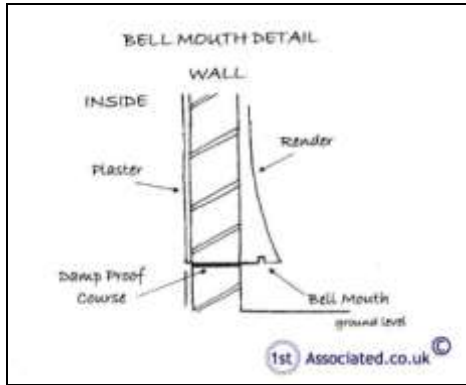
Bell mouth detail

**ACTION REQUIRED:** Interestingly, if you look to add drip details on this we would discuss it with the Listed Building Officer before you do it. Although it is a defect it may be considered part of the style of this property.

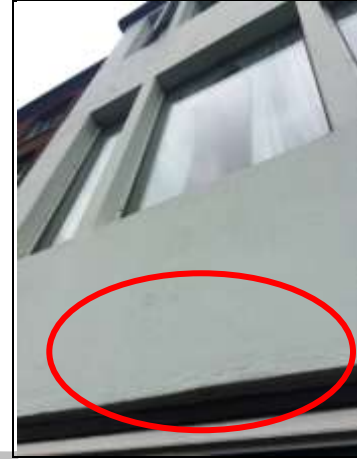
Repair

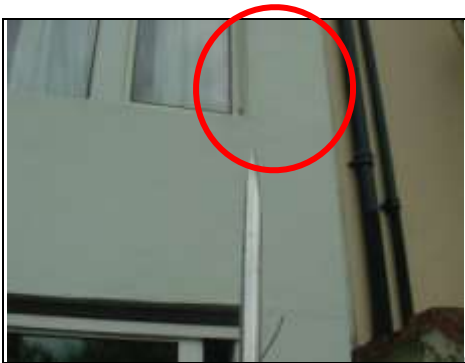
To the rear of the property there is a large area of painted render which looks like it has been finished in a harder cement mortar. We could also see cracking in it and what looks like cement mortar repairs as well. We would prefer a bell mouth detail here.

Vertical cracking

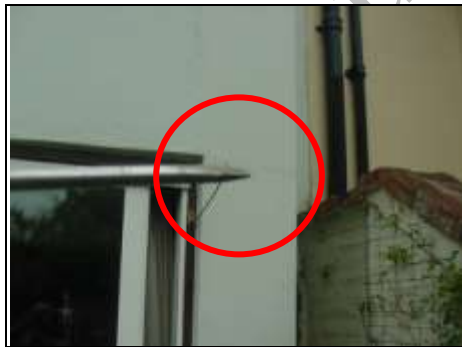
Horizontal cracking

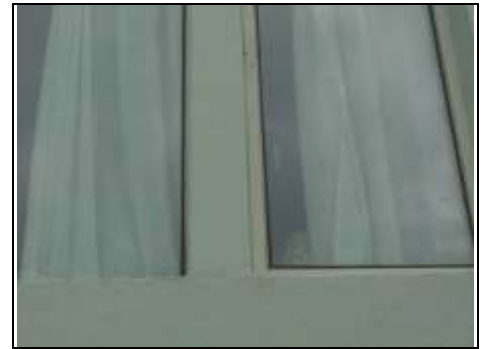
Repair around window area

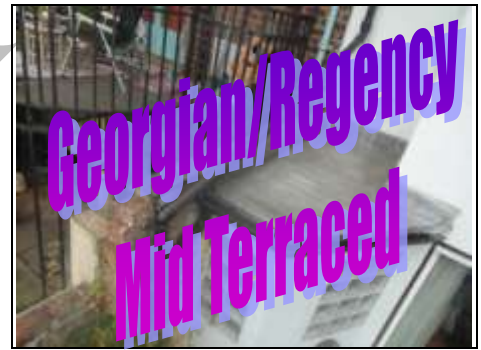
Toilet area changed to boiler room

**ACTION REQUIRED:** We would recommend legal advisors obtain a full list from the present owners as to what they have and have not done and what they consider previous owners have not done. Then arrange an informal 'cup of tea' meeting with the Listed Building Officer and show them the list and ask if they have a photographic record of the property as many local authorities do have. We noted it was originally listed on

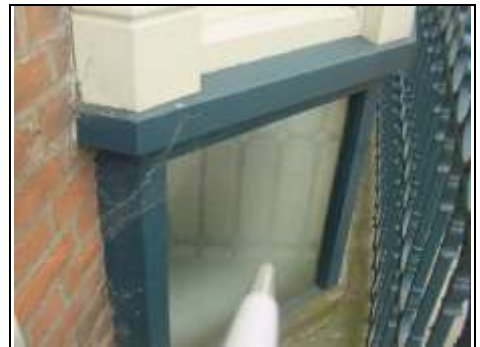
Glazed window to front not to listed building standard

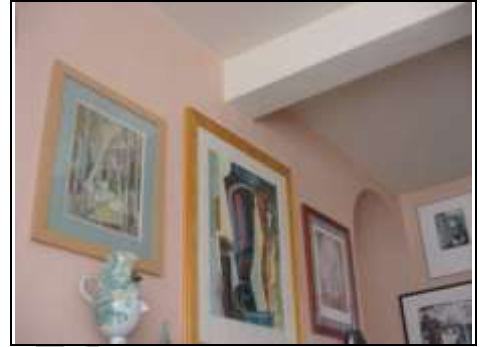
As with many properties of this age walls have been removed and the stairs have been altered for example today on the ground floor where the beam is you would be required to have a 450mm for it to be supported however the property has obviously stood the test of time.

No return to removed wall

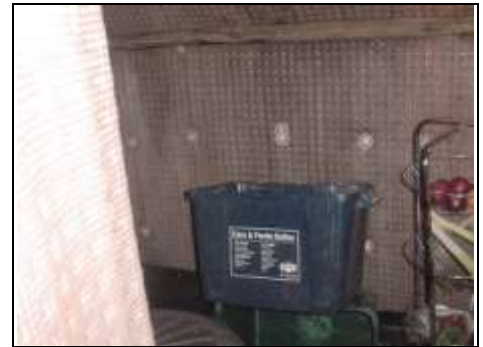
We found some dampness to the lower ground floor as we would expect. Basements were never meant to be dry or as what we would term as habitable rooms. The use of it as a bathroom to the front and a kitchen to the rear is probably ideal. There tends to be problems where these rooms are used for sleeping in.

Dampness in under road storage area

**ACTION REQUIRED:** You could add a French drain to the property to try and keep the lower ground floor/basement slightly drier however at the end of the day it is a basement.

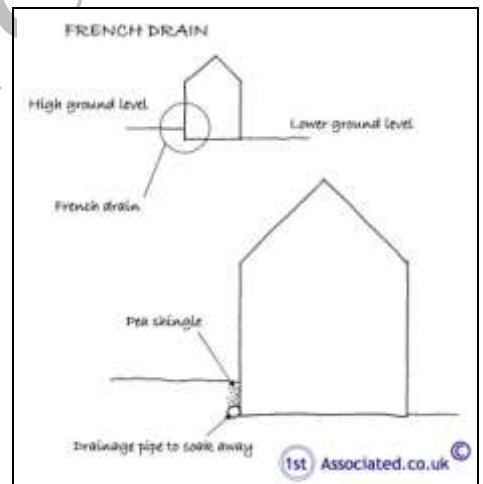
French drain

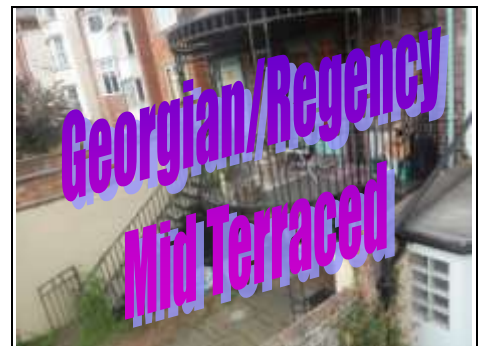
Next door have an upper ground floor level balcony which is a nice design we believe however it does mean that when they are sitting out in their garden they overlook your garden which may or may not suit you, it certainly would not suit us. You may wish to revisit to check this.

Next doors balcony overlooks your garden

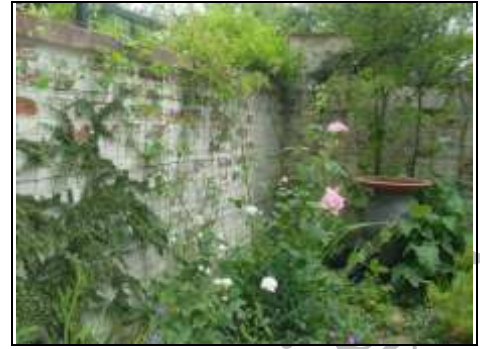
The rear garden wall is slightly unsafe and worse for wear. We could see it is built in a red brick which is starting to deteriorate and also some of the capping is not ideal, possibly because of the conifers and trees nearby. We tend to find that garden walls are built without proper foundations.

Garden wall

The photograph also shows where next doors garden wraps around behind yours and there looks to be a table and chairs directly next to your wall which again may not be ideal for privacy.

**ACTION REQUIRED:** With regards to gardens walls you always have to have discussions with regard to who owns what and who does what, etc.

**ANTICIPATED COST:** We recommend you set aside the sum of £500 to £1,000 (five hundred pounds to one thousand pounds) assuming that the adjoining owners will also pay some money.

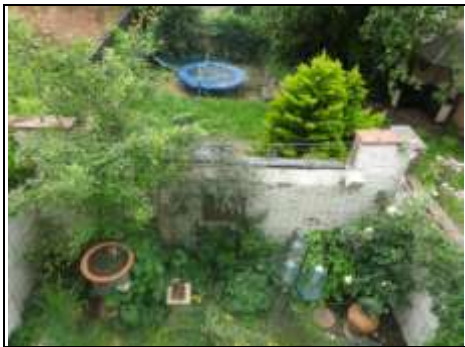
Rear garden wall and surrounding garden

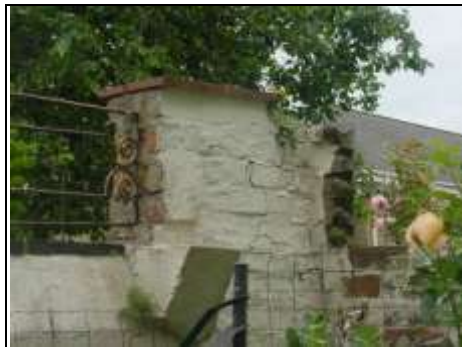
Cracking to wall

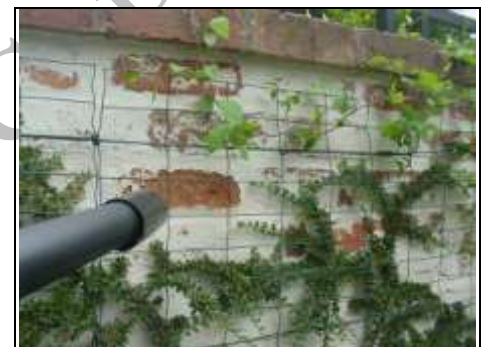
Spalling brickwork

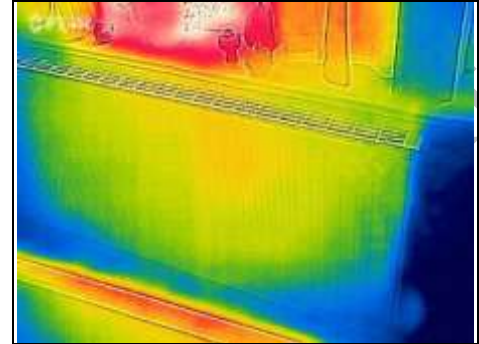
We gave the owners the opportunity to turn the heating on and warm the house up for a ten minute test however unfortunately we could not get any of the radiators warm.

Heating not working

There is a Baxi boiler located in the kitchen. We are advised the boiler was installed in xxxx. We would recommend that the system be tested and overhauled before exchange of contracts and that a regular maintenance contract is placed with an approved heating engineer.

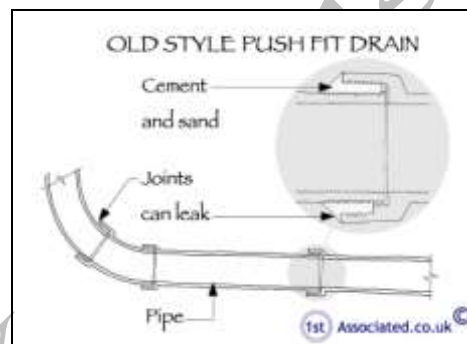
In older properties, such as this, drainage was often push fitted together rather than bonded together which means that they may leak over the years. Whilst we ran the tap for 15 minutes without any build up or blockages the only way to be 100% certain of the condition of the drains is to have a closed circuit TV camera report.

Push fit drain

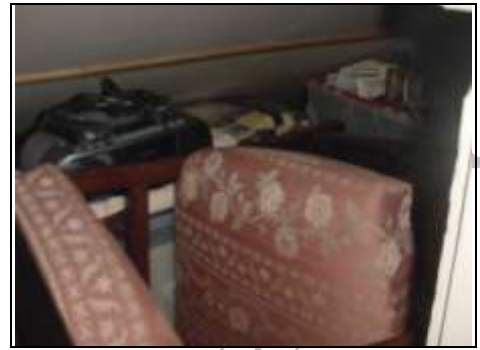
Area to front lined and full of stored items
