RESIDENTIAL BUILDING SURVEY

Hertfordshire

INDEPENDENT CHARTERED SURVEYORS

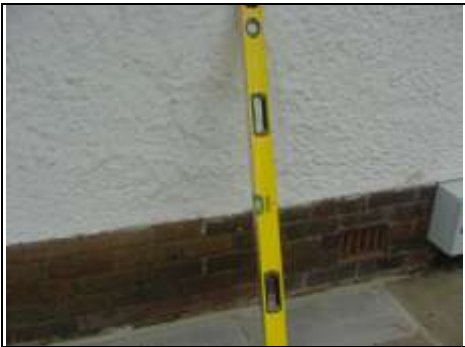
We are having slight difficulty obtaining information to understand exactly what work has been carried out. As with most underpinning work it is now hidden. In this case there are some undulations and poorer quality repairs to the painted render and there are different coloured paving slabs and the tree with the drain next to it however we do not have the exact details of what was carried out. We have the plans with piles around the kitchen area (please see overleaf). We were also given a cross section of piling work however were also advised this was not carried out. We would like to see sketches, drawings and details of information with regard to what has been carried out.

Marks to wall from movement visible after underpinning

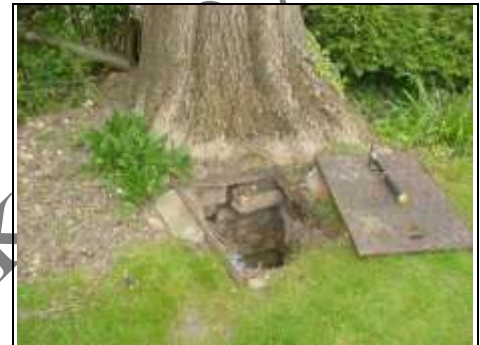
It is very unusual to have a drain with a tree on top of it as there is at this property. As mentioned, we do feel the tree roots are likely to get into the drains. We can see that the manhole is distorted and deteriorated and it is only a matter of time before the roots affect the drainage on this property.

Tree on the drain

ACTION REQUIRED: We recommend a closed-circuit TV camera report to establish the condition of the drains and partial rebuilding of the manhole.

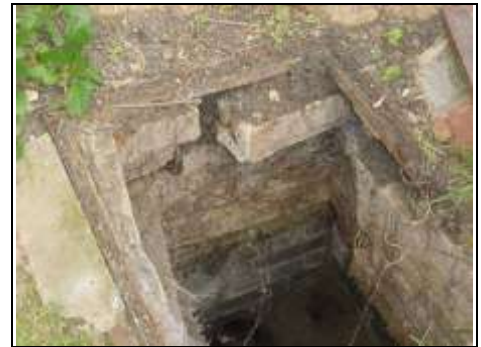
Tree roots in the manhole

Close up

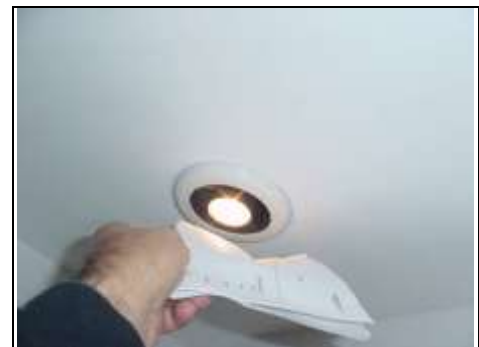
The extract systems in the bathroom and the en-suite are via light extracts and extract into the thatch which we are not keen on. We would recommend these are relocated so they extract to external air however, often this is easier said than done.

Checking the draw of the extract fan within the light

ACTION REQUIRED: We would recommend large good quality humidity controlled extract fans are added to the kitchen, bathroom, en-suite and any areas that are used for drying clothes internally during winter months (we would assume that clothes will be dried externally during the warmer months). By large extract fans we mean 150mm.

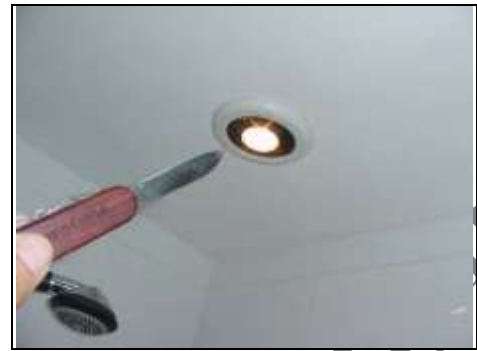
Extractor in en-suite shower room

ANTICIPATED COST: We would anticipate costs between £250 - £500 (two hundred and fifty pounds to five hundred pounds) per extract fan depending upon the wiring required. We always recommend quotes are obtained before work is agreed/commenced.

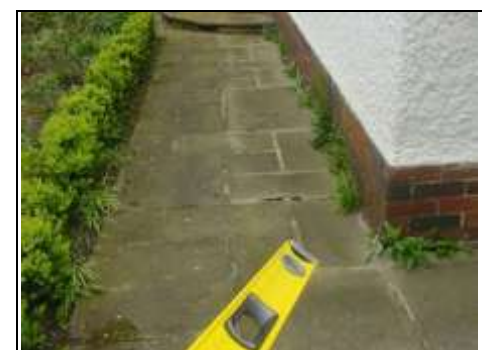
It does look like water discharges against the property at the base. Ideally we would recommend a French drain against the building and also the paving slabs being adjusted so they run away from the building.

Vegetation against the building

ACTION REQUIRED: Once you have established what the ground conditions are and seen the property when it has rained heavily it may be

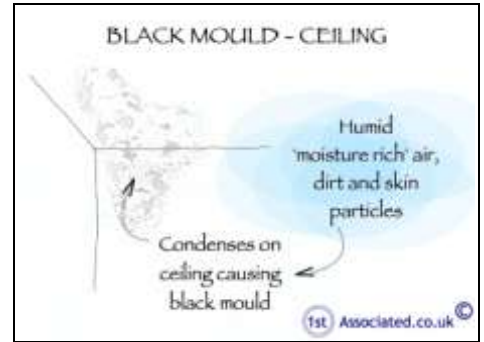
Black mould

ACTION REQUIRED: Please see our comments with regard to adding large good quality humidity controlled extract fans.

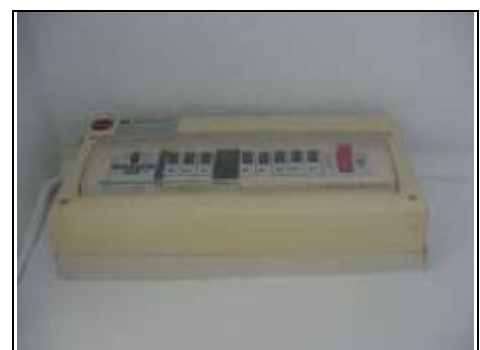
Dated electrics

ACTION REQUIRED: As the fuse board is dated we recommend replacement particularly as this property is thatched. The Institution of Engineering and Technology (IET) recommend a test and report when properties change hands, to be carried out by an NICEIC registered and approved electrical contractor or equivalent.

ANTICIPATED COST: £250 - £500 (two hundred and fifty pounds to five hundred pounds) for a test plus any work recommended; please obtain quotations.

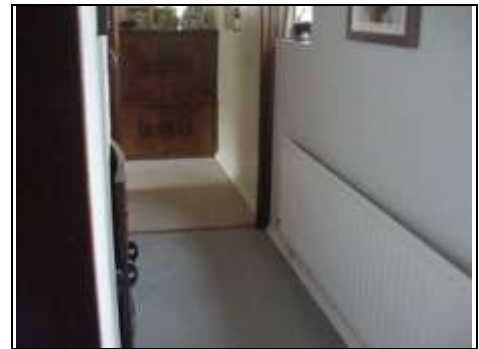
Single panel radiator

ACTION REQUIRED: We would recommend these are changed to double panel convection radiators and thermostatic radiator valves etc. are checked and ensured they are in working order. It is probably worth a pressure flush of the system as well.

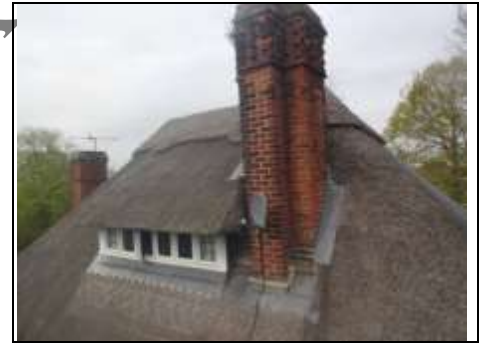
This is a large brick finished chimney with one chimney pot and a lead flashing and a tile on edge. There is a thick mortar bedding the lead in. From what we could see from ground level it looked in below average condition considering its age, type and style.

Rear left chimney
Aerial view – 360 photo

ACTION REQUIRED: Periodically inspect the chimney. Anticipate ad hoc repairs in the next few years to both the chimney and the flashing. The sooner the work is carried out the better.

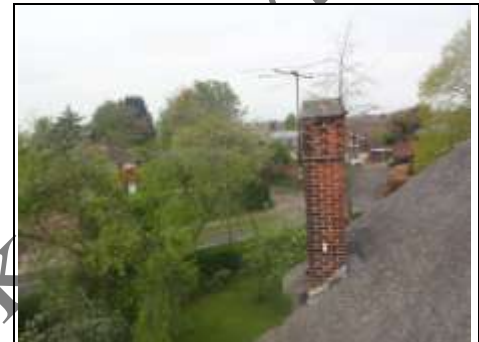
Rear right chimney

ACTION REQUIRED: We would recommend in the next year or so that this chimney is looked at more closely and repointing is carried out in an appropriate mortar. Remember if a cement mortar is used this will cause accelerated deterioration to the red bricks. You need to ensure the bricklayers who carry out the repairs know exactly what they are doing with regard to mortars.

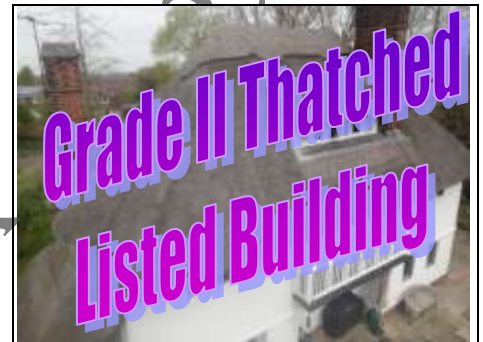
There is moss starting to occur particularly to the left side, which is the north side, however we do feel that the thatch will suffer from the trees surrounding it meaning that there is a lack of sunlight in some areas and also trees tend to reduce the amount of air movement around a property. It has been a fairly dry spring so far and it is still relatively early so some of the trees were still not fully leafed (and also the tree root systems are hunting for water).

Thatch main roof
Aerial view – 360 photo

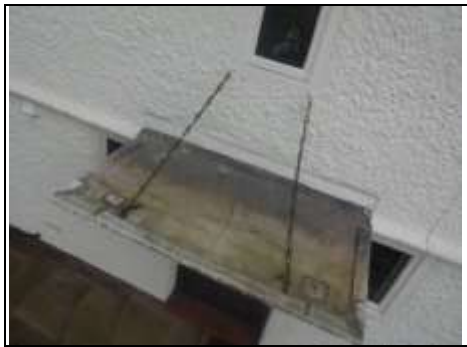
The porch roof is metal covered. Water is leaking through it and we can see there is rot underneath. This needs some attention.

Porch roof
Aerial view – 360 photo

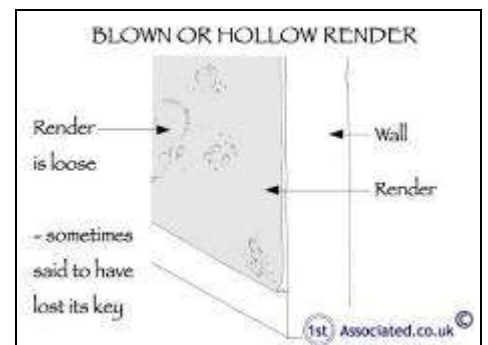
We have carried out a tap test (we usually hit the render with the back of a hammer, in this case we hit it with our hand as the owner was present and we did not want to appear to be damaging the property). We found it to be in average condition for its age, type and style.

Blown or hollow render

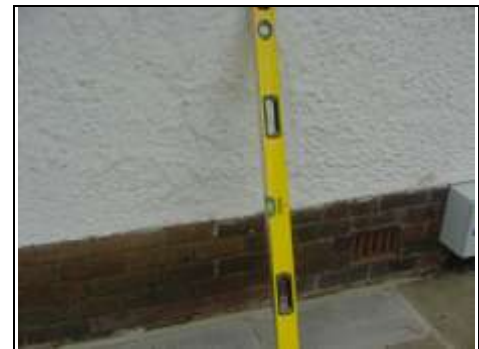
There is what remains of the cracking on the kitchen side; it would be interesting to see what the cracking was like before the work was carried out.

Cracking

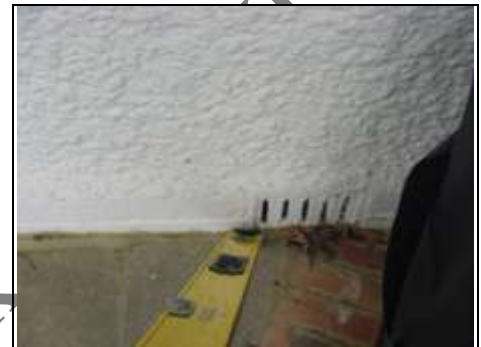
Air bricks are essential to have a through flow of air as this helps to reduce the chances of wet rot, dry rot and woodworm. In this case the airbricks are slightly lower than we would like; we would prefer to have two bricks from ground level. Also, in some areas, the water seems to be tipping towards the building. Please see our comments with regard to a French drain and releveling the paving slabs.

Airbrick acting as gutter

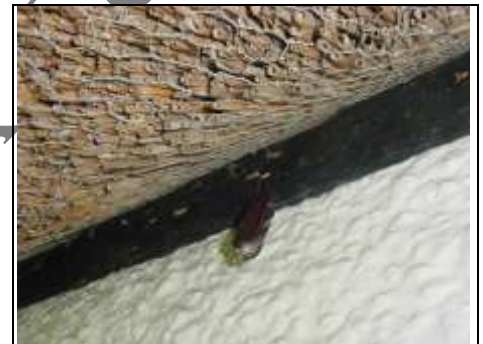
There are not fascias and soffits in the normal sense on a thatched roof however we can see there is a timber soffit board (for want of a better term) between the thatch and the wall which was slightly soft. There is also the feature of the exposed rafter feet which were slightly hidden away as you would have on a Wealden hall house. There is some minor soft rot to these.

Soffit under the thatch roof

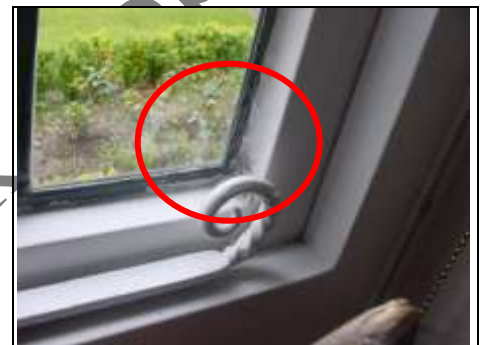
At the time of the inspection there were the slightest signs of black mould in some of the corners of the windows however the building had been kept generally in very good condition.

Black mould to the right bedroom corner

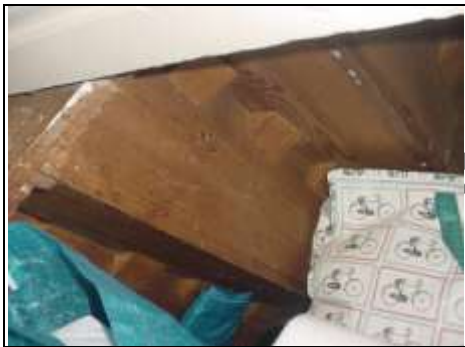
We noted that the underside of the staircase from the first floor to the top floor was exposed. It is more normal today to have a half hour fire barrier to stop fire spreading from the ground floor to the first floor in a worst case scenario. You may wish to take a view on whether you add this.

Underside of first floor to top floor staircase exposed

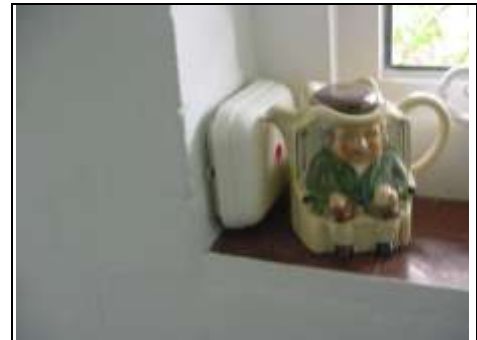
Some smoke detectors were noted, we were disappointed to see these were battery operated. The current Building Regulations require that they be wired into the main power supply. Obviously in a property of this age this is difficult, as it would mean having surface mounted wires or cutting wiring into the plaster.

Smoke alarm on first floor landing

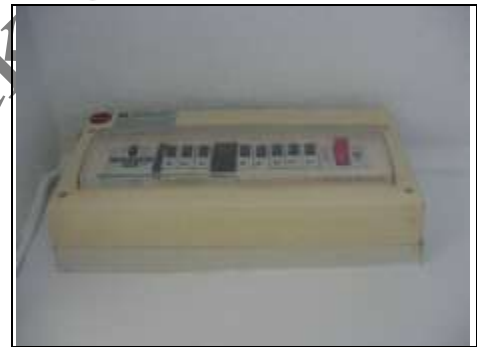
Fuse Board

We would recommend replacement.

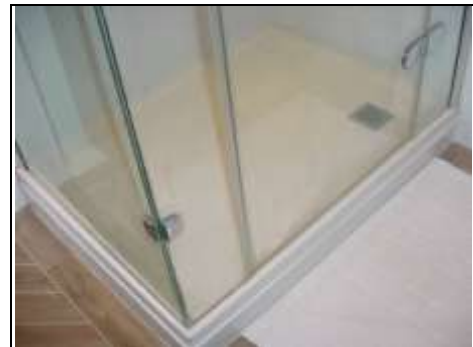
The property also has a four piece en-suite shower room, consisting of shower, wash hand basin, bidet and WC which looks in average condition. We noted a shallow shower tray; we have come across problems with these leaking.

Shallow shower tray

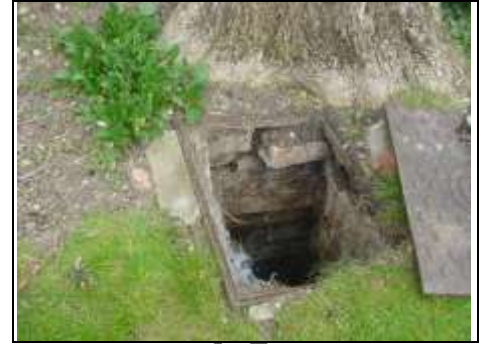
From what we could see it was brick built and requires partially rebuilding.

Front left manhole by tree

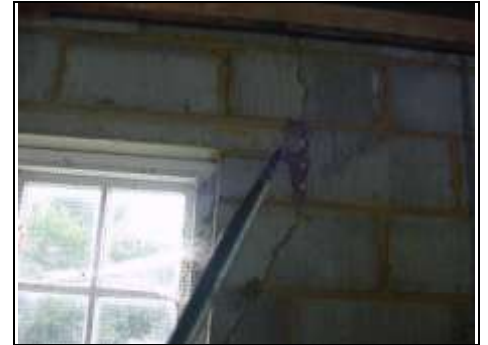
There is a double garage to the rear left. Cracking was noted within the garage.

Cracking to rear wall
