# RESIDENTIAL BUILDING SURVEY

Hertfordshire

## **EXECUTIVE SUMMARY**

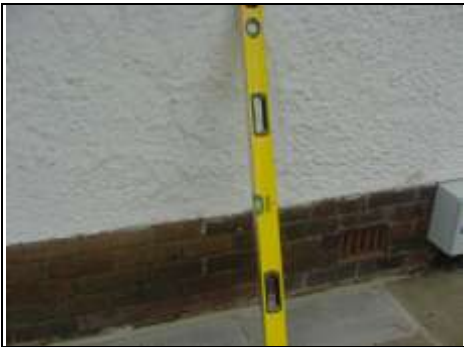
Marks to wall from movement visible after underpinning

**ACTION REQUIRED:** Your legal advisor to provide and email electronic information pack to us on all the work carried out thereafter we can comment further.

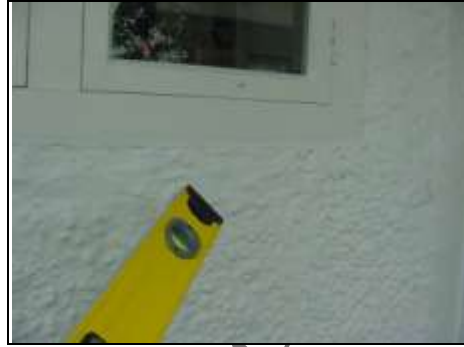
Undulations in the wall

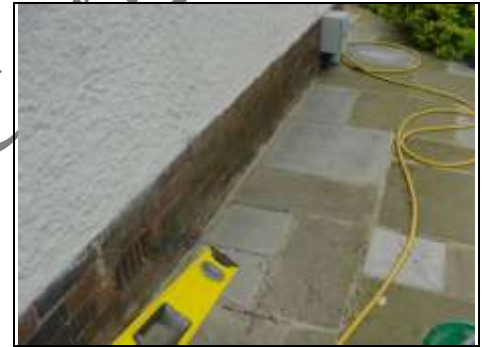
Area of underpinning

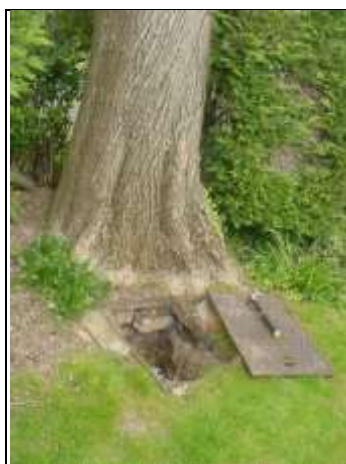
Tree with manhole to base

You also would be best to have a closed circuit TV camera report of the drains to ensure there are no tree roots in the drains.

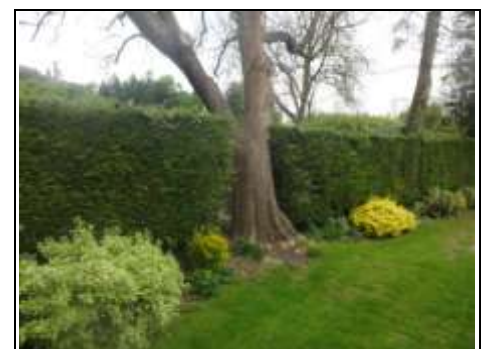
Tree with manhole to base

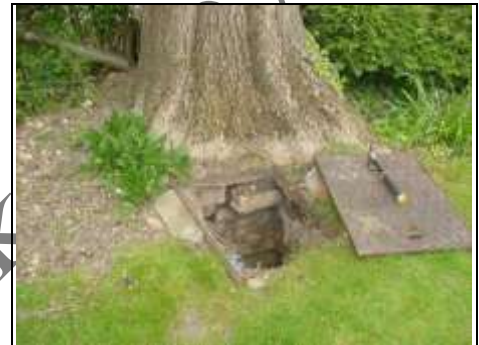
It is very unusual to have a drain with a tree on top of it as there is at this property. As mentioned, we do feel the tree roots are likely to get into the drains. We can see that the manhole is distorted and deteriorated and it is only a matter of time before the roots affect the drainage on this property.

Tree on the drain

**ACTION REQUIRED:** We recommend a closed-circuit TV camera report to establish the condition of the drains and partial rebuilding of the manhole.

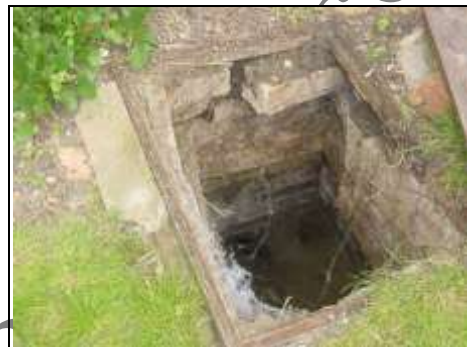
Tree roots in the manhole

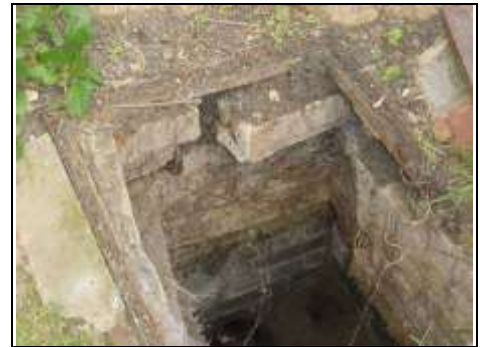
Close up

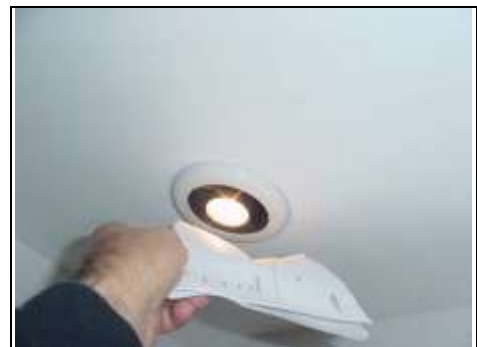
The extract systems in the bathroom and the en-suite are via light extracts and extract into the thatch which we are not keen on. We would recommend these are relocated so they extract to external air however, often this is easier said than done.

Checking the draw of the extract fan within the light

**ACTION REQUIRED:** We would recommend large good quality humidity controlled extract fans are added to the kitchen, bathroom, en-suite and any areas that are used for drying clothes internally during winter months (we would assume that clothes will be dried externally during the warmer months). By large extract fans we mean 150mm.

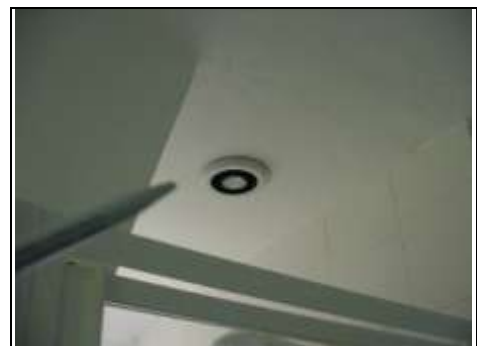
Extractor in the bathroom

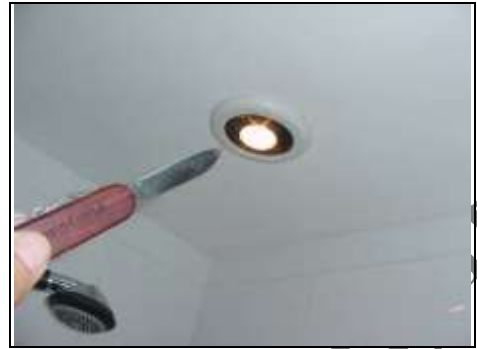
Extractor in en-suite shower room

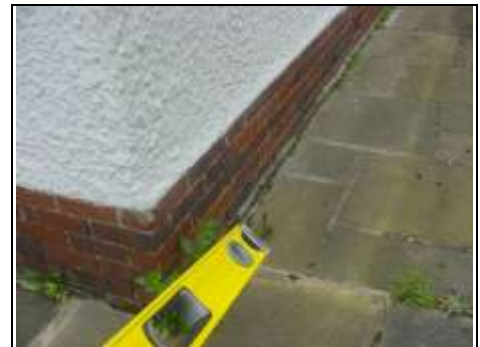
It does look like water discharges against the property at the base. Ideally we would recommend a French drain against the building and also the paving slabs being adjusted so they run away from the building.

Water marks against the building

**ACTION REQUIRED:** Once you have established what the ground conditions are and seen the property when it has rained heavily it may be

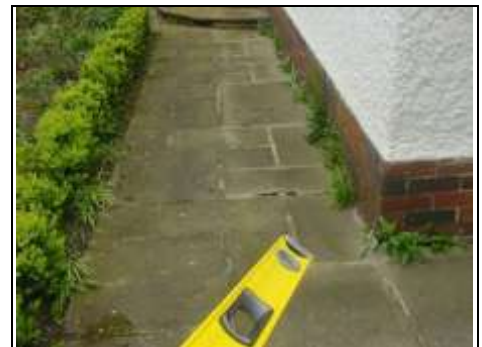
Vegetation against the building

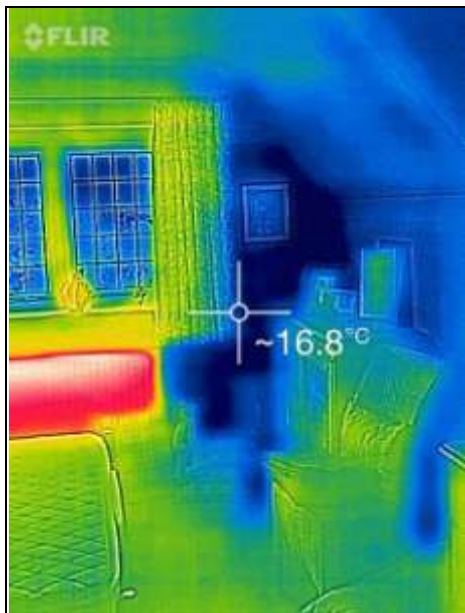
Thermal image  
Colder walls in upstairs bedroom

**ACTION REQUIRED:** Please see our comments with regard to adding large good quality humidity controlled extract fans.

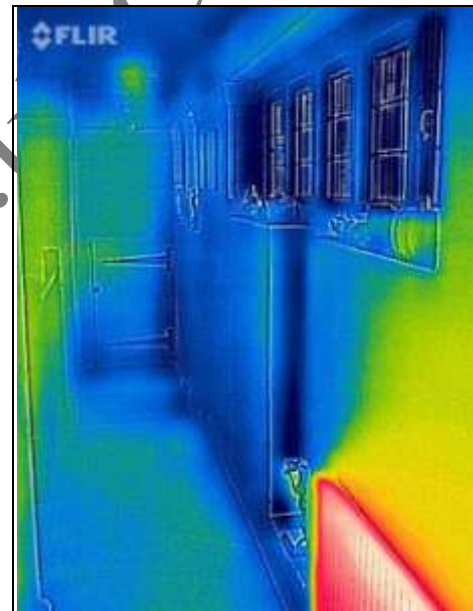
Thermal image  
Cold walls to first floor landing

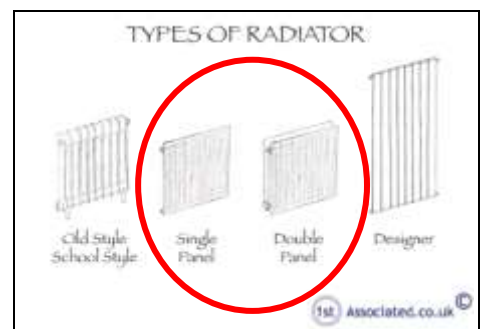
Single panel radiator

**ACTION REQUIRED:** We would recommend these are changed to double panel convection radiators and thermostatic radiator valves etc. are checked and ensured they are in working order. It is probably worth a pressure flush of the system as well.

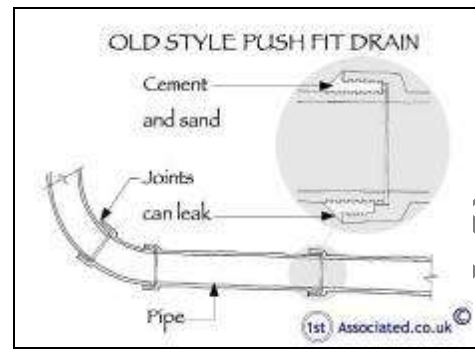
Whilst we have lifted the two manholes covers to the front left hand side of the property one of which is practically under a tree, the only true way to find out the condition of the drains is to have a closed-circuit TV camera report to establish the condition of the drains. In this age of property there have often been leaks over the years.

Push fit drain

Closed-circuit TV camera report to establish the condition of the drains.
