RESIDENTIAL BUILDING SURVEY

London

INDEPENDENT CHARTERED SURVEYORS

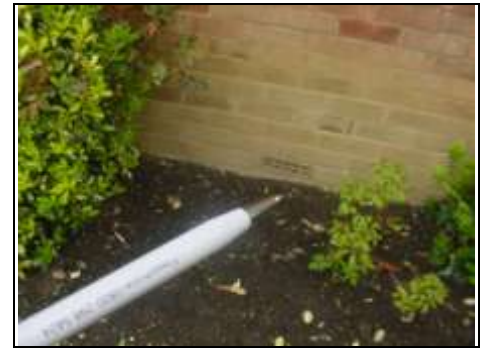
Darkening of bricks to rear

High ground level to rear

We would recommend reducing the ground level to the rear and adding a French drain.

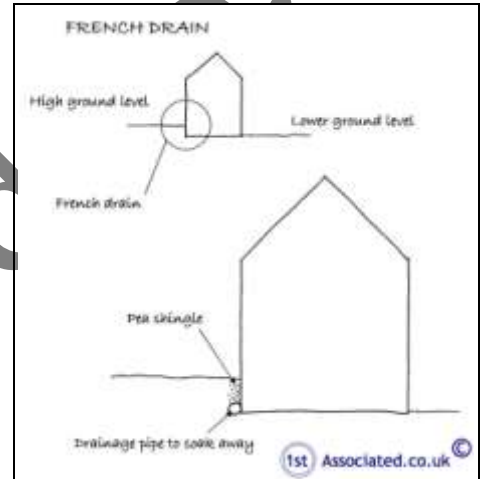
To the front there looks to have been a French drain partly added; we would recommend that this work is reinstated.

ANTICIPATED COST: In the region of £2,000 - £3,000 (two-three thousand pounds), these costs should be shared costs.

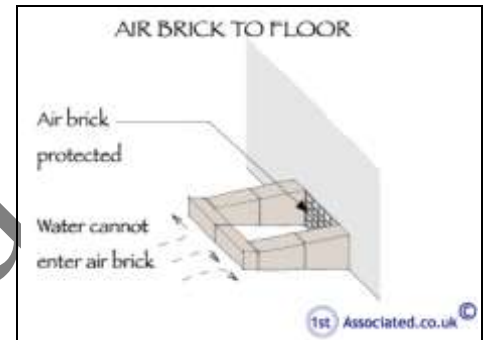
Airbrick almost covered in earth and acting as a gutter

Protect airbrick

ACTION REQUIRED: Reduce the ground level as much as possible. If for any reason this cannot be done we would recommend the airbricks are protected as shown in our sketch.

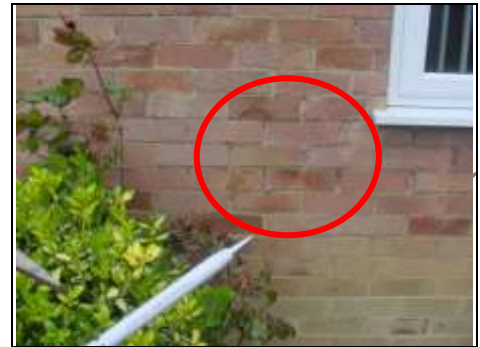
We noticed a small movement to the rear wall. This may have been due to leaks where the drains run parallel to the rear wall. When we lifted the drains one of the manholes had a small amount of tree root in it.

Movement in rear window

ACTION REQUIRED: The building is probably insured on a block insurance. We do not expect what we have seen to be a major problem. The only way to be one hundred percent safe is if the existing owners take out an insurance claim, advising that the cracking has been noted by a structural surveyor (this should cost them nothing other than time to write the letter). This usually means that the insurance company will carry out a monitoring exercise (the Building Research Establishment recommend monitoring any cracks for a minimum of one year) to establish if there is any progressive movement. Your future liability will be limited to the cost of the excess on the insurance providing the insurance company is happy for you to take over the insurance claim.

Your solicitor needs to ensure this is a legally watertight process and ensure your liability is limited to paying the excess on the insurance only.

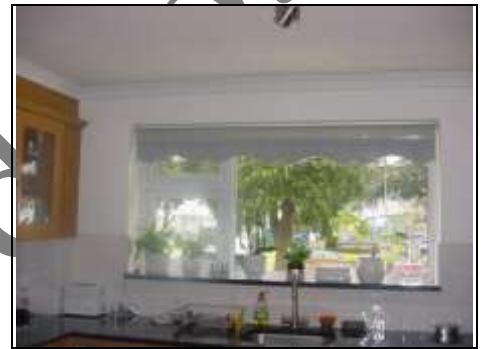
Trees viewed from kitchen window

Tree damage to garden walls

We can certainly see there has been damage to various garden walls surrounding the property so the trees need to be regularly maintained.

ACTION REQUIRED: Your legal advisor to check and confirm that the trees will be regularly maintained as part of the garden service charge.

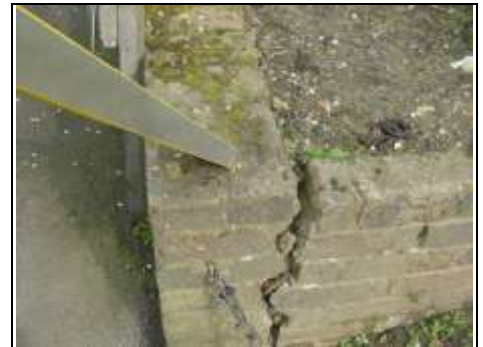
Tree damaged nearby wall

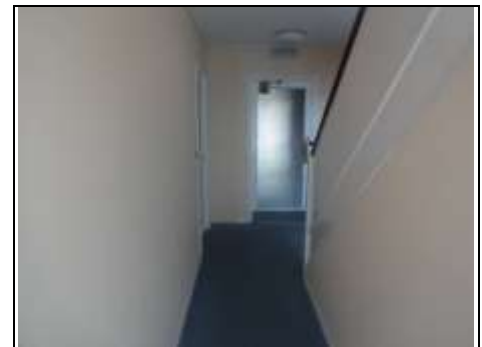
We cannot see a British standard safety kite mark on the glazed doors in the communal/shared area and we therefore assume that this glass is not safety glass therefore it can shatter. We would recommend changing the glass to safety glass.

Non-safety glass

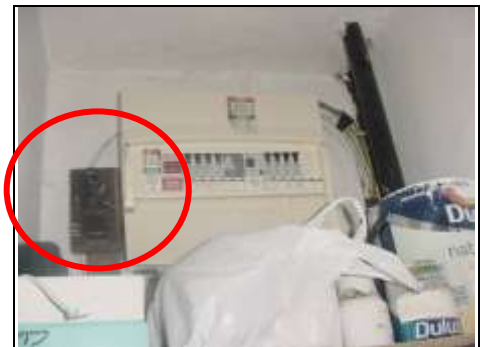
Dated electrics

ACTION REQUIRED: We recommend an Institution of Engineering and Technology (IET) test and report to be carried out by an NICEIC registered and approved electrical contractor or equivalent.

ANTICIPATED COST: £250 - £500 (two hundred and fifty pounds to five hundred pounds) plus any work recommended; please obtain quotations.

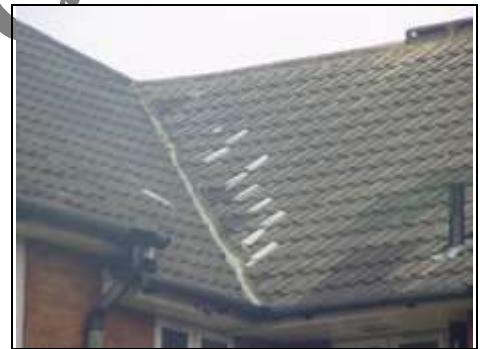
The roof to the far right has different tiles around the hips. It looks like the tiles have been replaced with a different type of tile although we could not see properly. This is not your roof however you may have a liability for it.

Roof to far right has different tiles

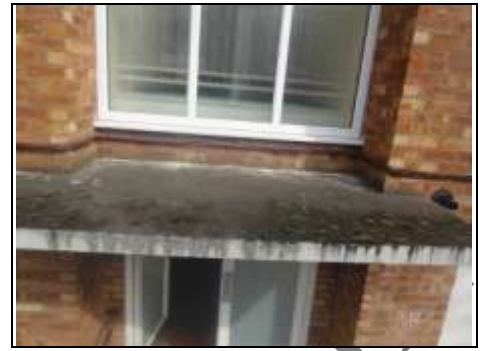
The entrance canopy roof is a flat concrete roof which was moss covered at the time of our inspection. There is no guttering so there will be some staining to the front as you can see.

Moss to concrete roof of entrance canopy

ACTION REQUIRED: Clear moss and ensure watertight. This would be a shared cost.

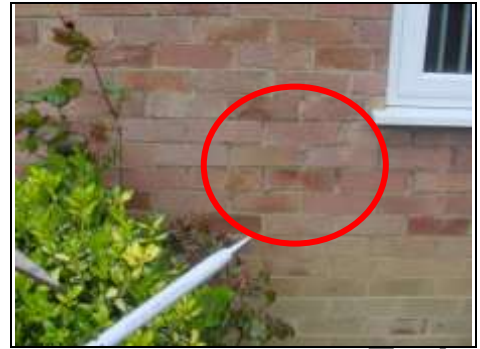
Movement in rear window

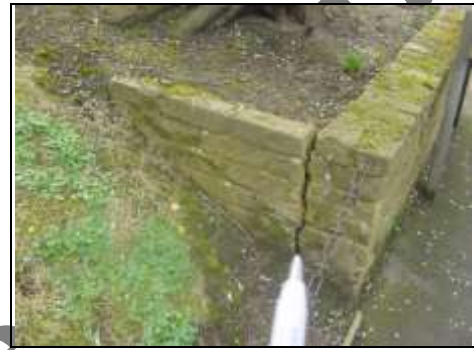
Tree causing damage to wall

ACTION REQUIRED: The trees need to be regularly maintained. The trees are helping hold the bank together as the property sits on a sloping site. Please see our comments in the Executive Summary.

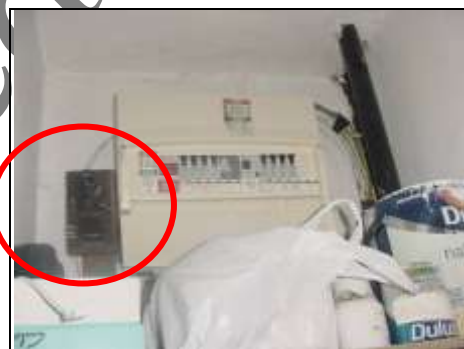
The electric fuses and consumer units were located in the hallway cupboard. The fuse board looked xxxxxxxxxxxxxxxx and better are now available. In multi occupied properties a defective fuse board can be particularly dangerous.

Fuse Board, dated electrics

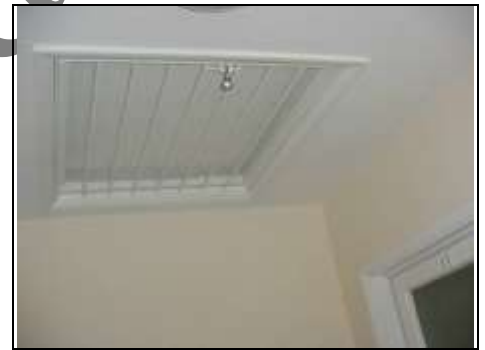
Roof access locked shut

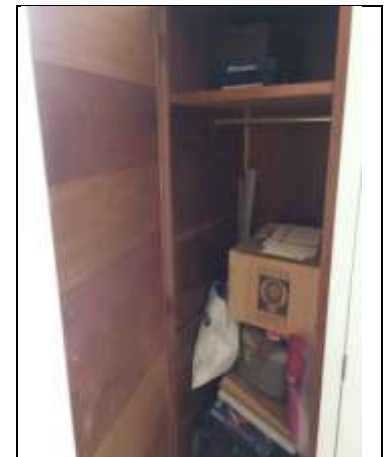
Cupboards lined so unable to view walls
