# RESIDENTIAL BUILDING SURVEY

Tenbury Wells,  
Worcestershire  
WR15 XXX

INDEPENDENT CHARTERED SURVEYORS

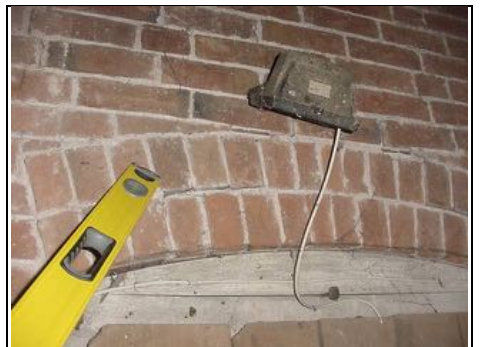
Crack to gable of house visible  
within the barn

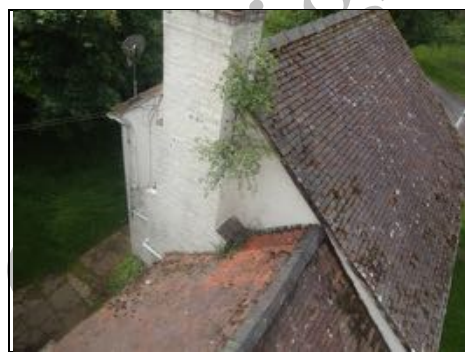
The chimney has suffered from a lack of maintenance, there is vegetation and plants growing out of it. It no doubt will require some repointing and repair work.

Plants growing out of chimney

**ACTION REQUIRED:** Remove plant/vegetation, repoint and repair.

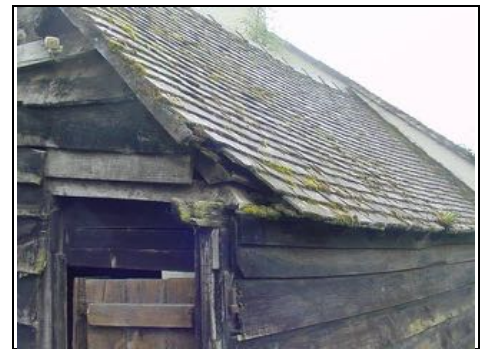
Part missing from barn roof

**ACTION REQUIRED:** We would recommend the moss is cleared with a soft brush and carry out ad hoc repairs to the roofs. The main repairs are required to the barn. Add lead flashing between the main house roof and the barn roof. Care needs to be taken when on the barn roof until the structure is stable.

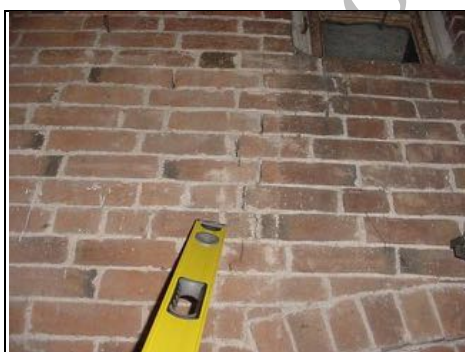
We believe that where the door is and the window on the left gable of the main house is a weak area. The barn is also taking support off this wall in the form of point loads from the purlins. This combination, we believe, has caused movement in the main property.

Crack to left gable of main house

**ACTION REQUIRED:** Ideally, we would recommend the existing owners take out an insurance claim, advising that the cracking has been noted by a

We believe the work needed will be to separate the barn to make it a self-supporting structure although obviously, it has stood the test of time as it is. Once this has been carried out, carry out repairs to the wall structure to re-bond it together.

**ANTICIPATED COST:** This should be covered under insurance (assuming the existing owners have insurance). If not we would set aside the sum of £1,000 - £3,000 for repairs. This is assuming that you are carrying out the work mentioned earlier; quotations required.

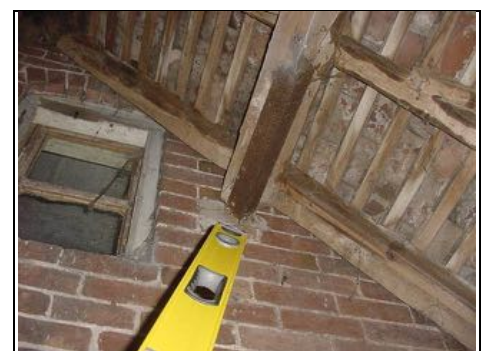
Point load created by purlin has had metal bracket added

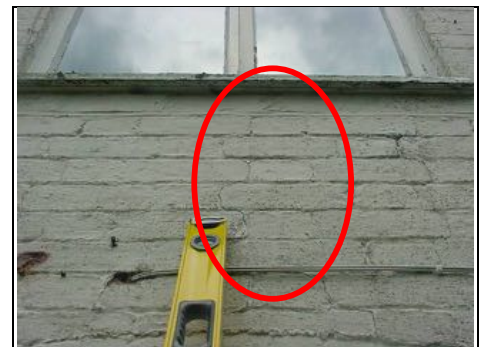
We have already discussed cracking within the left gable wall visible within the barn. There is also some movement throughout the property. To some extent it could be argued it has stood the test of time with very little appropriate maintenance from what we can see and things will only get better as you carry out the work.

Vertical crack which follows line of mortar

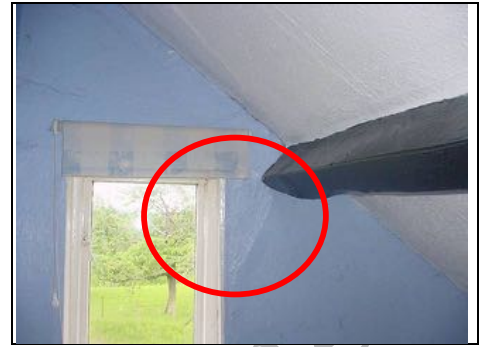
Movement around front window likely to be due to the timber lintel

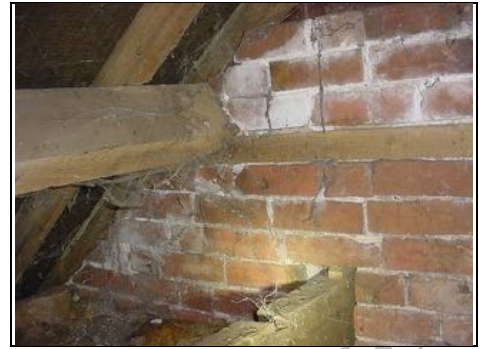
Efflorescence, bonding timber will be affected by dampness

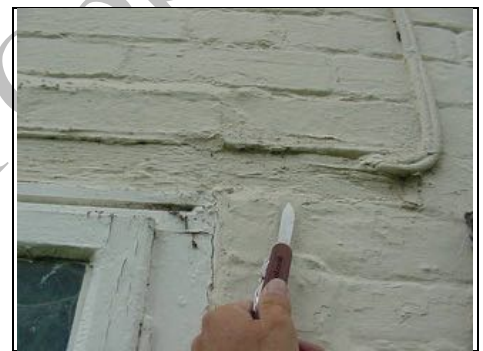
To the front of the property there are timber lintels. It may well be worth taking these out completely. You can replace them with a timber lintel or with a metal lintel.

Timber lintel over front window

**ACTION REQUIRED:** There is a lot of work required to the walls once you have stopped the water discharging down them by mending the gutters and get them back to a state where they are breathing again. Gently and gradually remove the modern paint that has been painted over the lime with a soft brush ensuring the brickwork is not damaged and then repoint and redecorate using a lime wash or modern microporous paint. This is likely to take several summer months (sunny days). We would anticipate this work to be carried out over a few years. Within it we would also incorporate repairs to the timber lintels and also underneath the windows which look to have been repaired in some areas with a modern cement rather than a lime plaster.

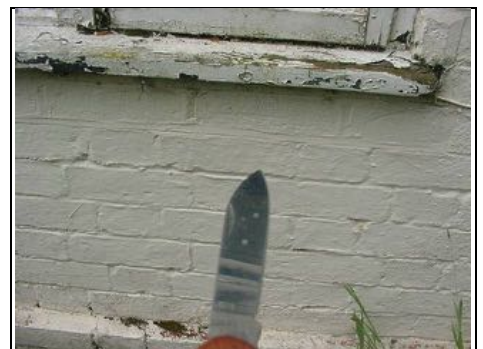
Damage under windows

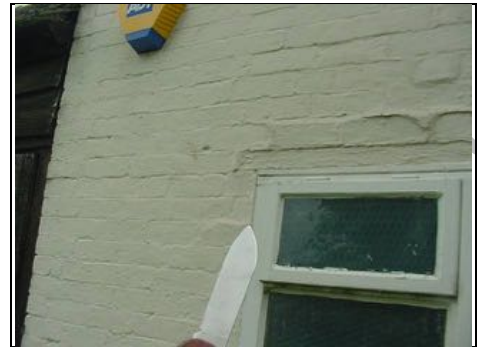
Rot to windows

Window put in flush and timber lintel above

**ACTION REQUIRED:** We would normally recommend you splice in new timber however these windows are relatively modern and it may be better to replace them with a good quality timber window. We suggest that the new windows are set back slightly to allow a drip detail so that the rainwater from the walls does not go impact the timber as much.

At the same time as carrying out repairs to the windows you will also need to check the lintels above them as we have already mentioned. Many of them are timber and may need replacing/repair.

**ANTICIPATED COST:** In the region of £1,000 to £3,000 to repair fully and £4,000 to £6,000 for new timber windows; please obtain quotations.

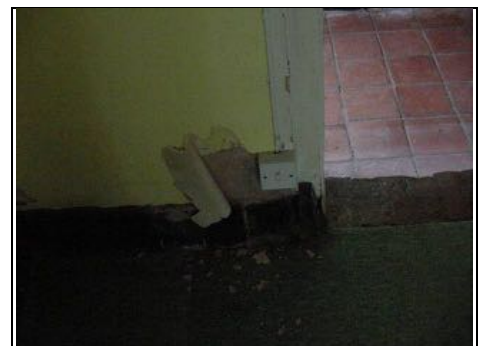
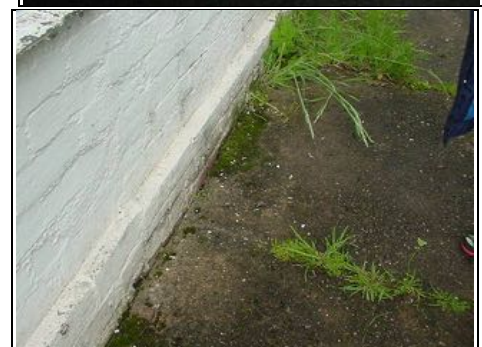
You need to look for the cause of the plaster losing its bond which we believe is dampness in the property. The deteriorating plaster (losing its key) is being caused partly by dampness coming through the walls, probably old age in the plaster in this particular instance but mainly dampness. We would refer you to our earlier comments about walls needing to breathe and removing the existing modern paintwork and repointing and also reducing the high ground level around the property.

Dampness/grass growing at base of property

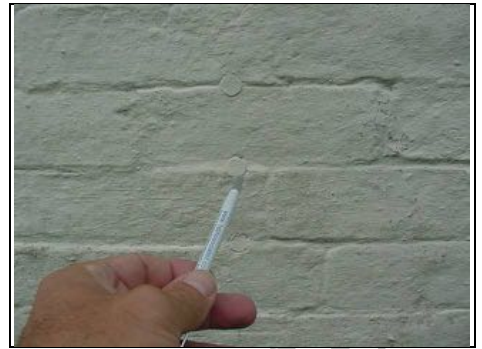
We can also see that the previous owners did not understand/were wrongly advised with regards to this property as we can see where the modern chemical damp proof course has been added horizontally and vertically which is not the way to resolve dampness in this particular property in our opinion.

Chemical damp proofing

**ACTION REQUIRED:** Once the work externally has been carried out to help the property dry internally the best way is to remove the wallpaper and this would then allow some of the plaster that has not lost its key to remain and dry. You could patch repair other areas. If and when you remove the plaster the walls are still very damp then it may be necessary to remove all of the plaster. In some cases, expose the brickwork to allow it to dry out.

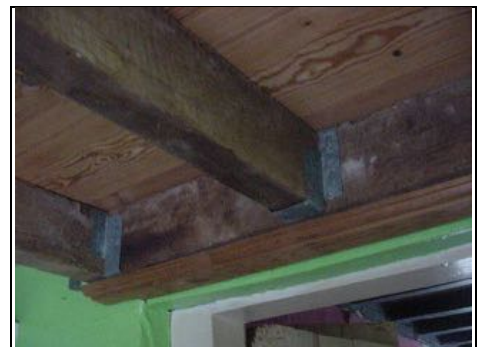
Mould to corner

Black mould to timbers

**ACTION REQUIRED:** We would recommend large good quality humidity controlled extract fans are added to the kitchen, the bathroom and any areas that are used for drying clothes internally during winter months (we would assume that clothes will be dried externally during the warmer months). By large extract fans we mean 150mm.

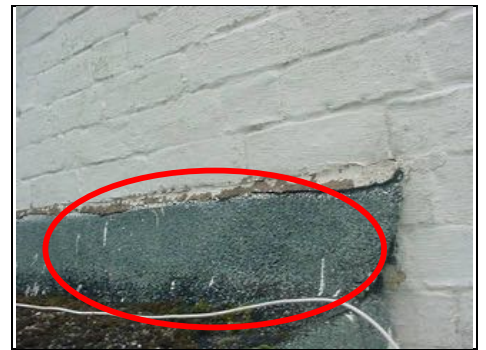
Moss to flat roof

Flashing starting to come away from wall

**ACTION REQUIRED:** We would suggest you clear the roof to see its condition and it is probably best if you put a layer of felt over the top of it and check the flashings. Also, add guttering. Ultimately, we would recommend that you put a pitched roof on this.

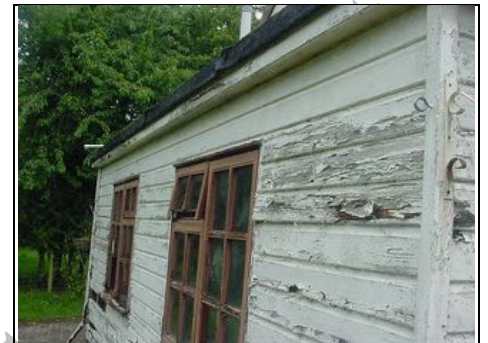
Timber deteriorated to left side

Rotten timber

**ACTION REQUIRED:** We recommend stripping back all of the shiplap boarding, adding insulation between the timber frame and then putting new shiplap boarding on the entire structure and redecorating. There would be some associated repairs with this around the windows and doors as well as adding the guttering of course.

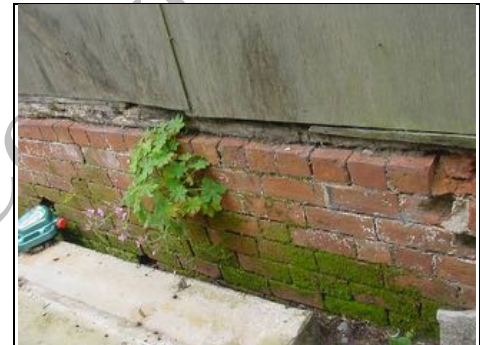
As mentioned you need to carry out work to the structure of the roof and also the repairs to the roof tiles as well as adding guttering. This in turn will then stop the mould and the dampness that we can see for example to the rear base of the barn. Rainwater is discharging onto the brickwork and to the front it is discharging onto the timber sole plate.

Water discharging down front of barn

Dampness to rear base of barn due to not having gutters

Guttering needs to be added to the barn. Once you have added gutters you then need to replace the shiplap boarding to the side and to the gable end, you may well be able to re-use some of the cladding. By adding guttering to the building will make it a lot better.

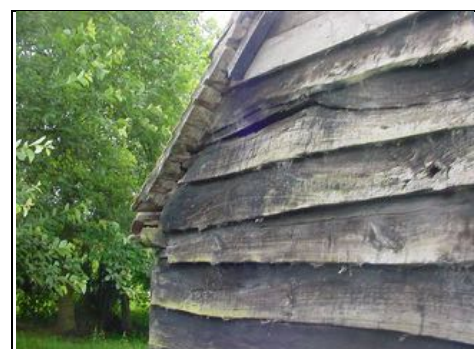
Deterioration to boarding on gable end

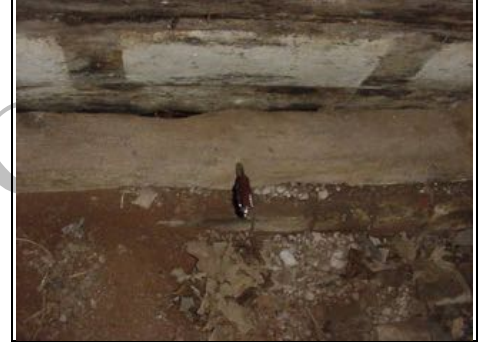
Rot to sole plate

**ACTION REQUIRED:** The timber that we knife tested is not doing too badly. We would suggest extra timbers are added in between the existing timbers and that repairs are carried out to some of the existing timbers including the sole plate that had some wet rot in it. There was not an excessive amount considering it was a sole plate.

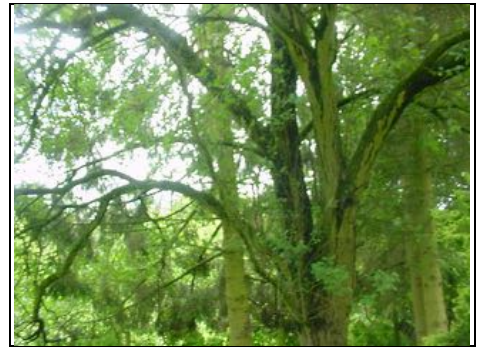
Trees need cutting back

**ACTION REQUIRED:** We believe that all of the trees need maintenance around the property and cut back to appropriate size for this property which we believe is much smaller. We would recommend an arboriculturalist (not a tree surgeon) is asked to view the property and give a ten-year plan for maintenance. There was a lot of tree cutting taking place on the day of our survey around the electrical lines.

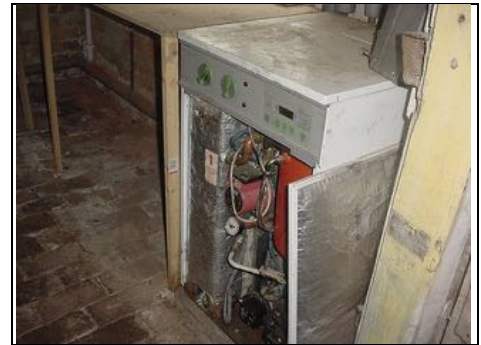
Boiler

The property has a Worcester floor mounted boiler. This may or may not work; it was not working on the day of our survey. It would be great if you could get it to work as to replace it would be costly.

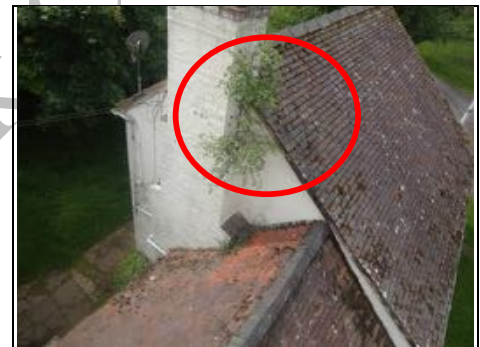
This chimney is painted brick finished with two chimney pots. From what we could see from ground level it looked in below average condition considering its age, type and style with plants growing from it. We are not sure what the flashing is; we could see internally that there was dampness coming in from the chimney.

Plants growing out of chimney

**ACTION REQUIRED:** Repair work required, removing of the plants/vegetation. Please see our comments in the Executive Summary.

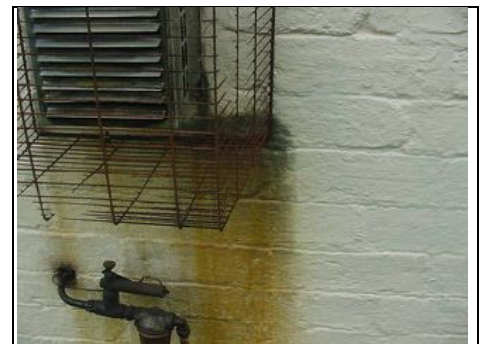
The property has a flue to the front of the main house for the boiler. There is rusting around the caging of the flue.

Rusting around flue

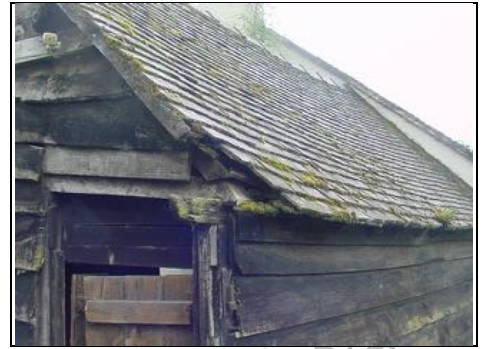
Part missing of barn roof

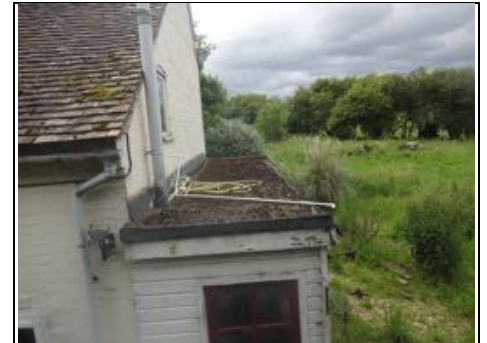
There is a storm porch with a flat roof running the length of the right-hand gable. The roof is in below average condition and was covered with moss indicating that it is a flat, flat roof (we would expect to see a fall of about fifteen degrees) and water is not discharging from it, it is more likely to be discharging into it. We can see this with the discoloration to the decking beneath it.

Flat roof to porch on right

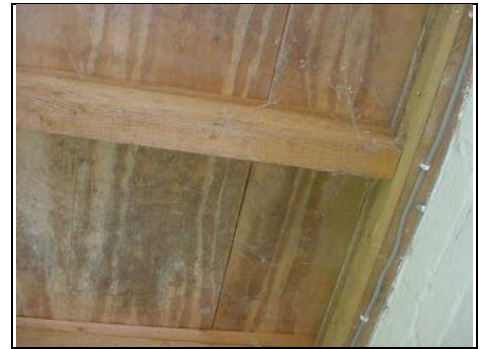
Decking deteriorating

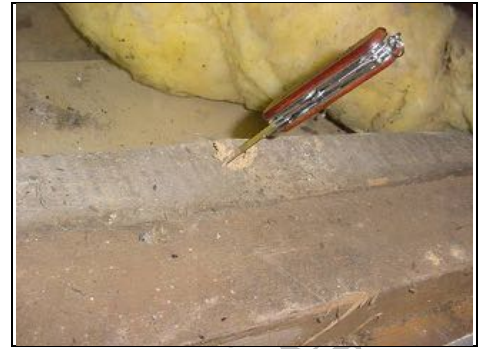
We noted some woodworm within the roof.

Woodworm

**ACTION REQUIRED:** The only way to be one hundred percent certain is to have the roof cleared and checked. We would like to come back and view this roof when you are underway with the project and we would then be able to give you further comments.

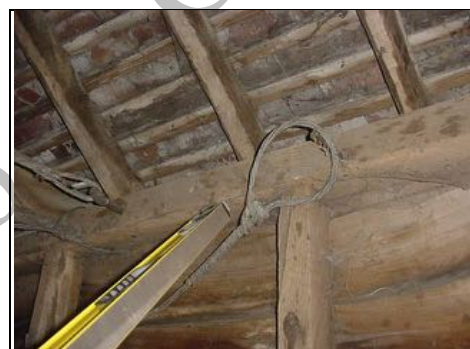
Tension wire loose

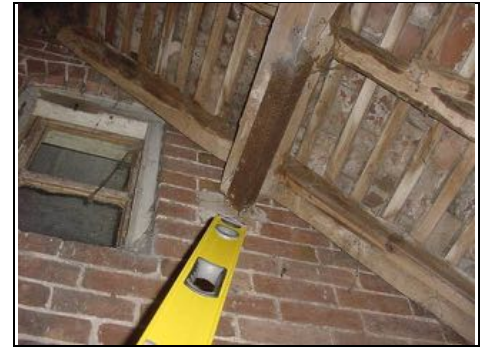
Dampness coming into roof  
Purlin end rotted away and angle iron added

Point load created by purlin has had angle iron/ bracket added

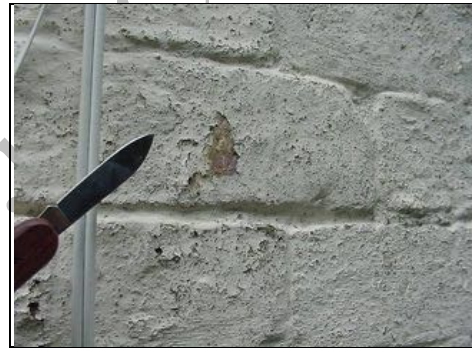
Pointing required

Lime underneath and red brick underneath

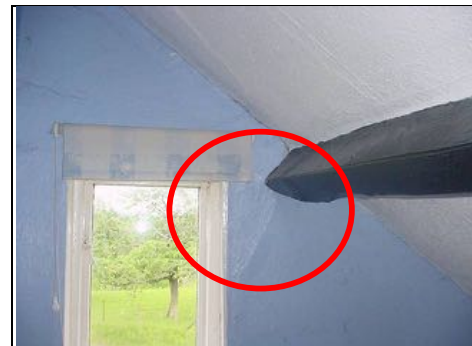
Cracking to left gable

Cracking around purlin

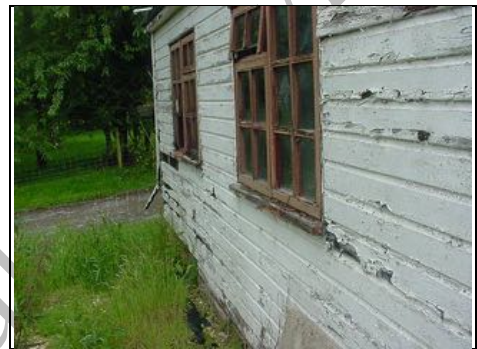
Cladding to porch has holes and wet rot

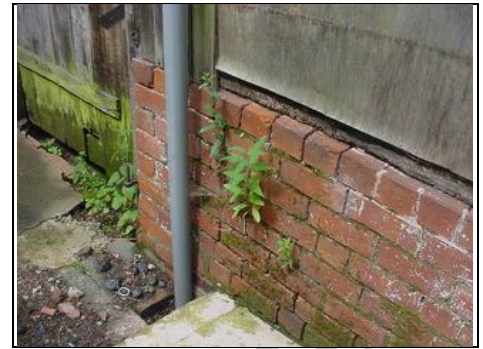
The brickwork is being badly affected by the lack of guttering to the barn. Once there is a guttering added this will be far better. There is also a boarded-up window in this area which we would like to see the boarding removed to inspect the condition of the timbers beneath it.

Brickwork to barn needs repair

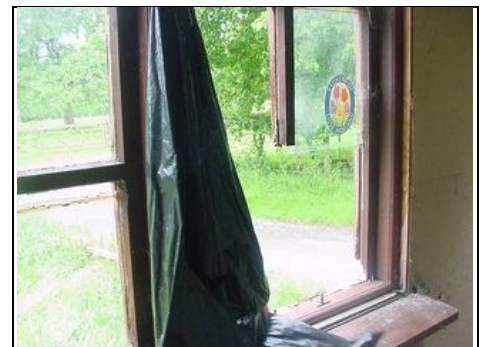
The property has timber casement windows. The windows are in poor condition and many are flush rather than set back which means that the rainwater has caused a lot of deterioration. There is one window with cracked glass indicating some movement in the property. This may be because it is saturated with water.

Missing windows to storm porch

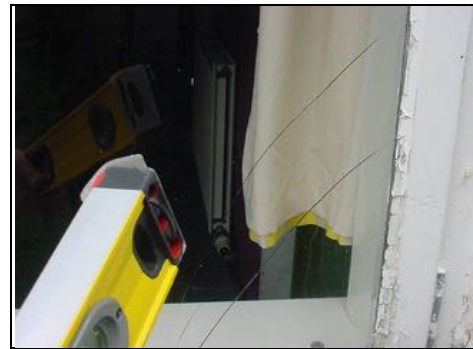
Broken glass indicating there is movement in the property

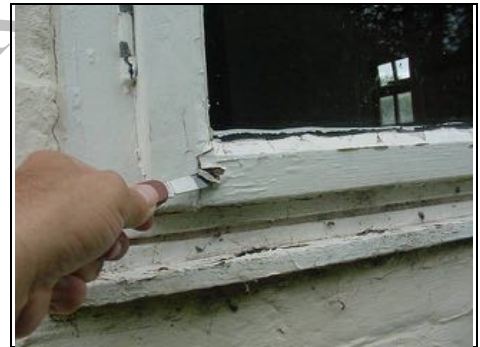
Rot to sills

Rot to windows

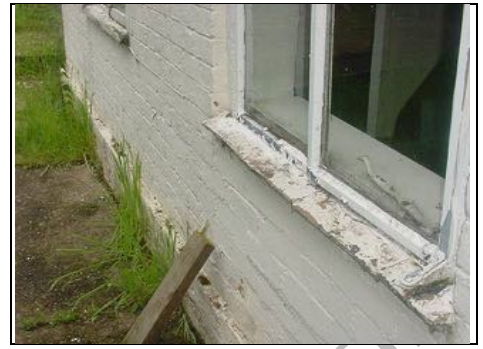
The property has one metal window to the rear. Often metal windows are the older windows in a property. Metal windows are often known by their generic name of Crittal windows which was one of the main manufacturers from the 1940's /1950's onwards. Typically, these windows warp and rust and become difficult to close which in turn makes them draughty. In this instance, we would consider replacing this window to match the others.

Metal Crittal windows

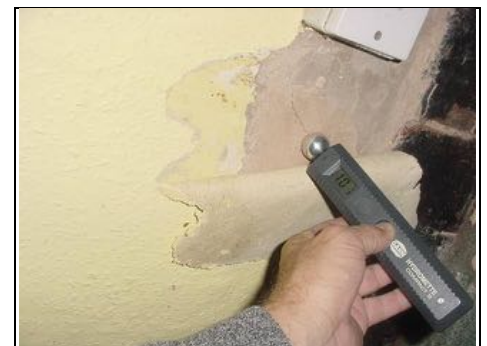
In many areas' the plaster is crumbling away from the wall where it has lost its key. It will ultimately need re-plastering. We find that plasterers tend to want to re-plaster everything, we believe in this instance there will be an opportunity to actually save some of the older plaster so our over-riding comment is when you are looking at the walls and taking the paper off is to carry it out slowly and

Modern plaster repair

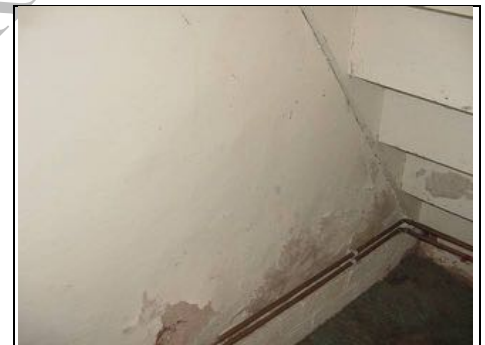
Rising damp

**ACTION REQUIRED:** Please see the Executive Summary.

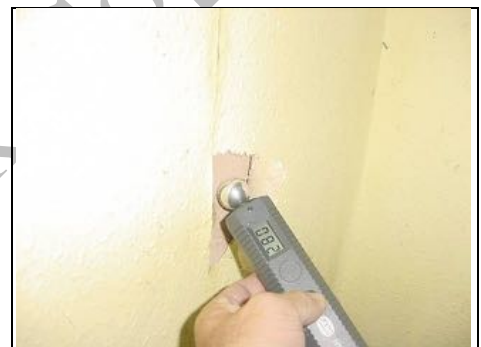
High damp meter readings between 80 to 100 (normally 30-60)

**ACTION REQUIRED:** Please see our comments in the Executive Summary.

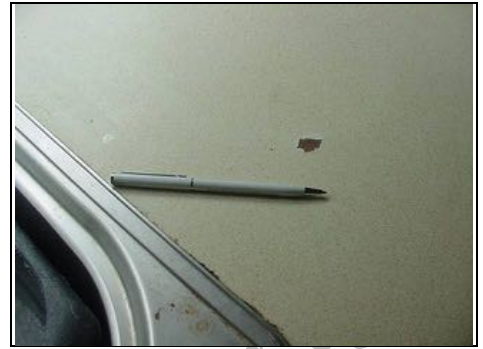
We found the kitchen in below average condition. The worktop is worn, we believe this could be replaced and perhaps the doors and have a kitchen that is useable until you decide to do the kitchen extension. The barn could even be converted into a living area to rent out/use for friends, relatives, etc.

Worn out worktop in kitchen

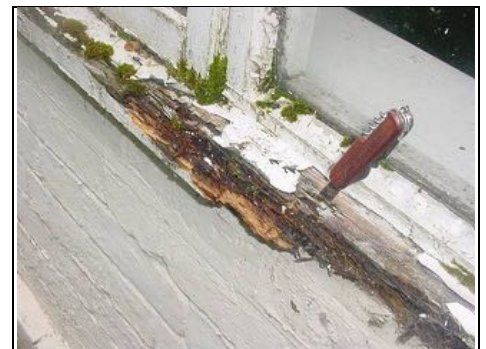
Rot to sills

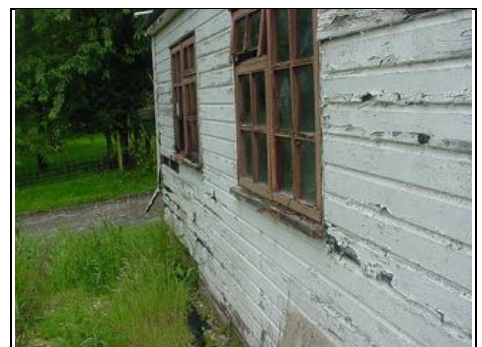
Cladding to porch has holes and wet rot
