# COMMERCIAL BUILDING SURVEY

Prepared by:

INDEPENDENT CHARTERED SURVEYORS

Firstly, may we thank you for your instructions. We have now undertaken an independent Building Survey (formerly known as a Structural Survey) of the aforementioned property.

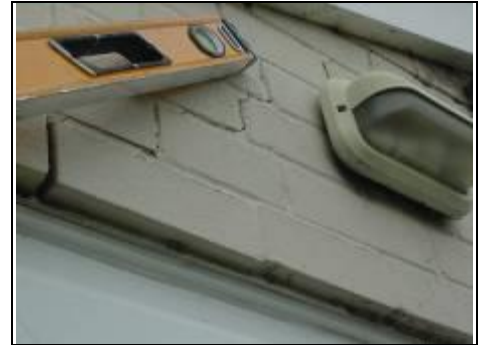
We noted cracking to the right hand side areas of the property. This was in the form of predominantly raking cracks (diagonal cracks) and also some vertical cracks. We believe this is a result of the lightweight construction of the original property and the extensions that have been carried out together with some of the alterations.

Cracking to front middle

**ACTION REQUIRED:** Ideally we would recommend the existing owners take out an insurance claim, advising that the cracking has been noted by a structural surveyor (this should cost them nothing other than time to write the letter). This usually means that the insurance company will carry out a monitoring exercise (the Building Research Establishment recommend monitoring any cracks for a minimum of one year) to establish if there is any progressive movement. Your future liability will be limited to the cost of the excess on the insurance providing the insurance company is happy for you to take over the insurance claim.

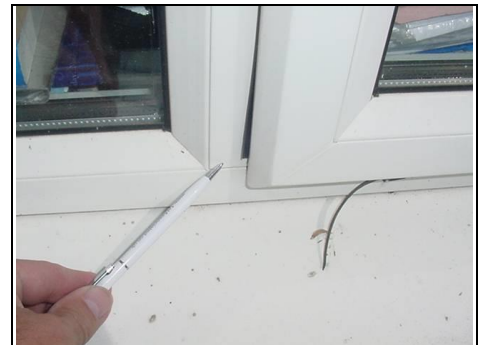
Some of the double glazed units were out of alignment which could relate to movement or it could relate to someone trying to break into the property.

Some double glazed units out of alignment

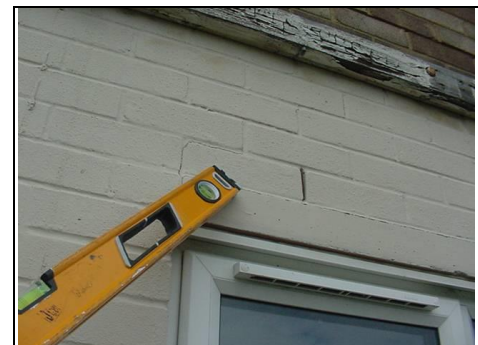
Cracking to rear right

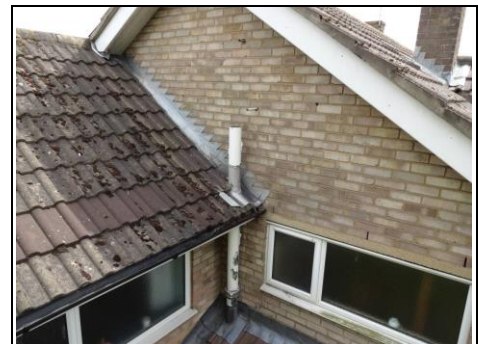
It may be an optical illusion but it does look like there has been some movement to the left gable.

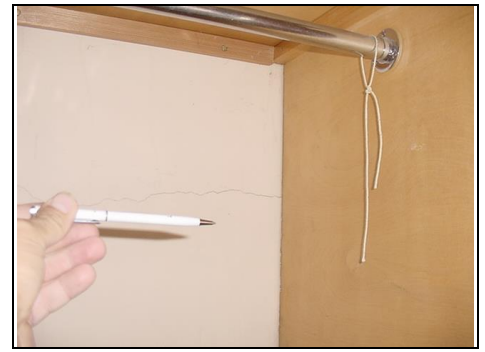
Hairline cracking

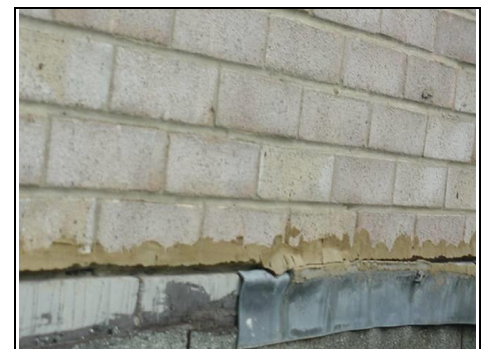
Amateur repair

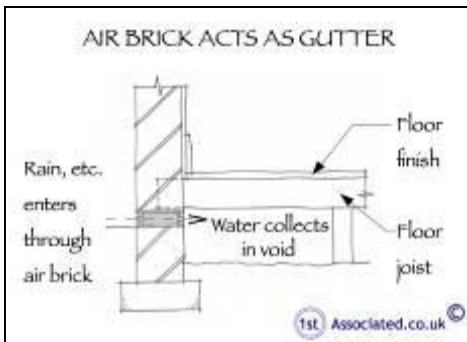
As the property has a suspended timber floor it needs an airflow underneath it to minimise wet rot, dry rot and woodworm. We noted airbricks, some of which looked to be very close to ground level and will be acting as gutters and need protecting.

Airbrick acting as gutter

**ACTION REQUIRED:** Open up the suspended floor to check its condition and also protect the airbricks.

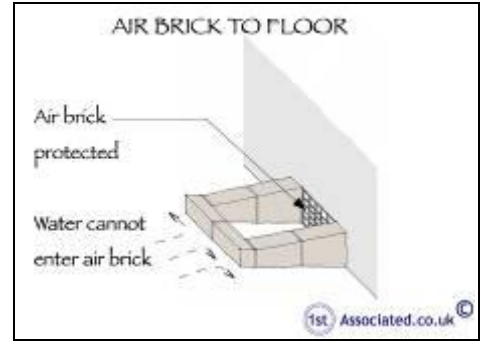
Protect airbrick

**ANTICIPATED COST:** A few hundred pounds to open up the floor; we would open up as much of it as possible. Nominal cost to protect the airbricks. Ideally we would prefer to see a French drain. Please read on.

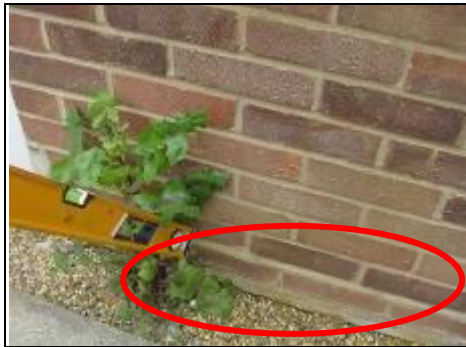
As an aside, we noted that around the building in general there were some areas the soil is slightly high not giving the two courses of brick between the ground and the damp proof course.

DPC slightly too low

**ANTICIPATED COST:** To lower the ground is likely to cost a few hundred pounds, possibly into the early thousands. To add a French drain likely to cost a few thousand pounds; please obtain quotations.

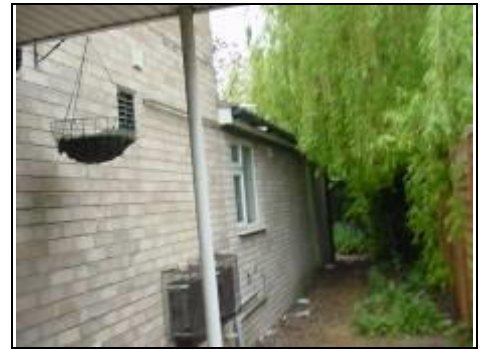
There are many trees surrounding the property including willows on the left hand side which usually means there is water in the area which may be another possible reason for the subsidence.

Weeping willow to left

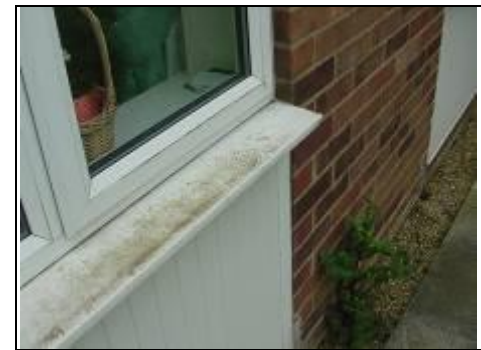
You will have a long term battle with the trees with falling branches and leaves and also a reduced air circulation around the building which can lead to an increased level of moss and/or mould within the property.

Impregnated moss to windows

**ACTION REQUIRED:** We would recommend an arboriculturalist is asked to comment on the trees. You need to have a cup of tea meeting with the next door neighbour on the right side who we spoke to briefly who advised that they once did work at the care home.

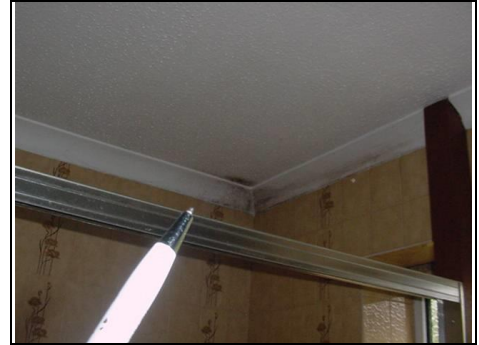
We noted black mould in the bathroom to the private living accommodation (middle left). This we believe is due to a lack of adequate ventilation. We would recommend you have a good large humidity controlled extract fan.

Mould in first floor bathroom

**ACTION REQUIRED:** We would generally recommend that you have good large humidity controlled extract fans fitted throughout the property in any humidity generating areas such as bathrooms, shower rooms, cooking areas, drying areas, washing areas.

**ANTICIPATED COST:** We would anticipate costs between £150 - £250 per extract fan depending upon the wiring required. We always recommend quotes are obtained before work is agreed/commenced.

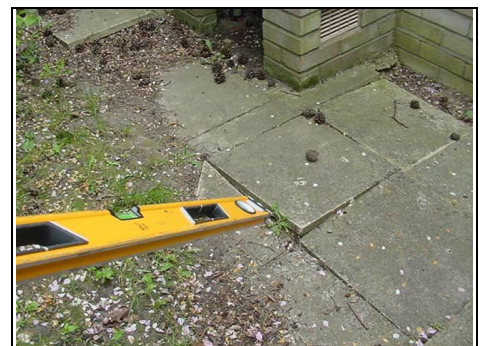
The footpath is up and down and appears to move in some areas and is a general trip hazard. This all needs re-laying and levelling.

Trip hazard on footpath

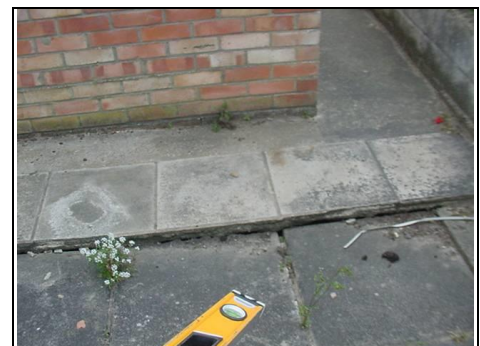
There looks to be some movement to the path as a whole to the rear of the property adjacent to the boundary wall. We are concerned about this and feel that this should form part of the insurance claim. Please see our comments on movement. It may in due course affect the building as well.

Movement to rear of property adjacent to boundary wall

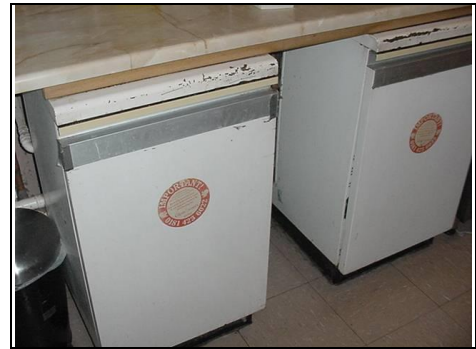
There are two old floor mounted boilers in the kitchen. We noted that there is also a mixture of old and new radiators.

Boilers in kitchen

**ACTION REQUIRED:** We recommend complete new central heating system throughout the property.

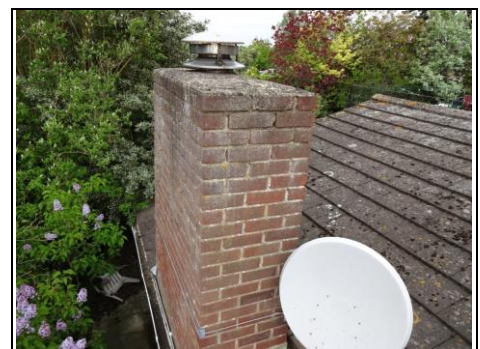
This chimney is brick finished with a lead flashing and looked in below average condition with weathering visible.

Right hand side chimney

**ACTION REQUIRED:** Recommend repointing in the summer of 2015.

**ANTICIPATED COST:** £100 - £250; please obtain quotations.

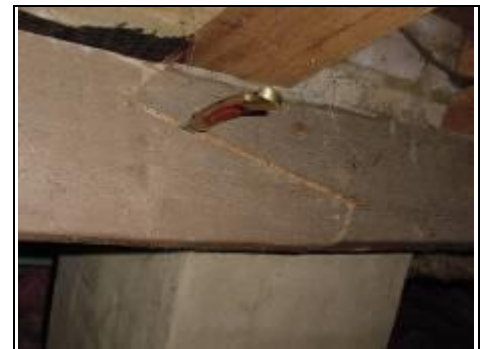
Minor movement to purlins

**ACTION REQUIRED:** Please see our comments in the Executive Summary. The only way to be 100 per cent certain is to have the roof cleared and checked.

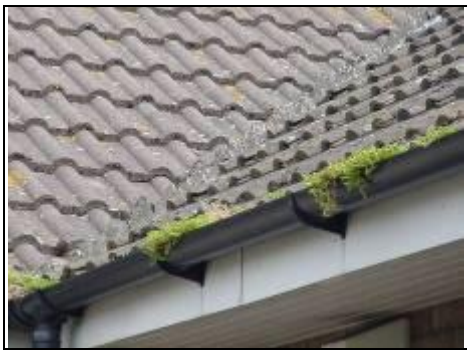
The gutters and downpipes are plastic. They are in below average condition for their age, type and style with vegetation visible.

Grass in gutters

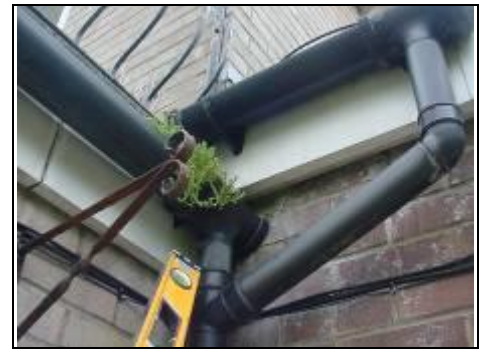
Vegetation growing out of gutters

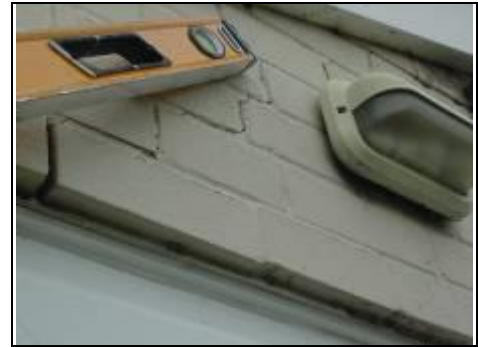
Cracking to front middle

**ACTION REQUIRED:** Please see our comments in the Executive Summary.

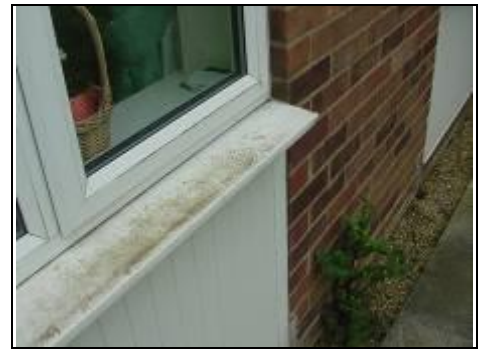
Impregnated moss to windows

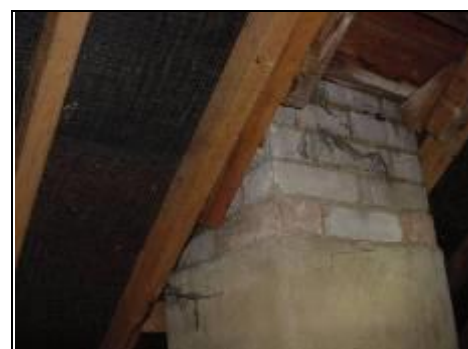
Dampness around chimney

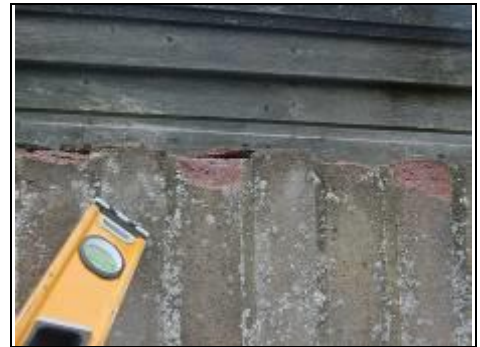
Spalling single brick wall

**ACTION REQUIRED:** Repair and check regularly.

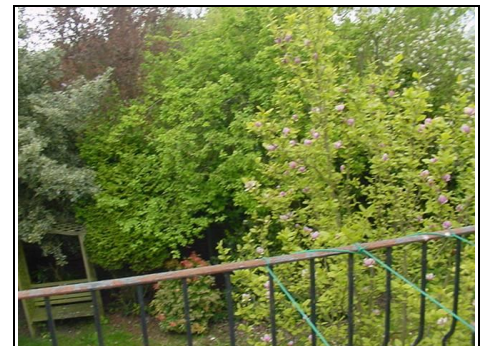
Balcony rusting

**ACTION REQUIRED:** Apply rust stop agent and redecorate.
