RESIDENTIAL BUILDING SURVEY

New Malden,
KT3 XXX

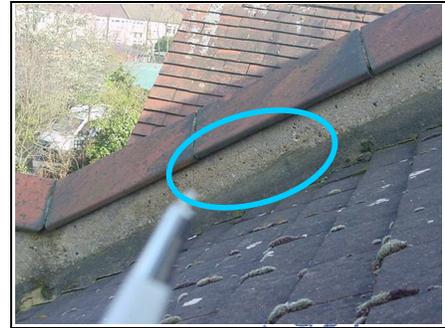
2.3) In turn we can also see that there has been movement, albeit minor, to the parapet wall flashing that is allowing dampness in.

Cracking and movement to parapet wall and moss on roof tiles

ACTION REQUIRED: We recommend that you make the building watertight by the following four stages:

1. Remove the cement flashings on the parapet walls and replace with a lead flashing to accommodate the movement in the structure.
2. Have additional support for the purlin so it is not literally sitting on a pile of bricks. For example, these can be cemented together.

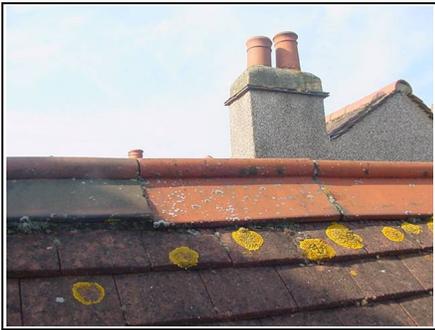
Ridge tiles have been replaced

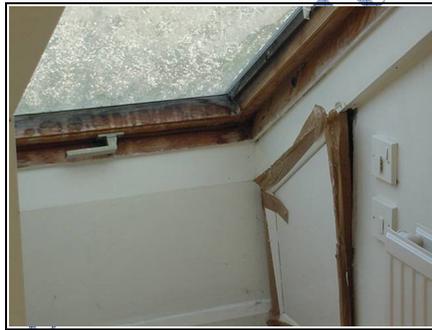
Dampness coming through roof windows causing deterioration to window frames

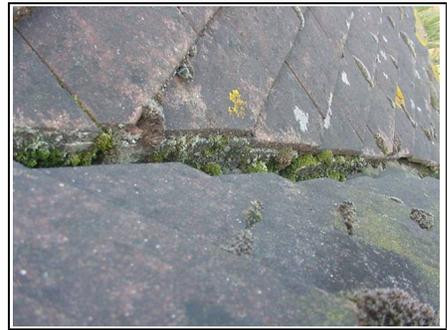
Valley gutter blocked with lots of moss

3. Clear the roof and gutters of moss, etc, to allow any water that gets on the roof to get off it as quickly as possible.
4. Put down boarding within the roof (ideally insulated), as this will then allow you to see any staining where dampness is coming through.

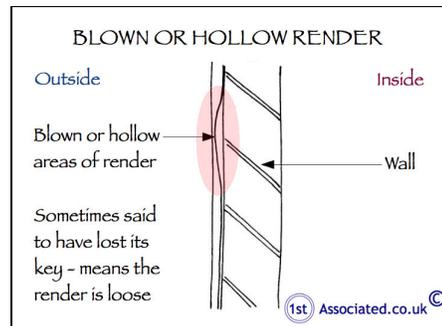
The majority of the property has the original render, which it could be argued is now coming to the end of its useful life. We can see cracks in it and we can also see areas that are blown and blistered, many of which have been repaired with a more modern pebbledash render.

Blown / hollow render

ACTION REQUIRED: You need to budget for extensive replacement to the render over time and you need to make good the hairline cracks as soon as possible. We feel you will get to the stage where it is economically more viable to replace large sections of the render, albeit there are quite large sections that have been replaced already, some over a metre in width. However, you will get to the stage where it is more economical to replace the entire elevation of the wall.

ANTICIPATED COST: It could be argued that you could carry out ad hoc repairs for a few hundred pounds, but we do not think that this is a sensible way to proceed in the long term. We would anticipate costs in the region of £2,500 to £5,000 over the initial period to carry out the major repairs. Costs for re-rendering and redecoration work to do the rendering as a whole will be approximately £5,000 to £10,000, as there is high level work requiring scaffolding. Please obtain quotations.

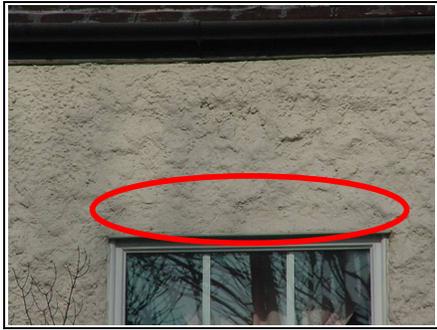
Examples of patch repairing are above the rear right hand bedroom window and numerous repairs to the right hand gable. We can also see many hairline cracks that look to have been painted over fairly recently, what we would term as painted to sell.

Repairs to the rough cast render above window on rear

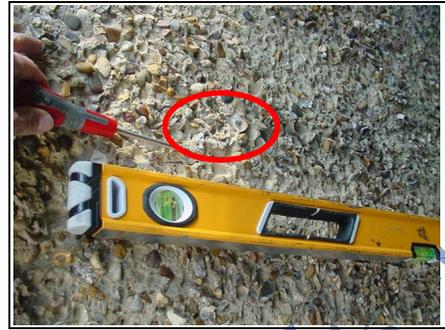
Vertical crack to render on right hand side

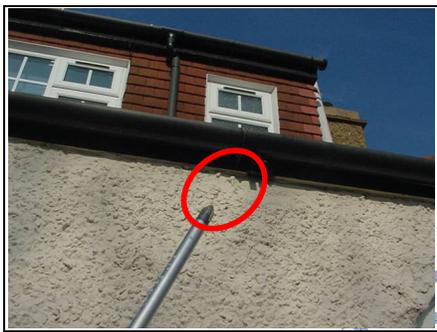
Hairline cracking in render

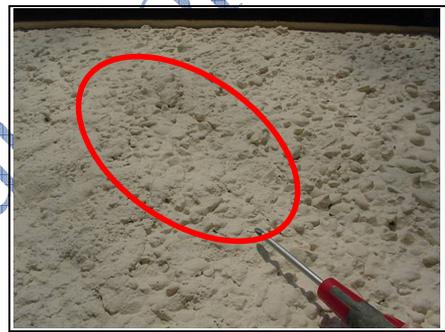
Hairline cracking

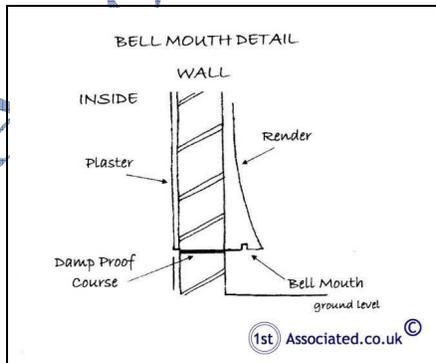
In addition to this we can see there is no bell mouth detail to the base of the render, which is causing some rising damp in the kitchen area.

Bell mouth detail

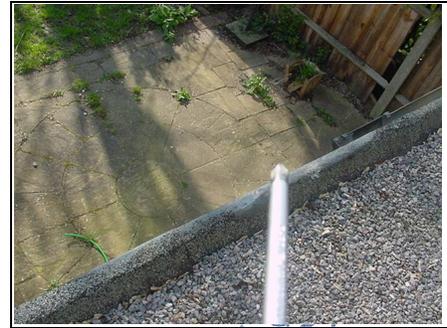
We can see there has been repairs to the perimeter of the flat roof which is normally the areas where roofs first deteriorate. This is where the sharper bends are in the felt. The flashing is also another area where deterioration occurs; this is where the join of the roof and the main building are.

Old repairs on flat roof

ACTION REQUIRED: We would allow for further repairs.

ANTICIPATED COST: In the region of £500 to £1,000 for patch repairs. The difficulty, as mentioned, is that this roof has chippings on it and it is very difficult to find out exactly where the leaks are. We therefore recommend that you also look at removing the chippings and adding a high performance felt.

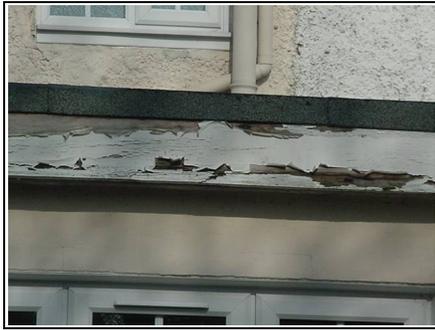
The majority of the external joinery would originally have been timber windows but these have been replaced with plastic, and these need a good clean. We can however see that the timber fascias and soffits are in need of repair and redecoration and it may possibly be more economical to replace. The paint is flaking off and bare timber is visible.

Fascias and soffits need repair and redecoration

ACTION REQUIRED: Repair / redecorate or may be more economical to replace.

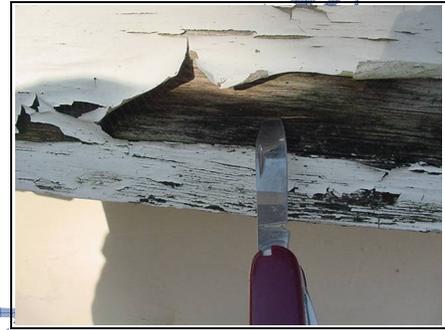
Knife test of timber

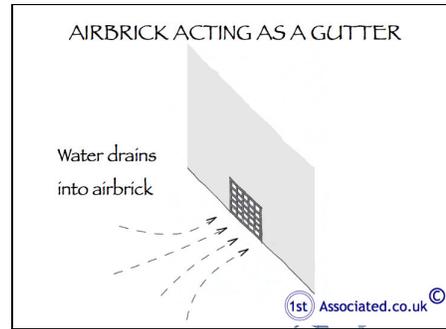
Air brick acting as a gutter

We have mentioned already we have found some dampness to the rear kitchen area which is likely to be contributed to by this poor detail.

ACTION REQUIRED: Lower the ground level and protect the air bricks, as per our sketch.

ANTICIPATED COST: In the region of £150 to £300 to protect the air bricks and a few hundred pounds to lower the ground level which is a DIY type job and a few hundred pounds to open up the floor and investigate to see how much dampness there is under there. Please obtain quotations.

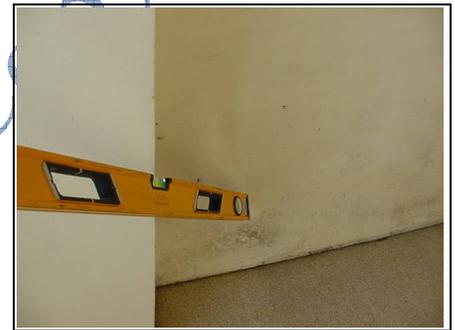
Black mould on top floor

ACTION REQUIRED: We would recommend large humidity controlled extract fans be added to kitchens, bathrooms and any rooms where drying clothes takes place. You also need to discuss this with any tenants that you have and educate them with regard to the reasons behind black mould. You will then need to redecorate the property.

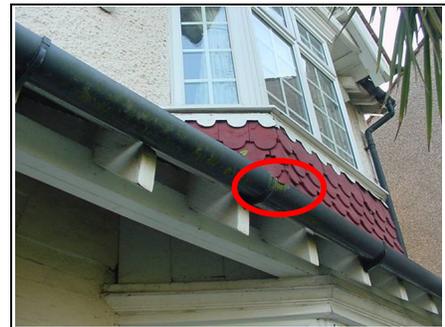
1. Gutters that are full and also areas where gutters are broken.

Broken gutter

All of this will need a handyman for a week or so to resolve these issues. There are other issues mentioned within the main body of the report.

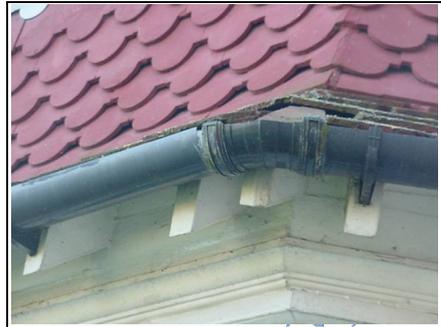
2. Poorly jointed guttering that is leaking

Poorly jointed guttering

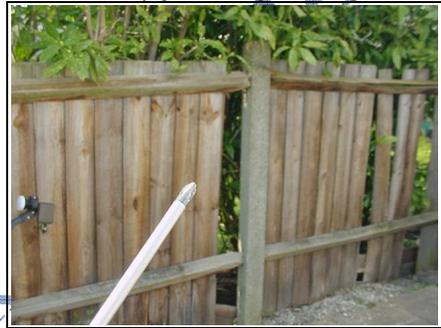
3. Fences are down and parts are missing, and generally requires re-staining. Your legal adviser need to check and confirm which fences are yours.

Broken fence

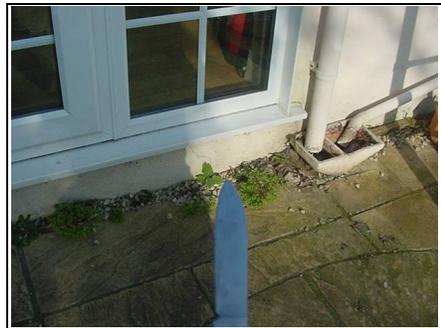
4. Areas of vegetation growing from long term leaking of water cistern and possibly water discharging against the wall.

Areas of vegetation

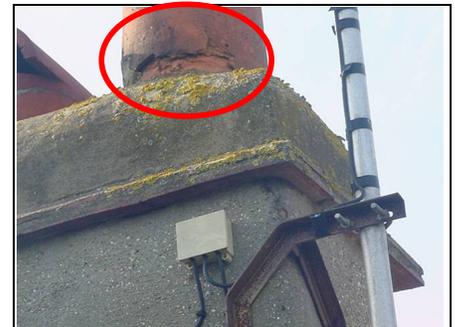
Spalling to base of chimney pot

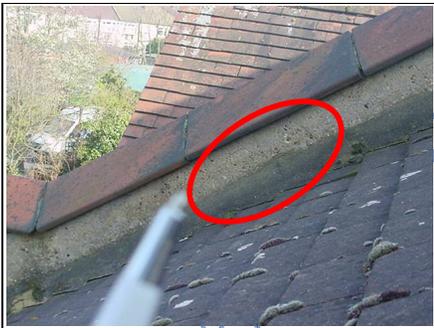
Pen indicates crack and deterioration in left hand side high level parapet wall

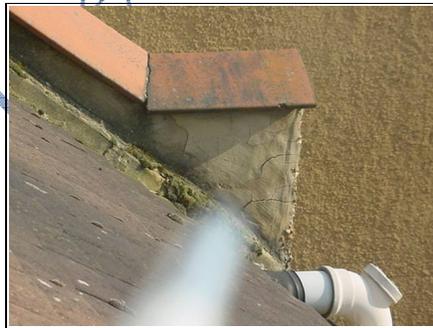
Cracking to rear of left hand parapet wall

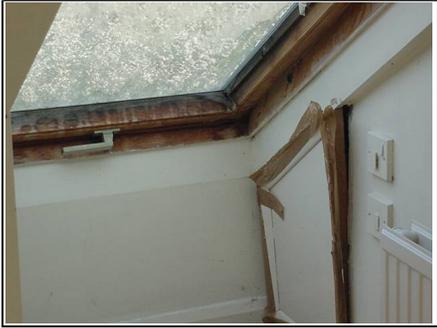
The property has two purpose made roof windows to the front of the property. The one into the top bedroom is in a poor condition and is showing signs of water getting in.

Roof window leaking

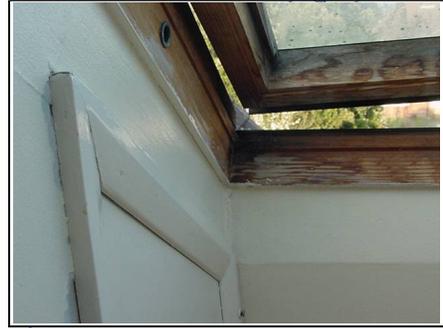
Roof window in bad condition

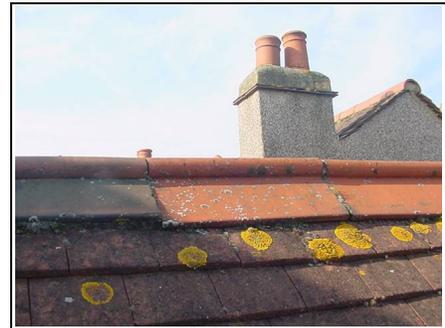
Ridge tiles have been replaced

ACTION REQUIRED: Please see our comments about the salts on the common rafters and the ridge tiles in the Executive Summary.

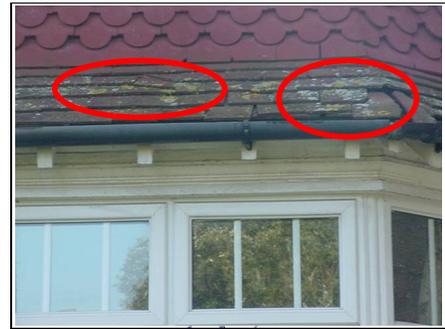
It is in below average condition with some slipped/broken tiles and moss.

Slipped/broken tiles over bay window

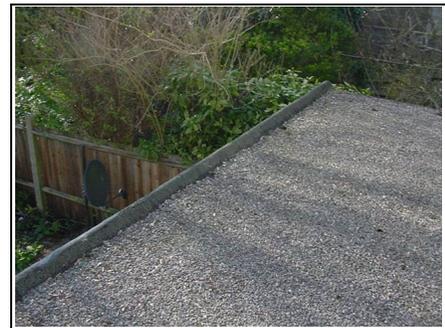
We noted that there have been some patch repairs to the perimeter.

Rear flat roof

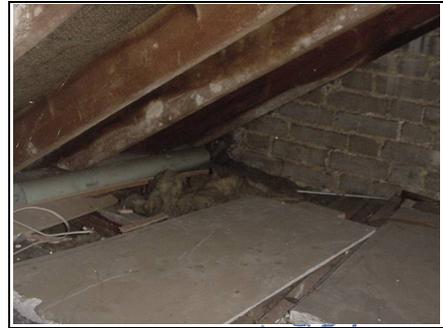
Looking into roof on front left hand side where we think roof is leaking

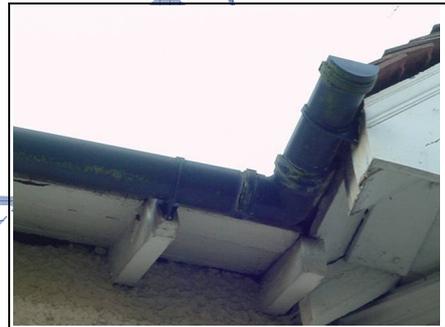
Leaking gutter

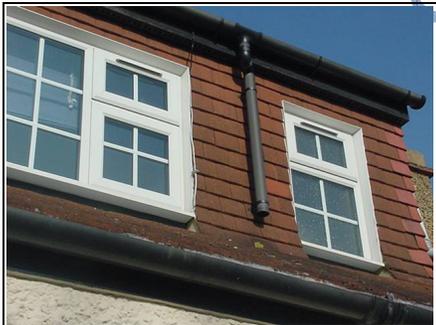
Loose downpipe to rear

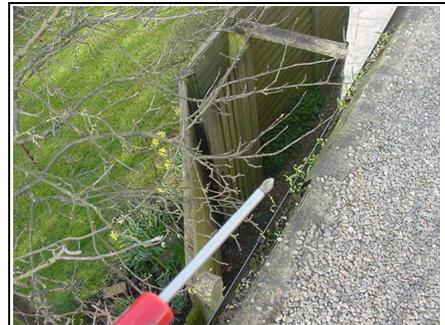
Flat roof gutters full of plants that needs clearing

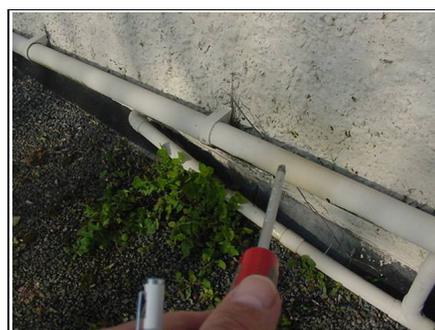
Leaking overflow pipes with grass growing at bottom

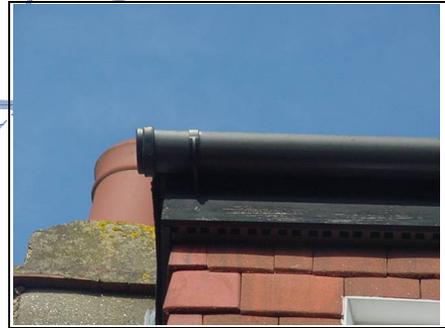
Timber fascia

ACTION REQUIRED: Please see our comments in the Executive Summary.

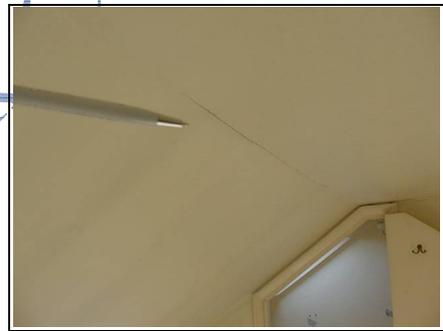
Hairline cracking in top room ceiling

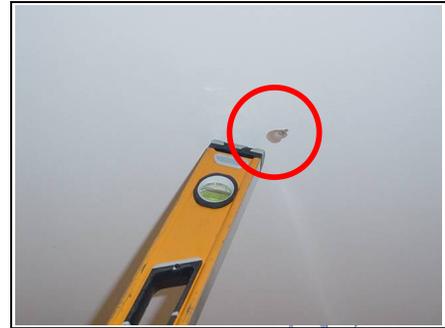
We noted popping of the plasterboard. This occurs where a ceiling is plastered over and the wrong type of nails are used causing slight movement.

Popping of plasterboard

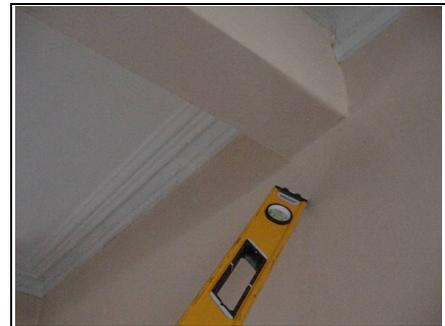
Wall been removed without pier

ACTION REQUIRED: Please see our comments in the Executive Summary regarding these.

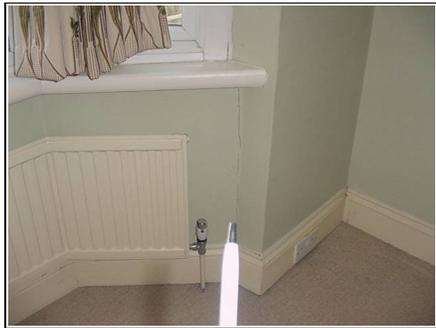
Cracking to bay window

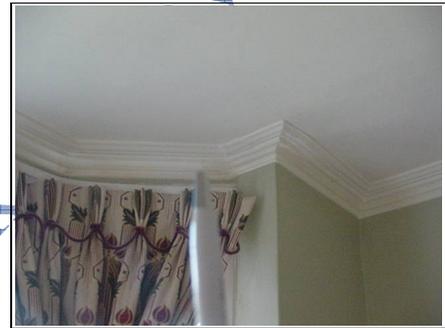
Cracking above bay window

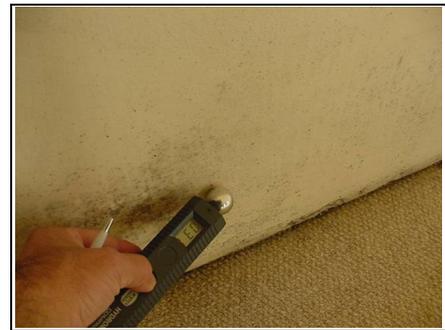
A visual inspection and tests with a moisture meter have been taken to the perimeter walls. In this particular case we have found significant rising damp due to high ground level and lack of a bell mouth detail to the render.

Testing for rising damp

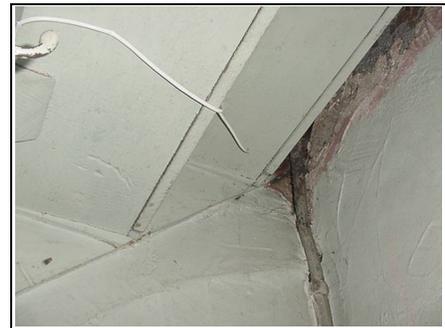
Stairs not lined

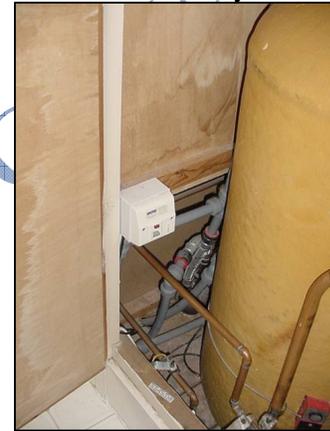
We noted it has plastic piping, which we are not keen on as it can be prone to leaking, and we much prefer to see copper piping.

Plastic pipes next to water cylinder that may leak

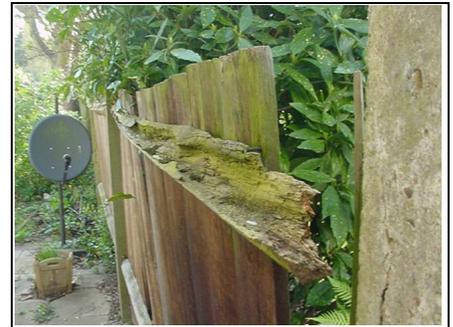
Right hand fence in poor condition

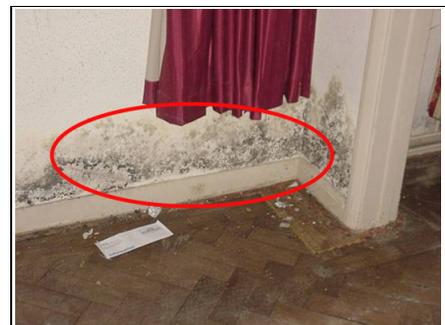
Mould caused by cold bridging
