RESIDENTIAL BUILDING SURVEY

XXXXXXXXXX,
Walworth,
London
SE17 XXXXX

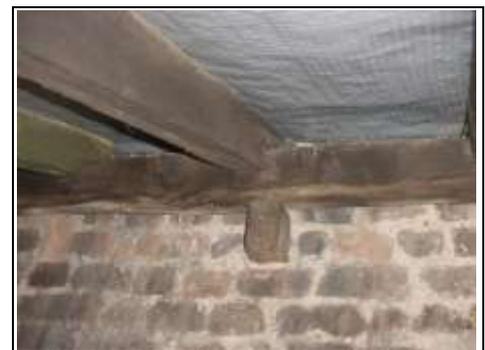
Dampness visible to timbers on the left hand side of the London Butterfly roof

ACTION REQUIRED: We would recommend adding a roof window to the London Butterfly roof to allow access to the roof and examination. Ideally this should be before you purchase the property so that we can return and view the roof. In our experience the owner is unlikely to allow this however we would still ask. Our concern is that the leaks that are coming through, although relatively minor, may be difficult to resolve, possibly due to fundamental

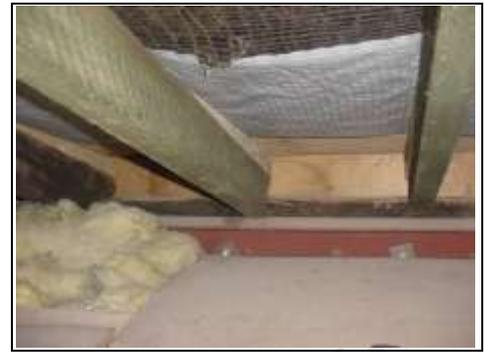
For example, the roofs tile construction may not have sufficient lap or there may be a problem with the valley gutter in the way it's been laid.

The valley gutter on the London Butterfly roof, there is staining visible indicating dampness is getting in.

ANTICIPATED COST: In a worst case scenario this would cost in the region of £10,000 - £30,000 (ten thousand pounds to thirty thousand pounds). The level of risk is unknown as we have not been able to get on the roof. However we believe the risk to be relatively minor but the possibility of it being a higher risk cannot be ruled out. We would expect the costs to probably be in the region of £2,500 - £5,000 (two thousand, five hundred pounds to five thousand pounds) for repairs to the lead flashings / valley gutter. Our concern is the relatively small gap we can see for the Valley Gutter which may indicate that the roof has been laid completely wrongly and that you may have to start again.

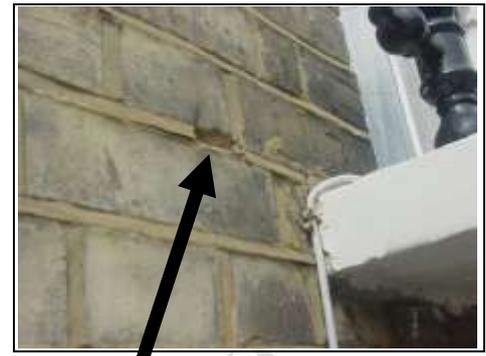
An older property such as this should be allowed to breathe. Unfortunately the property has been re-pointed in cement mortar and as such has been smothered by the cement. As we showed you, if you recall, the cement mortar will fall out on its own over time as it tends to become hard and brittle as opposed to the lime mortar that stays relatively soft. Having said that approximately eighty percent of buildings that we see today have cement mortar

Cement mortar falling out to the front of the property. If you recall we took a bit out.

ACTION REQUIRED: You need to employ an old style, term served, brick layer for the next few years to use a stiff brush once or twice a year on the cement and re-point in a lime mortar until a good proportion of it is replaced. The Bricklayer needs to be skilled in the use of lime.

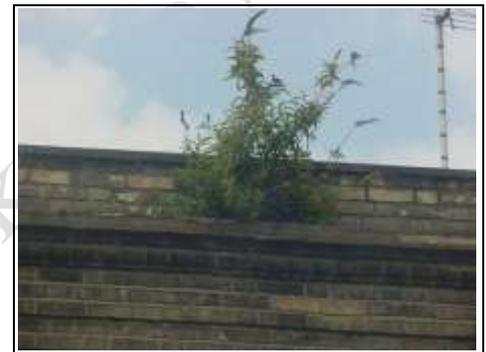
To the front of the property is a cornice with a pronounced brick string detail. From this there is a plant growing. There may well be similar areas on the main roof itself (although we could not see any in your photo). We can see this is an original design fault as there are other plants growing from the cornices of other buildings along the roads.

Plant growing from the cornice

ACTION REQUIRED: Remove the plant and check the detail as we believe a ledge has been formed that water sits on. This may originally have been a lead detail. When you access the roof you will be able to check this by looking to see what details other people have on the cornices of their properties.

ANTICIPATED COST: The plant needs to be removed and the detailing made watertight probably by re-pointing or using mastic. The work is likely to cost a few hundred pounds plus any scaffolding costs to gain access if it cannot be done over hand over the cornice; please obtain quotations.

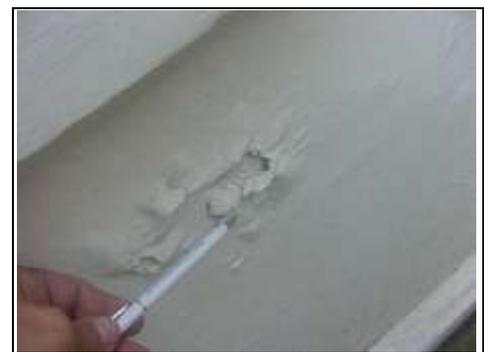
In addition to this we believe the wrong type of paint has been used. This looks to be a plastic based paint which stops the

Dampness to the front of the property

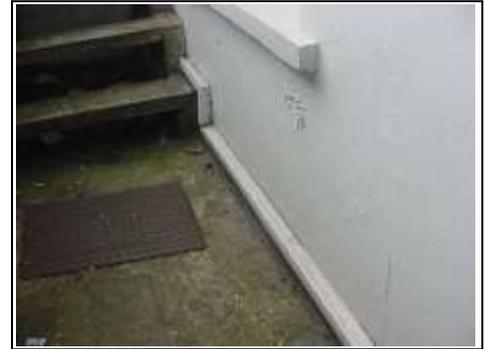
No bell mouth to render

ACTION REQUIRED: Add a bell mouth and repaint with a micro porous/breathable paint.

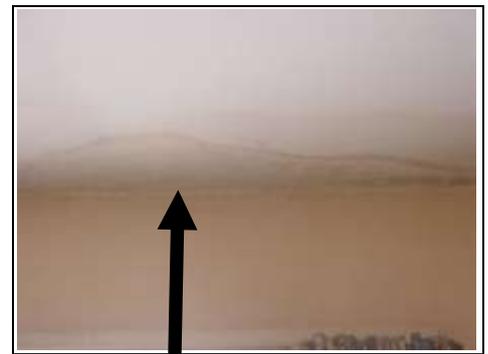
However there is one damp area to the front left hand side which as you know we investigated but could not see any obvious way that the water is getting in. We think perhaps it is getting in via the pronounced brick string detail to the front where it sits on the ledge (a similar place to where the plant is growing and sits). On reflection this could also be damp because of the valley gutter.

Dampness to first floor front bedroom

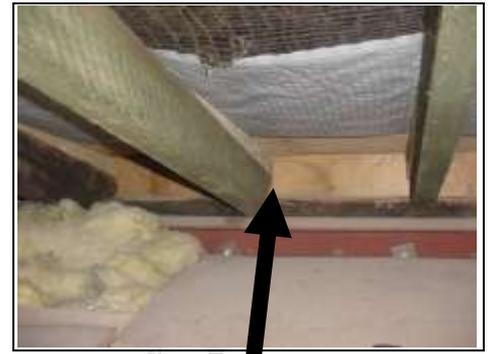
Staining to the timber of the valley gutter. This could be causing dampness in the bedrooms at first floor level

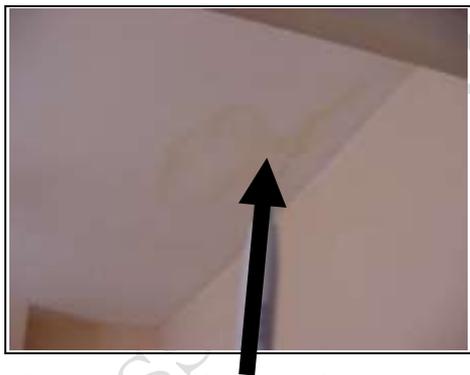
Again we think this may be coming through the brick string that is providing a ledge for dampness to come in.

Dampness to the reception room ceiling - upper ground floor

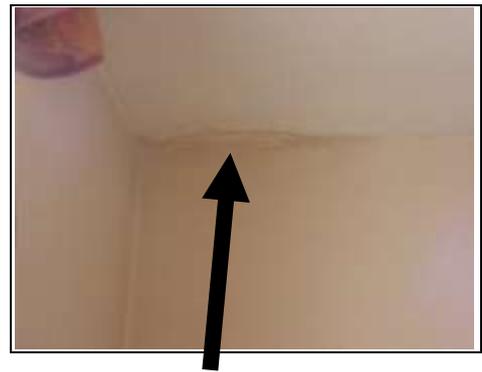
Dampness to upper ground floor

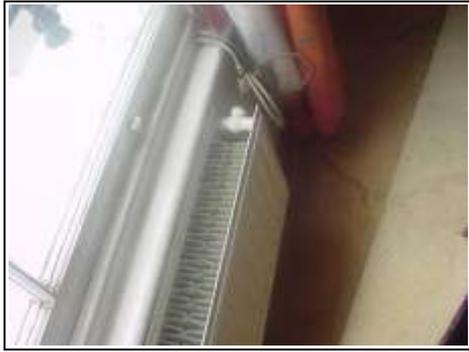
Leaking radiator on the upper ground floor causing possible dampness to the lower ground floor

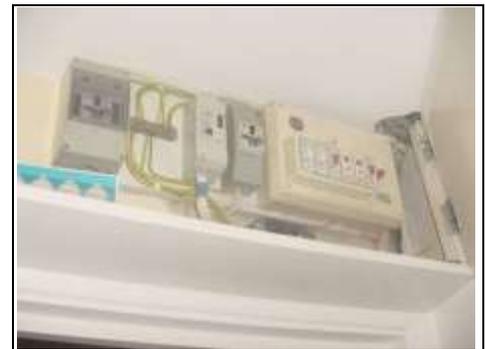
The electrics are dated circa 1970s / 1980s and better are now available.

Dated electrics in lower ground floor flat

ACTION REQUIRED: We would recommend a new fuse board is installed and also a general update to the electrics. We would also recommend that an Institute of Electrical Engineers standards (IEE) test and report should be carried out by an NICEIC registered and approved electrical contractor or equivalent.

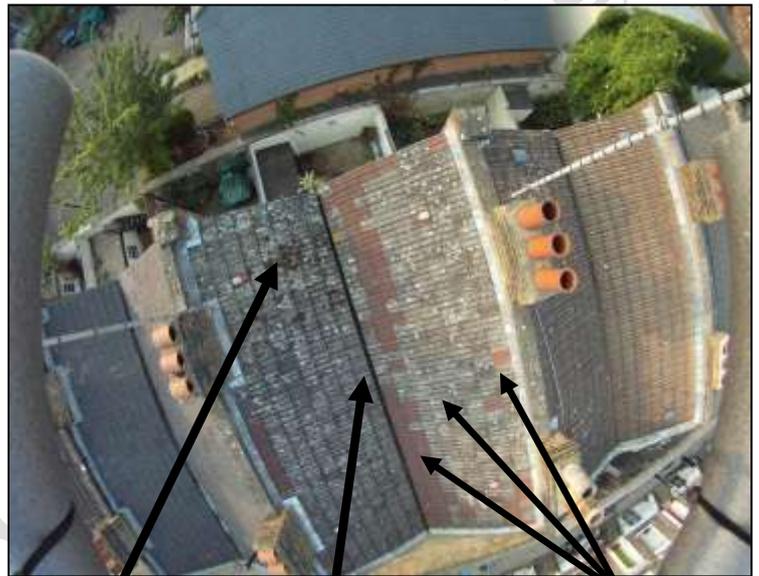
As you are aware we could not actually see the roof coverings. From your photo we would comment that the main roof is a London Butterfly roof clad with concrete tiles. There are a number of different colour concrete tiles. We can also see what look to be lichens from the spots on the roof. Lichens on a roof tend to indicate that the top surface is deteriorating which is why we have said in the Executive Summary ideally you need to get access to the roof before you legally commit to purchase.

Lichens Narrow Valley Gutter Different coloured tiles

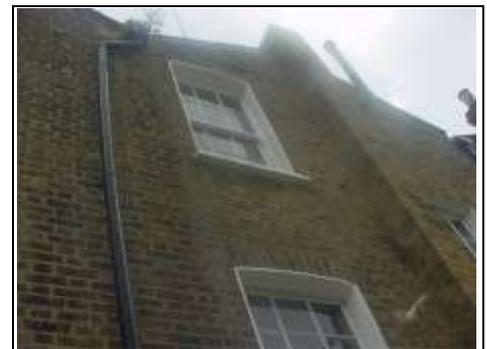
Pattern staining caused by the hopper head over flowing

ACTION REQUIRED: We would recommend you stand outside the property next time it rains heavily and see how well the drains cope with the rainwater particularly looking at the joints. We would also recommend that the hopper heads and downpipes are cleaned out and the joints are checked. As already mentioned we would recommend that the hopper head is replaced with a larger one.

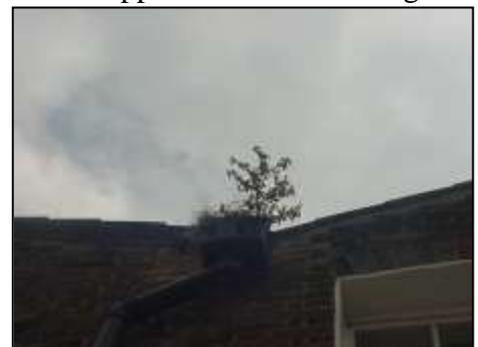
Plant growing in hopper head to the rear. Bigger hopper heads are needed.

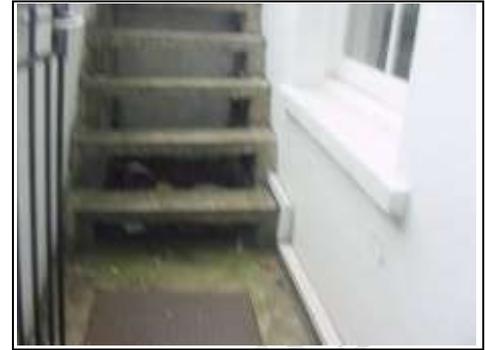
No bell mouth to base of property

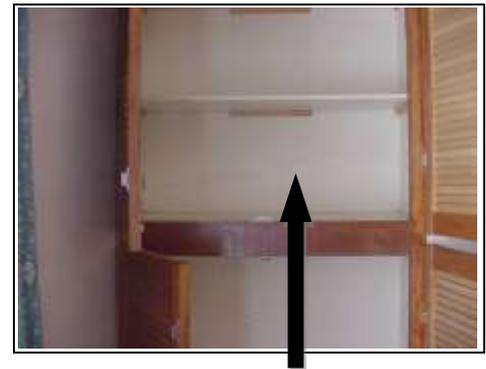
Hairline cracking visible

ACTION REQUIRED: In many cases painting will hide the cracks although you may have to do some filling in some areas. We much prefer a traditional lime based plaster in old properties such as this. However it will be very difficult to remove the skim coat of gypsum plaster.

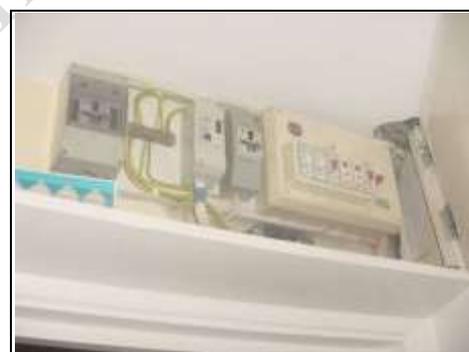
The only electric fuses and consumer units that we found were located above the door in the lower ground floor flat. The fuse board in the lower ground floor flat looked dated circa 1970's/1980's and better are now available.

Lower ground floor electrics

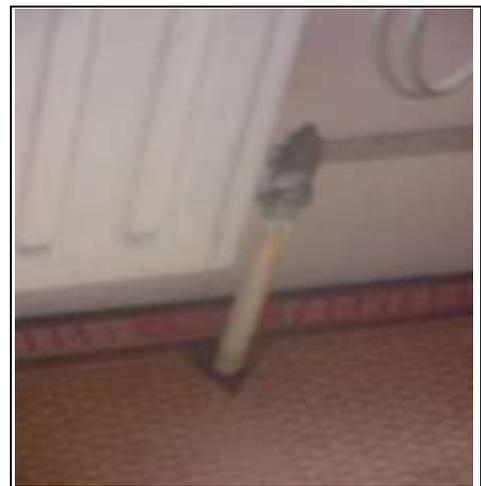
You noted that there was a leak to the radiator. This again could be a reason for the staining to the ceiling.

Leaking radiator pipe

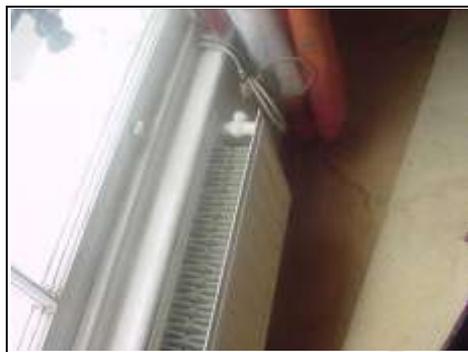
Leak visible on the hardboard under the carpet

inspection of the hot water and central heating system revealed no evidence to suggest any serious defects but we would nevertheless recommend that the system be tested and overhauled before exchange of contracts and that a regular maintenance contract be placed with an approved heating engineer.

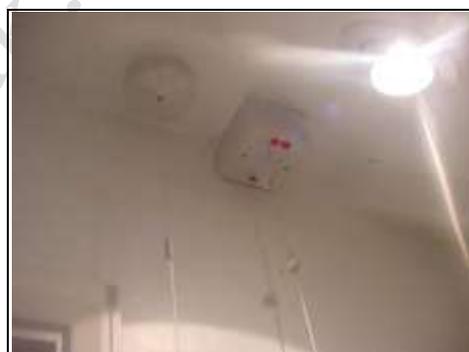
This is relatively new. We would recommend that the extract fan is replaced and improved. Also we spoke about the electric shower unit. If you recall it needs switching on and off at the wall which is a standard requirement of this type of shower unit. There are now better electric units available

Shower light and electric shower.
Better are now available
