COMMERCIAL BUILDING SURVEY

Mr XXXXXX

INDEPENDENT CHARTERED SURVEYORS

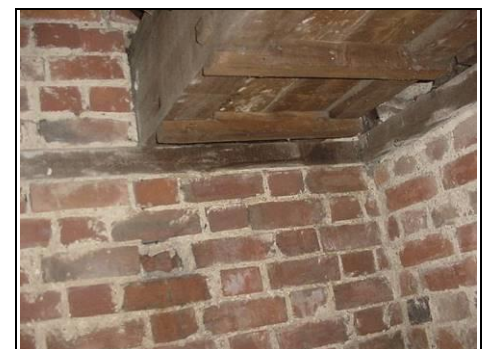
The hidden valley gutter to the main roof is a good example of an area which is allowing some dampness to get into the building and will cause deterioration over time.

Under side of box gutter visibly
leaking within main roof space

We were pleased to see that you have good access to this area (although it could be made safer) from the landing via a loft hatch internally. Externally a safe access is needed, which some thought needs to be given to.

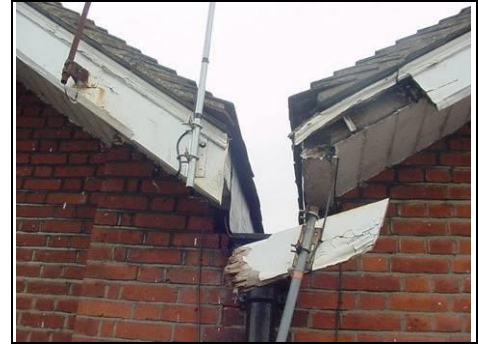
The property has a number of aerials, causing damage to the fascias and soffits.

Broken aerials pulling fascia away

ANTICIPATED COST: In the region of £250 to £500; please obtain quotes.

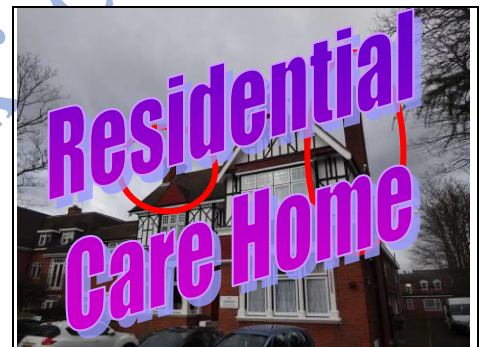
The chimneys look like they need ad hoc repointing. We also checked to the rear of the chimneys where there is a ledge that could be carried out as part of the guttering work to make sure there is no built up of debris, etc, that could cause dampness.

There is a particularly large chimney on the right side of the property which we have only been able to view from ground level which we feel needs examining before the summer of 2017 and photographs taken, which can be whoever will be carrying out the guttering out work. We would then ask that these photos are forwarded to us for us to comment further.

Chimneys to left and right

ACTION REQUIRED: Checking of chimneys and ad hoc repointing.

ANTICIPATED COST: Assuming you have a high level tower scaffold we expect costs to be in the region of a couple of hundred pounds up £500 if problems are found. Without the tower scaffold we would expect the chimney to need scaffolding access which could bring the costs into the thousands of pounds. Please obtain quotes.

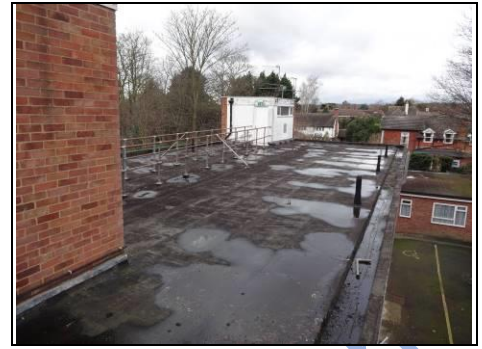
The main flat roof over the two storey extension (attached to rear of the main property) has ponding/water sitting upon it which will accelerate its deterioration. The very fact that water is sitting on it is not a good sign, as despite the name of the flat roof indicating it should be flat, generally we would expect there to be a fall of 12 to 25 degrees.

Two storey flat roof
Aerial view – 360 photo

We also noted from our thermal imaging it has poor thermal qualities.

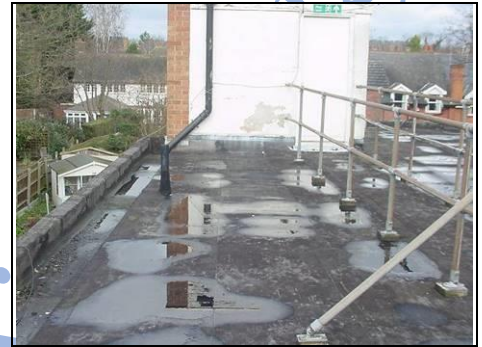
We can also see there has been ad hoc repairs to the flat roof, particularly to the perimeter. We could see one area where water damage is occurring within one of the rooms that we viewed; there may be others.

Ponding on two storey flat roof
looking towards the lift

ACTION REQUIRED: You need to decide strategically how you wish to deal with this flat roof and the other flat roofs.

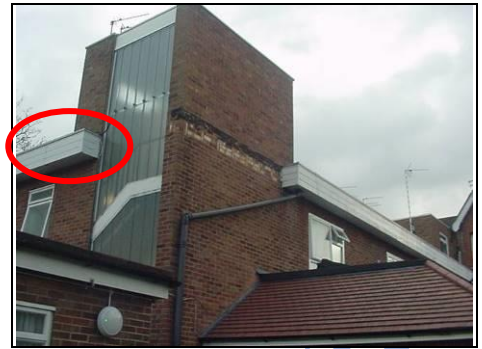
Dampness coming in this area

ACTION REQUIRED: We recommend you redecorate the ceiling and monitor to see if dampness does re-occurs. Again it may be from wind driven rain and will only occasionally occur.

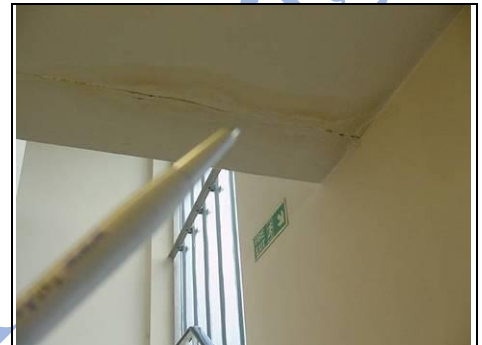
We do think to the lift area leak that the fascia board and the roof detail may have deteriorated allowing water in and we recommend this is checked first.

Damage in lift area likely to be caused by flat roof and deteriorating fascias and soffits

Also carry out repair works to the fascias and soffits and flat roofs.

We would anticipate costs for redecoration a few hundred pounds for one guest accommodation room. Costs for the rear lift area, including the repairs to the fascias and soffits, a few thousand pounds. Please obtain quotations.

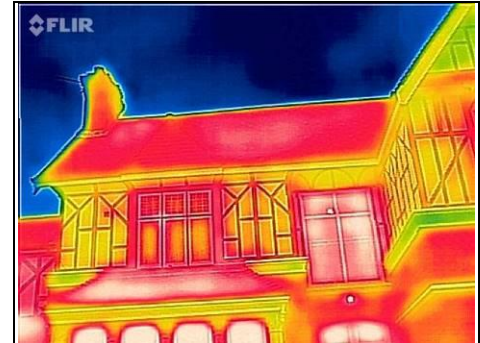
Heat coming through pitched roofs

We recommend that you add insulation to the front pitched roof. You do need to ensure that you also add ventilation at the same time to reduce the effects of condensation. You should also add a vapour barrier, which you will have to periodically check to ensure there is no condensation occurring.

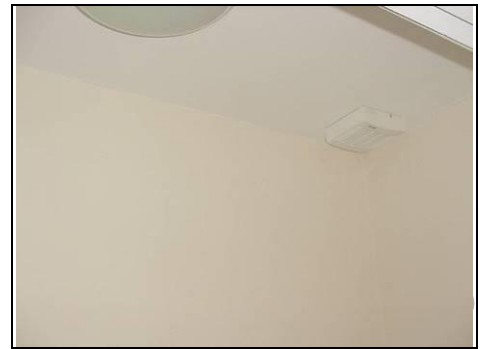
These are located within the en-suite facilities. We much prefer to see good quality large humidity controlled extract fans as opposed to the smaller fans that are currently present.

Small extract in one of the en-suite facilities

ACTION REQUIRED: Add good quality large humidity controlled extract fans to en-suite facilities.

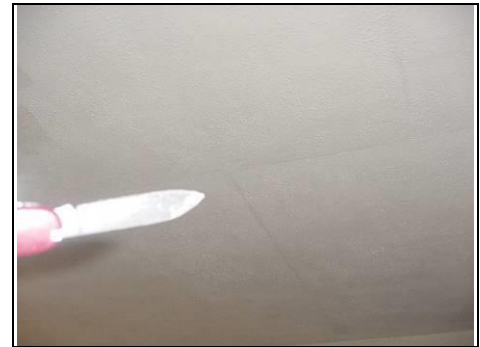
During our discussions we were advised that you did have an asbestos report on the building. We ask that you check it as in this case we noticed some textured painted ceilings (commonly known as Artex) which may contain asbestos. There may be other elements of asbestos within the property.

Textured paint may contain asbestos

Our insurance company require us to advise we are not asbestos specialists and recommend you have an asbestos survey carried out by a specialist asbestos company.

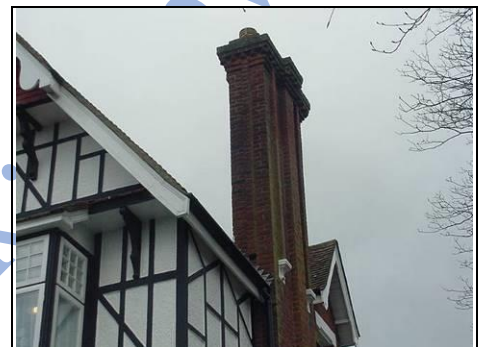
Large chimney to front right side

ACTION REQUIRED: Close examination and ad hoc repair and repointing likely to be required

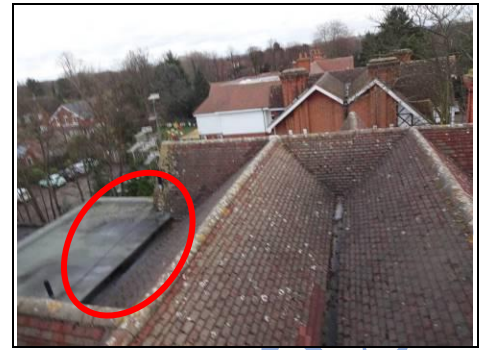
Rear box gutter
Aerial view – 360 photo

We recommend somebody accesses the roof and ensure it is cleared.

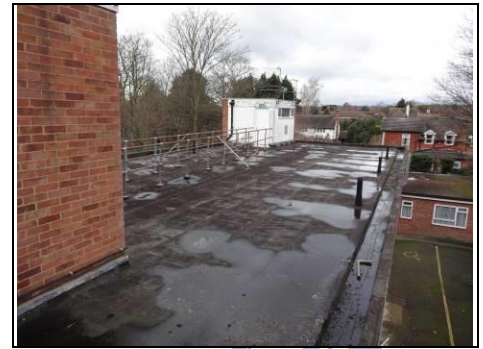
Ponding on two store left flat roof
Aerial view – 360 photo

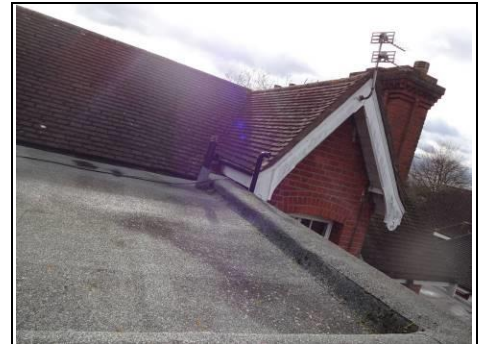
Roof over fire exit
Aerial view – 360 photo

ACTION REQUIRED: Patch repairs.

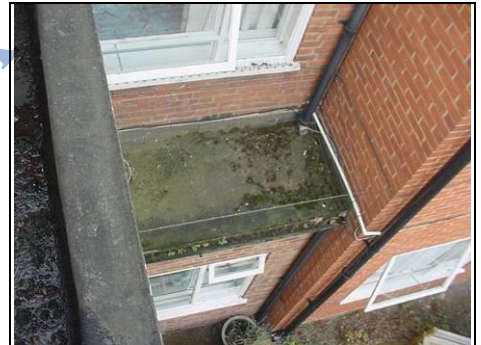
Small flat roof to rear
Aerial view – 360 photo

ACTION REQUIRED: We recommend you re-roof with a high performance felt and add an insulation cut to falls.

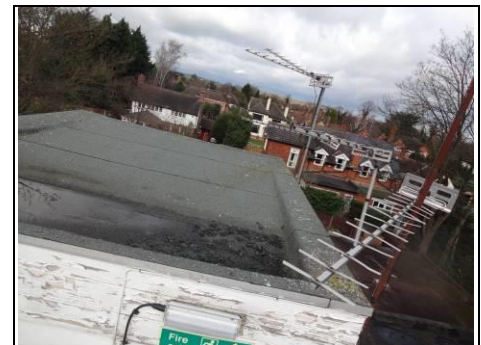
Roof over lift area
Aerial view – 360 photo

Remove/re-position aerials and repair fascias and soffits. Please see our comments in the Executive Summary.

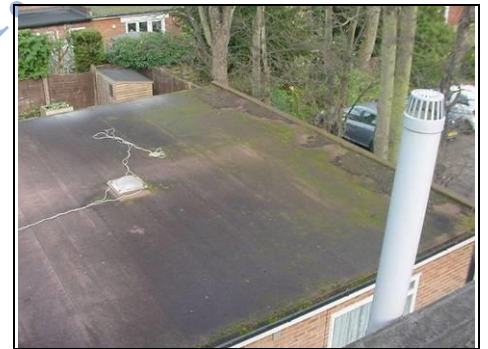
Leaves and moss on right side of roof
Aerial view – 360 photo

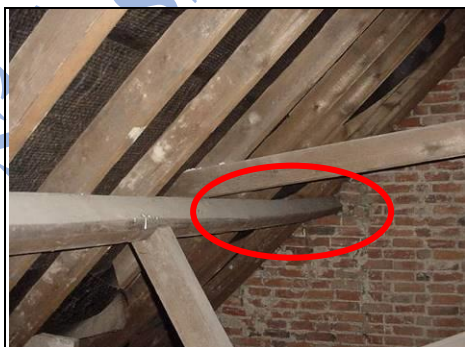
We noted minor deflection to the purlins and dampness coming in via the valley gutters to the front.

Deflection to purlin in front roof

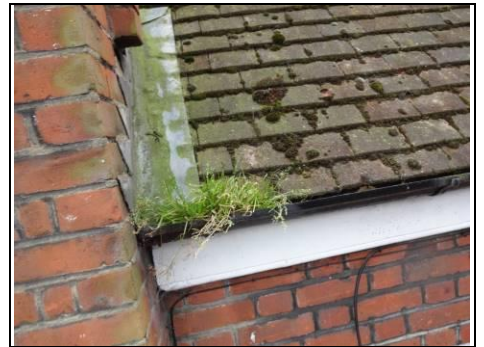
We noted more examples of grass growing from gutters than we would expect to see, however we do appreciate that many of the gutters are high level and difficult to access.

Grass growing out of gutter
Aerial view – 360 photo

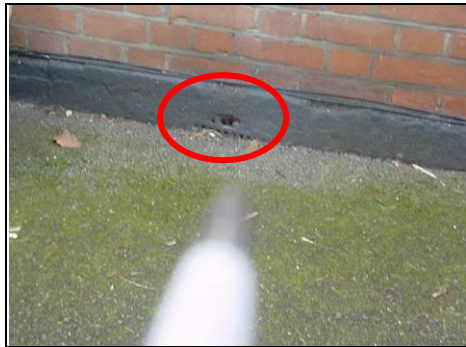
We noted air bricks to the property over the basement area.

Air brick over basement needs clearing

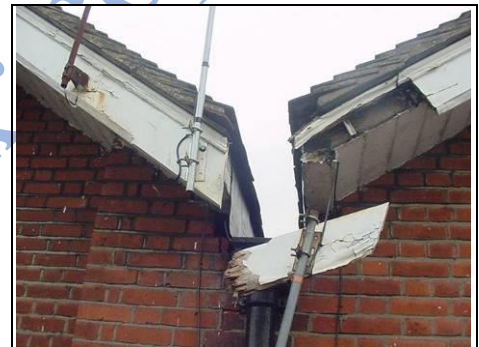
Broken aerials pulling fascia away

ACTION REQUIRED: We recommend the fascias and soffits are prepared, repaired and redecorated at the same time as the windows in the mid-term; i.e. one to three years.

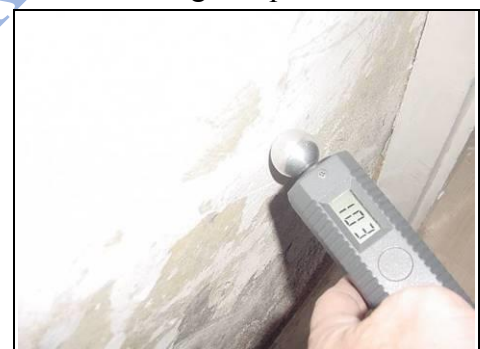
A visual inspection and tests with a moisture meter have been taken to the perimeter walls. In this particular case we have found significant rising damp but this was in the basement area.

High readings of rising damp in basement

ACTION REQUIRED: Please see our comments with regard to the air bricks acting as gutters.

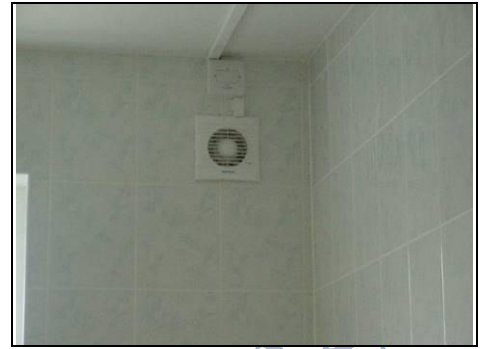
Small extract

ACTION REQUIRED: We would recommend large good quality humidity controlled extract fans be added to kitchens and toilets.

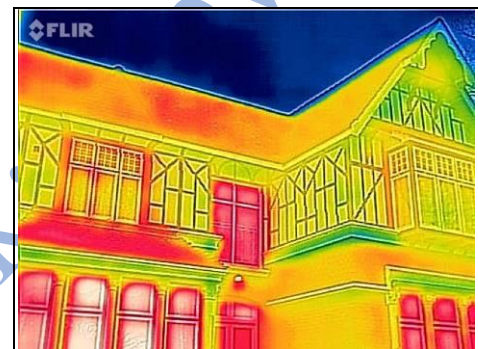
Thermal imaging of the front the property. Red areas indicating heat loss areas

These areas may have insulation. We recommend drilling into the walls to check, insulation companies may be able to carry out this work.

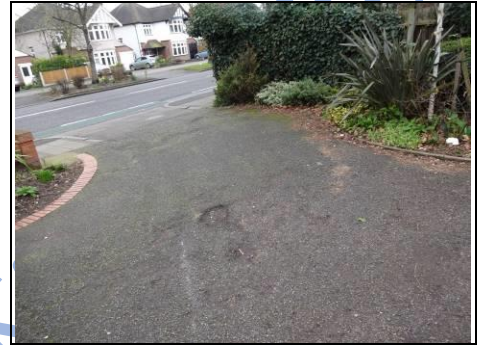
Deterioration to car park

ACTION REQUIRED: Make good parking area. It would possibly benefit from adding white lining/designated parking spaces.

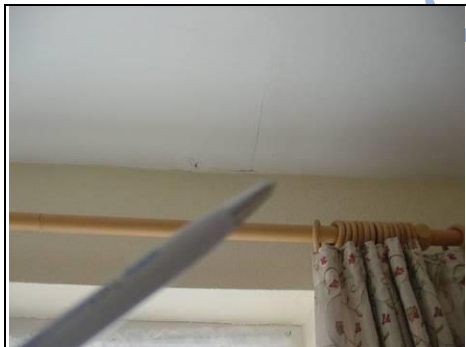
Leak coming in from flat roof
above

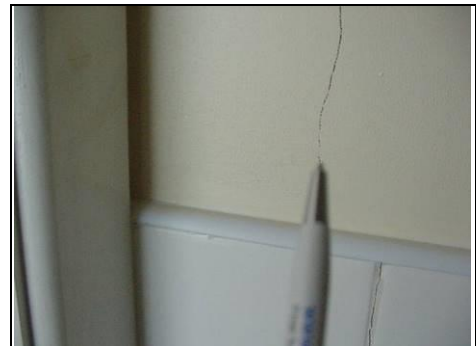
Hairline cracking, possibly from
roof above

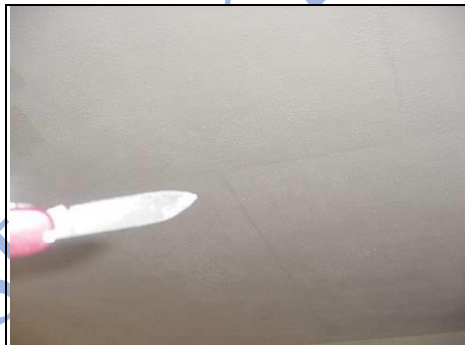
Hairline cracking and textured paint on ceiling in top floor accommodation

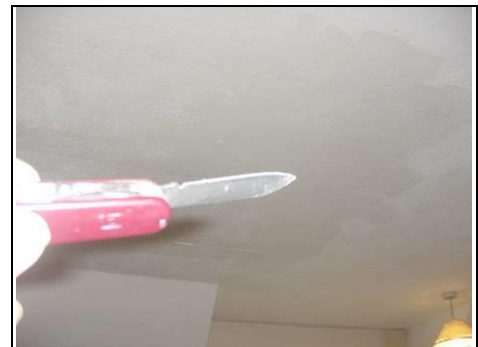
Repainting on ceiling. We assume this relates to water coming through
