JOB REFERENCE: XXXX

COMMERCIAL BUILDING SURVEY

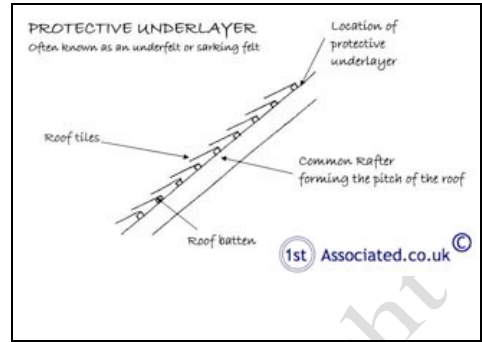
ANTICIPATED COST: As it is likely that you will require scaffolding with a roof covering. Most insurance companies require the areas to be protected from any weather during the course of construction.

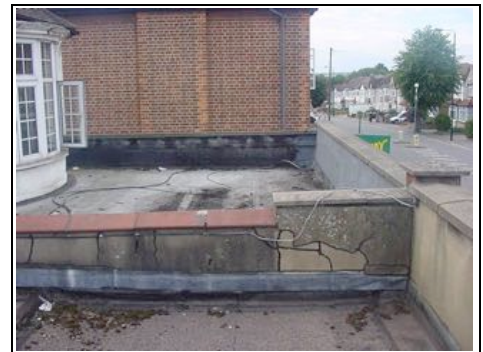
Flat roof to the front of the property

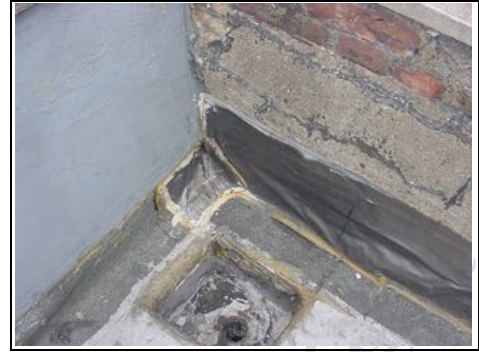
Previous Flashband repair to corner

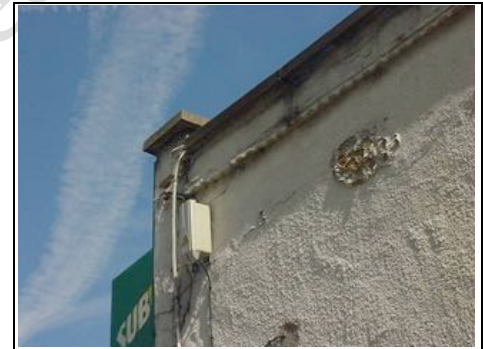
Spalling occurs to brick or stone when water penetrates the surface and via freezing and thawing starts to cause deterioration to the surface. This in turn allows further water penetration and the surface breaks up further. This ultimately can lead to water damage or structural damage to the area.

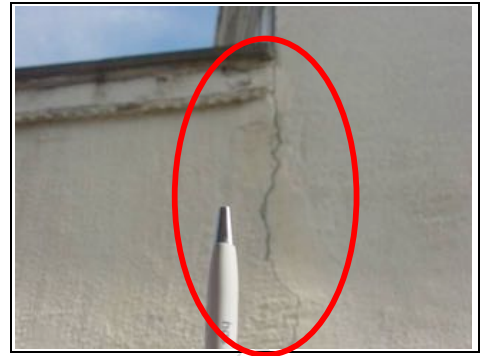
Crack between single storey extension and the main building

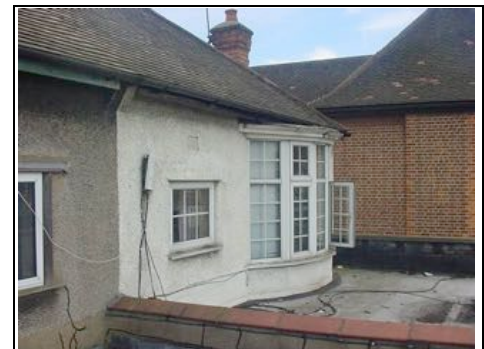
ACTION REQUIRED: The roof we believe is a relatively new felt therefore we would recommend redecorating the ceiling of the front right hand side (all directions given as you face the property) in the private living accommodation to check if the dampness is coming through or not.

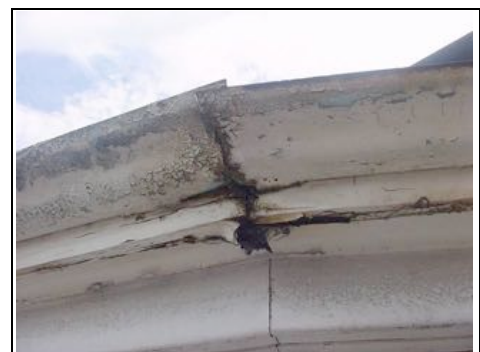
Leaking and rusting gutters

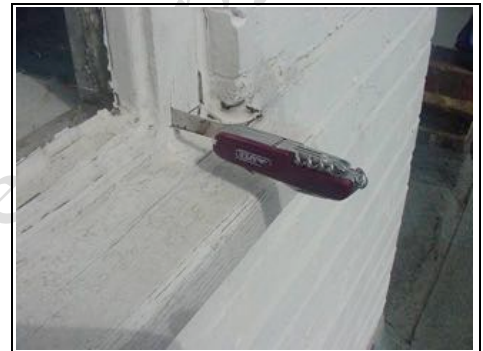
Knife test reveals deterioration to timber windows

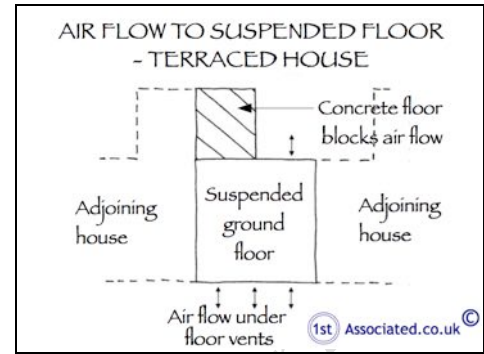
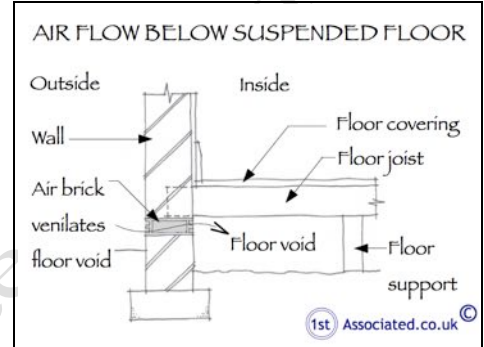
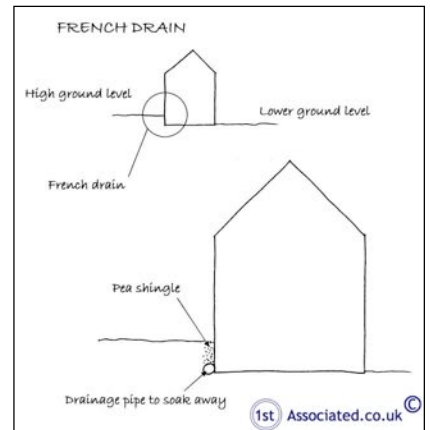
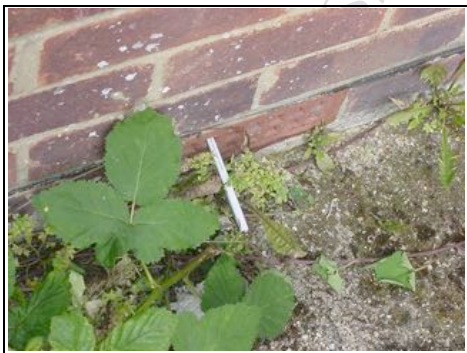
Airbrick broken and too low

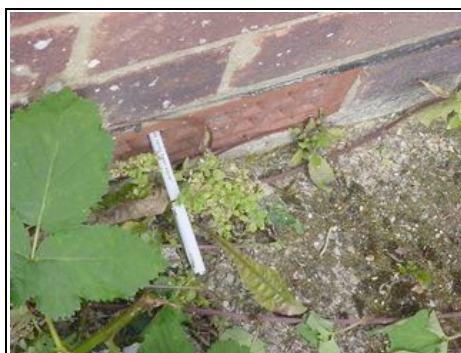
Close up of airbrick which is too low

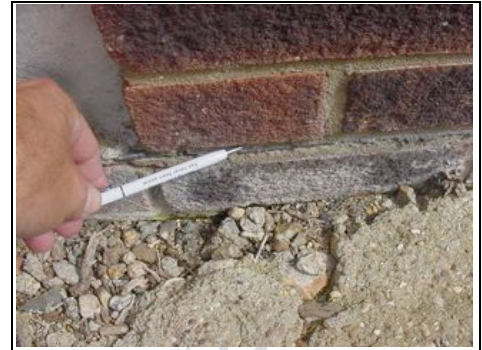
The damp proof course is too low

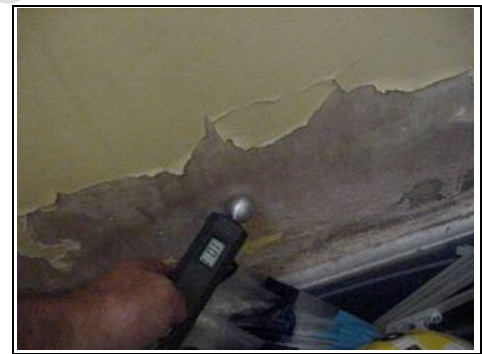
Dampness in private living accommodation showing readings of 101, typically we would expect to find 30-60

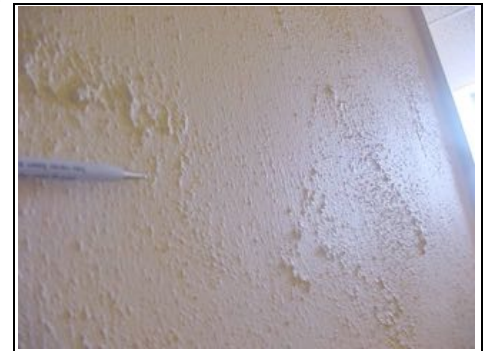
Artex/asbestos on walls

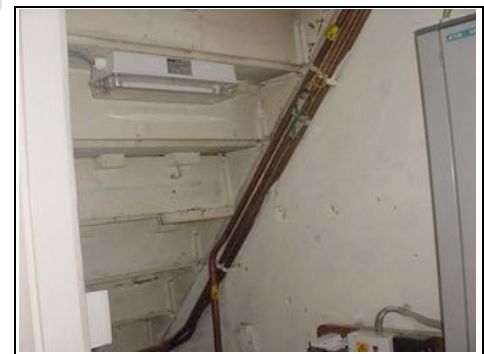
We were surprised to note that the underside of the staircase was exposed. It is more normal today to have a half hour fire barrier to stop fire spreading from the ground floor to the first floor in a worst case scenario. You may wish to take a view on whether you add this.

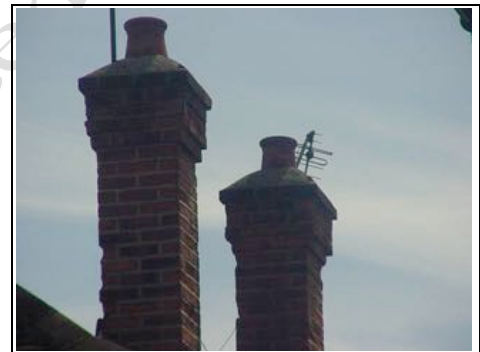
Spalling occurs to brick or stone when water penetrates the surface and via freezing and thawing starts to cause deterioration to the surface. This in turn allows further water penetration and the surface breaks up further. This ultimately can lead to water damage or structural damage to the area.

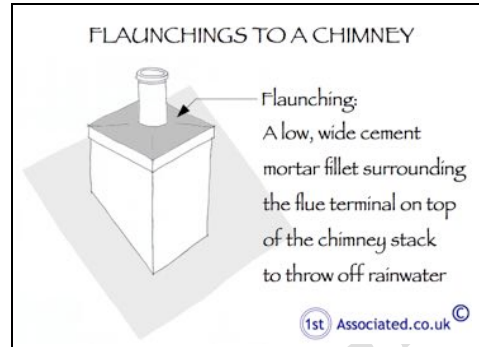
ANTICIPATED COST: £500 - £1000 (five hundred to one thousand pounds) the main cost being scaffolding; please obtain quotations. When you are carrying work out to renew the roof you could also have a further review of the condition of the chimneys.

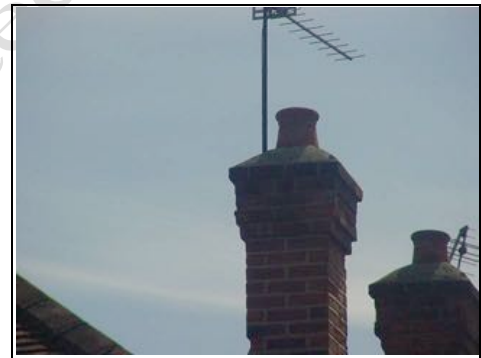
ACTION REQUIRED: Again this chimney has spalling brickwork and requires re-pointing work to be carried out within the next few years. Periodically check the chimneys.

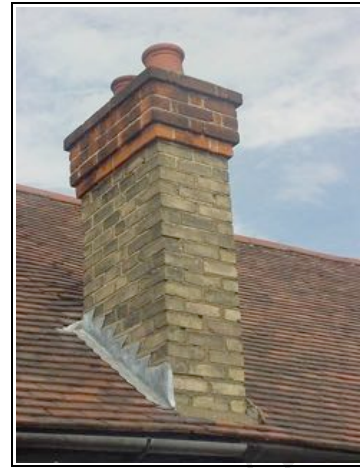
This chimney is brick finished with a lead flashing and two chimney pots. From what we could see from ground level it looked in average condition considering its age, type and style. We would prefer to see the cement flashing present at the front of the chimney removed and replaced with a lead flashing.

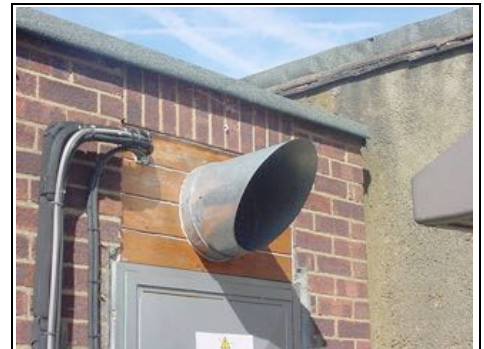
ACTION REQUIRED: We all food extract flues we recommend internal cleaning of the flues as regularly as necessary dependent upon the grease build up etc.

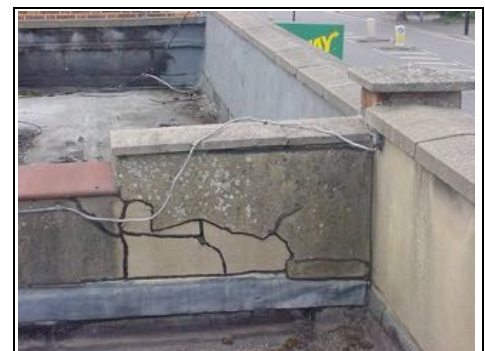
Rendering to parapet wall on neighbouring side

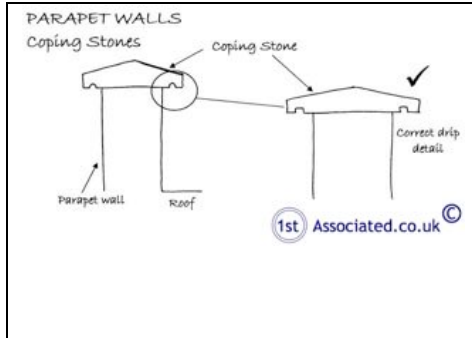
The rear parapet wall has felt flashing coming away which we believe is allowing dampness into the structure.

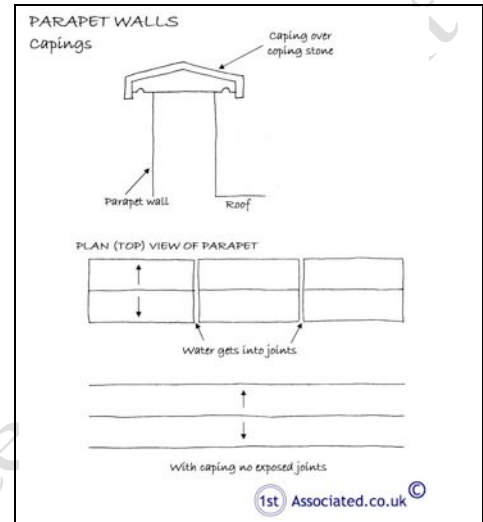
ACTION REQUIRED: Again we would recommend replacing with a lead flashing.

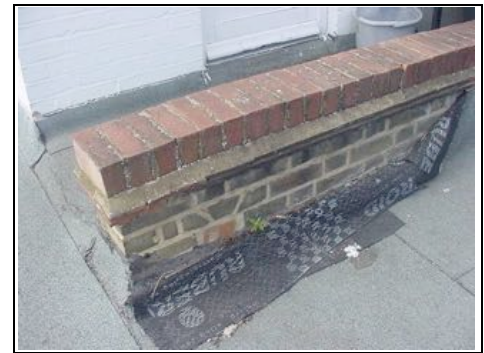
Felt flashing coming away

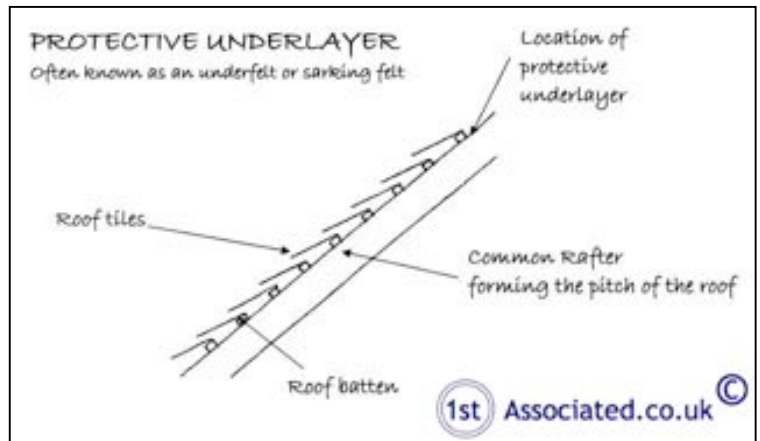
There is no protective underlayer. Often an older roof will have no protective underlayer at all unless it has been re-roofed post war and then it will have a Hessian base bitumen membrane.

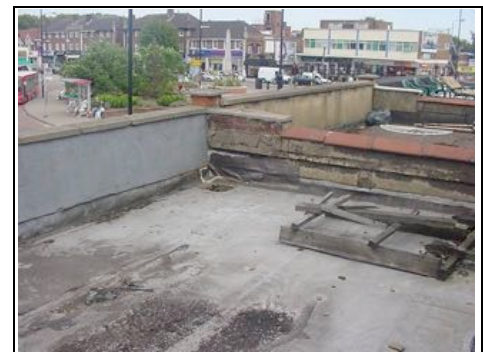
Please refer to our comments with regard to the front roof, the leak in the corner and the recommendation that the roof is replaced to the rear.

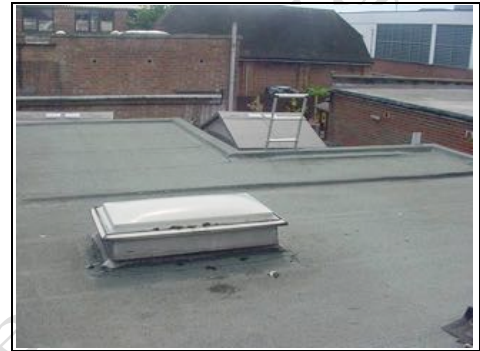
There is a possibility that the roof light is leaking due to the staining we could see. The staining may be old staining prior to it being re-roofed but we have no way of knowing and needs to be checked the next time it rains heavily.

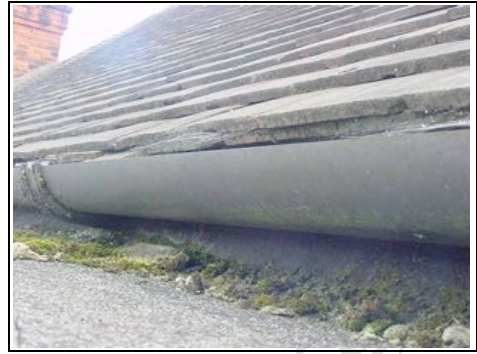
Flat roof over bay window at the front of the property leaking

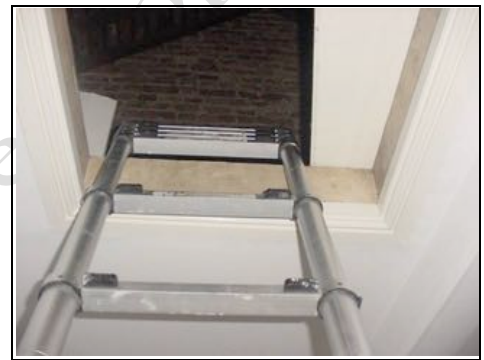
The loft (perimeter) has been viewed by torch light, which has limited our viewing slightly.

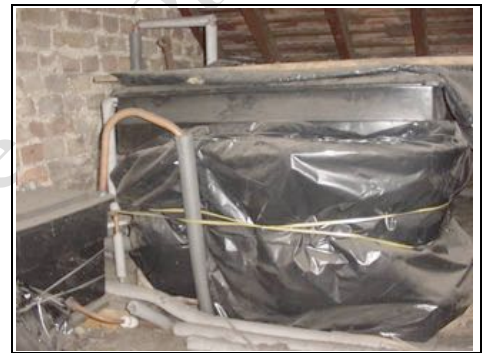
We would always recommend that water tanks be drained down and cleared of any debris etc. (we have seen dead birds and other unmentionable things in these tanks). As you are cleaning your teeth with this water it is best that it is as clean as possible!

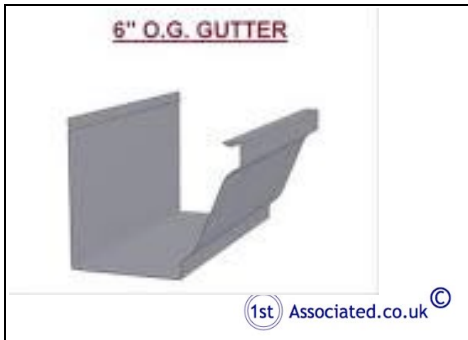
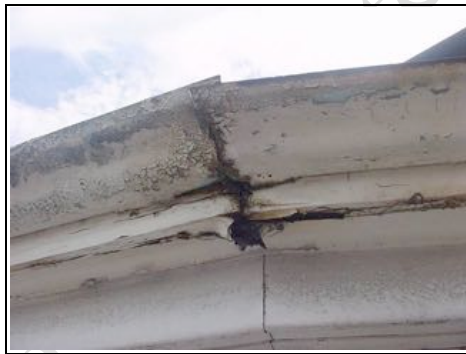
Front flat roof has a rusting cast Ogee gutter

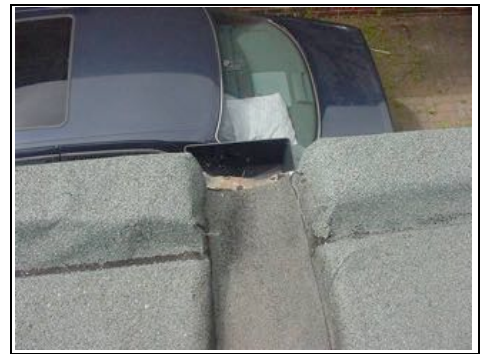
Box gutter to left hand side of rear flat roof blocked

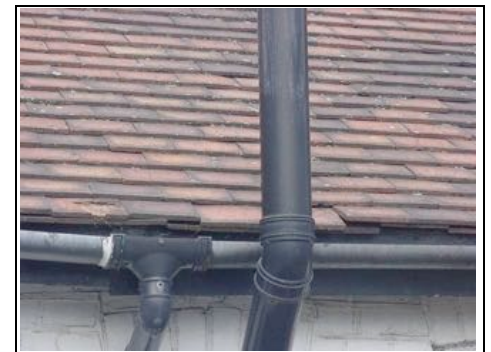
Gutter needs repairing again has previously been repaired

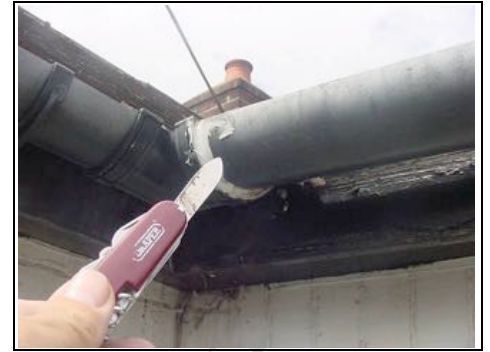
Close up of mastic repair

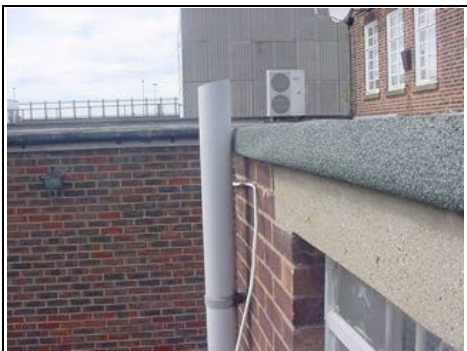
Soil and vent pipe not as high as it should be

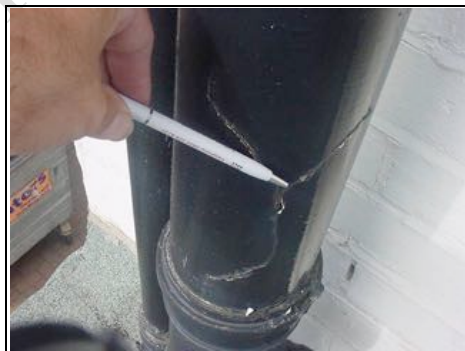
Soil and vent pipe cracked

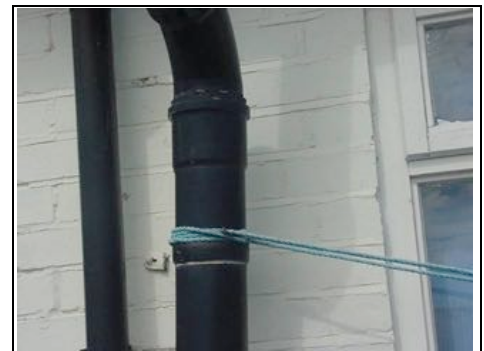
Soil and vent pipe cracked possibly due to washing line being attached to it

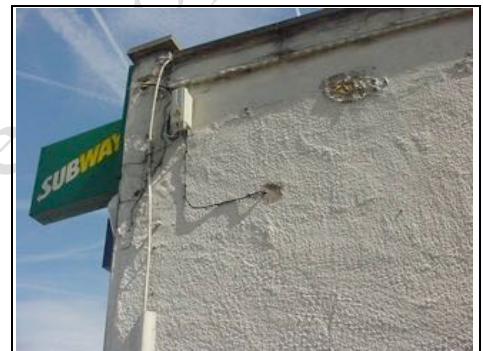
Spalling to render on the right hand side caused by the leak from the roof

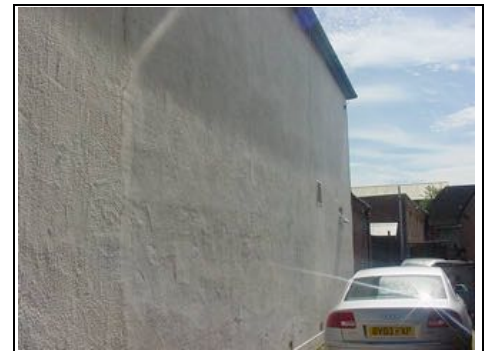
Rear to the right hand side

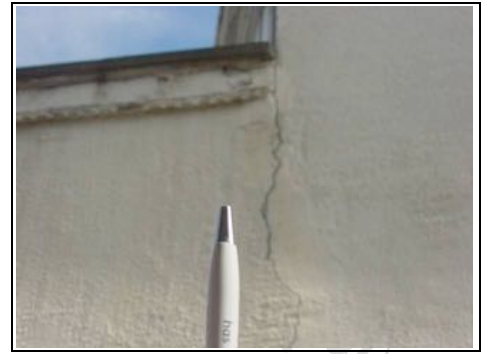
Cracking to the render on the right hand side

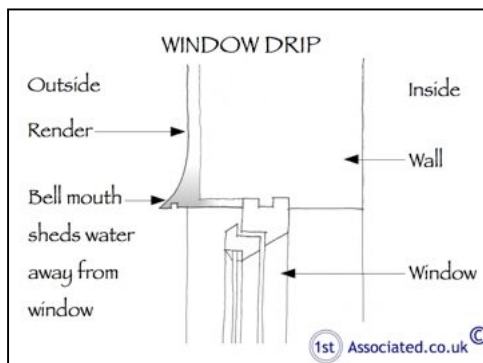
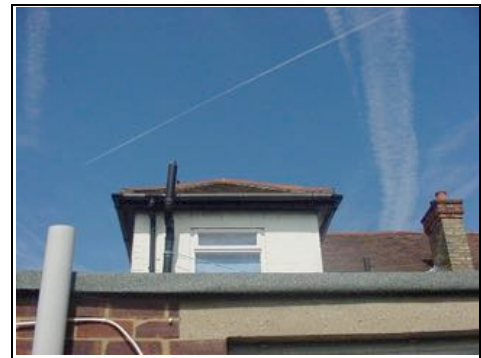
In this case we found a drip detail to the window.

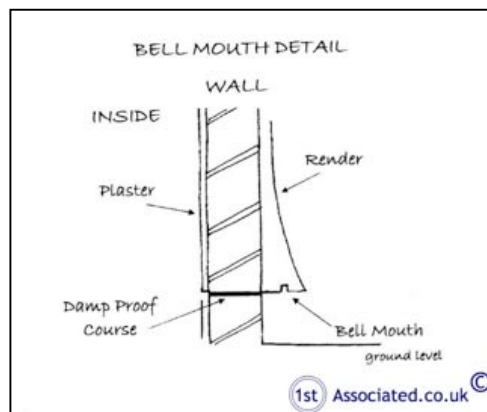
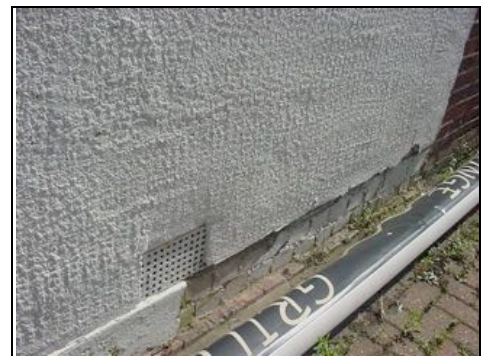
Plinth broken and missing at base

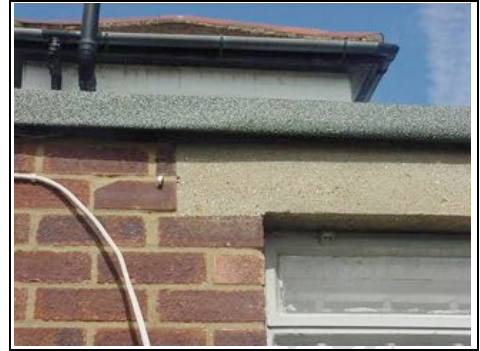
Concrete lintel to the rear

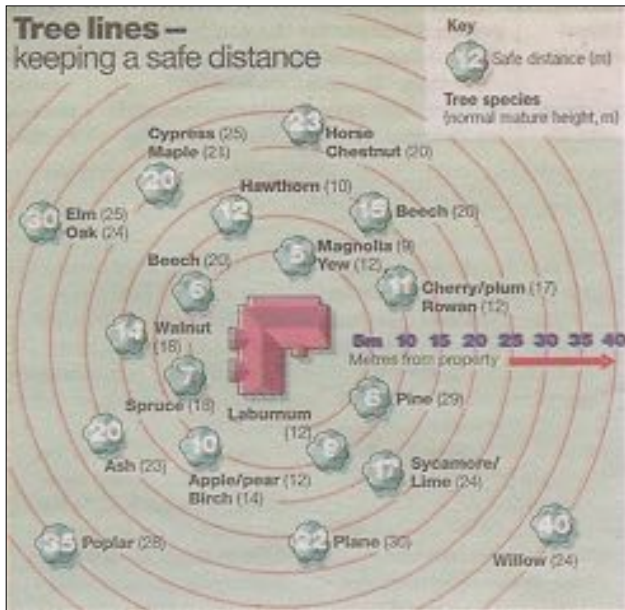
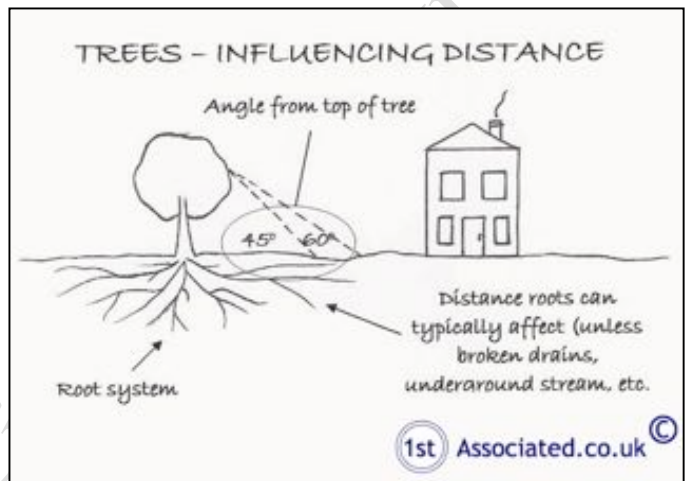
Influencing Distance Defined

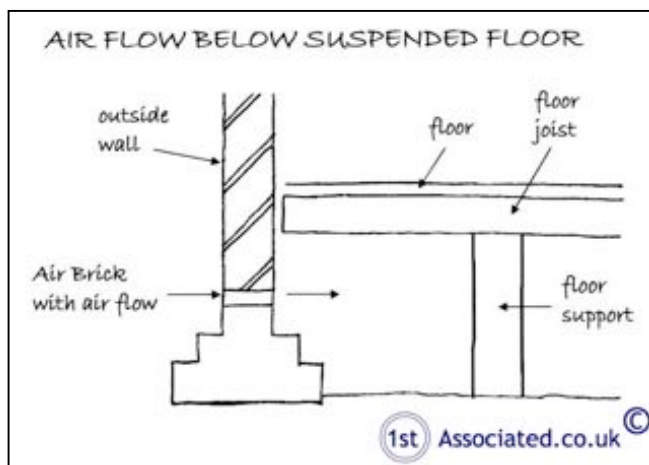
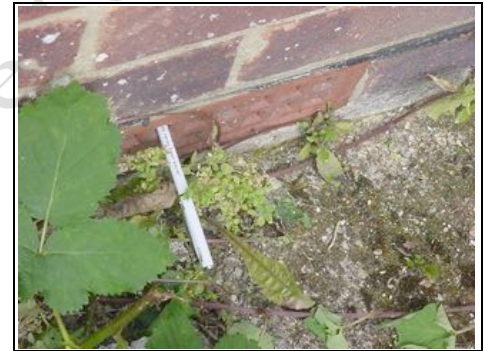
The airbricks to the property are too low and some are cracked and require replacing.

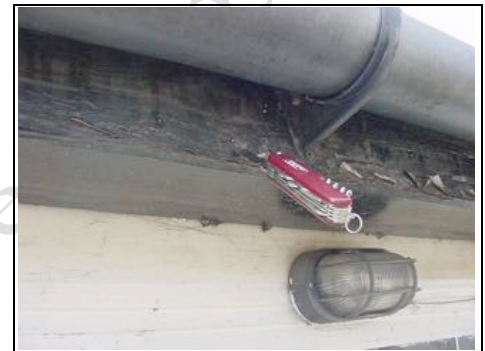
Fascias in a poor condition

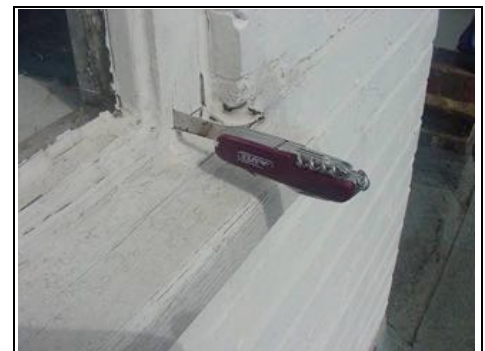
Rotten timber window at the rear of the property

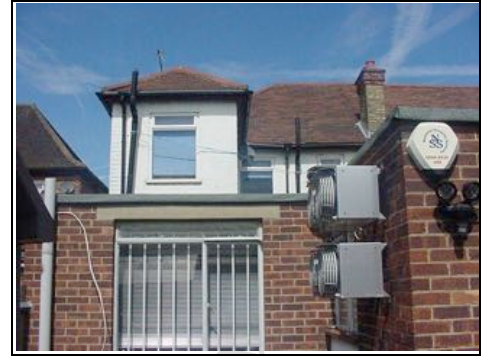
First floor level plastic window
Ground floor level metal window

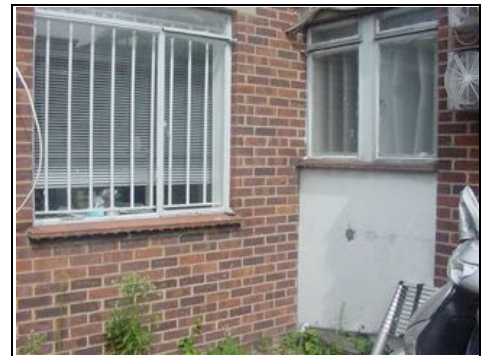
Bars to windows at ground level at the rear

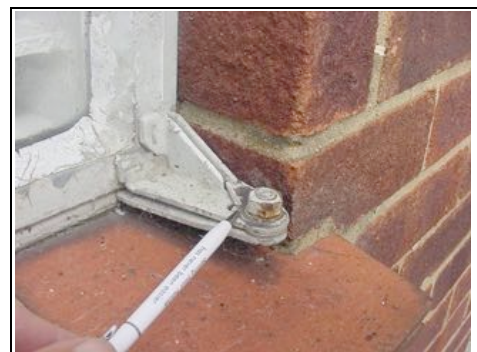
Rusting and deterioration to rear metal windows

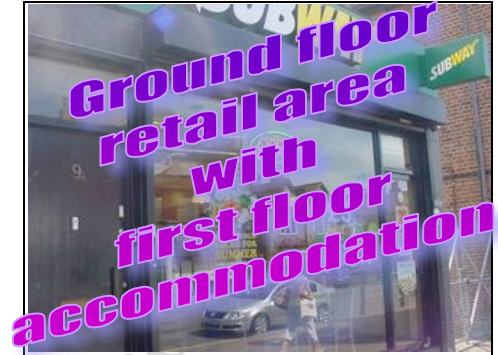
The shop front window is heavily marked due to the amount of wear to this window.

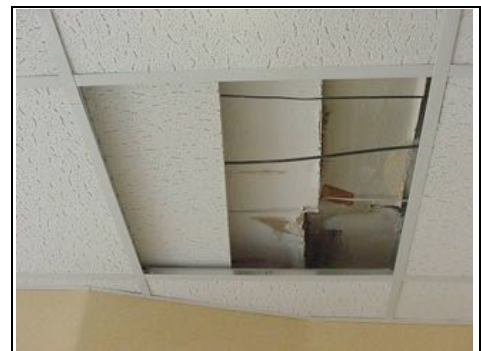
Decking to ceiling in retail unit front of house coming away

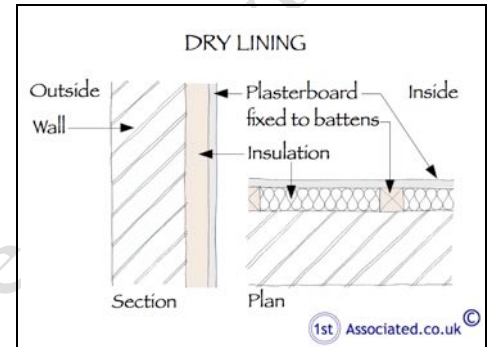
We cannot comment upon the condition of the structure hidden behind plaster, dry lining, other applied finishes, heavy furniture, fittings and kitchen units with fitted back panels.

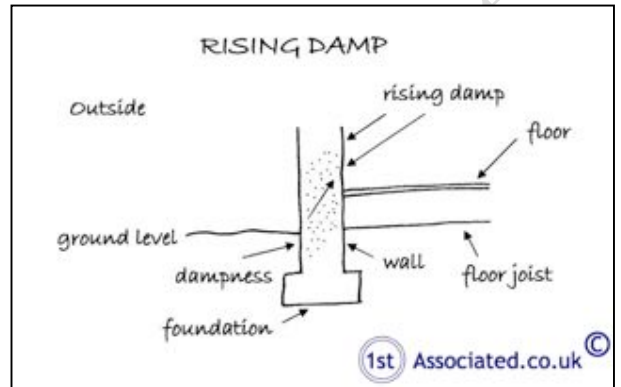
A random visual inspection and tests with a moisture meter have been taken to the perimeter walls and some internal walls. In this particular case we have found rising damp.

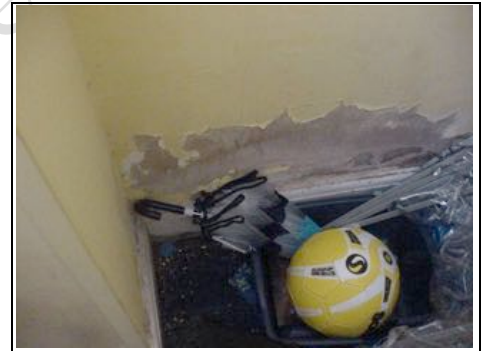
ACTION REQUIRED: Please see the Executive Summary.

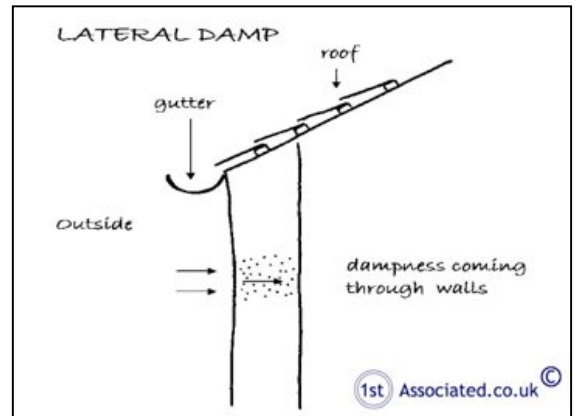
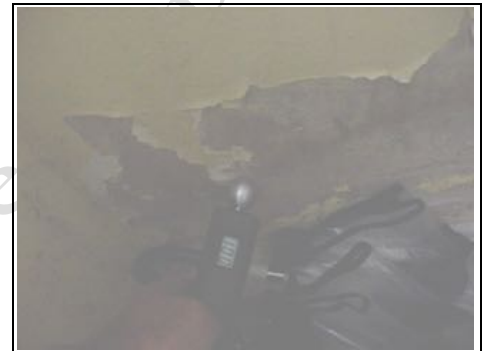
Testing for lateral dampness with readings over 100

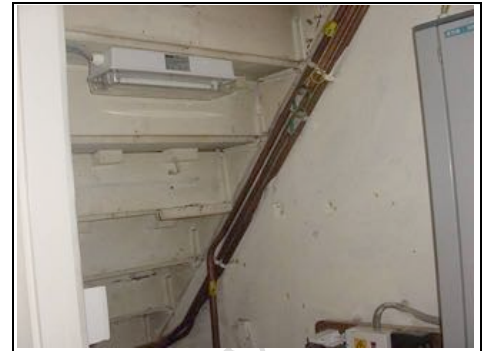
We noted that the underside of the staircase was exposed. It is more normal today to have a half hour fire barrier to stop fire spreading from the ground floor to the first floor in a worse case scenario. You may wish to take a view on whether you add this.

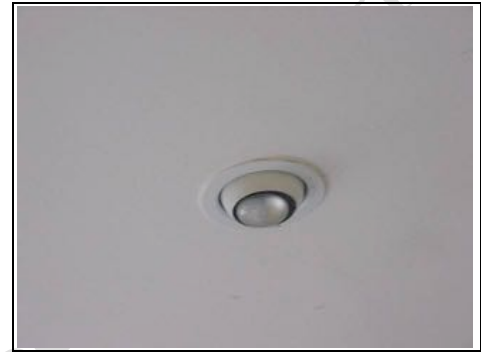
1970s light fittings

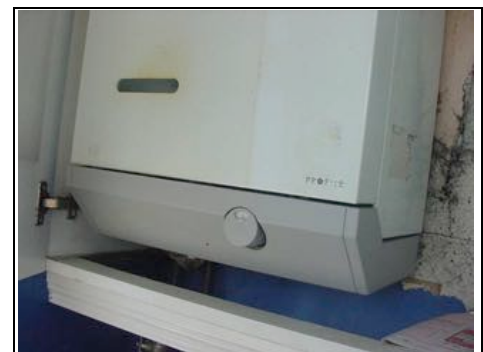
Potterton Profile boiler in kitchen

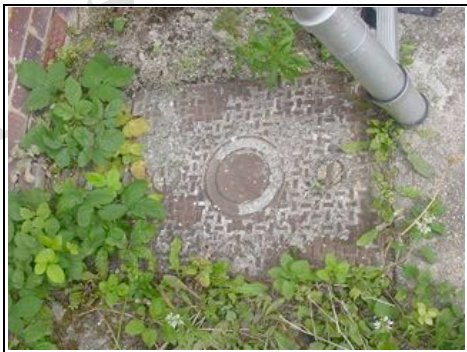
Unable to lift manhole at rear
