PROPERTY REPORT

XXXX
City of London,
EC3V XXX

We have been instructed to inspect and prepare a Report and Schedule of Condition for XXXX, City of London, EC3V XXX. We inspected the property on XXXX

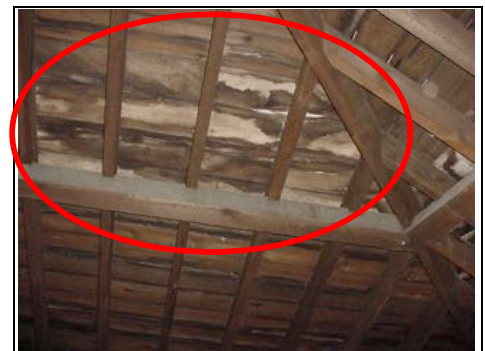
We have had no access to view the roof coverings; however we have had a view of the underside of the roof from within the roof space. From within the roof space we can see the underside of the roof is close boarded and has many areas of dampness coming in which looks to have been a long term problem.

Dampness coming through close boarding

ACTION REQUIRED: We would recommend a joint inspection of the roofs externally or the roofs are completely excluded from the Lease.

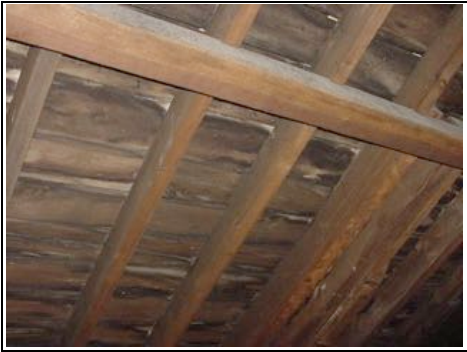
We can also see one area to the centre of the roof where a polythene sheet has been laid down, presumably to stop dampness getting through to the store room below.

Dampness coming through the roof

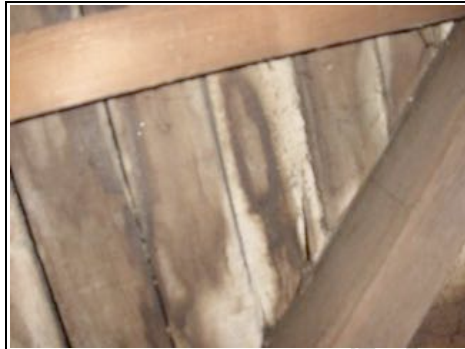
Signs of dampness to boarding

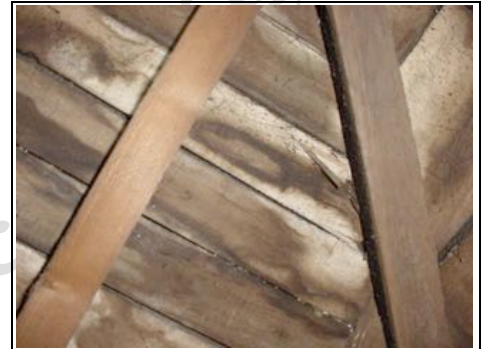
Dampness to boarding

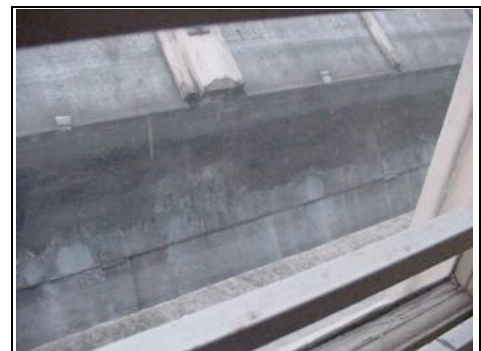
We can see through the windows at second floor level that there are lead lined box gutters. Unfortunately box gutters are renowned for leaking. We were unable to closely inspect the box gutters as the windows had been screwed shut which we assume is for security purposes.

Lead gutter

ACTION REQUIRED: A joint inspection to be carried out of the lead guttering. We suspect the guttering is leaking.

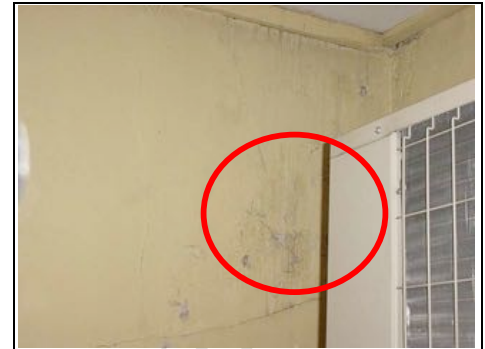
Dampness is visible to the plant room to the front elevation of the top floor, particularly to the right hand side which may relate to the roof. We do not have a view of this section of the building (the windows have been screwed shut therefore there is no access onto the roof as far as we could see).

Dampness in plant room

In our experience this damp area will only become worse in time.

ACTION REQUIRED: A joint inspection with the landlord's surveyor to confirm condition and remedial action.

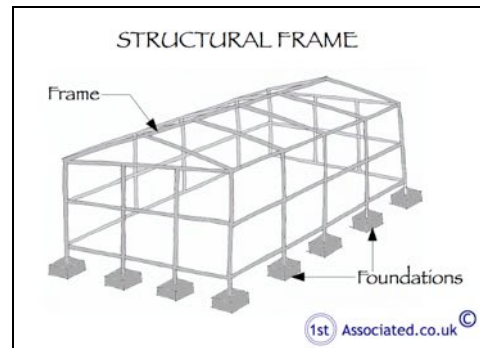
Dampness is causing the structural frame on the ground floor to rust. We can see there have been additional steels added in the basement.

Structural frame

ACTION REQUIRED: We believe that this structure may require additional support over the term of the lease. You need to exclude the structural frame from the lease and/or receive information from the landlord with regard to the additional steelwork that has been added to the property.

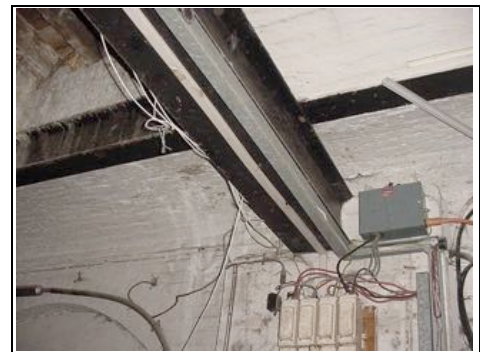
New steels added in basement¹²

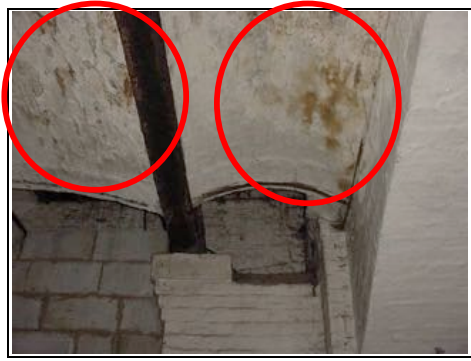
Dampness to
Vaulted brickwork coming
through from ground floor

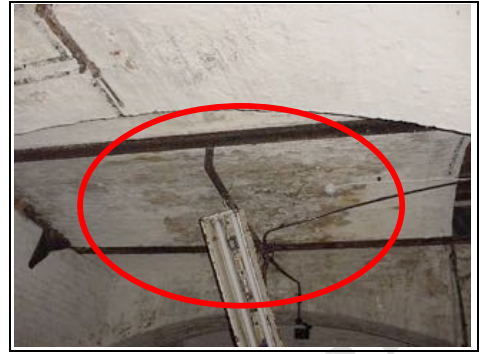
Dampness within basement
causing rust to cast iron

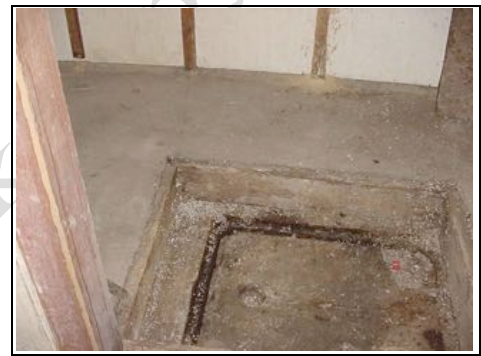
The basement looks to have been partially flooded, possibly by sewerage.

Drain within basement

The drains did look to have overflowed but this could be years old.

ACTION REQUIRED:
Responsibility needs to be established with regard to the drains and access requirements. We recommend you speak to the existing occupiers to check and confirm the frequency of access required with regard to the drains.

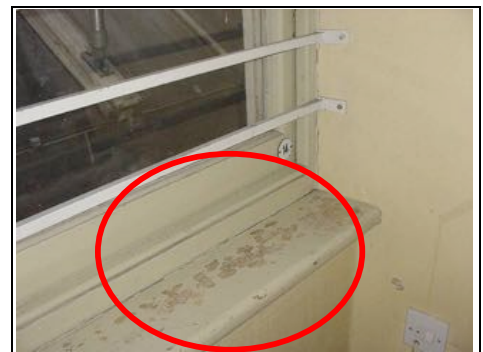
There is a considerable amount of joinery work internally that requires redecoration to the windows. Most leases require a redecoration at the end of the Lease/Yield up clause which has clearly not been carried out.

Window in need of redecoration

ACTION REQUIRED: Repair, prepare and redecoration to be carried out by existing lessee's or a sum agreed.

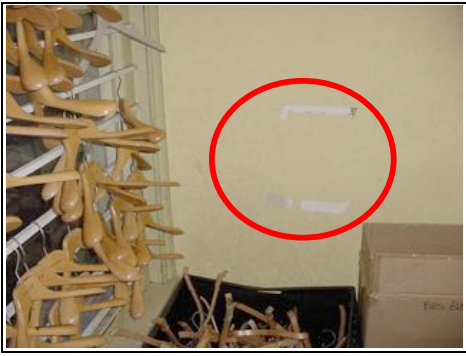
Heavily marked wall in store room

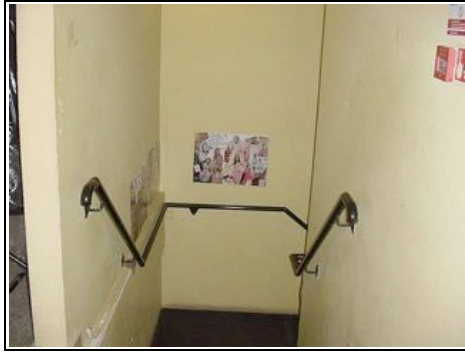
Staff room staircase marked walls and old pictures

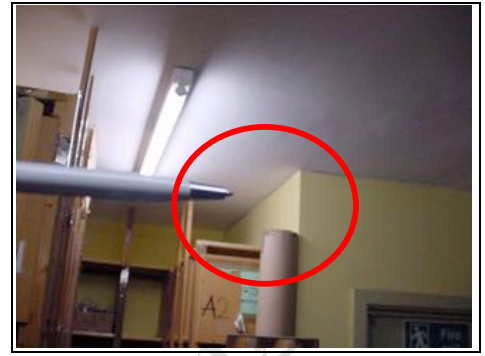
Cracks between studwork partitions and ceilings

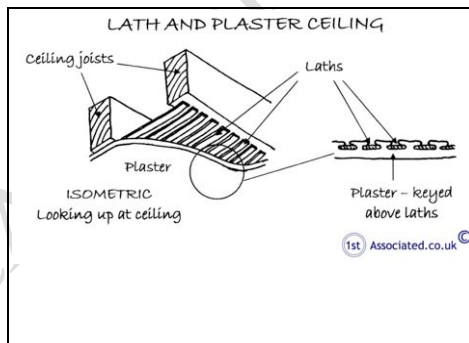
The laths have broken on the lath and plaster ceiling.

Lath and plaster ceiling

ACTION REQUIRED: You may need to replace the ceiling during the term of the lease.

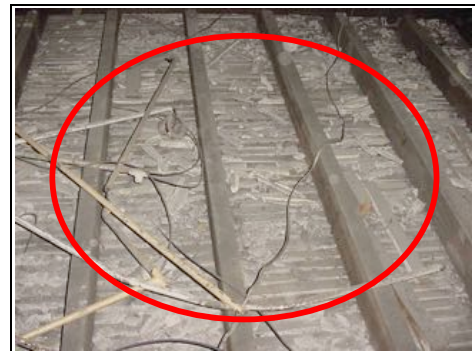
Laths broken
