JOB REFERENCE: XXXXX

SCHEDULE OF CONDITION

Islington

London. N1 XXX

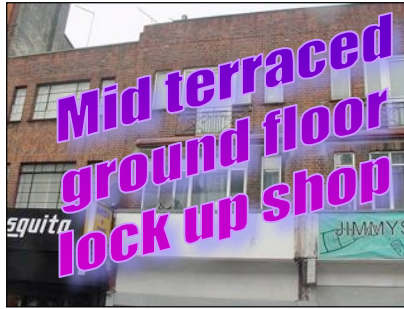
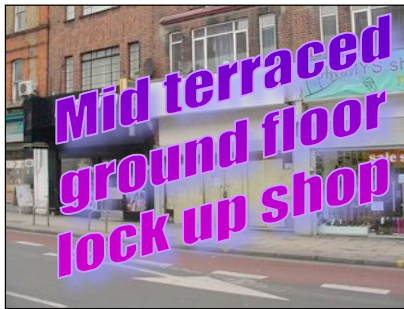
FRONT EXTERNAL ELEVATION

DESCRIPTION	CONDITION	ACTION REQUIRED
Roofs: Pitched (assumed) but not visible		If there is a liability Legal Advisor to instruct.
Gutters and Downpipes: Cast iron and plastic		Ensure all gutters are watertight and falling towards the downpipe. Repair and secure as necessary, ensure downpipes are clear.
Walls: Flemish bond brickwork	Dirty and stained	Clean

<p>External Detailing:</p> <p>Shop Front Window: Single glazed, metal frame</p>   <p>Shop Entrance Door: metal, glazed</p> <p>Signage: None, plywood thick only</p>   <p>Lights: None visible</p>	<p>Dirty</p> <p>No insulation</p>	<p>Clean, make good.</p> <p>Make good and build to normal building standards. Re-instate signage and infill wall.</p> <p>Add lights</p>
--	-----------------------------------	---

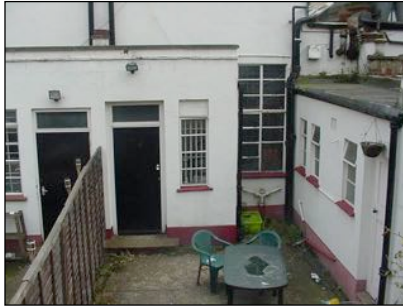
REAR ELEVATION

DESCRIPTION	CONDITION	ACTION REQUIRED
<p>Roofs: Main Roof: Pitched (assumed) not visible</p> <p>Flat Roofs:-</p> <p>Flat roof over the shop</p>   <p>Flat roof over the toilet</p>   <p>Flat roof over the entrance</p>  	<p>Not visible</p> <p>Generally there is a lack of falls to the flat roofs which has lead to water damage internally which is visible and also old repairs can be seen.</p>   <p>Water sitting on roof, we believe this is getting into the property.</p>	<p>If there is a liability Legal Advisor to instruct.</p> <p>All flat roofs need falls adding and the detailing improving.</p>

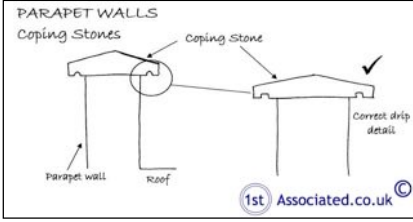
<p>Up stand</p>

<p>Up stands and parapet walls: Brickwork and render</p> <p>Coping stones</p>

<p>Appear to be allowing in water.</p> <p>Not adequate size.</p>

<p>Missing coping stone to parapet wall toilet area</p> <p>Vegetation present</p>	<p>Replace/improve flashings ideally to be formed in lead.</p> <p>Make watertight, this may require adding new coping stones as incorrect see sketch.</p> <p>Remove vegetation</p>
<p>Gutters and Downpipes:</p> <p>Cast iron and plastic</p>	<p>Rust visible</p>	<p>Remove rust and paint with rust stop paint. Ensure all gutters are watertight and falling towards the downpipe. Repair and secure as necessary, ensure downpipes are clear.</p>
<p>Walls:</p> <p>Flemish bond brickwork</p>	<p>Dirty and stained</p>	<p>Clean</p>

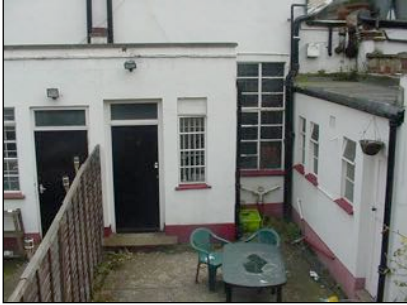
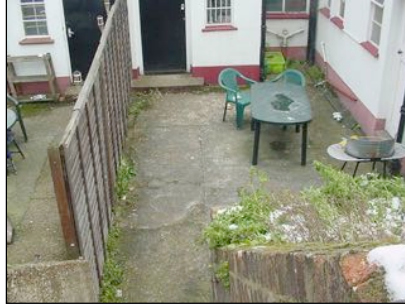
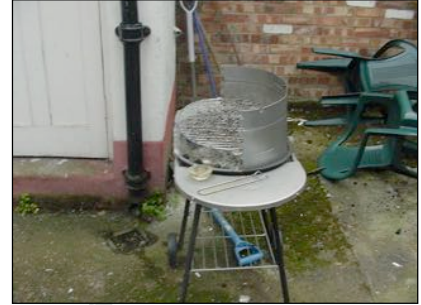
REAR COURTYARD AREA

DESCRIPTION	CONDITION	ACTION REQUIRED
<p>Walls:</p> <p>Retaining wall</p>	<p>Degraded by ground water coming through it</p>

<p>Uneven. Vegetation</p>	<p>Make good any trip hazards. Clear vegetation</p>
<p>Steps:</p> <p>Concrete</p>	<p>Some wear</p>	<p>Make good</p>
<p>Fence:</p> <p>Panelled</p>		<p>Re-stain/paint</p>
<p>Drains:</p>	<p>Blocked</p>	<p>Clear</p>

<p>Add weep holes to relieve pressure on wall and make good wall.</p>
<p>Ground:</p> <p>Concrete</p>

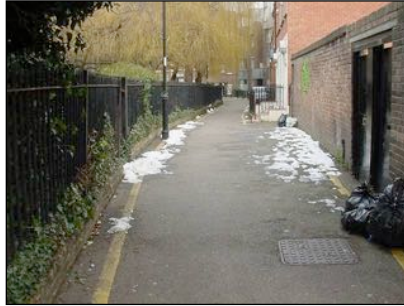
OUTSIDE AREAS

DESCRIPTION	CONDITION	ACTION REQUIRED
Alleyway to rear For record a view of access to rear courtyard area

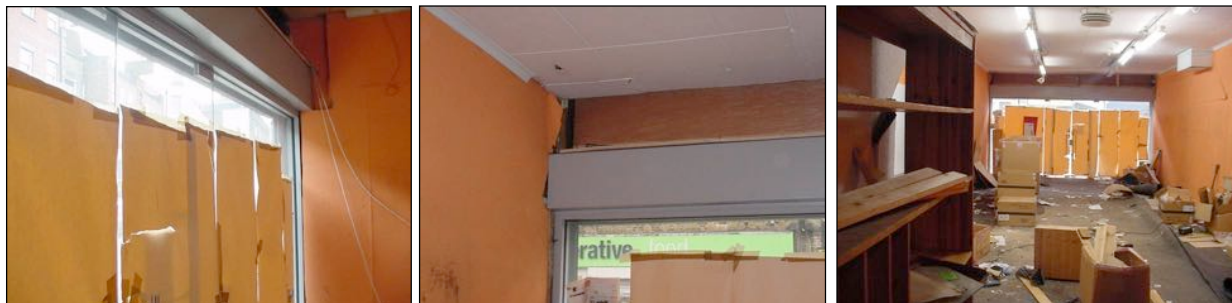
Shop Trading Area
Front elevation

DESCRIPTION	CONDITION	ACTION REQUIRED
<p>Ceilings:</p> <p>Foam/polystyrene tile</p>	<p>Fire hazard</p>

<p>Water damaged</p>	<p>Remove.</p> <p>Replace with modern ceiling system to current Fire Regulation requirements.</p> <p>Ensure that roofs above are watertight before carrying out work.</p>
<p>Floors:</p> <p>Concrete centrally with wooden flooring on batons to outside.</p>	<p>Worn</p>	<p>Replace entirety of floor</p>
<p>Detailing:</p> <p>Metal window frame: single glazed.</p> <p>Doors: Two glazed double doors.</p>	<p>Dirty, marked.</p> <p>Dirty</p>	<p>Clean and repair.</p> <p>Clean.</p>
<p>Services:</p> <p>Heater/vent in centre of room</p>		<p>Remove/improve</p>

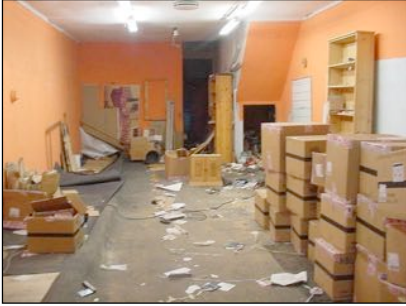
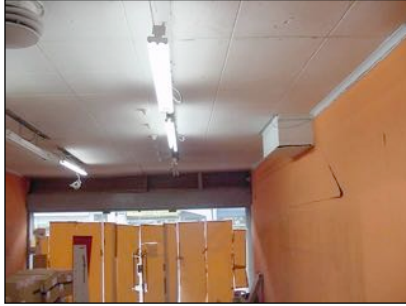
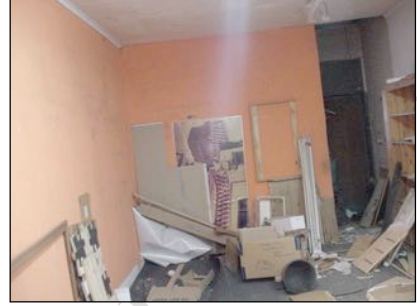
Shop Trading Area
Left elevation

DESCRIPTION	CONDITION	ACTION REQUIRED
<p>Ceilings:</p> <p>Foam/polystyrene tile</p>	<p>Dated, considered a fire hazard.</p> <p>Stained, looks to be coming from the small flat roof above</p>	<p>Remove.</p> <p>Replace with modern ceiling system to current Fire Regulation requirements.</p> <p>Ensure that roofs above are watertight before carrying out work.</p>
<p>Lighting: Older style</p>	<p>Dated</p>	<p>Remove replace with Category 2 lighting</p>

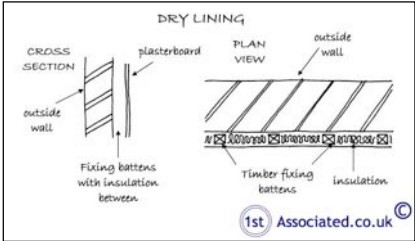
<p>Walls:</p> <p>Painted woodchip paper</p> <p>False walls otherwise known as dry lining.</p>

<p>Marked</p>	<p>Repair, prepare and redecorate.</p>
<p>Floors:</p> <p>Concrete centrally with wooden flooring on batons to outside.</p>	<p>Worn</p>

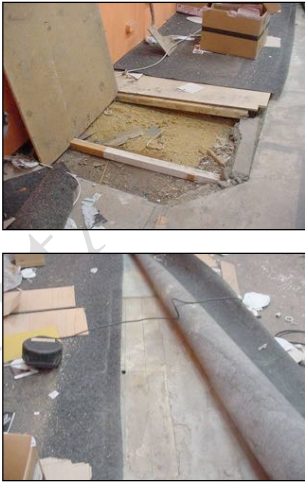
<p>Replace entirety of floor</p>
<p>Services:</p> <p>Electrics:</p>

<p>Fuse board</p>	<p>Dated. Service mounted electric points were not working.</p> <p>Fuseboard painted over, not possible to view.</p>	<p>Re-wire to Institute of Electrical Engineers (IEE) standard by an NICEIC approved electrician or equivalent.</p>

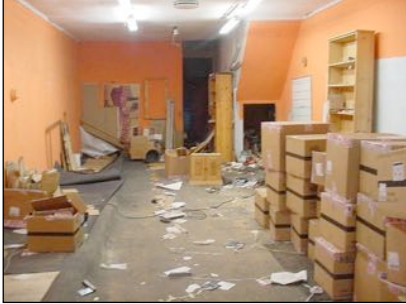
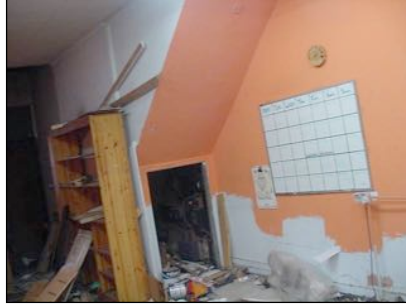
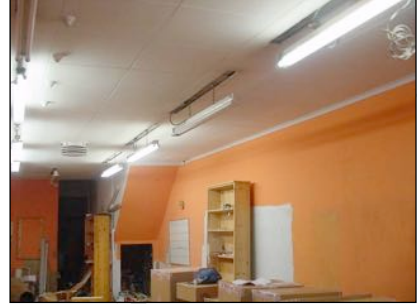
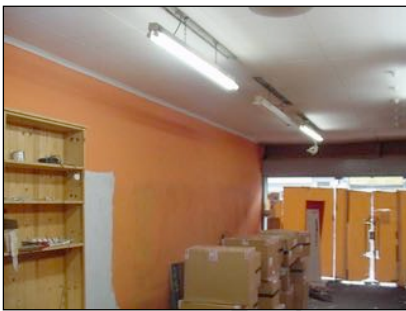
Shop Trading Area
Right elevation

DESCRIPTION	CONDITION	ACTION REQUIRED
<p>Ceilings:</p> <p>Foam/polystyrene tile</p> <p>Lighting: Older style</p>	<p>Dated considered a fire hazard.</p> <p>Dated</p>	<p>Remove.</p> <p>Replace with modern ceiling system to current Fire Regulation requirements.</p> <p>Remove replace with Category 2 lighting</p>

<p>Walls:</p> <p>Painted woodchip paper False walls otherwise known as dry lining.</p>	<p>Marked</p>	<p>Repair, prepare and redecorate.</p>
<p>Floors:</p> <p>Concrete centrally with wooden flooring on batons to outside.</p>	<p>Worn</p>	<p>Replace entirety of floor</p>
<p>Detailing:</p> <p>Door: To staircase</p>		<p>Replace with a fire door</p>
<p>Staircase: To rear with stairs sanforded from ceiling</p>		<p>Landlord to confirm this staircase has been built to fire safety standards.</p>
<p>Services:</p> <p>Electrics:</p>	<p>Dated. Service mounted electric points, earth check proved satisfactory.</p>

<p>Re-wire to Institute of Electrical Engineers (IEE) standard by an NICEIC approved electrician or equivalent.</p>

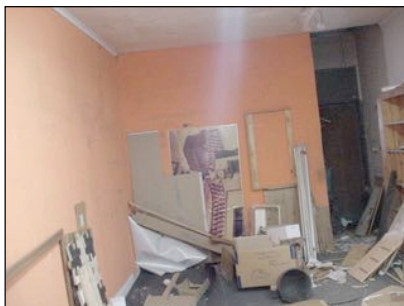
Shop Trading Area
Rear elevation

DESCRIPTION	CONDITION	ACTION REQUIRED
<p>Ceilings:</p> <p>Foam/polystyrene tile</p> <p>To rear: wood slated ceiling</p>

<p>Dated considered a fire hazard.</p> <p>Needs removing</p>	<p>Remove.</p> <p>Replace with modern ceiling system to current Fire Regulation requirements.</p> <p>Remove and upgrade.</p>
<p>Lighting: Older style</p>	<p>Dated</p>	<p>Remove replace with Category 2 lighting</p>
<p>Walls:</p> <p>Painted woodchip paper</p> <p>Studwork partition</p>	<p>Marked</p>	<p>Repair, prepare and redecorate.</p>
<p>Floors:</p> <p>See front elevation</p>		
<p>Services</p> <p>Boiler on rear wall</p> <p>Surface mounted conduit</p>		<p>Replace</p> <p>Replace</p>

You advised this is going to be removed; you will need to get the landlord's permission and consent for this.

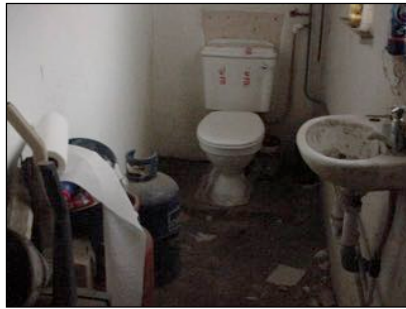
Toilet and wash area

DESCRIPTION	CONDITION	ACTION REQUIRED
<p>Ceiling: Plastered</p>	<p>Signs of water penetration to left hand side from the flat roof above.</p> <p>Please see our comments on the rear elevation</p>	<p>Make watertight. Prepare, repair and redecorate</p>
<p>Walls: Plastered</p>	<p>Long term dampness coming through the walls</p>
