SCHEDULE OF CONDITION

XXXXX
Northampton
Northamptonshire
NN1 XXX

Prepared by:
[XXXXXX](#)
INDEPENDENT CHARTERED SURVEYORS

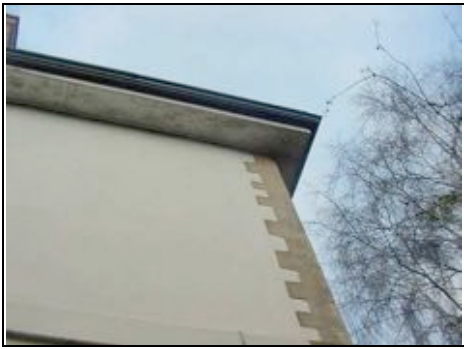
Fascias and soffits deteriorating

Fascias and Soffits: Painted timber	Weathered and deteriorating. Looks to be an area that has been replaced.

Repair, prepare and redecorate
Walls: Cement based render and plaster Brickwork to lower area	Inappropriate cement mortar for this age, type and style of property.

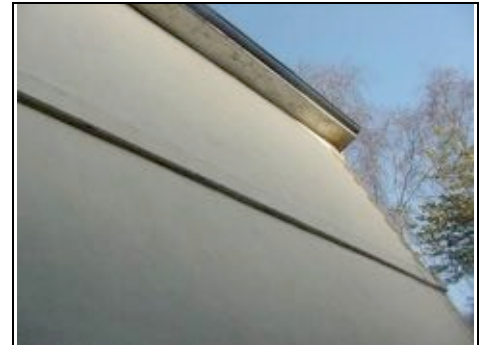
Modern plaster to left side

Deteriorating	As this is a listed building we recommend removing cement mortar and replacing with lime based breathable render Ad hoc repointing

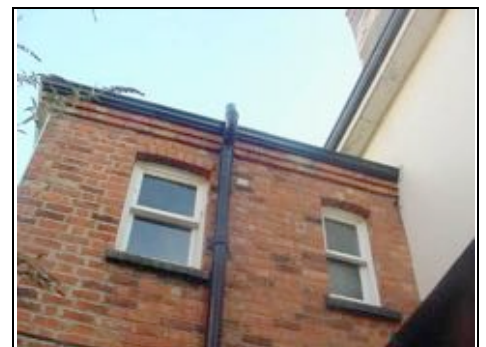
Wall repairs

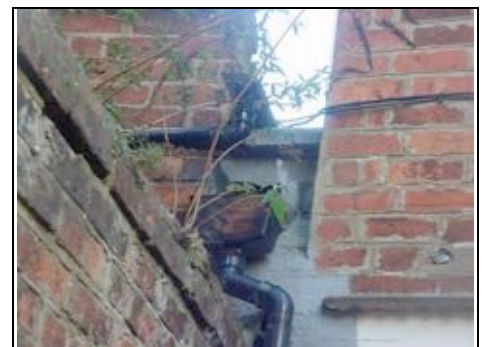
Rusting cast iron hopper head

<p>All gutters and downpipes viewed from ground level.</p>	<p>Rusting and long outstanding leak, leading to growth of vegetation in top of adjoining wall</p>

<p>Exclude from lease And/or</p> <p>Ensure all gutters are watertight and falling towards the downpipe and clear.</p> <p>Repair downpipes and secure as necessary, ensure downpipes are clean and clear.</p>

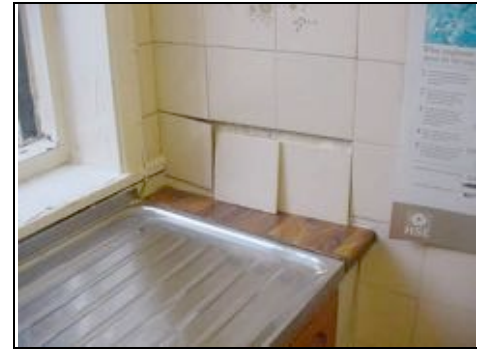
Tiles off wall

<p>Dampness coming through despite dry lining. Hairline cracking.</p>

<p>Resolve dampness (see other comments throughout the report) Repair, prepare and redecorate.</p>

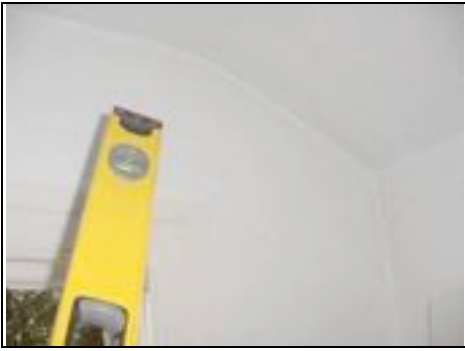
Hairline cracking

DESCRIPTION	CONDITION	ACTION REQUIRED
<p>Ceiling:</p> <p>Woodchip paper</p>	Dated	Repair, prepare and redecorate
<p>Walls:</p> <p>Woodchip paper</p>	<p>Dampness visible</p> <p>Hairline cracking</p>

<p>Resolve dampness</p> <p>Repair, prepare and redecorate.</p> <p>Landlord to place insurance claim regarding cracking</p>
<p>Floors:</p> <p>Safety style flooring</p>	Average	Deep clean or replace

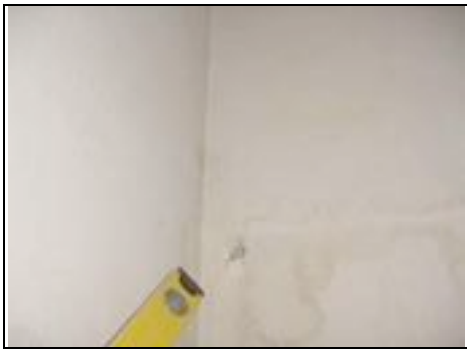
Dampness coming through

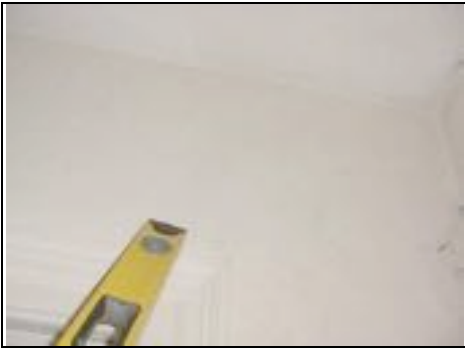
Cracking

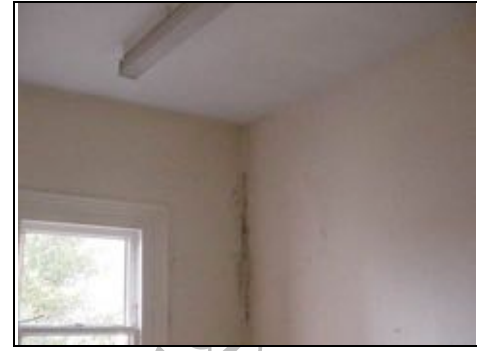
Black mould to corner

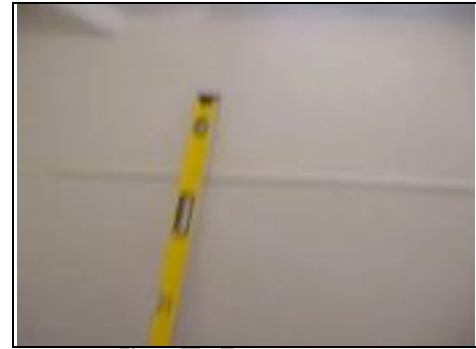
Hairline cracking

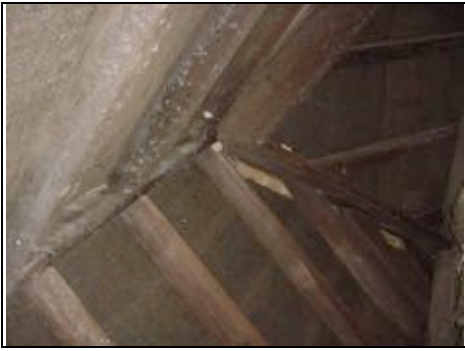
Timber visible to ridge

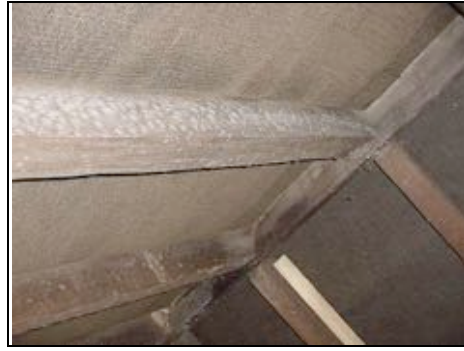
Mould due to lack of ventilation

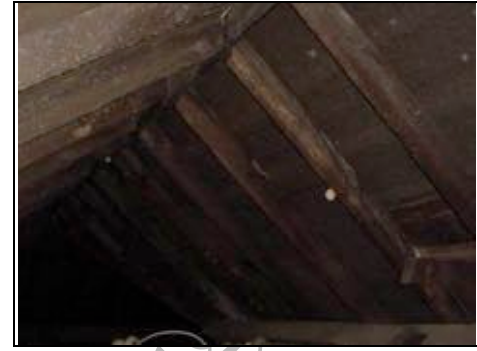
Mould to timbers
