SCHEDULE OF CONDITION

City of London,
EC3V XXX

We have been instructed to inspect and prepare a Schedule of Condition for XXXX, City of London EC3V XXX. We inspected the property on XXXX

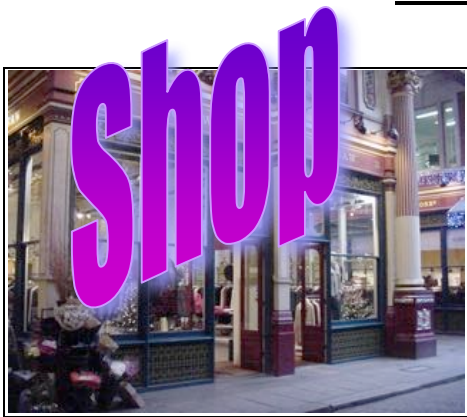
Front Elevation

DESCRIPTION	CONDITION	ACTION REQUIRED
<p>Roofs:</p>	<p>Roof not visible but noted leaks within roof space.</p>	<p>Joint high level inspection with the landlord or landlord's surveyor to be carried out prior to signing of the lease or legal completion of the lease.</p>
<p>Box Gutters and Downpipes:</p> <p>Cast Iron</p>	<p>Not visible.</p>	<p>Joint inspection as above</p>
<p>Walls:</p> <p>Cast iron with infill cladding panels.</p>

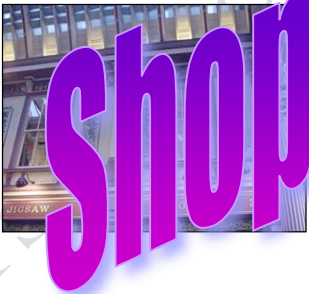
<p>Rusting at basement/ground floor level.</p> <p>Deterioration to coving</p>	<p>Repair, prepare and redecorate.</p>

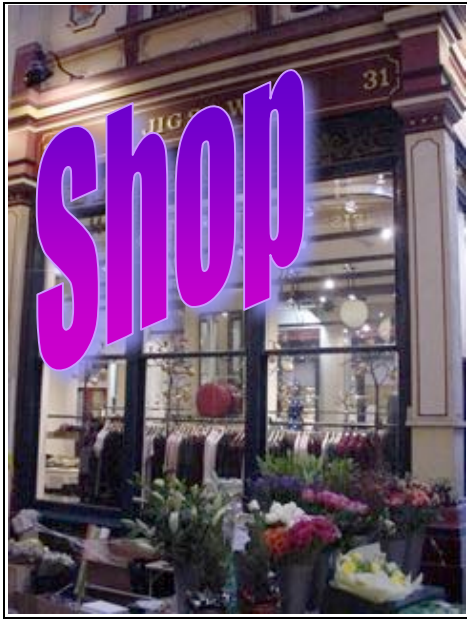
Left hand elevation

DESCRIPTION	CONDITION	ACTION REQUIRED
Roofs:	Not visible	Joint inspection; see front elevation.
Box Gutters and Downpipes: Lead and Cast Iron	Not visible	Joint inspection; see front elevation.
Stone fascia: High level limited view

Confirmation is required that the stone fascias does not form part of the Lease or repair liability associated with this.

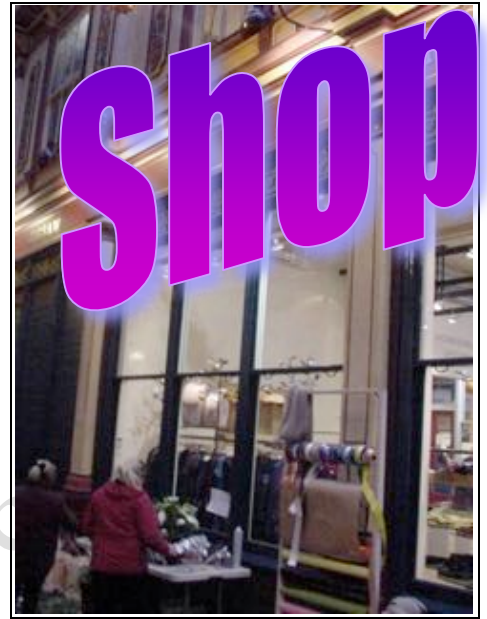
<p>First Floor: Sliding sash windows at first.</p> <p>Top floor:</p>	<p>Dated</p>

<p>Dated</p> <p>Not visible</p>	<p>Repair, prepare and redecorate.</p> <p>Repair, prepare and redecorate.</p>
<p>Signage: Timber fascia sign</p>		<p>Remove</p>

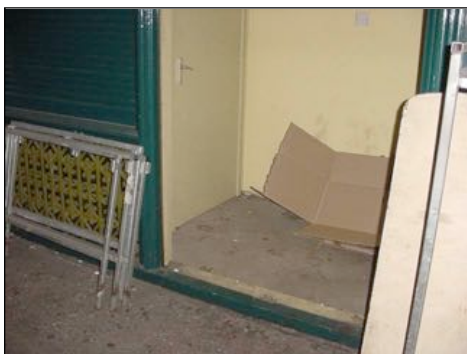
Lobby area giving access to basement via a ladder

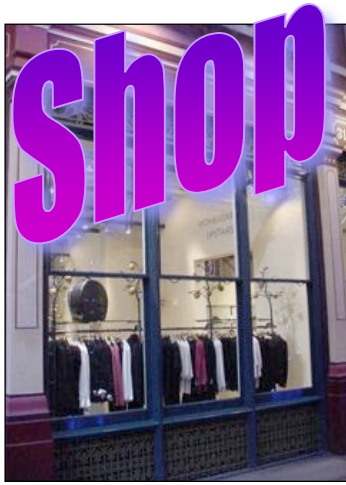
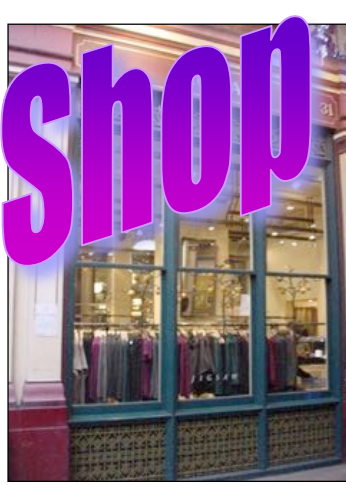
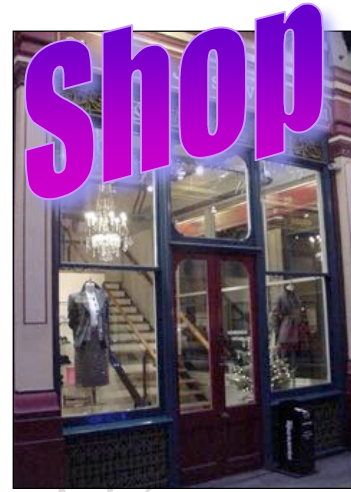
Deterioration at high level and leaking box gutter Deterioration to coving Rusting at ground floor level.	Repair, prepare and redecorate.

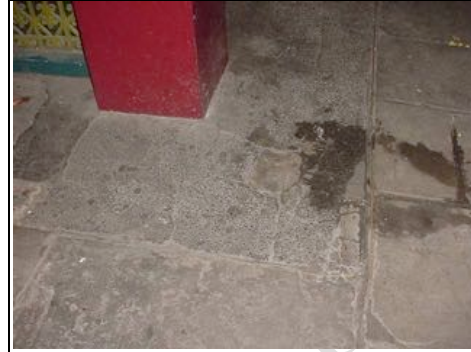
DESCRIPTION	CONDITION	ACTION REQUIRED
Area around property	Rear left corner heavily marked, stained and undulating.	Re-surfacing

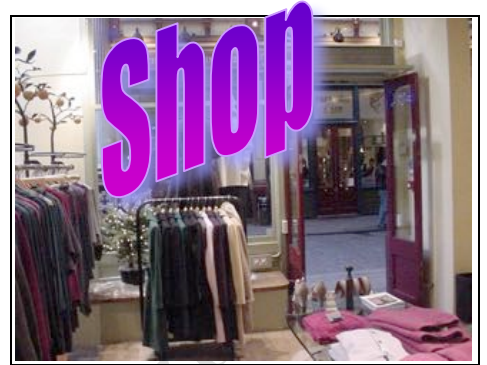
Front right trading area

<p>Walls: Predominately shop front windows. Painted above windows and to corners</p> <p>Timber top display areas with painted sides</p>	<p>Repair work not completed to front right hand side</p>   <p>Marked</p>  	<p>Repair, prepare and redecorate</p> <p>Repair, prepare and redecorate</p>
<p>Floors: Wood</p> <p>Matt wells in front of doors</p>	<p>Worn and marked by foot traffic</p>   <p>Wear to flooring</p>	<p>Sand, repair, prepare and re-stain.</p>
<p>Detailing: Windows: Two entrance double doors</p>	<p>Marked</p> <p>Marked</p>	<p>Clean. Repair, prepare and redecorate</p> <p>Clean. Repair, prepare and redecorate</p>

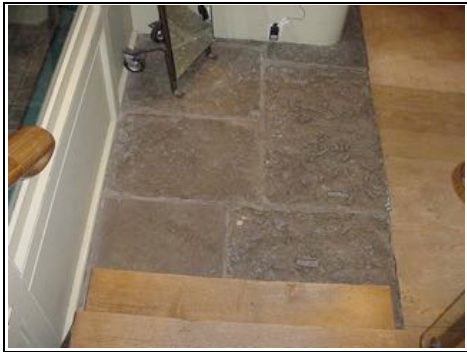
Rustic floor

<p>Floors:</p> <p>Rustic stone slab</p> <p>Floorboards run front to back</p> <p>Matt wells in front of doors</p>

<p>Marked by foot traffic</p>	<p>Deep clean</p> <p>Sand, fill, repair, prepare and re-stain.</p>
<p>Detailing:</p> <p>Windows</p>

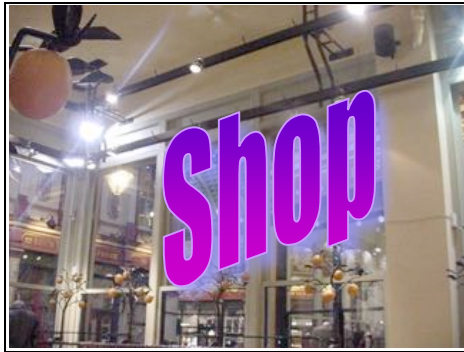
Front right

<p>Areas of repair to right side front corner that have not been decorated</p> <p>Dated</p>	<p>Repair, prepare and redecorate.</p>

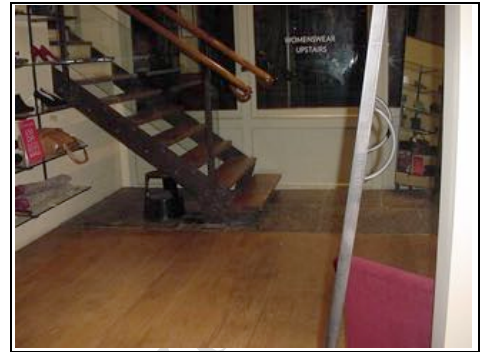
Customer's stairs to first floor

<p>Floors:</p> <p>Timber</p> <p>Rustic stone slabs near stairs</p>	<p>Marked</p>   <p>Timber floor and rustic stone slabs and marked staircase</p>	<p>Sand, fill, repair, prepared and re-sand</p> <p>Clean and/or replace</p>
<p>Detailing:</p> <p>Windows: Painted</p> <p>Doors:</p> <p>Staircase to first floor:</p> <p>Wood</p>	<p>Dated</p> <p>Worn areas of steps</p>	<p>Repair, prepare and redecorate.</p> <p>Sand and re-stain and/or replace</p>
<p>Spiral staircase Fire Exit:</p> <p>Metal</p>

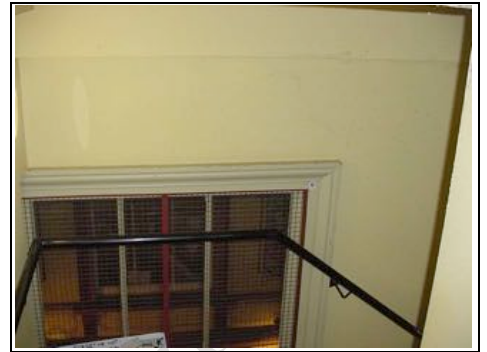
Window within staff staircase area

DESCRIPTION	CONDITION	ACTION REQUIRED
Ceilings: Painted	Dated	Repair, prepare and redecorate
Walls: Painted	Dated Heavily marked in staff staircase area	Repair, prepare and redecorate
Floors: Wood	Marked and worn by foot traffic Heavily marked in staff staircase area	Sand, fill, repair, prepare and re-stain.
Detailing: Window in shop area one partly hidden by staircase	Dated	Repair, prepare and redecorate

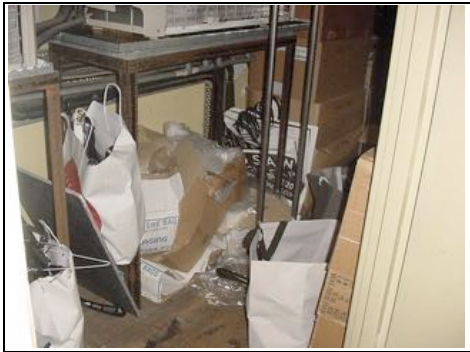
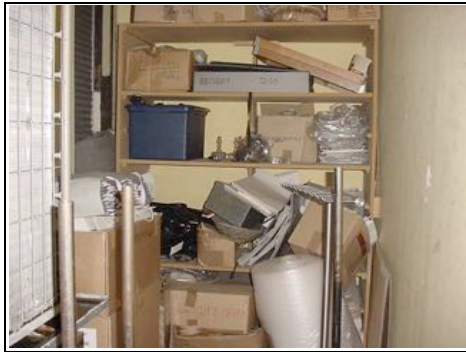
<p>Walls:</p> <p>Painted</p>	<p>Dated</p> <p>Hairline cracking to right hand side and dampness coming through</p>

<p>Hairline cracking and dampness coming through</p>

<p>Dampness</p>	<p>Resolve dampness. Repair, prepare and redecorate</p>
<p>Floors:</p> <p>Wood boarded with joists running front to back</p>	<p>Signs of dampness</p> <p>Rusting to unit that holds the three air conditioning modules in place</p>	<p>Sand, fill, repair, prepare and re-stain.</p>
<p>Detailing:</p> <p>Four grilled windows</p> <p>Doors:</p>	<p>Dated</p> <p>Dated</p>	<p>Repair, prepare and redecorate</p> <p>Repair, prepare and redecorate</p>

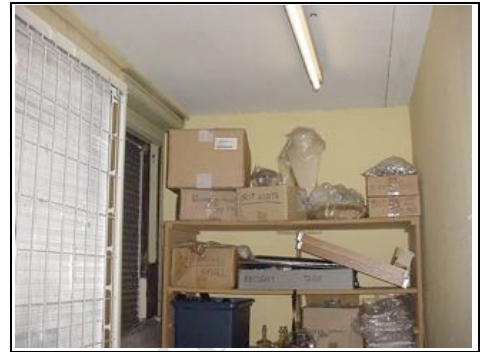
Ceiling in plant room

<p>Dated and marked</p>	<p>Repair, prepare and redecorate</p>

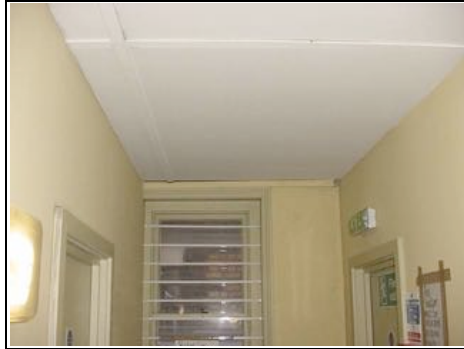
Ceiling

DESCRIPTION	CONDITION	ACTION REQUIRED
Ceilings: Painted Access hatch	Dated	Repair, prepare and redecorate
Walls: Painted	Heavily marked and indented

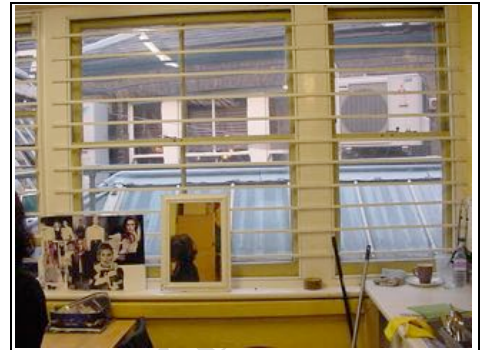
Staffroom

DESCRIPTION	CONDITION	ACTION REQUIRED
<p>Ceilings:</p> <p>Painted</p>	<p>Board missing Signs of dampness Patch repairs to corner</p>

<p>Ceiling</p>	<p>Resolve dampness.</p> <p>Repair, prepare and redecorate</p>
<p>Three fluorescent lights</p>	<p>No diffusers</p>	<p>Add diffusers</p>

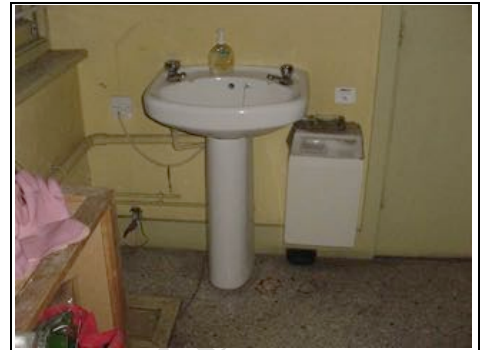
Wash hand basin

DESCRIPTION	CONDITION	ACTION REQUIRED
Ceilings: Painted	Dated and impact damage Cracking to ceiling level	Repair, prepare and redecorate
Walls: Painted plaster Studwork internal wall	Dated Vertical cracking to the studwork internal wall	Repair, prepare and redecorate Repair, prepare and redecorate
Floors: Vinyl	Worn	Clean and/or replace
Sanitary Ware: Two WC's, one wash hand basin	Dated	Deep clean

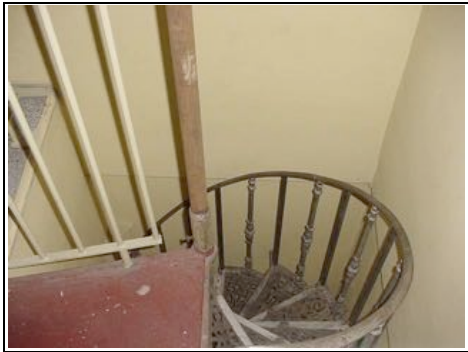
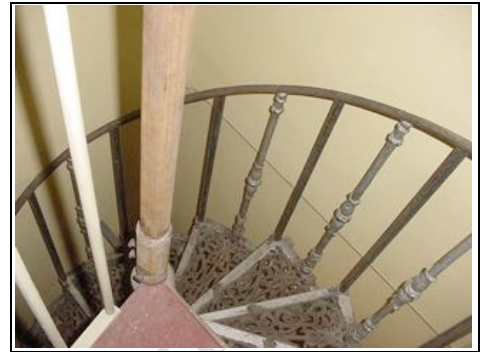
<p>Replace</p>
<p>Stairs: Spiral metal staircase (not accessed)</p>	<p>Dated</p>	<p>Repair, redecorate, prepare and</p>
<p>Detailing: Sliding sash green windows:</p>
