SCHEDULE OF CONDITION
Retail Unit and
Private Living Accommodation
XXX
Chingford
London. XXX

SCHEDULE OF CONDITION

The Schedule of Condition offers a detailed description of the condition of the property at the time of our inspection on XXXX.

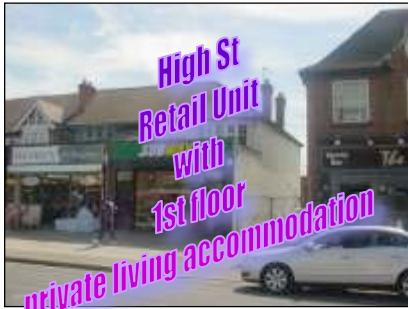
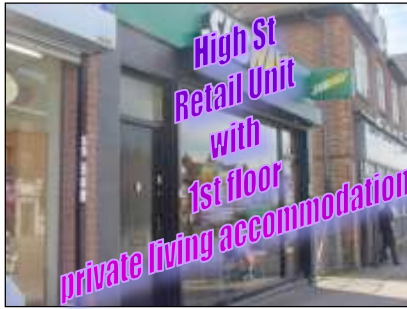
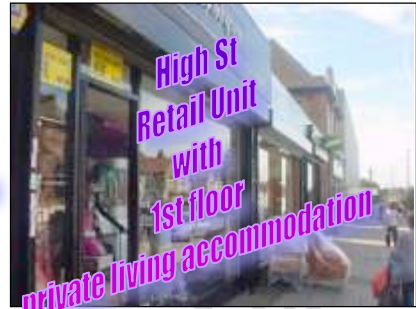
FRONT EXTERNAL ELEVATION

DESCRIPTION	CONDITION	ACTION REQUIRED
<p>Chimneys: Two red brick chimneys to right hand side</p>

<p>Spalling</p>	<p>Repair</p>
<p>Roofs: Main Roof: Hipped, pitched, tiled (without sarking felt)</p>

<p>Front Flat Roof:</p>

<p>Slipped and damaged tiles</p> <p>Movement visible at the junction of the adjoining building.</p> <p>Leak to left hand side possibly leaking elsewhere</p>	<p>Re-roof with adding a protective underlayer and immediately re-sit, re-bed any tiles and make watertight.</p> <p>Make watertight.</p>

<p>Gutters and Downpipes:</p> <p>Mixture of cast iron and plastic</p>	<p>Cast iron – rusting</p>

<p>External Detailing:</p> <p>Windows: Plastic bay window at first floor level</p> <p>Shop Front Window: Fixed window</p> <p>Shop Entrance Door: Right hand side</p> <p>Private Living Accommodation Entrance Door: Timber door, left hand side</p>	<p>Marked</p>

<p>repairs to door</p>

<p>Repair cast iron gutters and downpipes and use a rust stop agent.</p> <p>Ensure all gutters are watertight and falling towards the downpipe.</p> <p>Repair and secure as necessary, ensure downpipes are clear.</p>
<p>Fascias and Soffits:</p> <p>Painted timber</p>	<p>Redecorate/repair</p>

<p>Prepare, repair and redecorate.</p>
<p>Walls:</p> <p>Predominately painted render</p>		<p>Prepare, repair and redecorate.</p>

<p>handle push pull plate</p>   <p>Marked</p>	<p>Clean</p> <p>Prepare, repair and redecorate.</p> <p>Prepare, repair and redecorate.</p> <p>Prepare, repair and redecorate.</p>
--	---	---

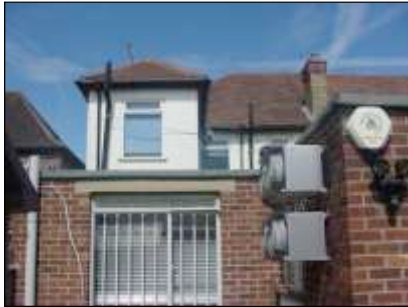
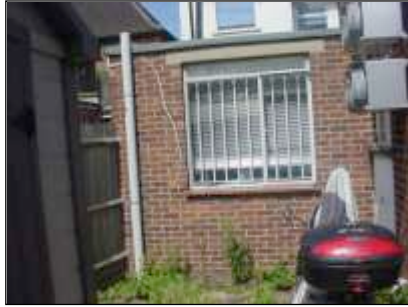
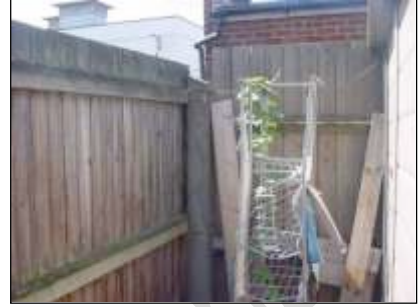
REAR ELEVATION

DESCRIPTION	CONDITION	ACTION REQUIRED
<p>Chimneys:</p> <p>London stock brick</p>

<p>Check flashing and ensure watertight.</p>
<p>Roofs:</p> <p>Main Roof: Hipped, pitched, tiled (without sarking felt)</p> <p>Flat Roof: Mineral felt with limited falls</p>	<p>Slipped and damaged tiles</p> <p>Felt is not bonded in many areas and we noted there is minimum fall.</p>

External Detailing:		
Windows: First floor: Timber	Rotten, knife test carried out.	Prepare, repair and redecorate.
Ground floor: Metal single glazed	Paintwork deteriorating, metal visible.	Prepare, repair and redecorate.
Doors: Painted.	Deteriorating	Prepare, repair and redecorate.

<p>As front elevation.</p> <p>Check and confirm the roof window is watertight</p>

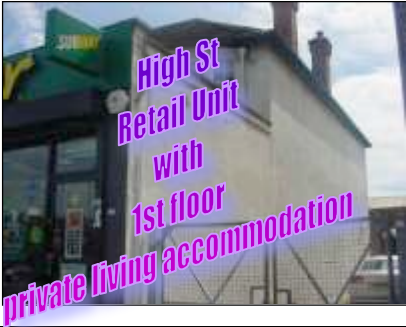
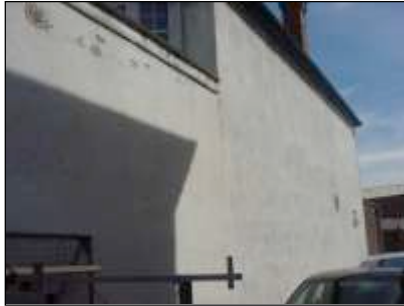
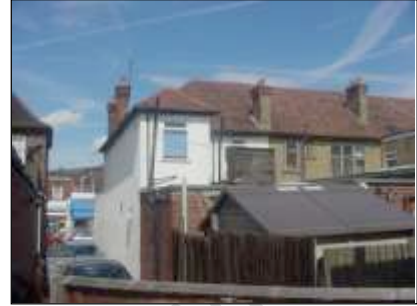
RIGHT HAND EXTERNAL ELEVATION

DESCRIPTION	CONDITION	ACTION REQUIRED
Chimneys: See front elevation		
Roofs: Hipped, pitched, tiled (without sarking felt) limited view		See front elevation
Gutters and Downpipes: Mixture of cast iron and plastic	Cast iron - rusting	Repair cast iron gutters and downpipes and use a rust stop agent. Ensure all gutters are watertight and falling towards the downpipe. Repair and secure as necessary, ensure downpipes are clear.

<p>Walls: Painted render</p> <p>Stretcher Bond brickwork Airbricks</p>	<p>Vertical crack to right hand side running the length of the single storey extension</p>

<p>Dampness visible to the front at high level from a leaking roof.</p>

<p>Prepare, repair and redecorate.</p>
<p>External Detailing: Windows: One plastic window</p>		<p>Clean</p>

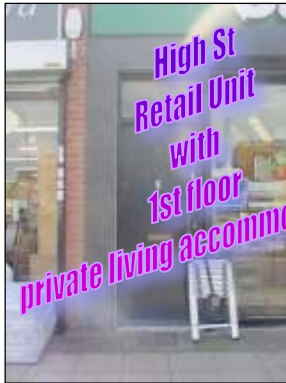
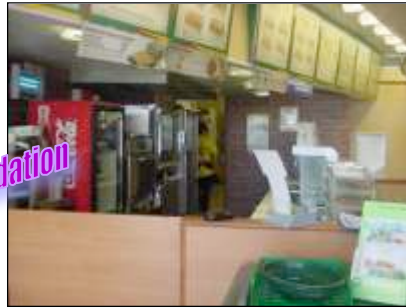
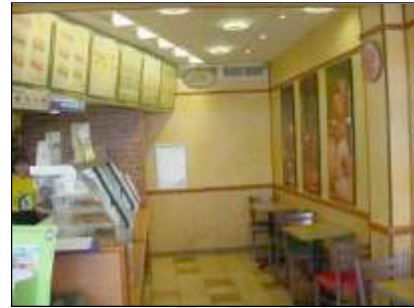
Shop Trading Area

DESCRIPTION	CONDITION	ACTION REQUIRED
Ceilings: Suspended ceiling with exposed grid	Average	
Walls: False walls/dry lined	Average, may be hiding latent defects such as damp and asbestos	Reports to be provided.
Floors: Tiled	Average	Deep clean
Detailing: Windows: Glazed shop front window Doors: Painted	Average Marked	Clean Clean

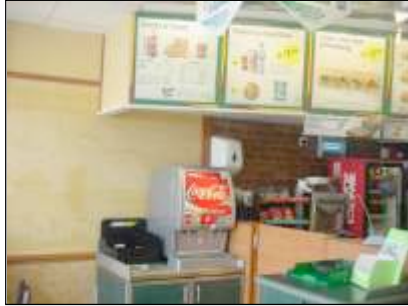
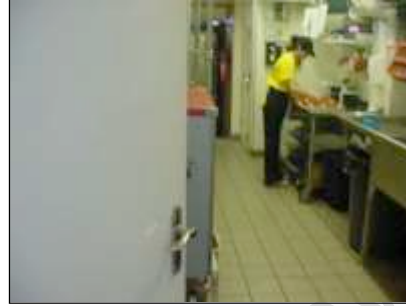
Counter area

DESCRIPTION	CONDITION	ACTION REQUIRED
Ceilings: Suspended ceiling with exposed grid	Average	
Walls: False walls/dry lined	Average, may be hiding latent defects such as damp and asbestos	Reports to be provided.
Floors: Small tiles	Average	Deep clean

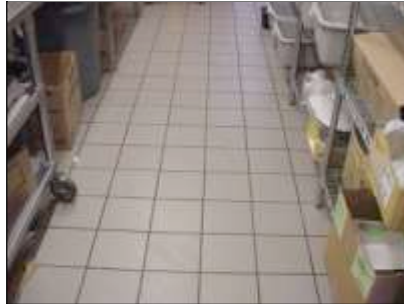
Preparation Area

DESCRIPTION	CONDITION	ACTION REQUIRED
Ceilings: Suspended ceiling with exposed grid	Average	
Walls: False walls/dry lined	Average, may be hiding latent defects such as damp and asbestos	Reports to be provided.
Floors: Small tiles	Average	Deep clean

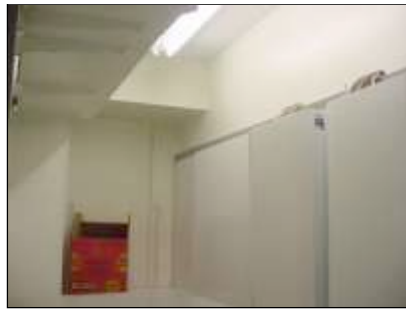
Fridge/Freezer Area

DESCRIPTION	CONDITION	ACTION REQUIRED
Ceilings: Painted plasterboard	Average	
Walls: False walls/dry lined	Average, may be hiding latent defects such as damp and asbestos	Reports to be provided.
Floors: Small tiles	Average

Deep clean

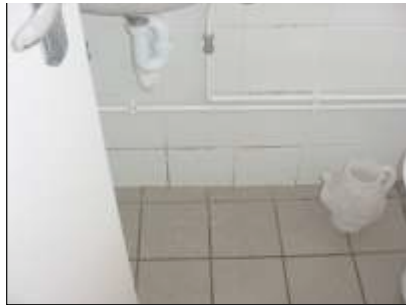
Staff Toilets

DESCRIPTION	CONDITION	ACTION REQUIRED
Ceiling: Painted	Average	
Walls: Tiles	Dampness found Possibly Rising Damp or condensation

Deep clean Stop dampness
Floors: Small tiles	Average	Deep clean
Sanitary Ware: WC and wash hand basin	Average	Deep clean
Detailing: Windows: Metal single glazed with bars	Average Bars not straight Broken pain of glass	Benefit from painting. Bars re-straighten. Replace glass

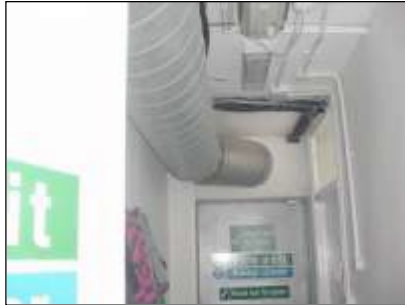
Access Corridor/Staff Area

DESCRIPTION	CONDITION	ACTION REQUIRED
Ceilings: Painted	Average	
Walls: Painted	Average Staircase not lined	Line to make fire resistant
Floors: Small floor tiles	Average	Deep clean

Services:

Electrics and Gas meter are located under the stairs. Appropriate testing required.

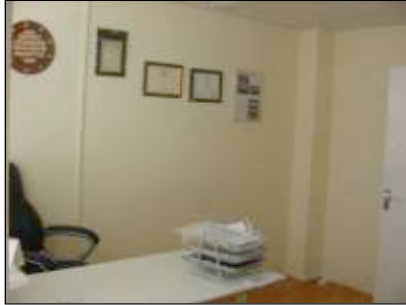
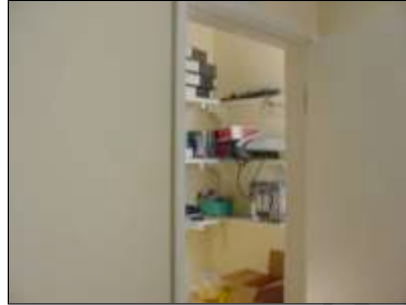
Rear Office One

DESCRIPTION	CONDITION	ACTION REQUIRED
Ceilings: Suspended ceiling with exposed grid	One broken ceiling tile	Replace
Walls: False walls/dry lined	Average, may be hiding latent defects such as damp and asbestos	Reports to be provided.
Floors: Laminate	Marked Internal manhole	Clean/replace Unable to open to inspect. Closed tv camera report required.
Detailing: Windows: Barred metal single glazed	Require redecoration and bars	Prepare, repair and redecorate

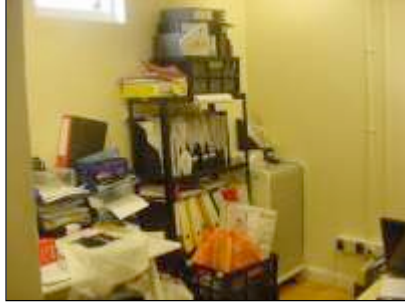
Office Two
(middle)

DESCRIPTION	CONDITION	ACTION REQUIRED
Ceilings: Suspended ceiling with exposed grid	Average	Clean/replace
Walls: False walls/dry lined	Average, may be hiding latent defects such as damp and asbestos	Reports to be provided.
Floors: Laminate	Marked	Clean/replace
Detailing: Windows: One small window	Marked	Clean

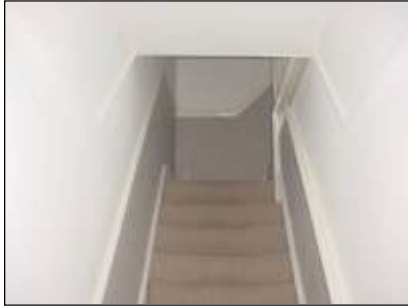
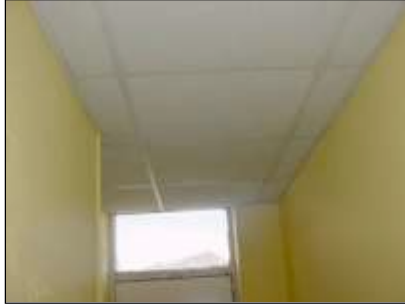
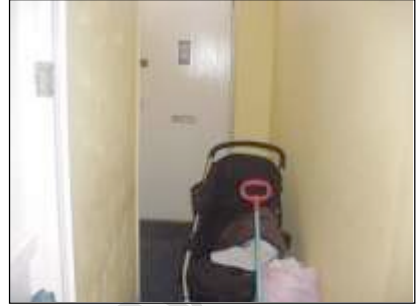
Entrance Hallway

DESCRIPTION	CONDITION	ACTION REQUIRED
<p>Ceilings:</p> <p>Suspended ceiling tiles with exposed grid</p>	<p>Dampness coming in from the flat roof above</p>	<p>Make watertight</p>
<p>Walls:</p> <p>Painted with Artex/Asbestos paint</p>	<p>Rising damp to bottom left hand side wall</p> <div style="text-align: center;">

</div>	<p>Asbestos Report required Dampness Report required</p>
<p>Floors:</p> <p>Carpet</p>	<p>Marked</p>	<p>Clean/replace</p>

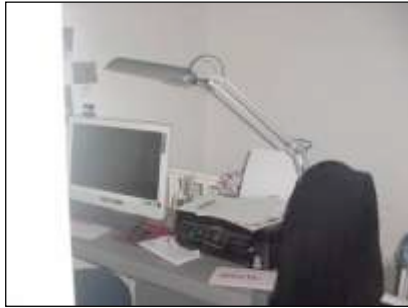
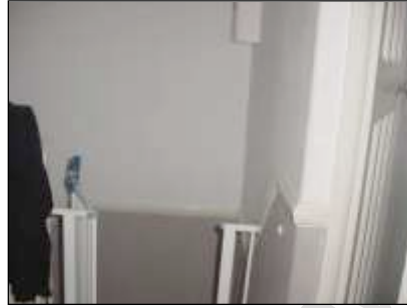
Landing currently used as an office

DESCRIPTION	CONDITION	ACTION REQUIRED
Ceilings: Access into the roof	Dated	Prepare, repair and redecorate.
Walls: Painted with Artex/Asbestos paint	Marked	Asbestos Report required
Floors: Carpet	Marked	Clean/replace

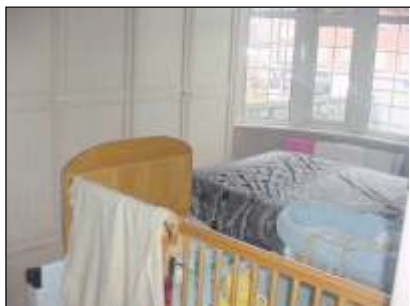
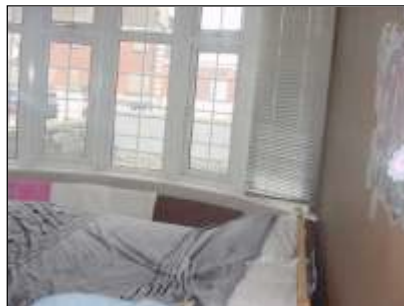
Bedroom Two
(front right hand side)

DESCRIPTION	CONDITION	ACTION REQUIRED
Ceilings: Painted	Dated Flaking paintwork

Check if bay window roof is leaking and make watertight if found to be leaking. Prepare, repair and redecorate.
Walls: Painted	Marked	Prepare, repair and redecorate.
Floors: Carpet	Marked	Clean/replace
Detailing: Windows: Plastic double glazed	Marked, leak to Bay window at the front of the property.	Make watertight. Clean
Built in Cupboard: running the length of right hand side wall	Could be hiding dampness, this is the area where the crack in the building is present

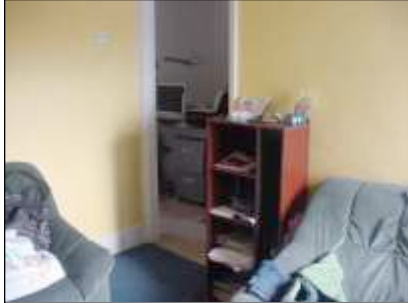
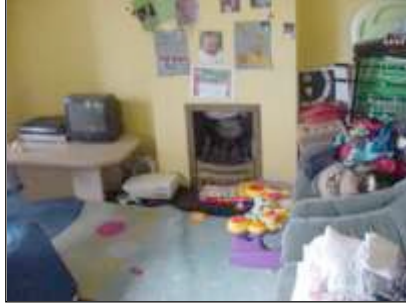
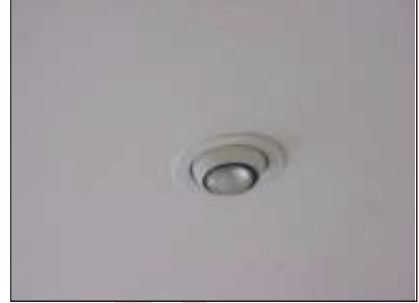
Lounge (middle)

DESCRIPTION	CONDITION	ACTION REQUIRED
Ceilings: Painted	Dated	Prepare, repair and redecorate.
Walls: Painted	Marked	Prepare, repair and redecorate.
Floors: Carpet	Marked	Clean/replace
Detailing: Windows: Timber	Deteriorating	Prepare, repair and redecorate.
Lighting: Older style 1970s ceiling lights		Replace

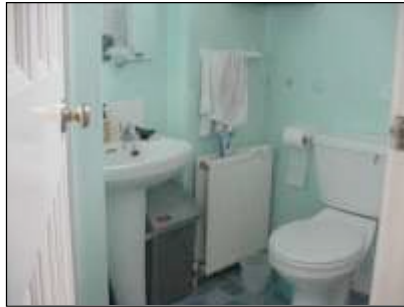
Shower room

DESCRIPTION	CONDITION	ACTION REQUIRED
Ceilings: Painted	Dated	Prepare, repair and redecorate.
Walls: Painted and tiles Tiles	Dampness and mould visible Dirty

Services:		
Extract Fan:	Dated	Overhaul/replaced

Remove mould Prepare, repair and redecorate. Deep clean
Floors: Carpet	Marked	Replace
Sanitary ware: WC, wash hand basin and shower	Marked	Deep clean
Detailing: Windows: Timber	Deteriorating	Prepare, repair and redecorate.

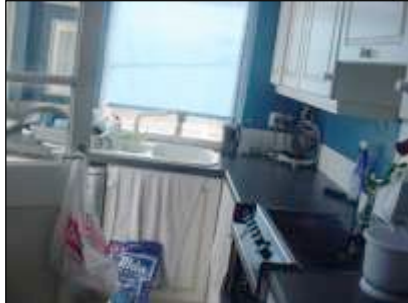
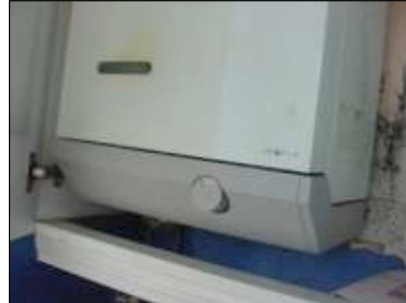
Kitchen
(rear)

DESCRIPTION	CONDITION	ACTION REQUIRED
Ceilings: Painted	Average	Repair, prepare and redecorate
Walls: Painted	Average	Repair, prepare and redecorate
Floors: Vinyl	Average	Clean and/or replace
Detailing: Windows: Doors: No door	Black mould from condensation No door

Remove mould. Repair windows, prepare and redecorate Replace door
Kitchen Equipment: The domestic equipment has not been inspected. Advised area cold
