# PROPERTY REPORT AND NEGOTIATION DOCUMENT

XXXXXXXXXXXXX,  
XXXXXXXXXXXXXXXXXXXXX,  
XXXXXXXXXXXXX,  
XXXXXXXXXXXXX,  
Hampshire,  
XXXXXXX

INDEPENDENT CHARTERED SURVEYORS

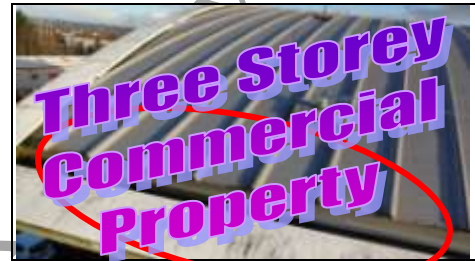
We can see that there is water damage and deterioration occurring underneath the domed roofs that are on both the left and the right of the property. We have not been on the roof but this usually relates to poor detailing and/or poor workmanship and/or poor materials. We feel that in this case it may be due to the box gutter detail allowing water into the property. Also, the edge of the roofing material looks to be delaminating.

Deterioration to end of sheets of domed roof on front left

**ACTION REQUIRED:** We recommend works in relation to the domed roof are excluded from the lease. We do not see any easy way of removing your liability other than excluding these areas from the lease.

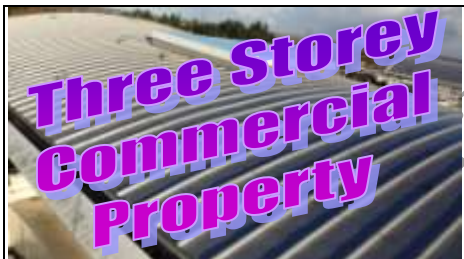
General view of dome on left side with old atrium. Atrium covering is very flat, we would expect water to impregnate in this area over the course of the lease

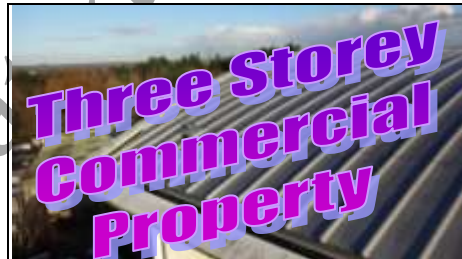
Discoloring to corner indicating water damage

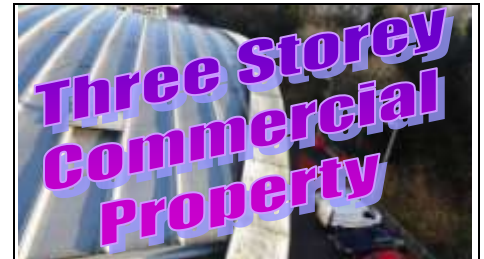
Ends of roofing panels coming away

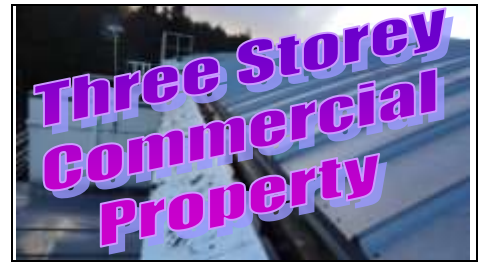
The domed roofs discharge into box gutters that run along the perimeter of either side of the property. These can be problematic and dampness looks to be getting into the building via these as well.

Debris and water sitting in box gutter on domed roof

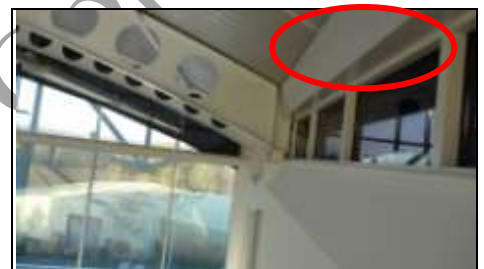
It looks like there has been high level repair work carried out so this is a known about problem.

Dots in corner where roof has been replaced at high level

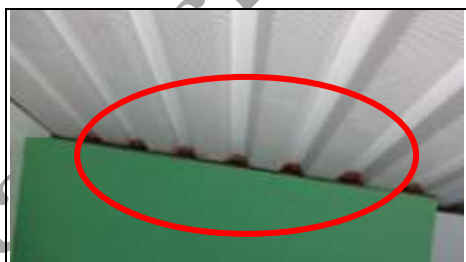
To several areas of the dome we can see repair work, for example to the corners expanding foam has been used. Our concern is this may have been with regard to repairs of the roof or leaks in the area.

Expanded foam

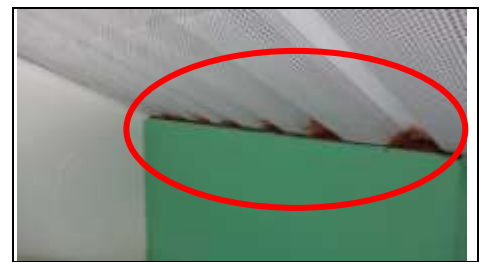
Marks where roof meets wall looks to be expanded foam

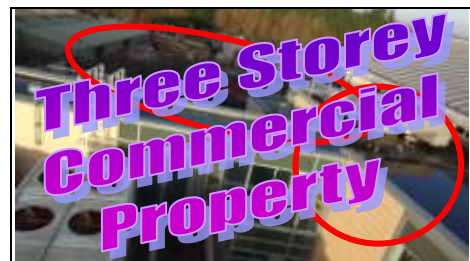
Leak to narrow roof over corridor  
Also ponding to flat roof

**ACTION REQUIRED:** In our experience we find there are problems with mono-ply/single ply roofs. We also feel they are particularly difficult to repair and water can also get into them for some time without it being visible externally/internally and this is a major problem and risk when taking on a property like this.

We would recommend removal of the entirety of the mono-ply roof, re-laid to falls, insulation added as appropriate to create the fall and a three layer felt system using a high performance elastomeric felt to replace it.

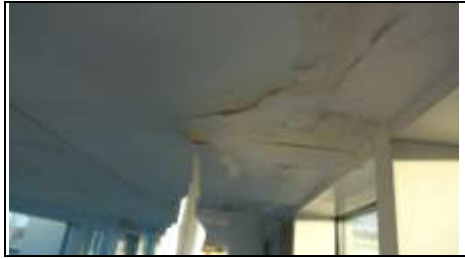
Leaks in corridor under flat roof

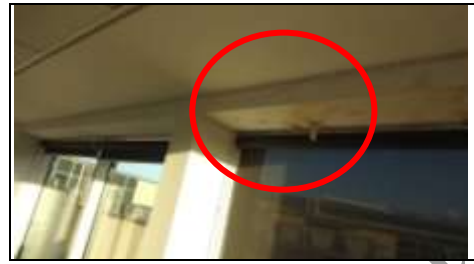
Leaks coming into property from flat roof

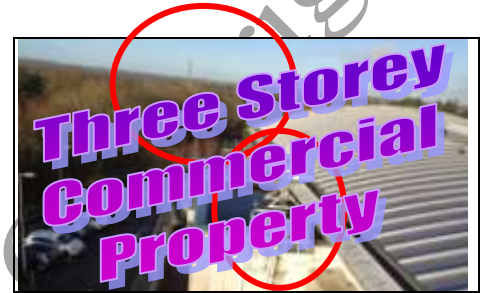
There are no obvious walkways adjacent to access the roof areas, etc so in addition foot traffic will tend to damage the single-ply system when any roofs are accessed.

Ladder access with no protected walkway

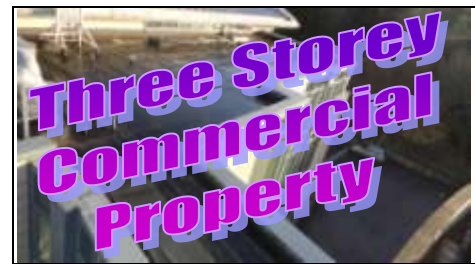
There looked to have been an attempt at some sort of protection of the mono-ply next to the man safe cable system in some areas and of course note the ponding.

This would be extremely difficult work due to the air conditioning units. Also, from what we can see, a man safe system will need to be added. Attention should also be given to the flashings and detailing to ensure they are watertight. We recommend this is excluded from the lease.

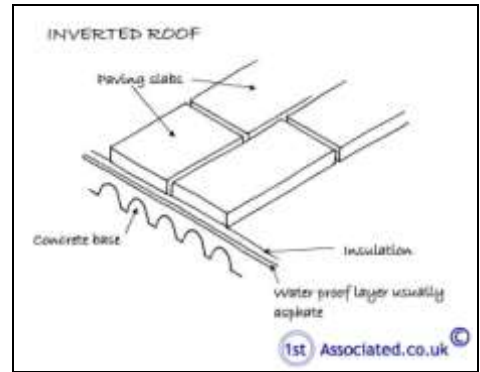
The balcony areas use an inverted roof system as far as we can see. An inverted roof is where the pavers cover the actual roof and there is normally a pea shingle or pebble infill to perimeters which allows access to the roofs. On a sunny day these areas can be quite pleasant, on rainy days they can allow water to sit on them and vegetation grow and ultimately this water then gets into the roof structure. We can see areas where vegetation is growing and sooner or later this will get into the building.

Inverted roof

**ACTION REQUIRED:** We would recommend that the inverted roofs are excluded from the lease as well as again water could already be in the structure; you have no way of knowing without opening up the structure.

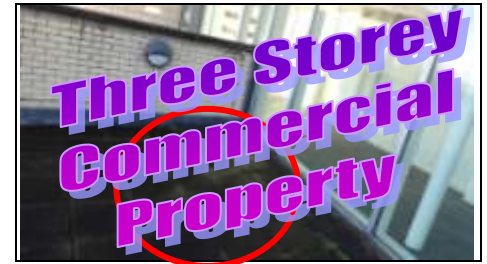
Vegetation growing on inverted roof

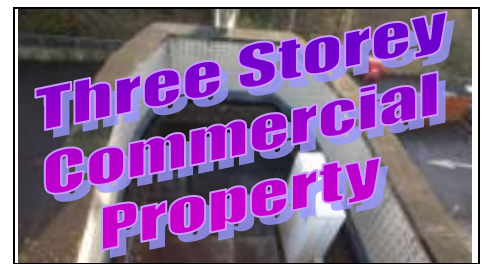
The inverted roof to the rear centre is an unusual inverted roof as it is almost inaccessible due to the air conditioning.

Inverted roof rear centre

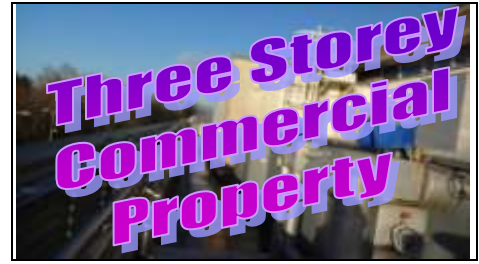
Inverted walkway used as walkway

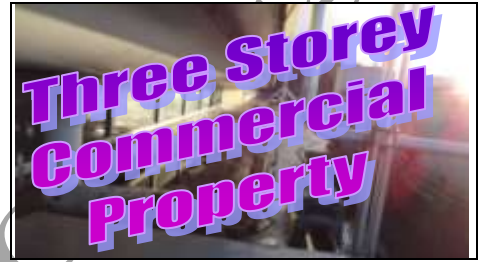
Rainwater from left domed roof discharging onto flat roof with nowhere to go as far as we could see

**ACTION REQUIRED:** Review all the rainwater goods.

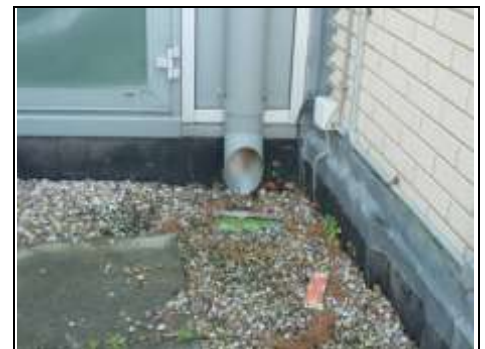
Rainwater pipe discharging onto inverted roof with no obvious flow path

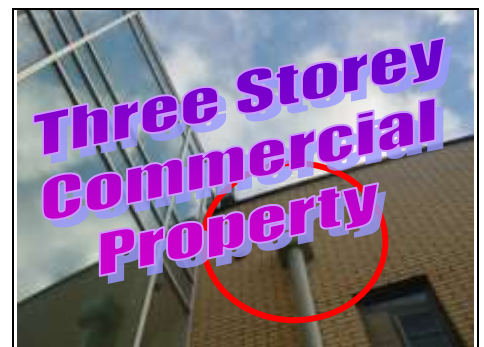
Some of the hopperheads seem to not be able to cope with the rainwater and this is leaking into the building. This can be seen generally throughout the building for example in the restaurant area and the link corridor area.

Hopperheads not able to cope with rainwater

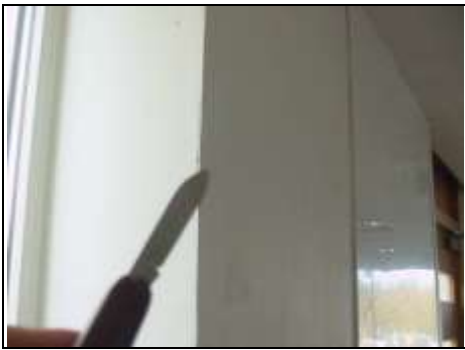
Dampness in restaurant

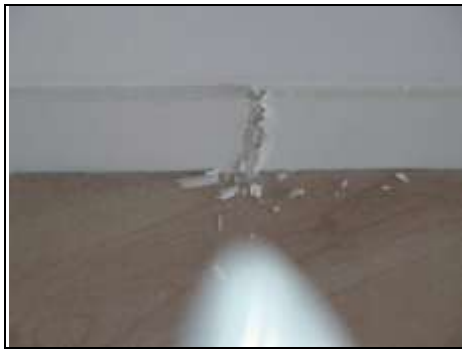
Dampness in skirting of restaurant

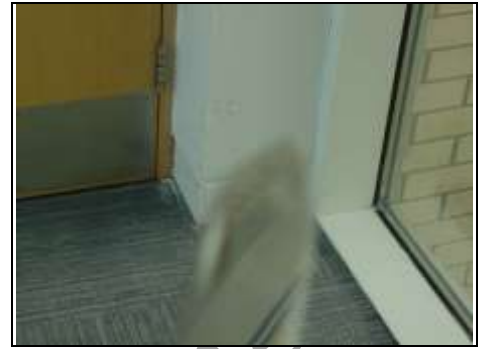
Dampness in first floor corridor from leaking hopperhead

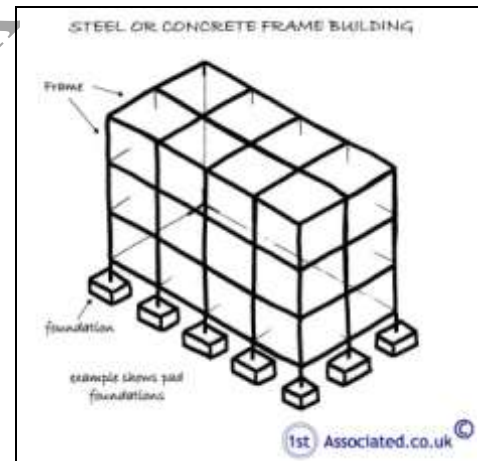
For example in this case under each of the canopies to the left and right roofs there is a tubular metal frame which is rusting.

Structural frame

**ACTION REQUIRED:** Generally we need to open up the structure to comment further, but specifically with regards to the tubular metalwork and indeed any metalwork that is rusting it needs work as soon as possible to stop the rusting as these are structural members and then it needs regular redecoration. Obviously if you can see rust as you can at the moment it is past its decoration date.

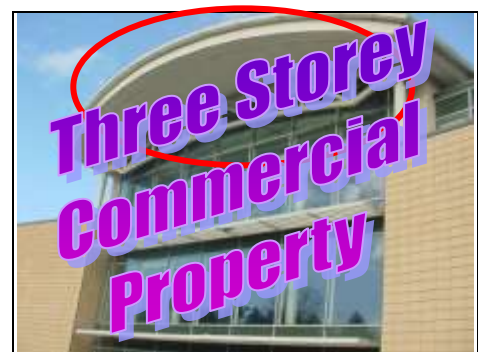
Tubular metal frame

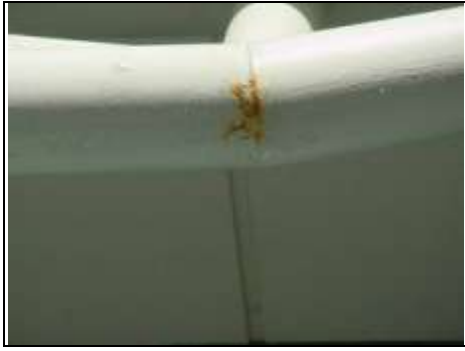
Rusting to tubular steel

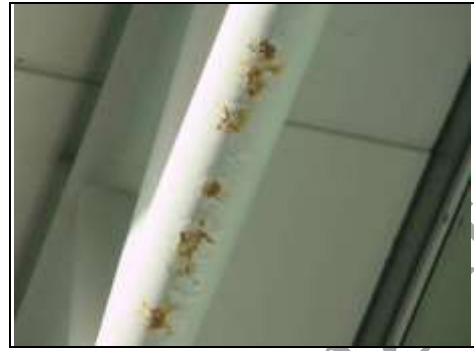
Rusting to tubular metal frame

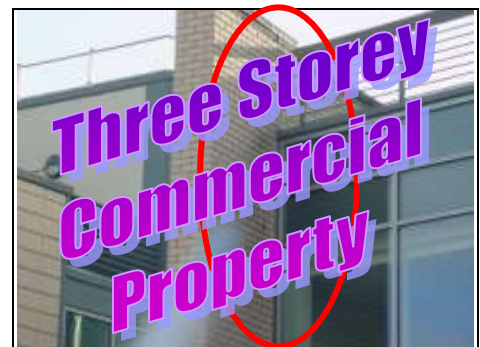
Moss to brickwork and pattern staining to front

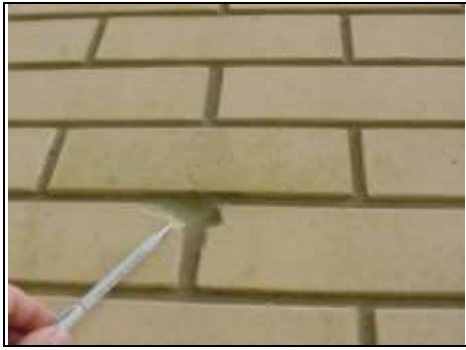
Damage to brickwork

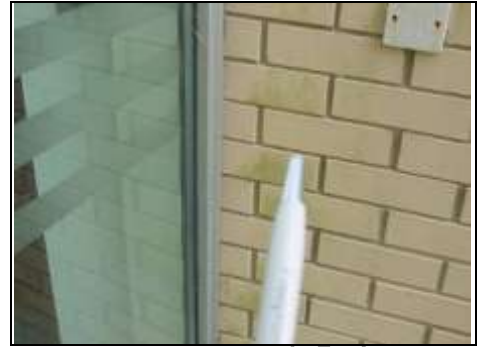
Moss impregnated into brickwork

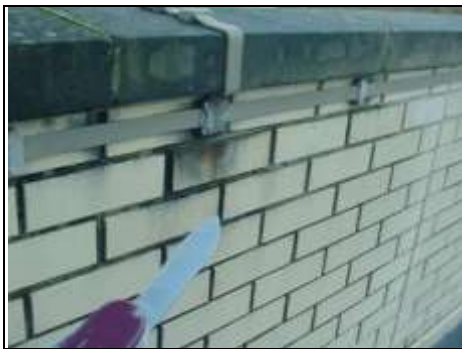
The top of the brickwork in some instances is protected with a coping stone. There are problems with this and it looks to be leaking at points or it could be that the drip details are incorrect.

Example of coping stones joints leaking

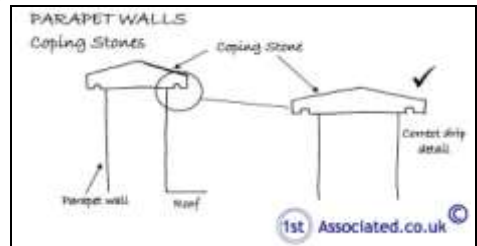
Drip details to coping stones

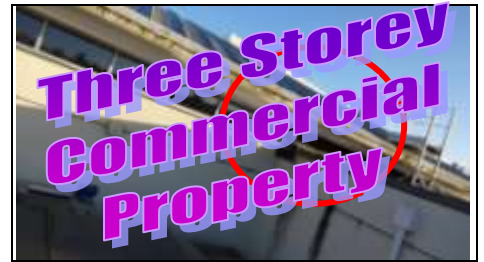
We could see the parapet wall was discharging onto the render. We have not opened up these areas however modern render tends to be cement based, fairly brittle and also relatively thin compared with renders of the past and damage and deterioration with cracking or any water getting into them can cause failure.

Parapet wall discharging onto render

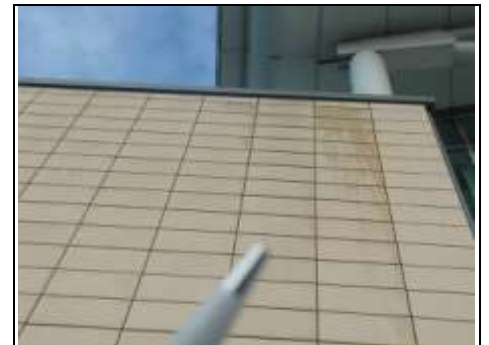
Rainwater going down rain cladding from coping above

**ACTION REQUIRED:** The areas will need cleaning or else they will look unsightly, particularly where there are parapet wall details above which is discharging onto the brickwork and glazed curtain walling beneath.

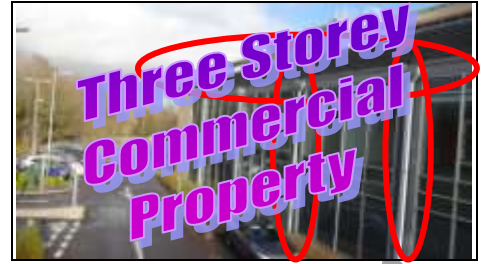
There are profile metal sheets at high level and also a vent type system. In the case of the main profile metal sheets they are starting to degrade, we could see some joints starting to open up and there is general weathering to the metal. We were not sure whether this metalwork has been sprayed before or cleaned; certainly something has happened to it. This is noticeable in particular behind where the downpipes are the weathering of the profile metal sheeting.

Profile metal sheets and vents

**ACTION REQUIRED:** This may be related to the box gutter leaking and the downpipes leaking or it may have been that it has been sprayed and it is a difficult area to spray. Either way we think the gauge thickness of the paint is very thin and that redecoration will be needed during the course of your lease and that it will be very difficult. We recommend this is excluded from the lease.

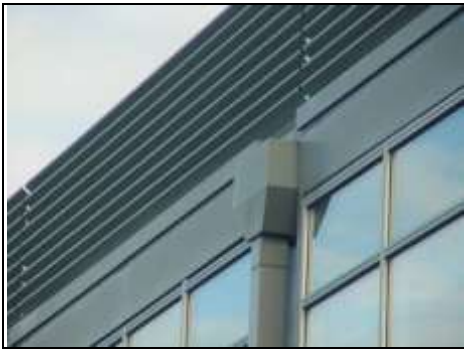
Close up

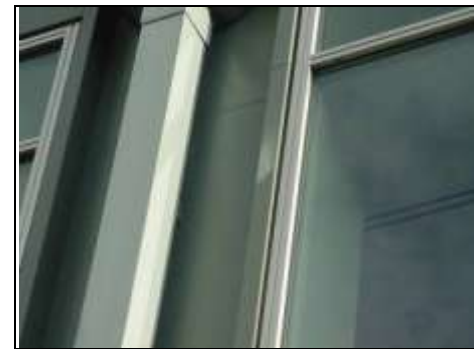
Weathering to metal or it has been resprayed and missed an area

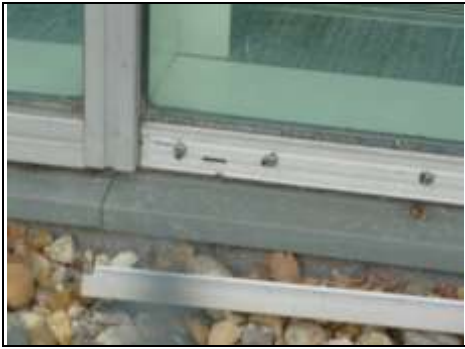
Displaced

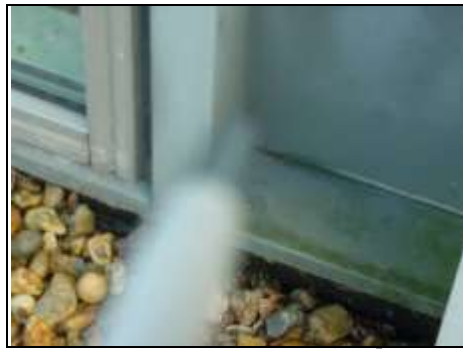
Moss on sill

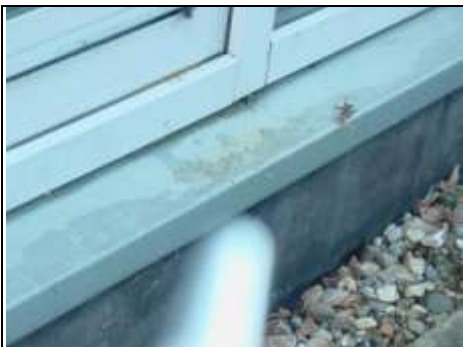
Rust to sill

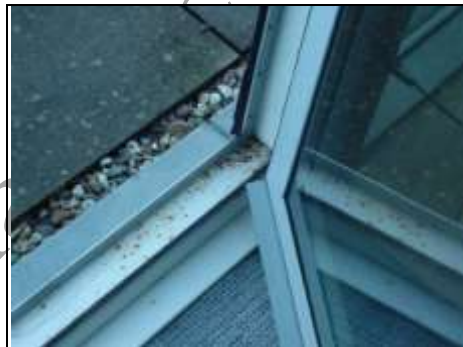
Rust spots to door

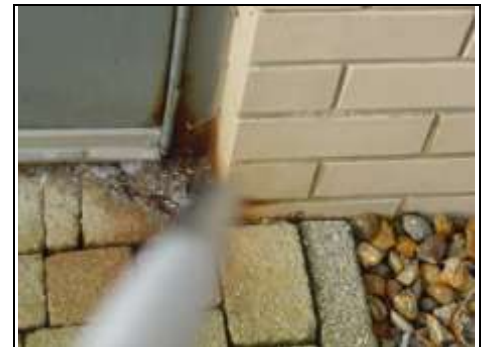
Rusting

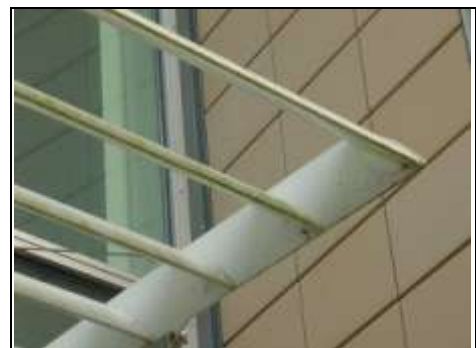
There are sunshades to many of the windows which have moss on them.

Sunshade

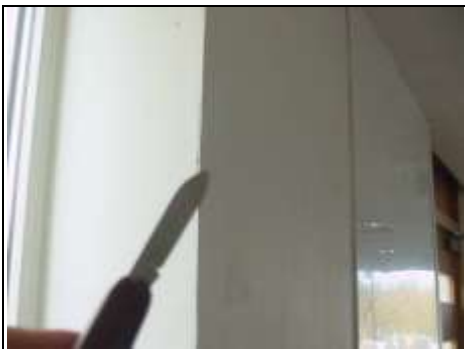
Unfortunately we feel this is a design fault with the hopperheads, possibly the roofing as well and the copings. We believe the hopperheads are allowing water to discharge down the building and this is then soaking in through the wall structure.

Dampness in restaurant

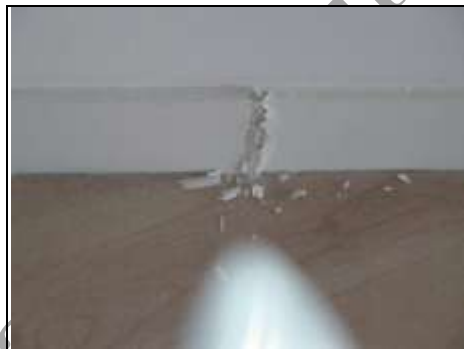
Dampness in skirting of restaurant

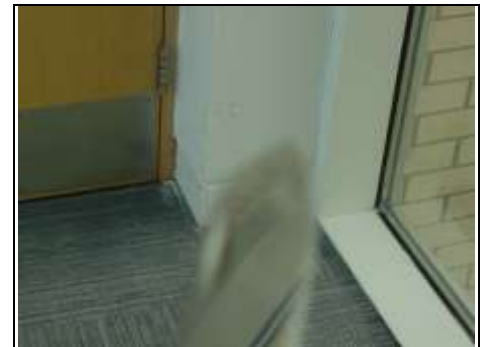
Dampness in first floor corridor from leaking hopperhead

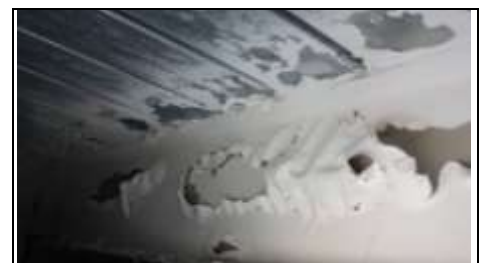
We believe this relates to flat roof failure. Please see our comments with regard to problems with the roofs and the difficulty in resolving the problems. We feel the roofs should be excluded from the Full Repairing and Insuring lease and any associated damage. We noted in particular to the left hand second floor office that the water damage was so bad it had affected most of the room. It was causing the fire protective paint to perish. Our concern is

Paint perishing on top floor

that there may be areas where the fire protection has been damaged and this has not been seen and there may be other areas where other damage is occurring unseen.

**ACTION REQUIRED:** We would recommend that every room ceiling is inspected, lifting the ceiling tiles or thermal imaging the area to establish any problems.

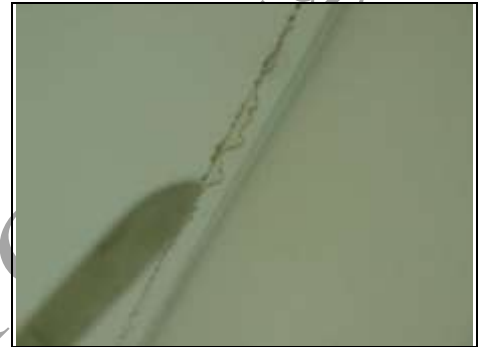
With so much water getting into this building there is some movement visible internally, for example we can see to the right hand corner movement visible internally. Our concern is that continued water ingress into this property will cause structural damage to it. There are already elements visible such as the tubular steels to the domed roof that are rusting. This leads us to believe there has been a lack of general maintenance on the property and effectively it will be soaking the water up like a sponge, which is never good for a building.

Cracking to ceiling ground floor front right

**ACTION REQUIRED:** We would exclude all of the roofs and any cracks that become visible in this property we feel should be carried out as part of either landlords works or as an insurance claim by the landlord. We feel that the landlord should, as part of your lease agreement, place an insurance claim with his insurers and/or take appropriate legal action with the companies involved in this building.

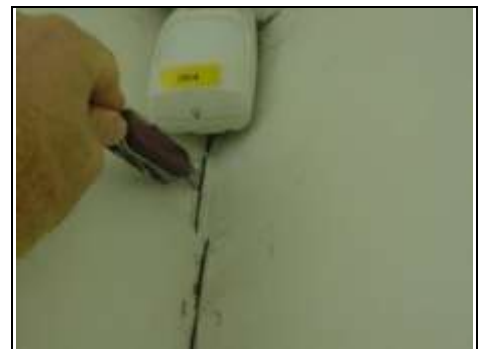
Cracking to wall ground floor front right

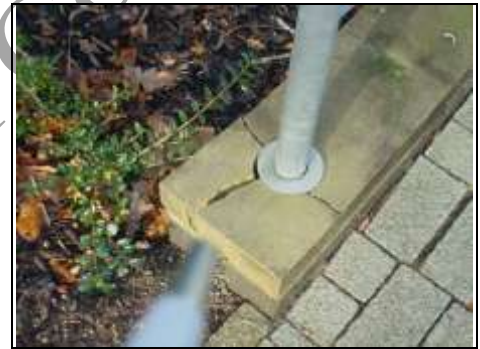
Damage to ramp access

**ACTION REQUIRED:** You need to ensure that the external areas are also excluded appropriately from the lease.

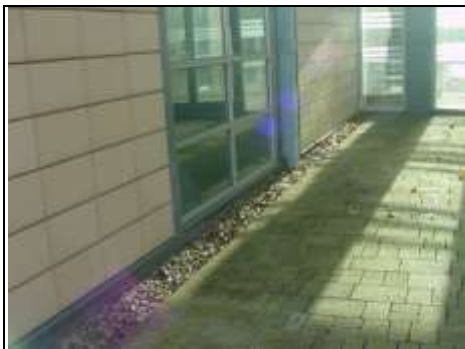
Moss to paved area at front

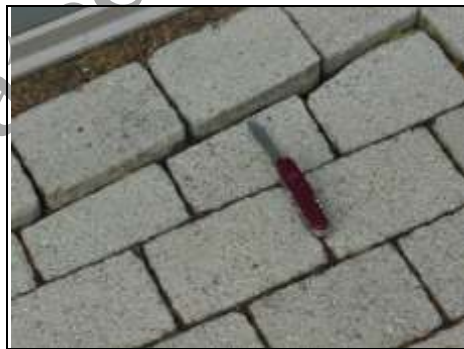
Unevenness in external cobbles

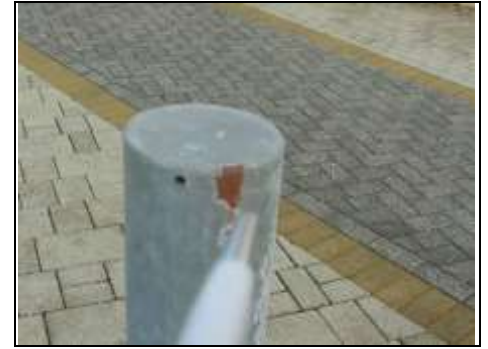
Bollard rusting

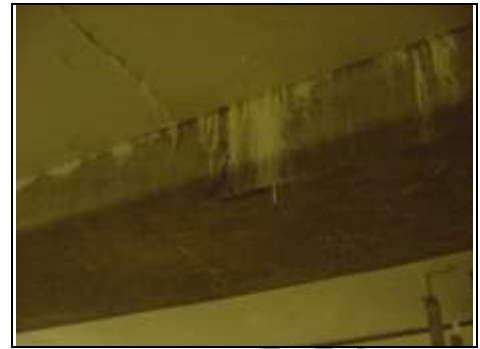
There looks to be long term leaks within the car park as we can see stalactites and also can see there are areas of staining, etc to the ceiling of the underground car park which leads us to believe there have been long term problems with leaks.

Stalactites

**ACTION REQUIRED:** Exclude any leak damage from the lease.

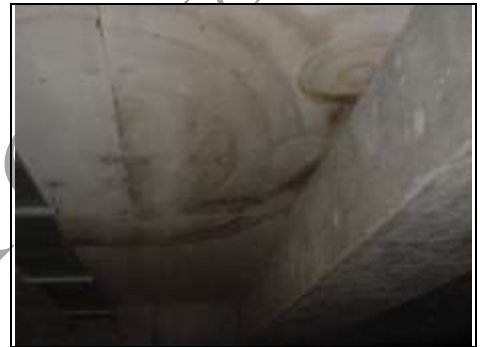
Staining to concrete
