# PROPERTY REPORT

**Warehouse  
XXXX  
XXX Erith,  
Kent. DA8 XXX**

We have been instructed to inspect and prepare a Report and Schedule of Condition for XXXX, Erith, Kent. DA8 XXX

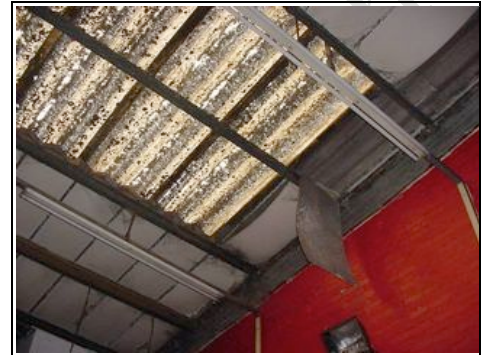
from your lease and/or you need the landlord to produce an asbestos report and confirm that the asbestos is safe. We can see areas where the asbestos is exposed and is being deteriorated due to the defects in the roof detailing.

Asbestos roof taken from internally

Please note we are not asbestos surveyors. You do need specialists to carry out this type of work.

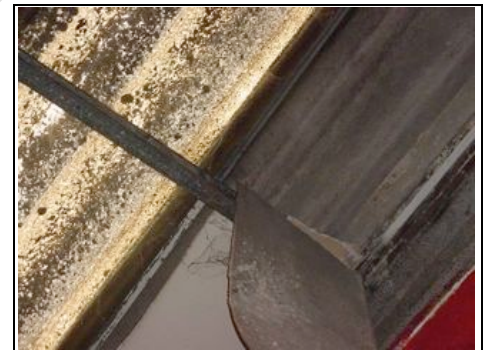
Close up of asbestos sheet on roof

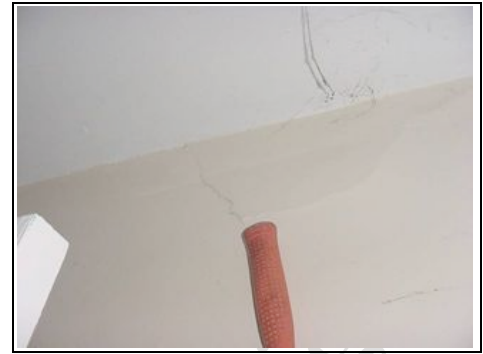
Due to the movement that is occurring there is an above average number of areas where the plaster is cracking or blown (lost its bond). We can see that the problems are long term and that previous repairs have been carried out.

Internal cracking in toilets

**ACTION REQUIRED:** You need to exclude the damage that exists in the property via a Schedule of Condition. We would also recommend that the landlord redecorates before you access the property which would be the normal way things are carried out with the last lease holder having the responsibility to redecorate.

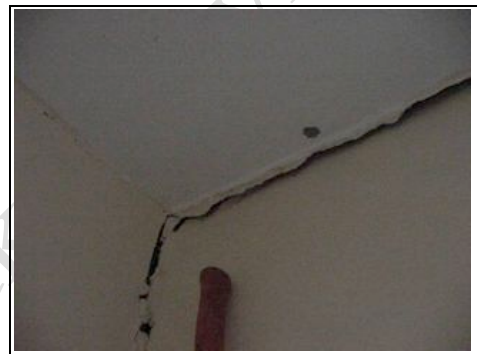
Cracking between wall and ceiling in hallway

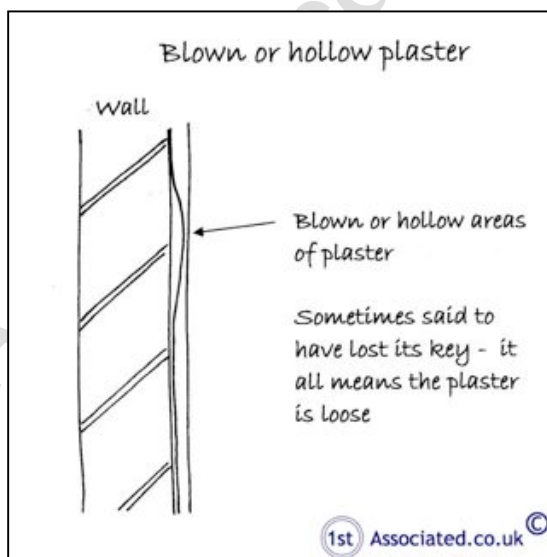
Blown or hollow plaster

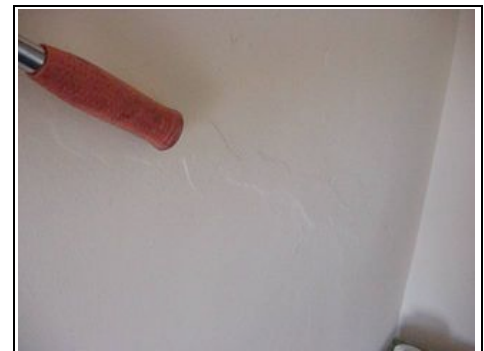
Repair to cracking in hallway

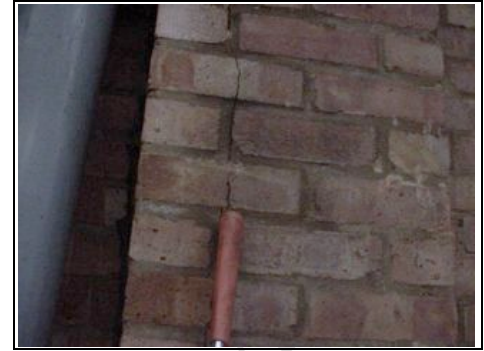
Please see our comments within the High Priority section of this report. Due to the roof leaking there has been deterioration to the metal frame structure and we could see where the structural columns are encased there is cracking to this indicating that there may be rust behind it to the metal frame.

Cracking in warehouse

**ACTION REQUIRED:** This needs to be excluded from the lease.

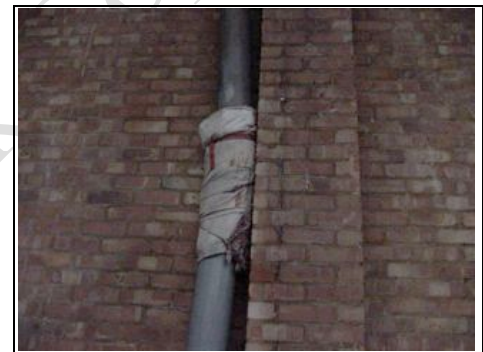
Cracking around columns in warehouse

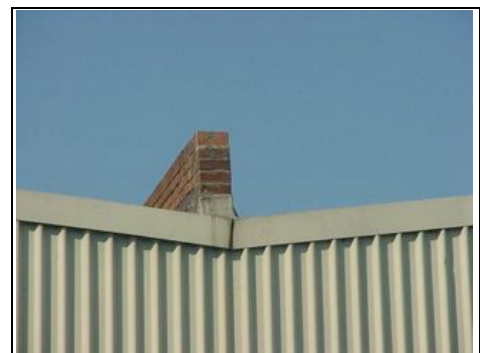
There also looks to have been problems with the parapet walls allowing water in as we can see that one has been capped. Having said that both parapet walls are weathered and require re-pointing as well as one of them needing a metal capping to be added.

Parapet wall which is weathered and looks to have had a repair to the flashing and needs new flashing and coping stone

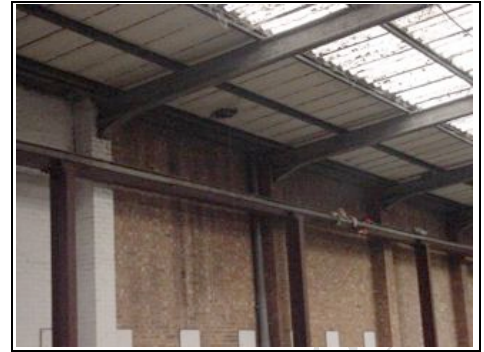
If you look at the walls carefully  
you can see the staining to the walls

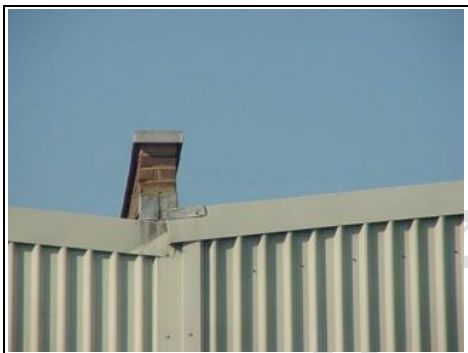
Parapet wall that has a capping  
added that still looks to be leaking.

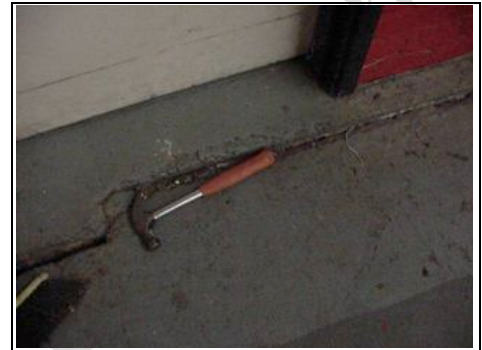
Unfortunately from our one off inspection we are not able to be conclusive as to what the problem relates to and we suspect it may relate to the retaining wall to the front of the property and the heavier weight within this property due to the lifting equipment 3.2 tonnes device.

Floor subsidence to the front toilets

If you were looking to purchase this property we would be saying to buy another property. This certainly needs to be excluded from your lease and we would also only advise taking on the property if the landlord can offer a programme of repairs to the floor.

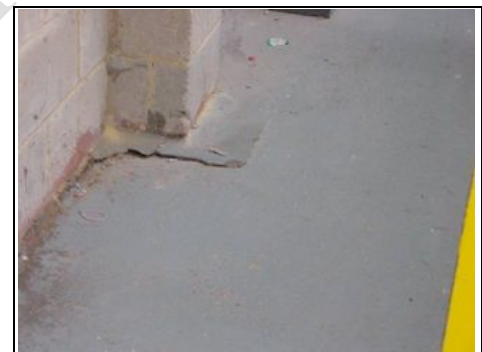
Post Office warehouse subsidence to the rear

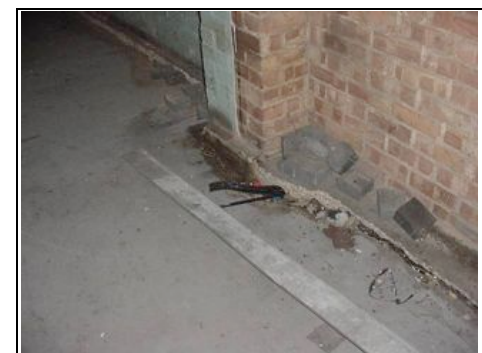
Floor subsidence to the rear of the warehouse

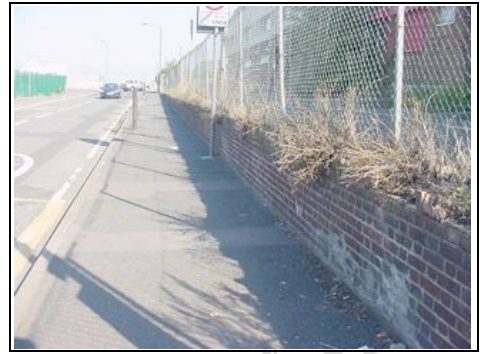
Retaining wall indicates that built up land has been used in this area

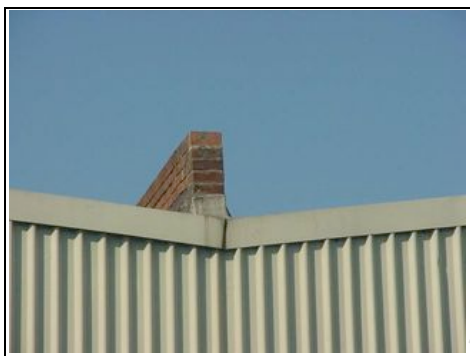
Please see our comments in the Executive Summary. The left hand side parapet wall (all directions given as you face the property) looks to be in poorer condition than the right hand side parapet wall but from what we can see both are leaking.

Left hand side parapet wall

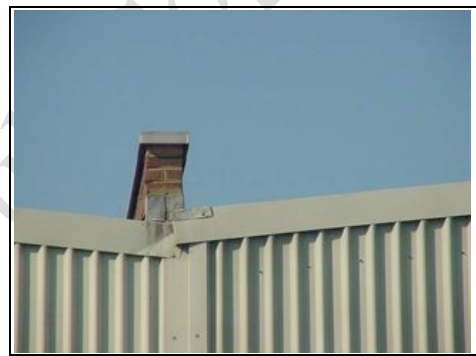
Right hand side parapet wall

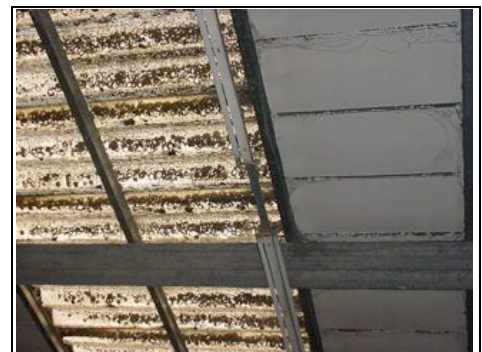
**ACTION REQUIRED:** We would normally expect the roof lights to have been cleaned. We could also see some staining to the concrete below indicating that they are leaking.

GRP roof light in need of cleaning

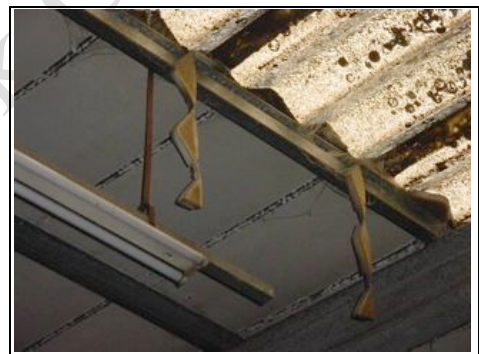
We opened up the suspended ceilings in the right and left offices and unfortunately we were unable to see the made ceiling but we were only able to see previous suspended ceiling tiles. We did however note leaks in the office areas shown by staining to the tiles.

Ceiling tiles in place, note the water damage around the suspended ceiling units

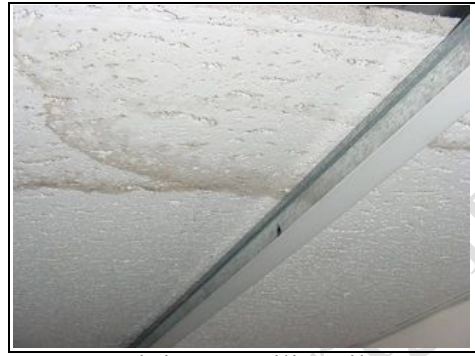
Staining to ceiling tiles

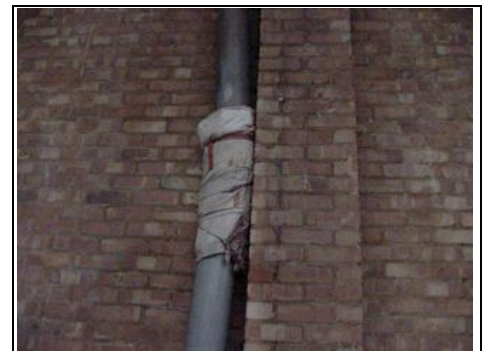
The property's gutters and downpipes are in very poor condition and we feel you should think about replacement.

DIY repair to downpipe

**ACTION REQUIRED:** The valley gutters and the downpipes need to be made water tight and the piers need to be opened up to check that there is no rusting to the metal frame.

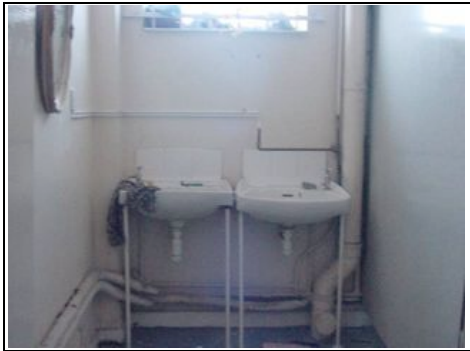
The property has internal soil and vent pipes set within the toilets. Some of the soil and vent pipes have been damaged, as mentioned the property looks to have been occupied and used as accommodation and has been left in a poor condition.

Ladies toilets internal soil and vent pipe

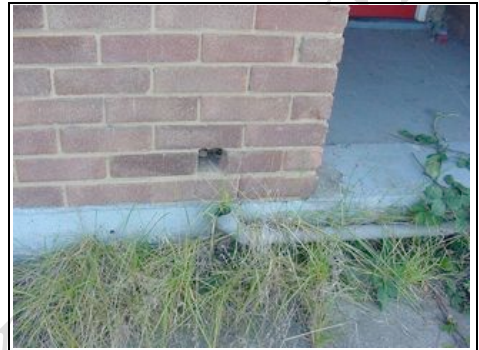
Drainpipe not connected

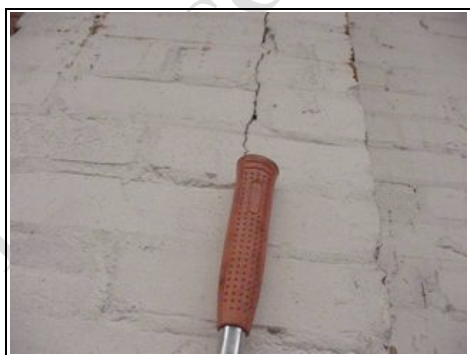
Our concern is that the roofs have been leaking and that rusting is starting to occur to the steel frame. We can see that cracking is occurring to some of the internal piers.

The hammer handle indicates where the cracked line is to the pier

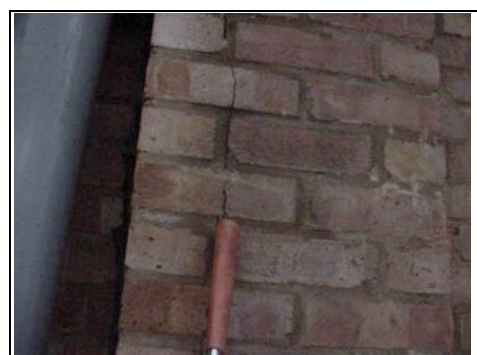
Hammer handle again indicating where the cracked line is

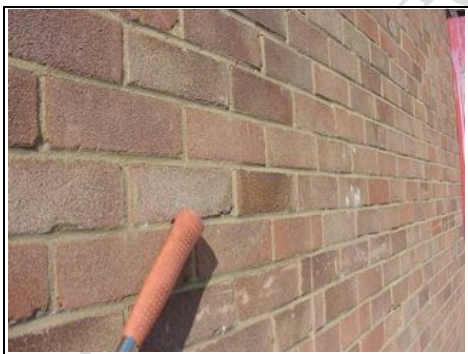
There are numerous cracks to the brickwork, far beyond what we would normally expect to see.

There is cracking to brickwork

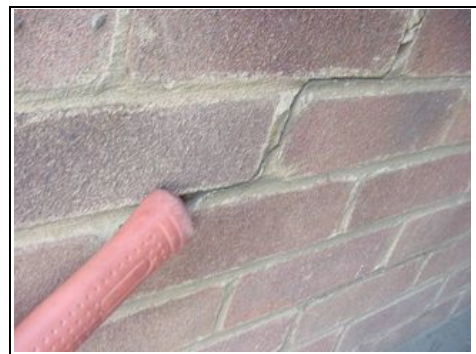
Cracking to brickwork

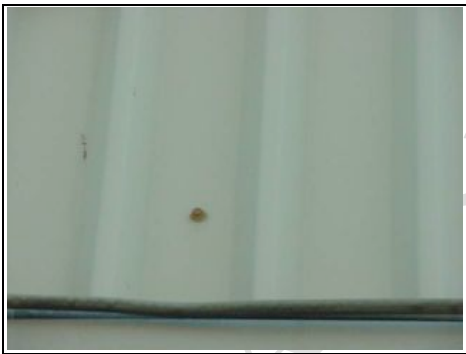
At high level there is metal profile cladding which we noted that the fixing bolts are starting to rust. In addition we noted that in some areas the face of the profile sheeting has been impact damaged. Furthermore in some areas the profile sheeting has been scuffed.

Rusting fixing bolts

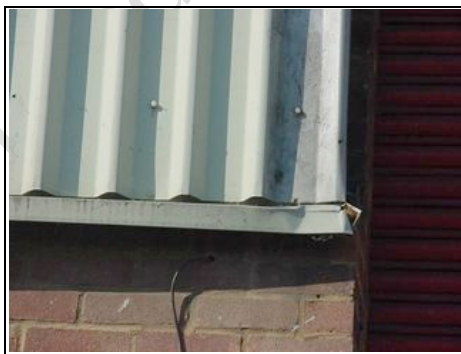
Impact damaged profile sheeting

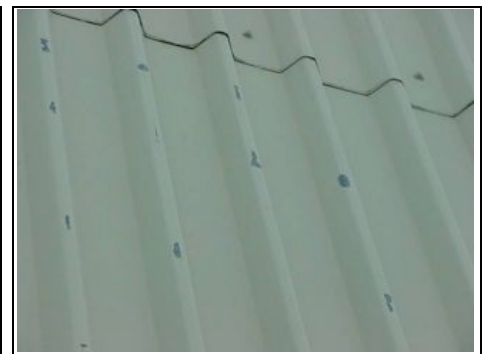
Scuffed metal profile sheeting

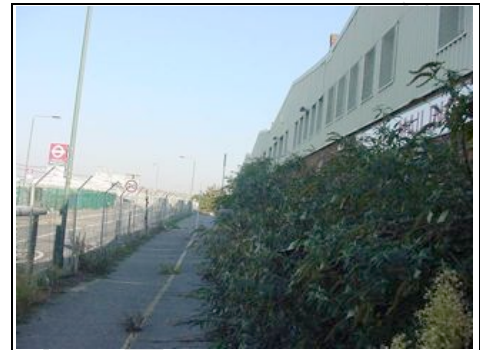
There are no trees within influencing distance of the property. There is however vegetation and bushes growing close to the property which is not ideal.

Vegetation

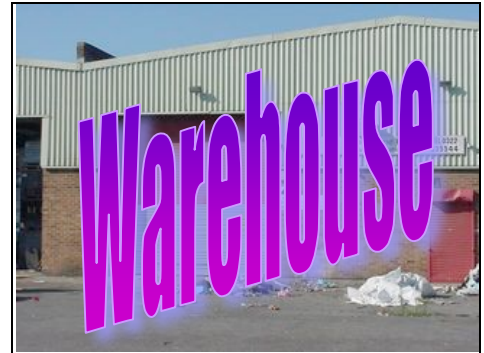
We have not tested the metal roller door delivery access. We would bring to your attention that security shutter box to the people entrance is damaged to the rear of the property.

Metal roller shutter doors

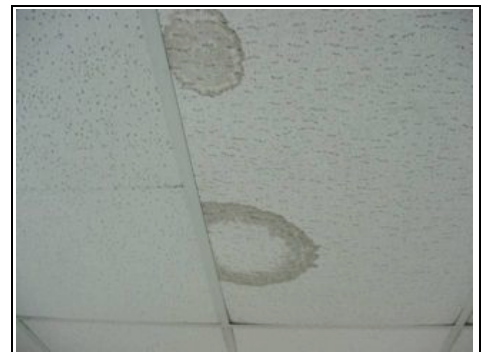
The ceilings are a suspended rectangular ceiling system to the office areas and a square suspended ceiling system to the right hand office. Behind the ceiling tiles is an older rectangular system. We would comment that there is no insulation and as such therefore you will be heating up the entire warehouse in this area which is not ideal with rising fuel costs. We would also draw your attention to the fact that the stains to the ceiling tiles may relate to condensation.

Dampness to ceiling tiles

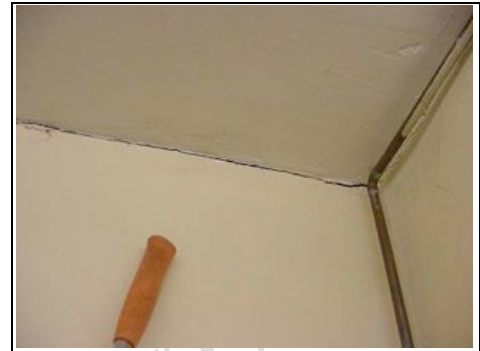
To the ground floor partitions there are structural cracks.

Partition dropping Kitchenette

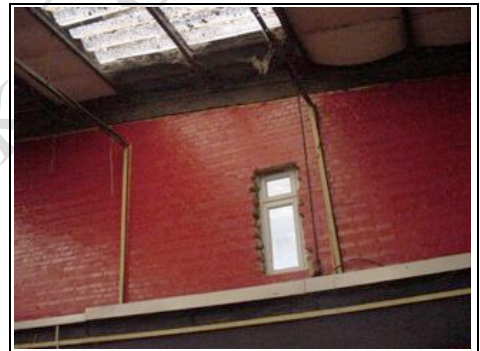
Block broken through to form window not been made good

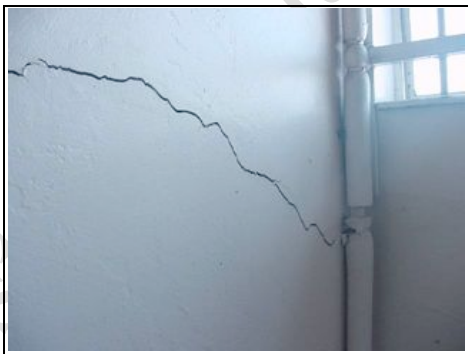
Cracks ground floor partition

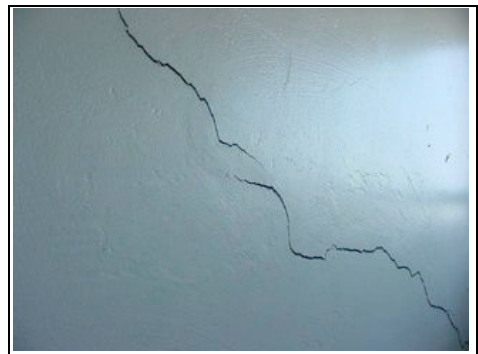
Cracks ground floor partition
