SCHEDULE OF CONDITION

INDEPENDENT CHARTERED SURVEYORS

We have been instructed to inspect and prepare a Schedule of Condition for
xx.

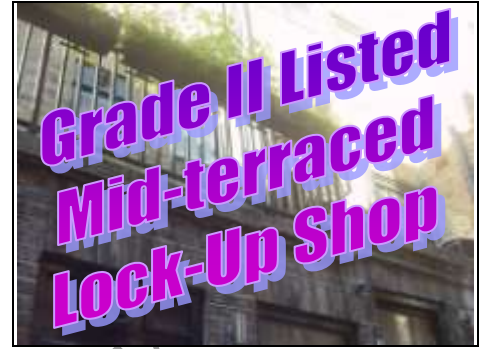
Rear entrance

DESCRIPTION	CONDITION	ACTION REQUIRED
Roofs: Hidden roof – which we believe to be a Butterfly roof. Low level flat balcony roof	A leak is occurring in side believed to be from flat roof

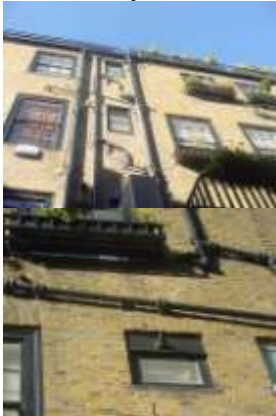
See front elevation Subject to Local Authority Approval.
Gutters and Downpipes: Cast iron Cast iron soil and vent pipe We viewed the gutters from ground level	Dated and dirty

Ensure all gutters are watertight and falling towards the downpipe and clear. Repair downpipes and secure as necessary, ensure downpipes are clean and clear. Subject to Local Authority Approval.

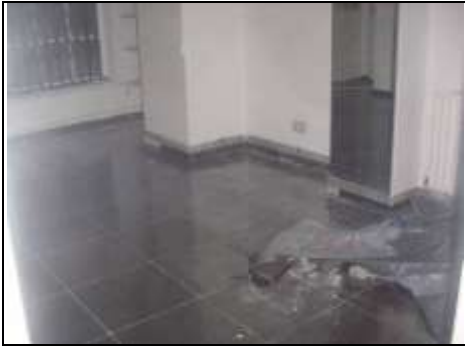
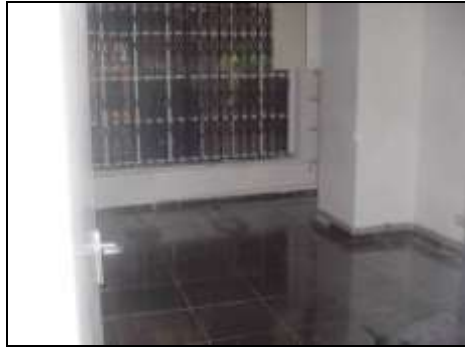
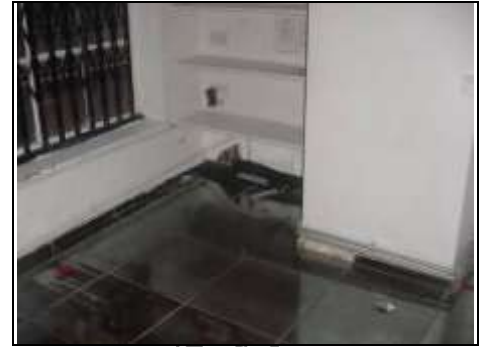
Rear Area

DESCRIPTION	CONDITION	ACTION REQUIRED
Ceiling: Painted plasterboard	Signs of water damage believed to be from flat roof above

Repair, prepare and redecorate
Walls: Painted Perimeter walls Solid Internal walls Studwork Pilasters and beams	Dated	Repair, prepare and redecorate.
