SCHEDULE OF CONDITION

Wandsworth

We have been instructed to inspect and prepare a Schedule of Condition for
XXXXXXXXXXXXXXXXXXXXXXXXXXXX Wandsworth XXXXXXXXXXXX.

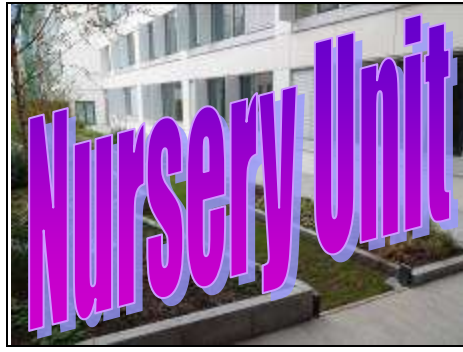
Front wall

DESCRIPTION	CONDITION	ACTION REQUIRED
<p>Rain cladding panelling</p>    	<p>Marked and puckered</p>   <p>Difference in joint thickness</p>   <p>Poor detailing to rain cladding metal return</p>  	<p>Clean</p>

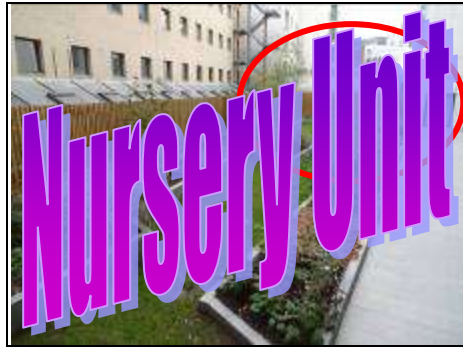
Left side

DESCRIPTION	CONDITION	ACTION REQUIRED
<p>Rain cladding: Small area of wall clad with rain cladding and double door</p>

<p>General marking and pucker</p>

<p>Make good</p>
<p>Metal double door with pre-finish and pair and a half of hinges and small metal sill</p>	<p>Pattern staining</p>

<p>Deep clean</p>
	<p>Old fixing points</p>

Re-stain
--	--	----------

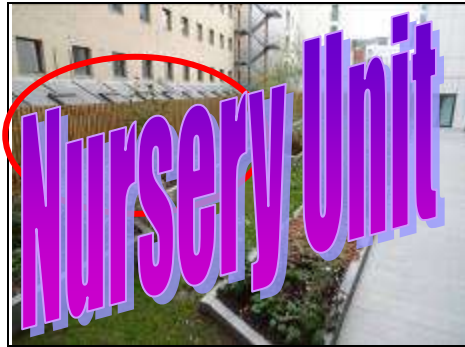
Rear fence

DESCRIPTION	CONDITION	ACTION REQUIRED
<p>Rear fencing: Wooden fence with vertical slats to perimeter</p>  	<p>Mortar splashes</p>

<p>Ground at high level, likely to be dampness</p>   <p>Mortar splatters on brickwork</p>

<p>Clean and re-stain</p>
<p>Rear brickwork Small area of stretcher bond brickwork wall in yellow brick with cement mortar</p>

<p>Clean</p>

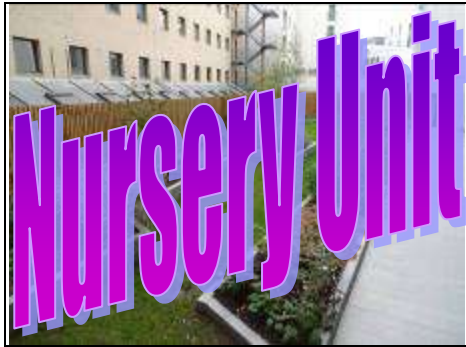
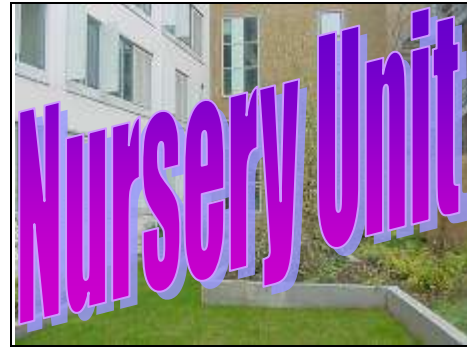
DESCRIPTION	CONDITION	ACTION REQUIRED
<p>High plant bed:</p> <p>High plant bed with reconstituted stones surrounding</p>  	<p>Reconstituted stones marked and mud marks and mortar splashes</p>   <p>Marked</p>

<p>Dry jointed, variation in dry joint thickness of between 1mm and 10mm</p>

<p>Clean</p>

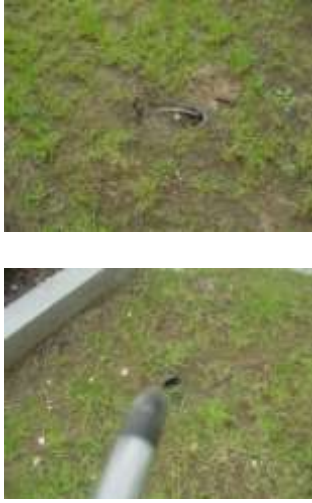
Grassed area:	Areas of cable conduit exposed	Safely seal

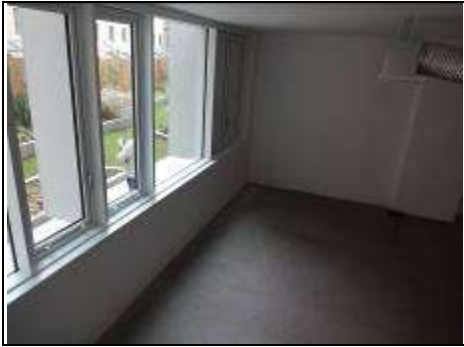
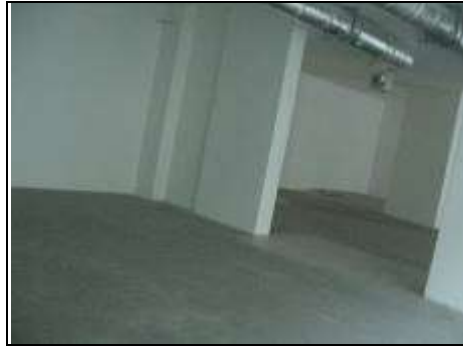
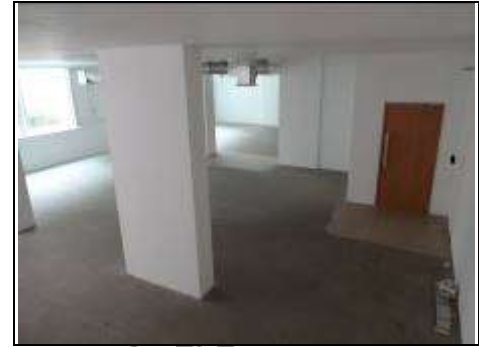
DESCRIPTION	CONDITION	ACTION REQUIRED
<p>Ceilings:</p> <p>Concrete painted white</p>	<p>Shuttering joints visible</p>

<p>Make good and redecorate</p>
<p>Walls:</p> <p>Painted white dry lined walls to external walls, solid on internal walls</p>	<p>Marked at low level, damage to base of wall near windows</p>

<p>Gap between wall and concrete floor</p> <p>Marked</p>	<p>Repair, prepare and redecorate</p>
<p>Floors:</p> <p>Finished concrete floor</p> <p>Left door</p> <p>Junction of internal and external</p>	<p>Minor marks and dirt</p> <p>Crack in concrete floor near where right and left room meet</p>

<p>Screed added where it joins the left room and exit door.</p>

<p>Similar ground levels will be susceptible to dampness and rainwater coming in</p>

<p>Marked</p>	<p>Repair, prepare and redecorate</p>

<p>Clean</p> <p>Make good</p> <p>Add fall</p>

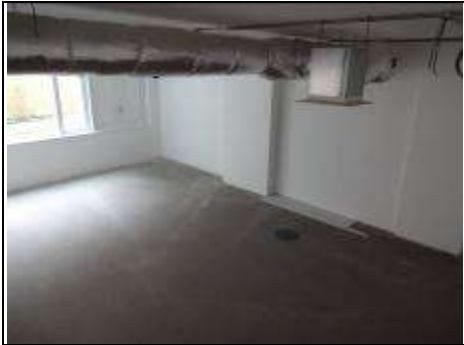
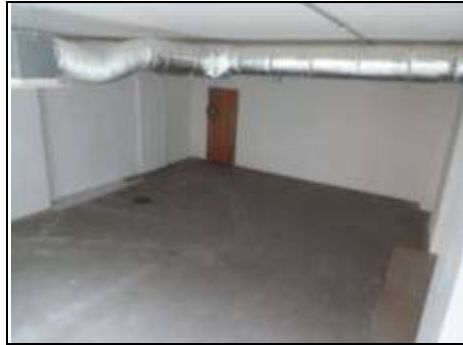
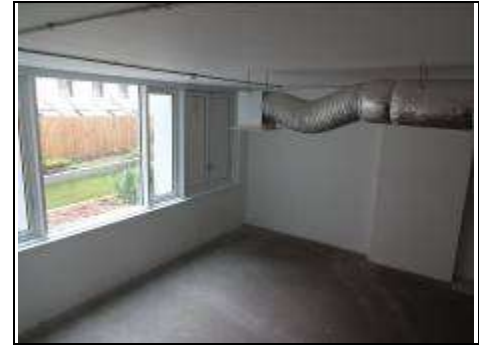
DESCRIPTION	CONDITION	ACTION REQUIRED
<p>Ceilings:</p> <p>Concrete painted white</p>	Shuttering joints visible	Make good and redecorate
<p>Walls:</p> <p>Painted white dry lined walls to external walls, solid on internal walls</p>	<p>Marked at base</p> <p>Damage to plaster finish to base near door to left</p>

<p>Repair, prepare and redecorate</p> <p>Make good</p>
<p>Floors:</p> <p>Finished concrete floor</p> <p>Concrete floor near where right and left room meet</p>	<p>Minor marks and dirt</p> <p>Crack</p>

<p>Clean</p> <p>Make good</p>

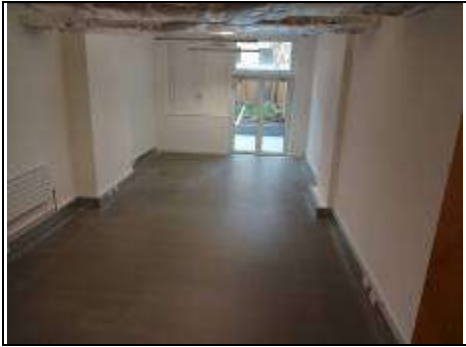
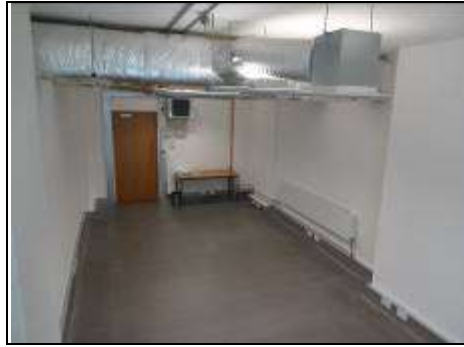
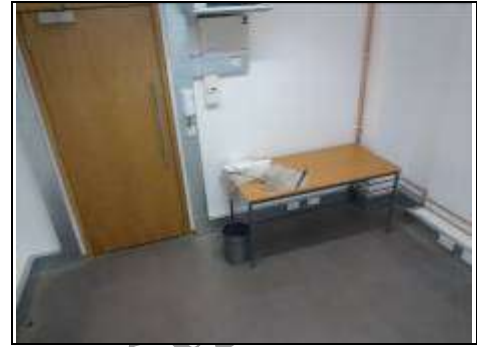
DESCRIPTION	CONDITION	ACTION REQUIRED
<p>Ceilings:</p> <p>Concrete painted white</p>	<p>Shuttering joints visible</p> <p>Damage</p>  	<p>Make good and redecorate</p>
<p>Walls:</p> <p>Painted</p>	<p>Marked</p>   <p>Fixtures and fitting adjacent to the door</p>	<p>Repair, prepare and redecorate</p> <p>Remove</p>

<p>Floors:</p> <p>Finished concrete floor</p> <p>Internal door area</p>	<p>Minor marks and dirt</p> <p>Cracking adjacent to internal door side</p>  	<p>Clean</p> <p>Make good</p>
<p>Detailing:</p> <p>Windows:</p> <p>Shutter windows (internal shutter and vents to outside)</p>   <p>Doors:</p> <p>Double exit doors to perimeter wall (adjacent to rusting running gully)</p>   <p>Door entry system</p> <p>Internal timber door to corridor</p>	<p>Average</p> <p>Mastic discoloured on shutter windows</p>   <p>Average</p>   <p>Average</p>	<p>Clean and make good mastic</p> <p>Clean</p> <p>Clean</p>

<p>One internal radiator</p>		<p>See Services Section</p> <p>Box in exposed pipework and add radiator cover</p>
---	--	---

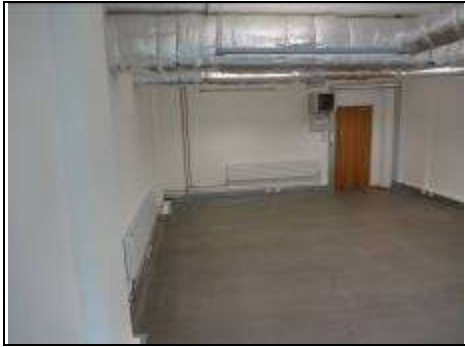
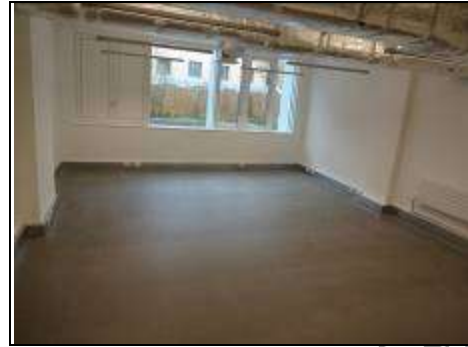
DESCRIPTION	CONDITION	ACTION REQUIRED
Ceilings: Concrete painted white	Shuttering joints visible	Make good and redecorate
Walls: Painted	Minor marks Hairline cracks adjacent to column

Fixtures and fitting adjacent to the door	Repair, prepare and redecorate
Floors: Finished concrete floor	Minor marks and dirt Crack in floor adjacent to internal door	Clean

<p>Crack in floor to left side</p>

<p>See Services Section</p> <p>Box in exposed pipework and add radiator cover</p>

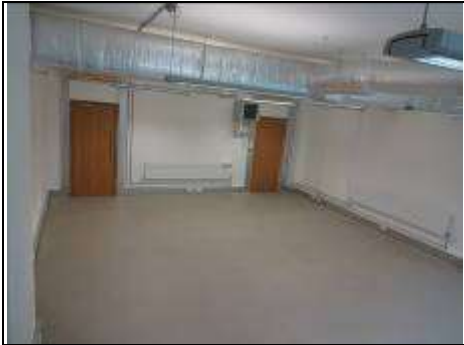
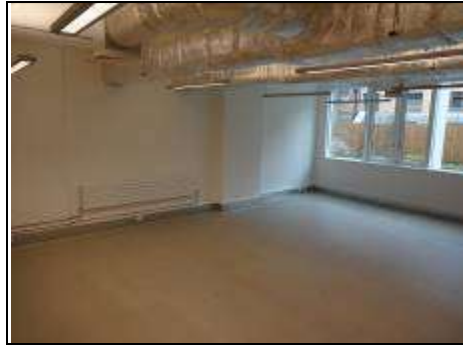
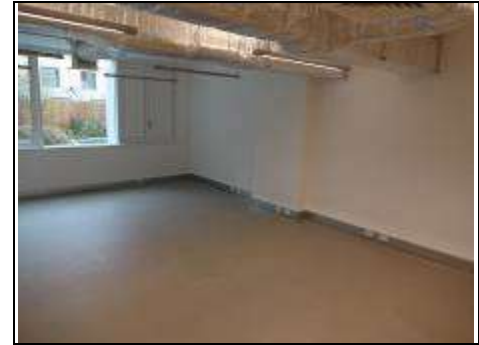
DESCRIPTION	CONDITION	ACTION REQUIRED
Ceilings: Concrete painted white	Shuttering joints visible Marked	Make good and redecorate
Walls: Painted	Minor marks	Repair, prepare and redecorate
Floors: Finished concrete floor	Minor marks and dirt	Clean
Detailing: Windows: One shutter window (internal shutter and vents to outside) Window	Average Average	Clean Clean

<p>Doors:</p> <p>Two internal timber doors</p> <p>Door entry system adjacent to left door</p>	<p>Average</p>	<p>Clean</p>
<p>Services:</p> <p>Two air conditioning units and ductwork</p> <p>Eight ceiling lights</p> <p>Two internal radiators</p> <p>Service ductwork conduit running around perimeter at skirting level</p>		<p>See Services Section</p> <p>Box in exposed pipework and add radiator cover</p>

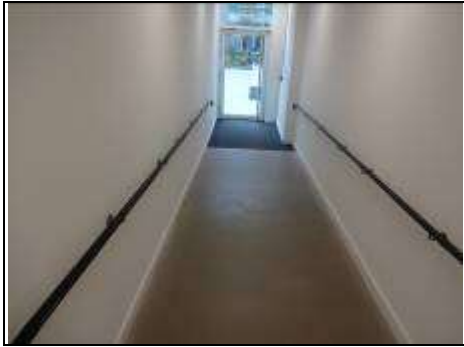
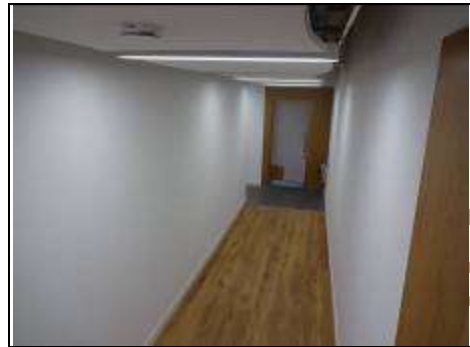
DESCRIPTION	CONDITION	ACTION REQUIRED
<p>Ceilings:</p> <p>Part suspended ceiling</p> <p>Above suspended ceiling is concrete</p>	<p>Section unfinished, pattern staining to concrete and marks around shuttering</p>

<p>Old fixing points</p> <p>Not painted</p> <p>Shuttering joints visible</p>	<p>Finish ceiling</p>

<p>Walls:</p> <p>Painted</p>	<p>Minor marks</p>   <p>Hairline cracking</p>  	<p>Repair, prepare and redecorate</p>
<p>Floors:</p> <p>Finished concrete floor</p> <p>Timber laminate with timber skirting</p> <p>Ramp leading to open area with two handrails and metal covering</p>	<p>Minor marks and dirt</p>	<p>Clean</p>
<p>Detailing:</p> <p>Doors:</p> <p>Two doors with timber surrounds</p> <p>Glass door with two pairs of hinges and vision panel above (no. 1 marked on wall adjacent to it)</p> <p>Door not accessed</p>	<p>Average</p>	<p>Clean</p>
<p>Services:</p> <p>Fire alarm equipment</p>		<p>See Services Section</p>
