SCHEDULE OF CONDITION

We have been instructed to inspect and prepare a Schedule of Condition for xxxxxxxxxxxxxxxxxxxxxxxxxxxx. We inspected the property on xxxxxxxxxxxxxxxx.

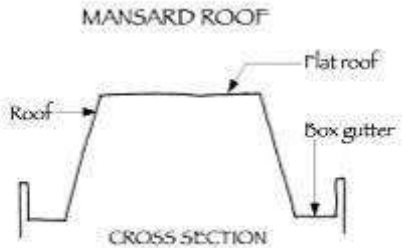
<p>Front of mansard</p>

<p>Limited view of roofs from ground level</p>	<p>Water getting in front right corner</p>

<p>Upper areas are normally shared liability. If that is the case here then joint high level inspection with the landlord's surveyor to be carried out prior to signing of the lease or legal completion of the lease from high level cherry picker or equivalent.</p>

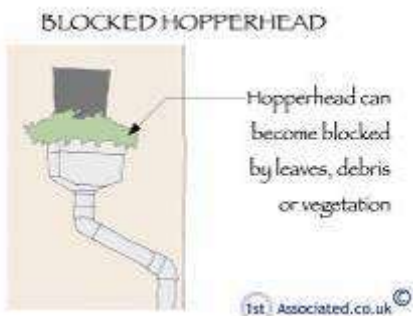
<p>Blocked hopperhead</p> <p>Hopperhead can become blocked by leaves, debris or vegetation</p> <p>We viewed the gutters from ground level.</p>	<p>Plastic hopperhead</p>

<p>Joint high level inspection of the guttering with the landlord's surveyor to be carried out prior to signing of the lease or legal completion of the lease from high level cherry picker or equivalent. See Main Roof.</p> <p>Ensure all gutters are watertight and falling towards the downpipe and clear.</p> <p>Repair downpipes and secure as necessary, ensure downpipes are clean and clear.</p>
<p>Walls:</p> <p>First and second floor: Flemish bond brickwork</p>	<p>Wrongly repointed in cement mortar</p> <p>Brickwork to left side has colourwash</p> <p>Hole where extract fan was</p> <p>Movement around plastic sliding sash windows on right side</p>

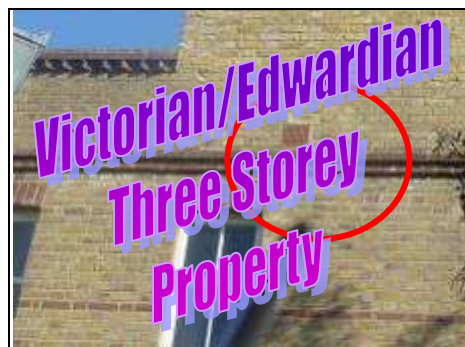
Cracking to brickwork

<p>Walls: Decorative brickwork at roof level forming a coping</p> <p>Flemish bond brickwork Note: different brickwork gable end of building</p> <p>Structural repairs</p>   <p>Vertical cracking through brick and brick joints.</p>  	<p>Spalling to red decorative brickwork</p>   <p>Wrongly repointed in cement mortar</p> <p>Stitching in of bricks, structural repair</p>   <p>Close up of cracks through bricks</p>     <p>Cracking around side of white door</p>	<p>Repair brickwork. Exclude from lease</p> <p>Ad hoc repointing in appropriate mortar.</p> <p>Landlord to place an insurance claim.</p> <p>Landlord to place an insurance claim.</p>
---	---	---

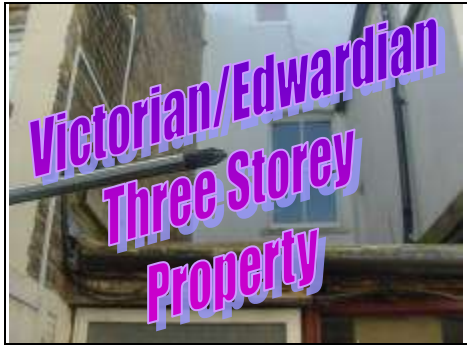
Diagonal and horizontal cracking

Amend soil and vent pipe to discharge at higher level
Walls: High level: Render	Movement with diagonal and horizontal cracks

Landlord to make insurance claim.

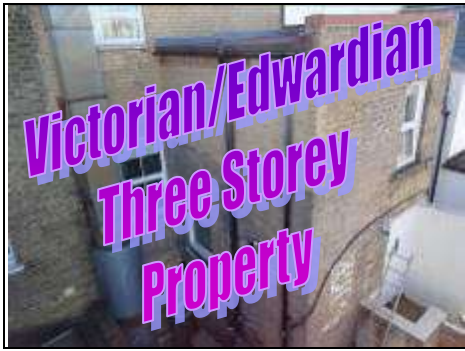
High level flat roof finished in mineral felt

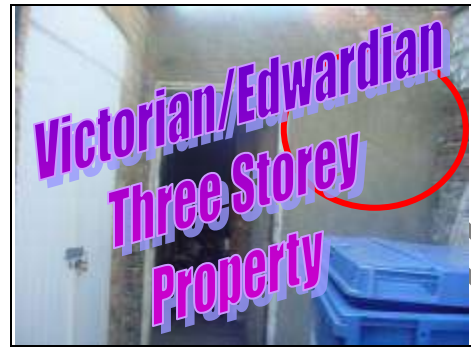
Cracking to outbuilding

Diagonal crack to render and DIY quality rendering	
Front: Render	Rubbish around wall

Remove rubbish Resolve dampness problems
Left: Brickwork	Efflorescence and cracking	Monitor. Landlord to make insurance claim.
Rear: Render	Vertical crack
