SCHEDULE OF CONDITION EXTERNAL

SCHEDULE OF CONDITION

We have been instructed to inspect and prepare a Schedule of Condition for XXXXXXXXXXX, XXXXXXXX, XXXXXXXX, XXXXXXXXXXX, Hampshire, XXXX XXX.

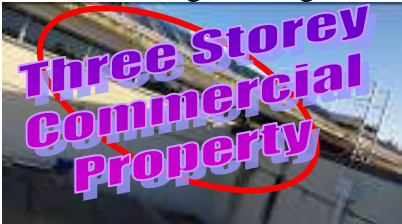
<p>Rusting rear left</p>  	
<p>Box gutter:</p>  	<p>Pattern staining to box gutter</p>

<p>Moss on box gutter and small flat roof</p>   <p>Water coming out of box gutter to rear central area</p>

<p>Exclude from lease</p> <p>And / or</p> <p>Landlord to fully repair and leave watertight.</p> <p>And / or</p> <p>Joint high level inspection with the landlord's surveyor to be carried out prior to signing of the lease or legal completion of the lease from high level cherry picker or equivalent.</p>

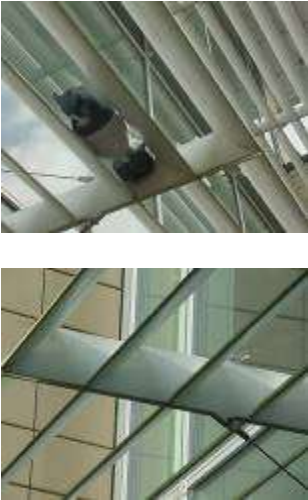
<p>External Detailing:</p> <p>Sun shades complete with poles</p>	<p>Moss</p>

<p>Clean</p>
---	--	--------------
