# SPECIFIC DEFECTS REPORT

Relating to dampness

Lincolnshire

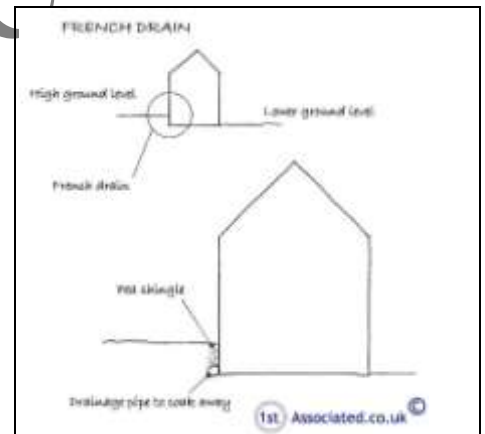
At the time of the survey work was being carried out around the property to add a French drain, which was partially completed on the left side, completed on the front and also the drains have been dug up on the right side.

French drain

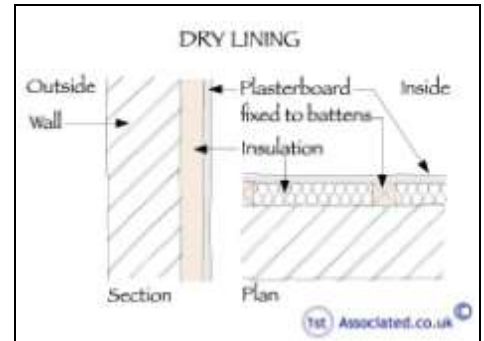
The rear extension (kitchen/dining room/lounge) is a mixture of construction. This area may originally have been a storage shed or similar meant for non-habitable use and has therefore been built differently. It is possible that there is some Stretcher Bond brickwork to this area; it is also possible that there is some solid brickwork here and/or single brickwork with a dry lining inside.

Dry lining

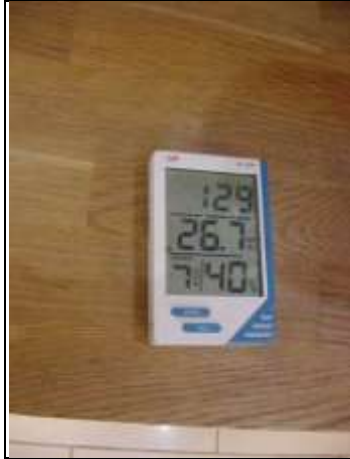
We recorded a difference of relative humidity readings of 40% in the rear area and 20% in the master bedroom. This then, after having a period of having the doors open, both externally and internally, the readings starting to balance and transferred to 31% relative humidity in the rear area and 30% within the master bedroom.

Relative humidity readings of 40% in the kitchen/diner/lounge

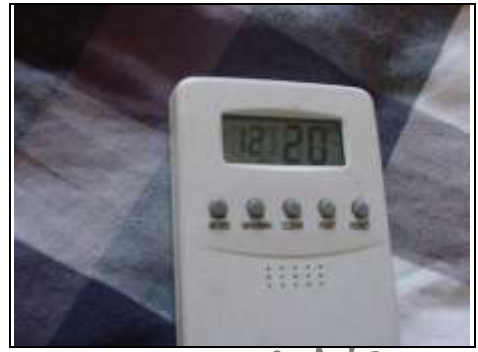
Relative humidity readings of 20% in the master bedroom

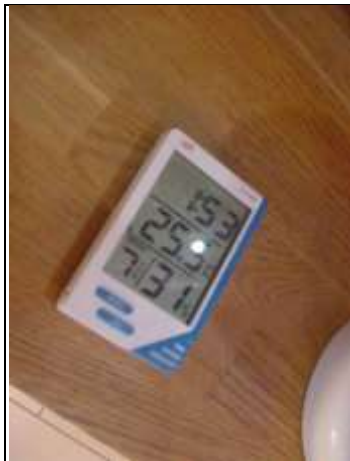
Relative humidity readings of 31% on the kitchen/diner/lounge after opening doors

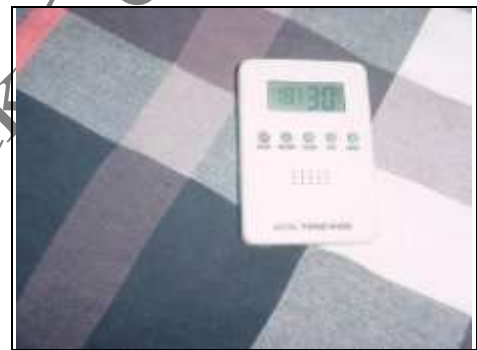
Relative humidity readings of 30% in the master bedroom after opening doors

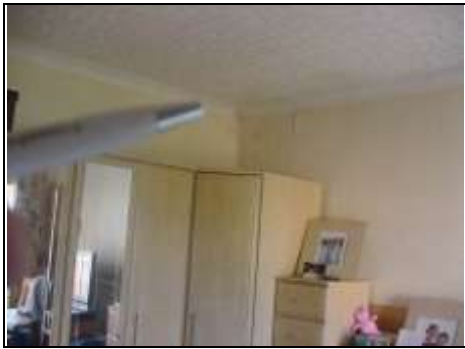
At the same time as this balancing out was occurring, what would have been happening was humid air would have been travelling from the rear extension into the bungalow, which will go to any cold spots, which inevitably tend to be in cupboards and corners and you get black mould forming.

Black mould in corner of master bedroom

**ACTION REQUIRED:** We recommend large good quality humidity controlled extract fans are installed in the bathrooms and kitchen and any rooms used for drying clothes internally. It is best to have one that is a quiet/low noise fan.

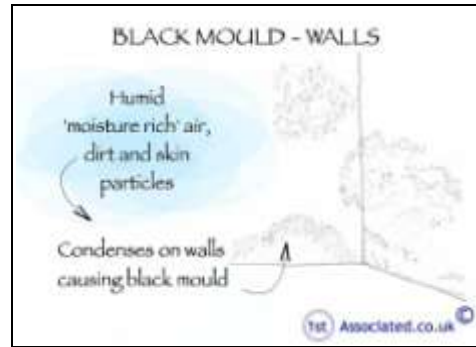
Black mould

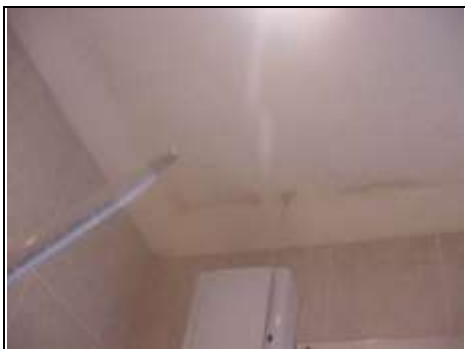
Black mould in bathroom

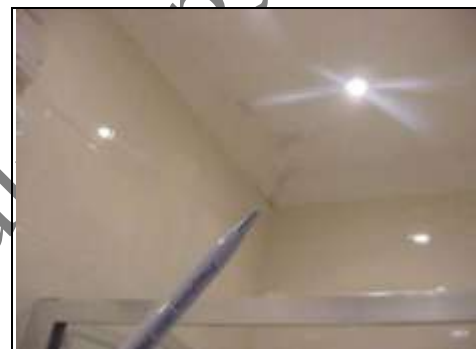
Black mould in en-suite shower

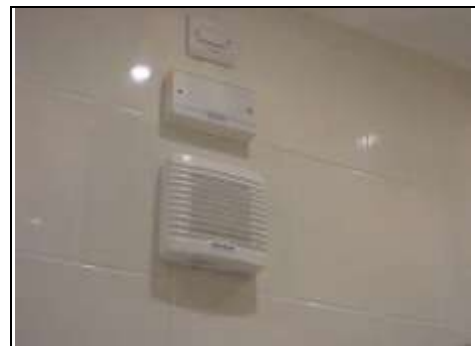
Extract needs improving in en-suite shower room

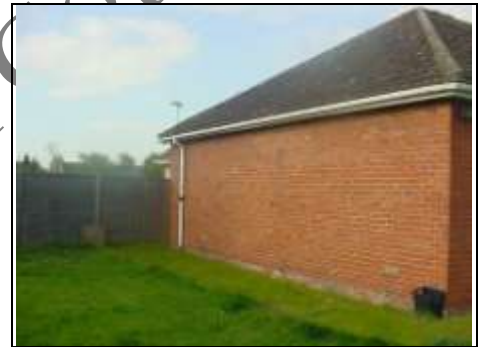
Left side of property where a chimney has been removed

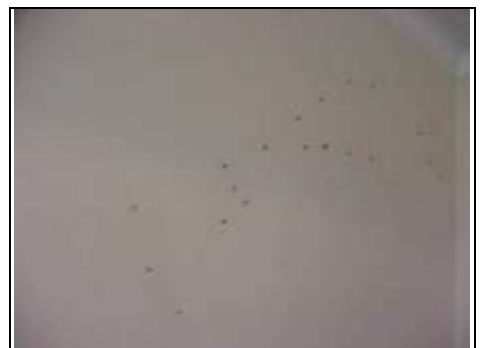
One of the remaining chimneys is the one to the front left side. You kindly marked out the pattern of the dampness to the chimney breast which seems to follow the line of the flue. As you are aware, there is no visible chimney on the left side.

Pattern of dampness found within chimney breast to left lounge

We would recommend an air vent at the base of the chimney if it was being blocked up and we would also recommend that the chimney be cleaned before any of the blocking up is carried out. We believe the soot within the chimney acts like blotting paper drawing dampness to it and you can get what is known as sulphate attack, which brings an orange/yellow dark stain to the chimney.

**ACTION REQUIRED:** We recommend you have a chimney sweep clean the chimneys.

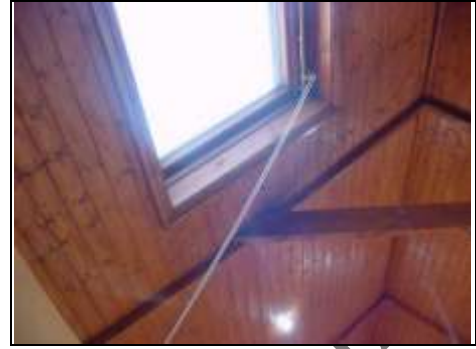
Roof window where we suggest a blind is added

One area that it may be worth experimenting with is whether a blind over the roof window in the kitchen/dining room/lounge area would help reduce the heat gain and heat loss.

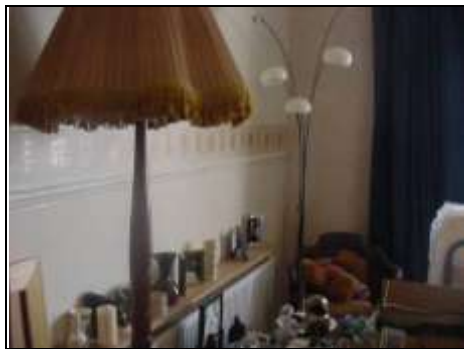
We also noted that some of the radiators are not positioned under windows. Again this means there will be lack of air movement in these areas.

Internal radiator in front left lounge

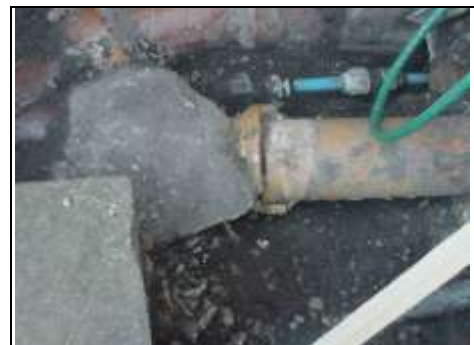
Redundant soil and vent pipe that needs to be checked

**ACTION REQUIRED:** We would just recommend that perhaps you have a closed circuit TV camera report of the drains to establish exactly where they are going, particularly in relation to the pipe that you believe is redundant. It may well have been to an old toilet like you suggested, or equally it may be from a downpipe.

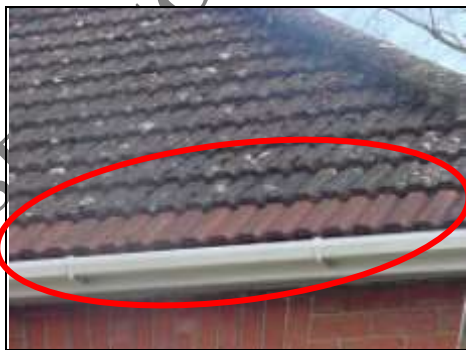
Close up of tiles. Are the walls getting damp from the roof?

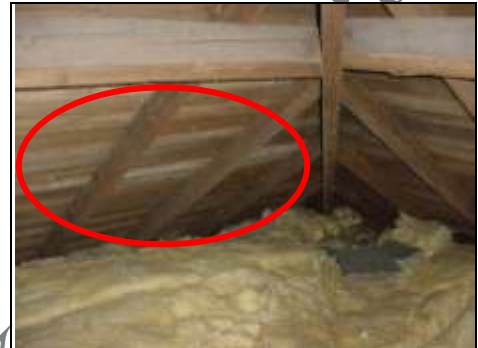
Efflorescence on timbers to rear left side

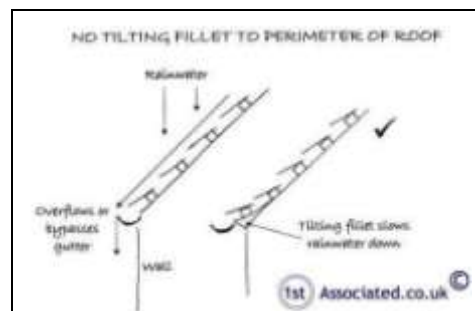
It is worth keeping a constant check on this roof because the replacement of the roofs in the 1970's were often carried out with minimal skills levels, for example there should be a tilting fillet to the base of the roof to slow the rainwater down and we cannot see one in this case.

No tilting fillet

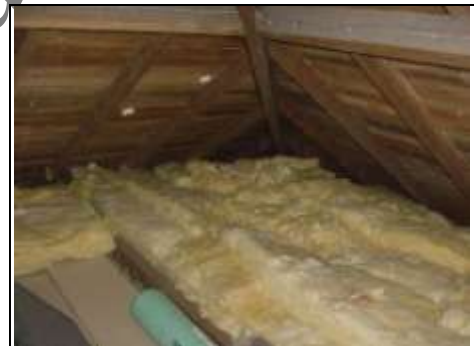
This is a gable end roof, finished with an interlocking concrete tile, with a roof window on one side. The exact construction is not known, from what we understand there is a polystyrene style insulation in the roof. This could lead to sweating and condensation in the timbers.

Mass of insulation in roof

**ACTION REQUIRED:** We do think it is worth opening up one section of the roof to see if there is any deterioration occurring. It may even be worth under cladding this roof with a modern dense insulation, such as Kingspan or Celotex (trade names).

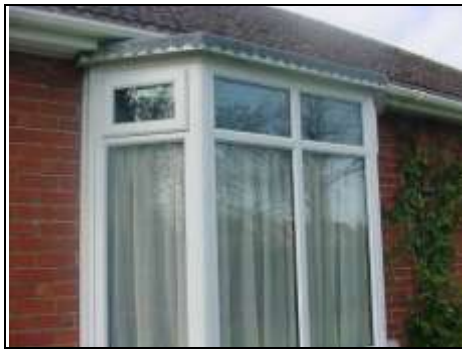
We noted that the windows have no trickle vents, which means there will not be any air movement around them.

Front bay without trickle vents

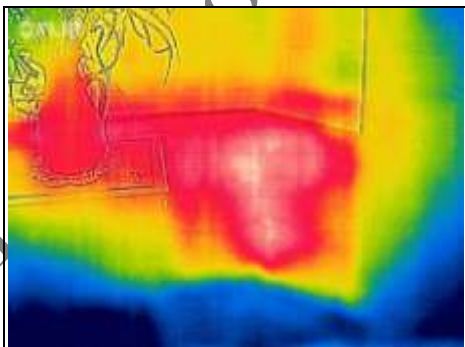
Heat loss through external bay  
walls

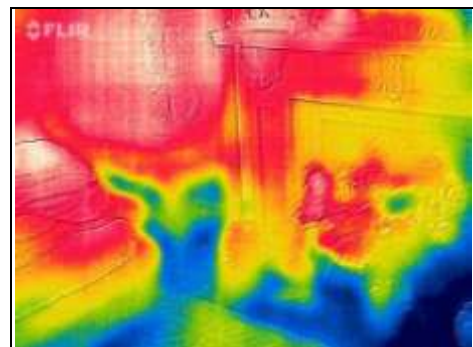
Heat loss to walls around chimney  
breast

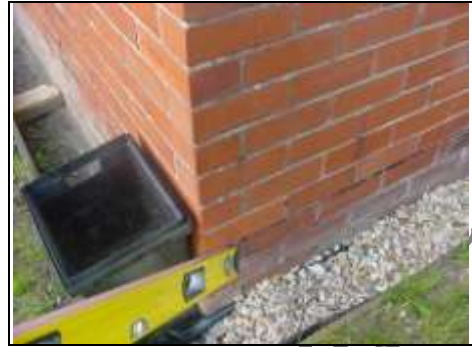
Basic French drain to front. It should really have a perforated drain on it to allow water to get away from the building, albeit you have more than two bricks between the DPC and the ground level

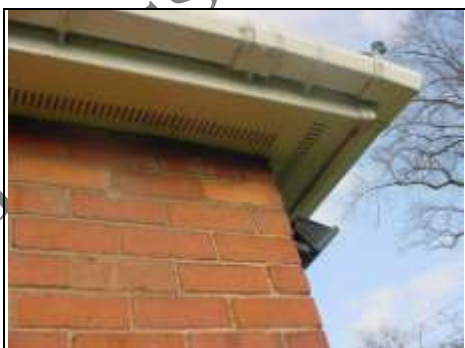
Fascias and soffits with vents. Are they being blocked by the insulation in the roof?

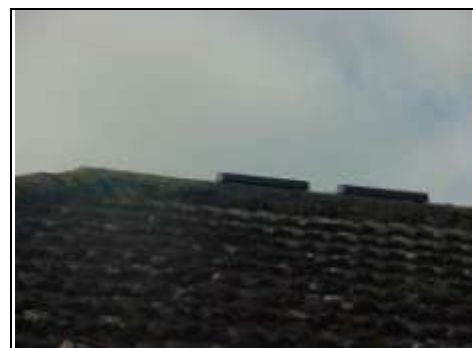
Vents have been added in the roof. These work in conjunction with the soffit vents so you may have to move the insulation back in the roof space

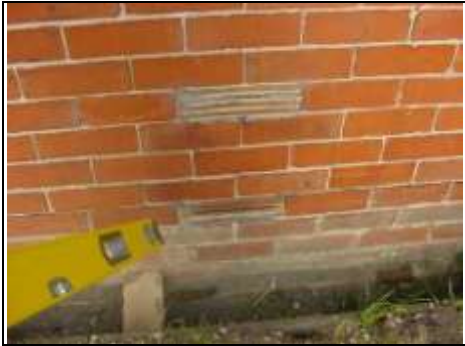
Vent under floor needs checking to see if it is blocked by insulation, particularly if there is a defective DPC. Check with a long screwdriver that it is working

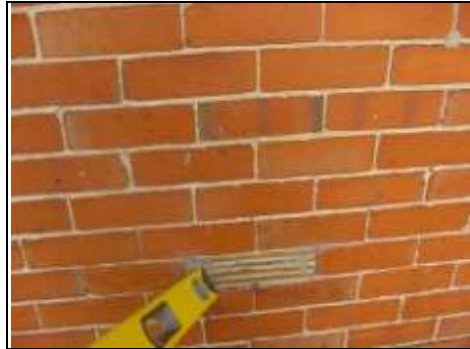
Blocked air brick which leads us to believe there is no longer a through flow of air at low level

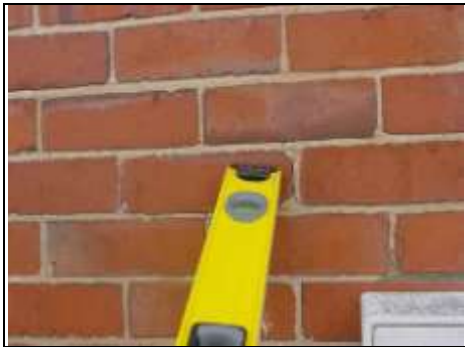
Crack to front right corner

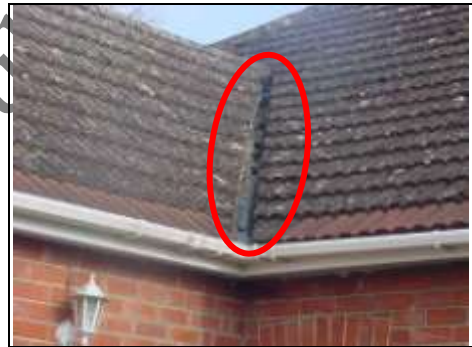
Valley gutter looks to have been tarred. Double check to make sure it is watertight

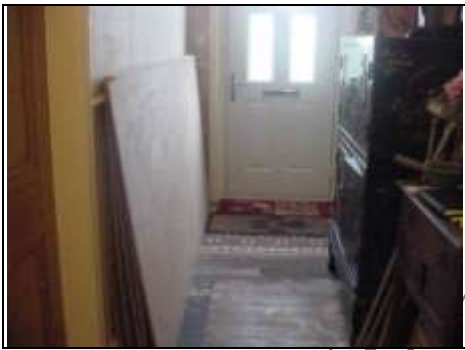
Hallway. We personally would not recommend laminate/parquet as it stops the floor from 'breathing'

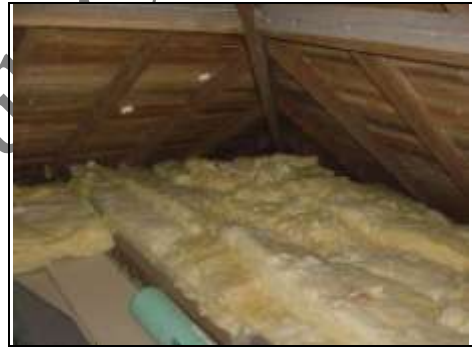
Mass of insulation
