RESIDENTIAL BUILDING SURVEY

Wells, Somerset BA5

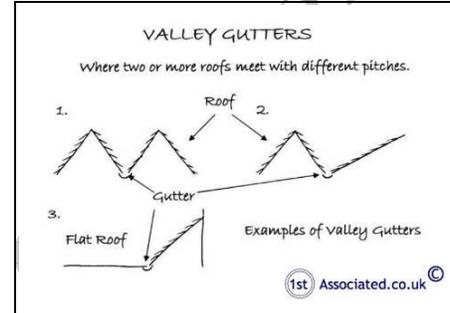
Valley gutters

Flashband is a sticky backed felt which is best used for temporary repairs only.

ACTION REQUIRED: We would recommend that lead repairs are carried out to the roof and valley gutters, where currently Flashband has been used, which we consider a temporary repair product.

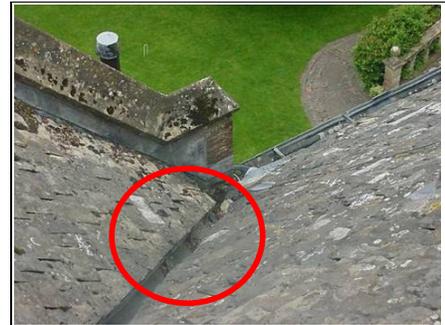
Valley gutter that is becoming blocked next to a lead guttering

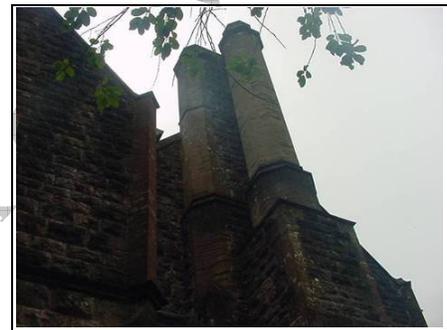
Rear right hand chimney which is starting to deteriorate

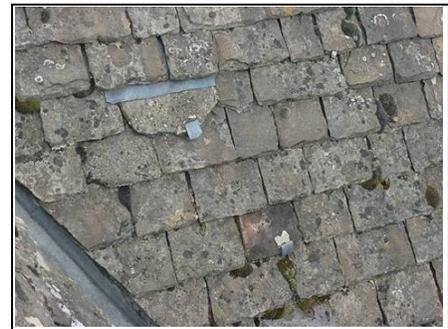
We note that some of the roof stone slates have deteriorated and have been fixed with a lead tingle, which indicates the nails are rusting. Ideally these should be replaced properly. There is also an outside chance the roof has nail sickness, which is where the fixing nails have rusted away and as such then sections of the roof will need to be replaced. This can only really be ascertained by removing sections of the roof and having a close look. It is this risk that we are concerned about with the high level work areas.

Lead tingles

The weakening of the fixing nails to slates or tiles due to the nails which fix them to the battens rusting. This is normally attributed to problems with slate roofs.

ANTICIPATED COST: We would set aside the sum of £20,000 to £40,000 for high level work as you are likely to need a scaffold access in some areas and also there may be problems with the nail fixings deteriorating to the slates. Having said that good maintenance will keep this roof going for many years to come and you may wish to wait until there are major roof leaks before commencing work. Quotations required.

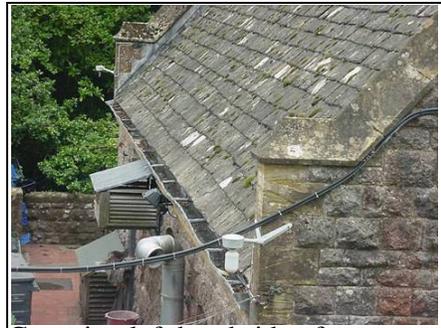
With this type of property and these surroundings, which is surrounded with trees, you will have a constant battle against leaves filing the gutters, you need to have a good maintenance regime which from what we can see has been put in place by Sid Hodges the maintenance man. Sid is working to a budget and has come up with some practical ways of maintaining the property. He uses a weed killer to kill the weeds in the gutters (via a water pistol!) and then clears these using long ladders. This is not ideal and we would recommend that you buy a tower scaffold and make the maintenance easier and safer (see adjacent photo).

Guttering left hand side of property

ACTION REQUIRED: You will need to constantly clean the gutters and hopper heads and downpipes. We recommend you buy a tower scaffold as blocked gutters, valley gutter or hopper head would very quickly cause major problems.

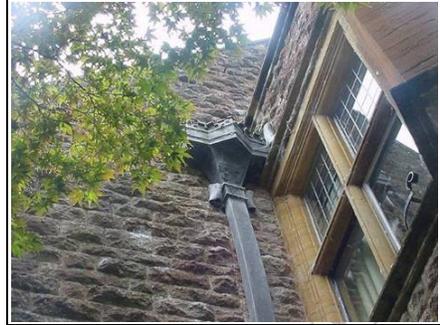
Looking up at a lead hopper head and downpipe and surrounding trees

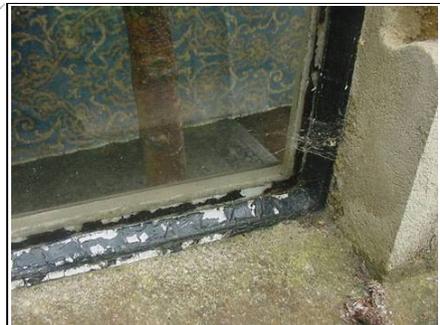
Metal windows require regular maintenance to ensure that you can open and close them fairly easily. We noticed that some of them were unopenable during the course of our survey.

Windows need regular maintenance

ACTION REQUIRED: We would recommend a programme of maintenance where you work on each elevation and improve the windows year by year together with removing the moss from any stonework such as the stone window sills and ad hoc repointing, removing any cement mortar and replacing with a lime mortar

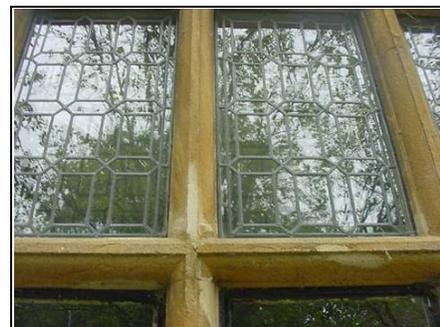
In this window you can see previous repairs

ANTICIPATED COST: We would consider this work as part of the general maintenance package. If you want to carry out one off repairs to the windows and cleaning the stonework we would expect costs in the region of £10,000 to £15,000. This will be changed considerably depending upon the access available; quotations required.

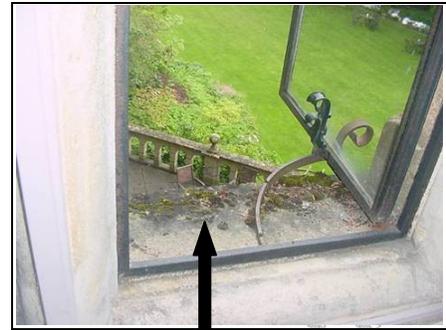
Moss on the window sill
– this will need clearing

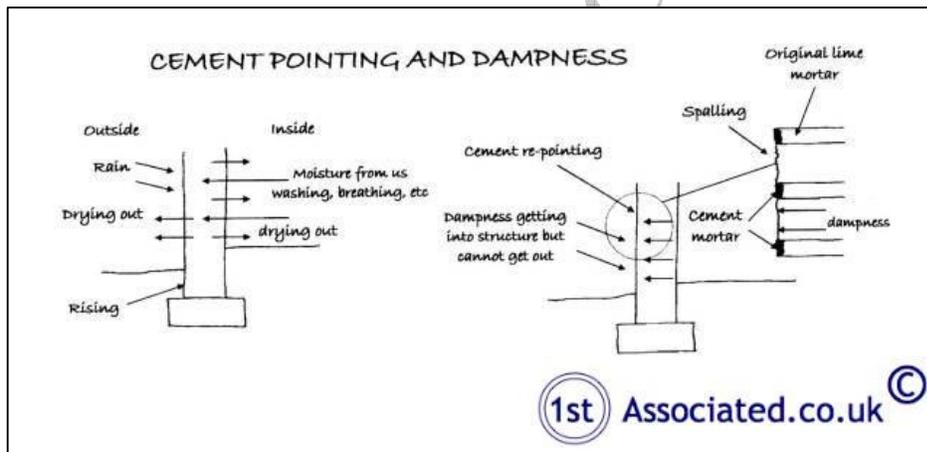
Cement pointing

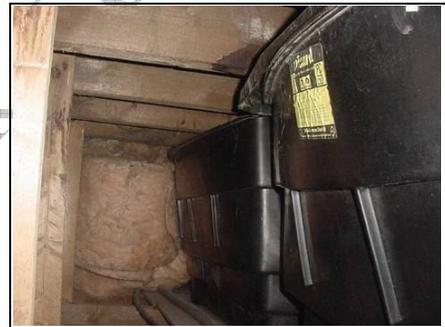
From what we can see water tanks in the flat roof are causing condensation and in turn wet rot to the timber roof above, which has the lead flat roof over this.

Looking at dampness beneath flat roof that has condensation from the water tanks

We believe that the condensation needs to be stopped otherwise severe damage will be caused to the flat roof above. You can do this by adding vents which will be relatively cheap as well as putting lids on the tanks and reducing the insulation, but we would say there are too many tanks in too small a space which becomes a warm area and causes condensation.

ACTION REQUIRED: We recommend lids for the water tanks and venting of the area, although we would add that it is very constricted in these areas and you may wish to look at relocating the water tanks.

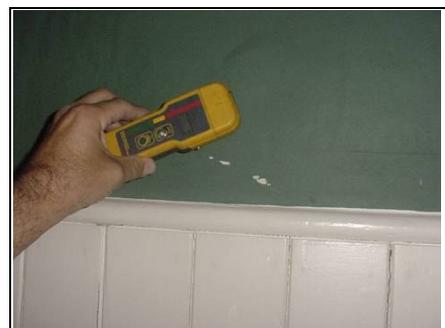
As we would expect in a property of this age, type and style and in this location, we found dampness, both in the form of rising damp and in the form of lateral damp. We would comment that we feel that dampness has been blown out of all proportion by damp proof companies, however in some areas plaster is deteriorating from the dampness coming through. If the property was left unheated we feel this would deteriorate rapidly.

Finding lateral dampness

We would recommend a constant background heat is maintained in the property. You may wish to look towards some sort of green energy solution such as solar panels to reduce/off-set your bill, however this is a long term commitment in our experience.

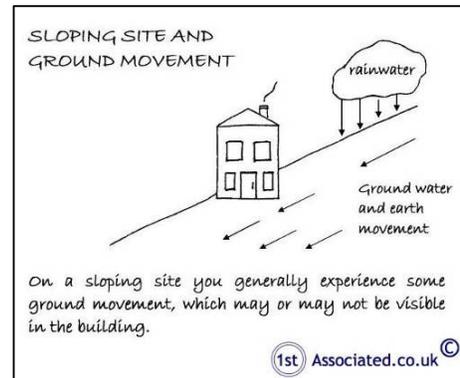
The property is on a sloping site; the adjacent road is considerably higher (approximately two to three metres) than the car park area. As such we feel that you will have problems with rainwater and surface water when it rains heavily and whilst this property is being sold in the summer we feel it will be a very different place in the winter and therefore we would look at managing how the rain travels around the building.

Currently you have one main drain in the centre of the car park and a running gully.

ACTION REQUIRED: We recommend increasing this to take the rainwater away and around the property and therefore minimise the unseen damage that can occur to the timber floors that are adjacent to the front and side walls.

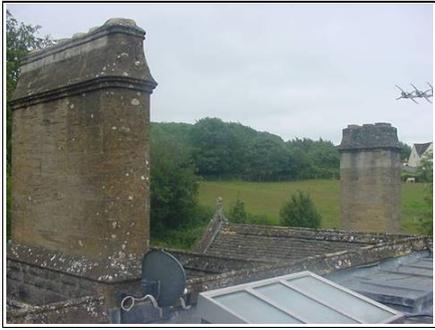
This property has six main chimneys; three to the front and three to the rear. On the visible sides they were all in reasonable condition. We would, however wish to have a closer look at the front left hand chimney and the two chimneys to the right hand side. The front left hand chimney seems to be coming away from the property slightly. This looks to be a historic problem as we can see repairs have been carried out. To the right hand side the chimneys are suffering due to the trees blocking the sunlight and lack of air movement in the area, as is the right hand elevation in general.

We would make the general comment that repairs in the past have been basic and look to be in cement mortar rather than a lime mortar and on the flashings a cement mortar has been used when we feel mastic, such as Plumbers Mate, would be a better solution.

The two front left hand side chimneys

ACTION REQUIRED: We recommend the trees are cut back to allow light to get to the chimneys and stonework generally and allow air circulation around the building. We recommend ad hoc repairs are carried out to the chimneys. We note no specific major issues; we feel they have suffered from wear and tear over the years.

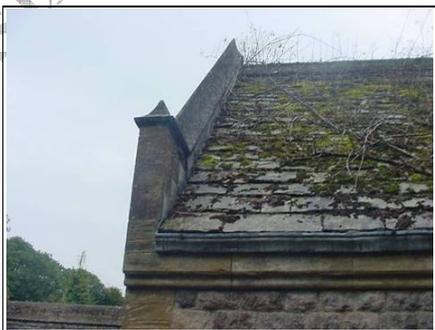
The worst area of roof that we can see is at low level to the left hand side where the kitchen and store area is. There is no obvious reason for its poor condition. It may have been covered with a tree or bush for some time and had water sitting on it.

Low level left hand side of roof

ACTION REQUIRED: We would clear this roof of moss and of vegetation and then check the condition. In addition at the same time there is a hidden valley gutter, investigation should be carried out here to check for excessive dampness.

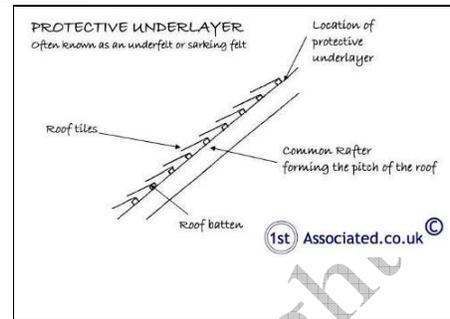
We were looking under the roof to see the decking and would normally expect to see a protective underlayer of Hessian. We have not seen that in this instance and believe that the majority of the stone slates may be very old, and possibly had major repairs since the 1970's.

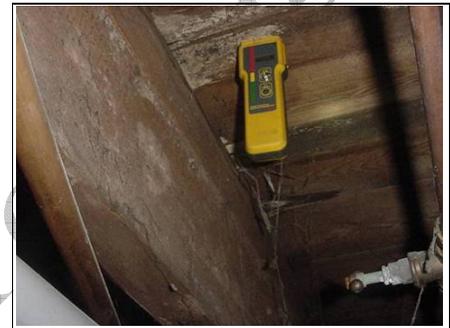
Dampness coming through the flat roof below the lead work

ACTION REQUIRED: You need to carry out a programme of maintenance, which not only looks at repairs necessary but also ensures there is a means to access the roofs in various areas. We very rarely come across roofs such as this, where we literally cannot see any of them. We would estimate we have seen about five, possibly ten per cent at the very most of the underside of the roofs in this survey. Typically we are looking at ninety to one hundred per cent of roofs.

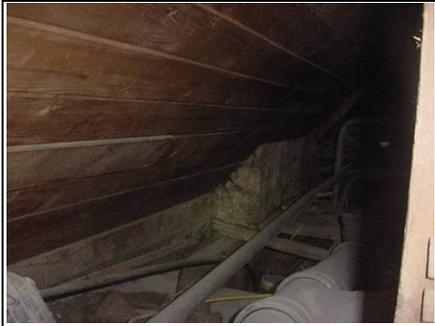
Far left hand side – here you can see a timber decking has been used to support the valley gutter which looks in reasonable condition

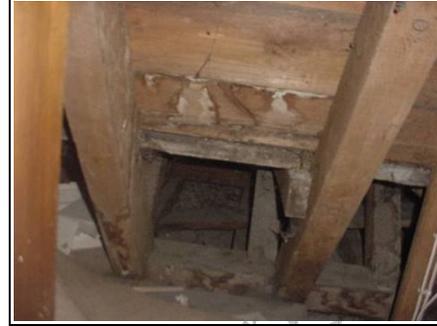
Far right hand side – we could see some water staining indicating that dampness was getting through

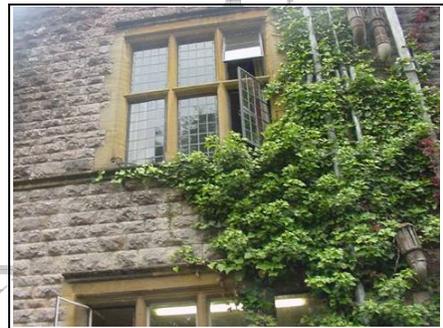
The walls are finished in a squared coursed stone. This is in average condition for its age, type and style. It has had some repair work carried out to the mortar using cement rather than the original lime mortar. This is what we generally come across. There will always be maintenance work to be carried out on stonework such as ad hoc repointing and also in this case general clearing of the moss.

Trees need cutting back

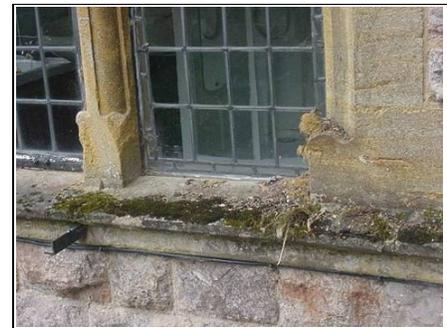
We can see the stone mullion windows have been repaired many times over the years and some would benefit from repair. Some of the stone is suffering from moss sitting on the ledges particularly the window sills.

Moss on ledges of window sills

ACTION REQUIRED: Initially we recommend cutting back of trees around the property to allow sunlight and air circulation. We also recommend the purchase of a good quality tower scaffold (see earlier photo) to first of all aid investigation and then maintenance of the property with a safe access.

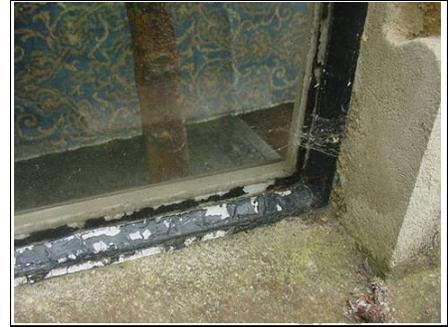
Windows deteriorating

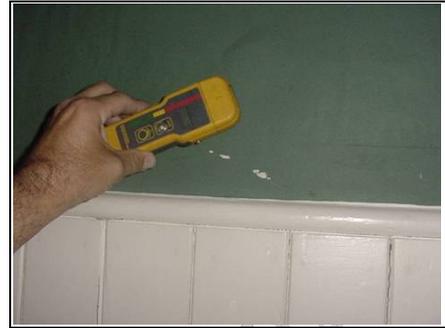
Testing for and finding lateral dampness!

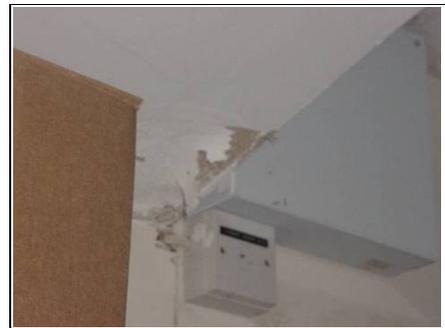
Dampness in Prep Room coming from car park area

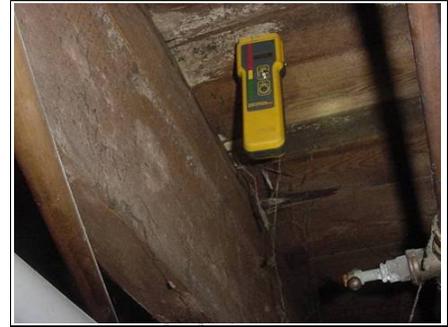
Dampness coming in through the flat roof

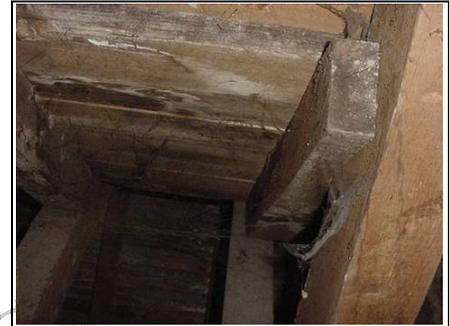
Dampness in timbers to valley gutters

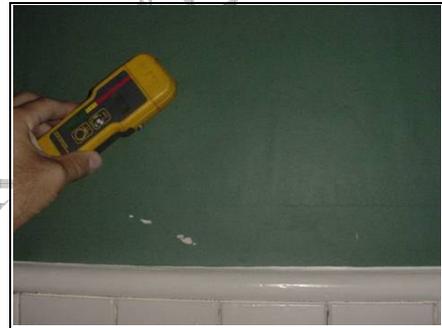
Lateral dampness coming through the walls
