# RESIDENTIAL BUILDING SURVEY

London Borough of Enfield

Mr L

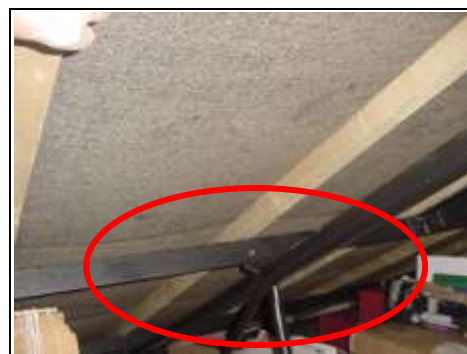
Metal frame, purlin and metal truss

We examined the steel frame that we can see within the roof and found it to be in average to above average condition. This is, from our question and answer session with the owner, because the roof has been replaced and also the steel frame has been treated when re-roofing work was carried out in 2000 (the owner wasn't exactly sure of the date but as mentioned this would originally have had a shallow pitched roof with an asbestos cladding which is no longer visible).

**ACTION REQUIRED:** The only way to be 100% certain as to the condition of this structural frame is to open up the structure. As mentioned you will need to obtain permission from the owners to carry out this work but we are more than happy to return and inspect once the structure has been opened up and you need to have a builder close it up satisfactorily.

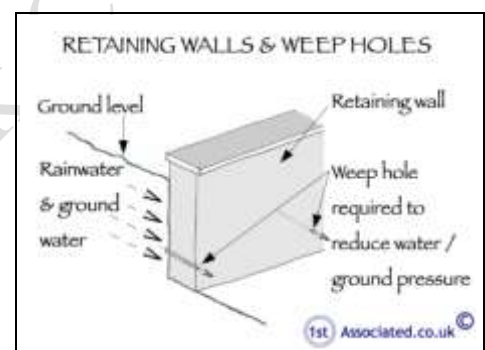
We noted that the retaining wall does not have weep holes which means there will be a build up of water weight behind this wall which may push it over.

Weep holes

**ACTION REQUIRED:** Ideally stand outside the property next time it rains to see how much of a problem this is and if it is a problem we would then recommend a French drain is put around the property to direct the rainwater around the property. We would also recommend the adding of weep holes into the retaining wall. Close examination needs to be carried out to the rear structural frame.

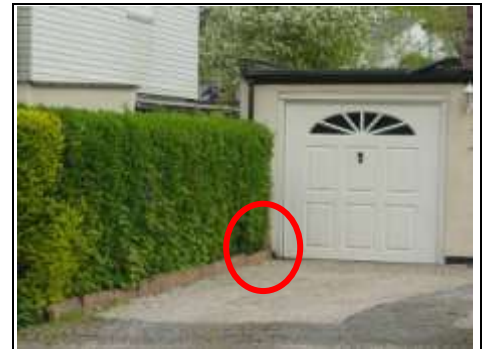
The owner advised there had been subsidence in the front corner of the property which has been underpinned. Subsidence of any sort does affect the value of a property considerably, for example:

Very bottom of render on left hand corner where underpinning has taken place

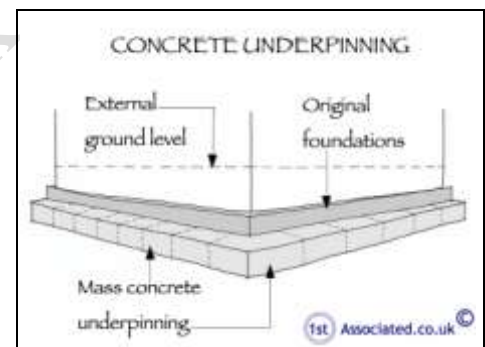
Concrete underpinning

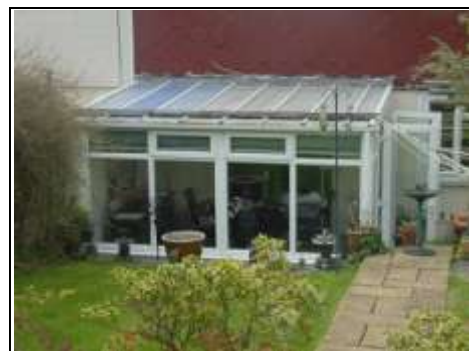
We noted the conservatory has quite a shallow roof which does tend to mean that water sits on it and you do get moss although it looked quite clean on the day of our inspection. We could also see that three of the panels on the right hand side (all directions given as you face the front of the property) have been replaced. We spoke to the owner about this during our question and answer session who advised that when the lights in the soffit board were being replaced damage was caused to the roof panels which he got the contractor to replace. We also noted that one of the windows had misted over.

Conservatory

**ACTION REQUIRED:** View the roof from time to time to check that build up of moss isn't occurring and clean as required. We would also check the flashing between the main building and the roof as this can be an area where leaks occur.

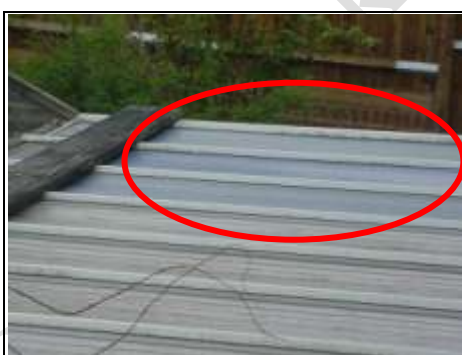
Panels that have been replaced

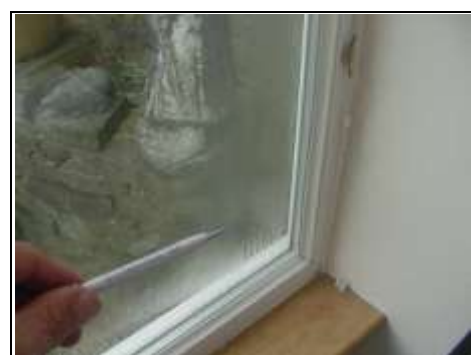
Seal has gone on conservatory window

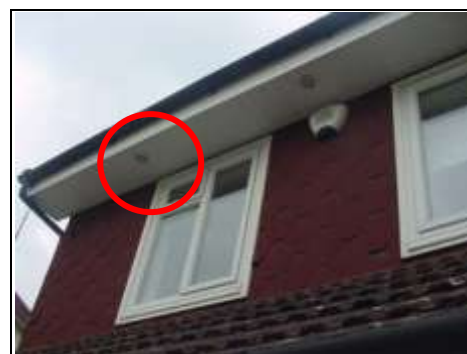
Lights in soffit board to front and rear of property are difficult to access to replace

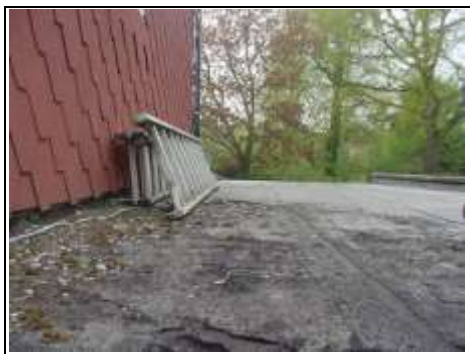
The flat roof over the garage is in a poor condition.

Flat roof viewed from the rear

**ACTION REQUIRED:** We would recommend patch repair in the summer of 2013 and obtain quotes for replacement with a high performance mineral felt roof and possibly add insulation as well although it may not be possible without stripping back the roof. Replacement recommended in the summer of 2014, possibly 2015 depending upon how deterioration occurs.

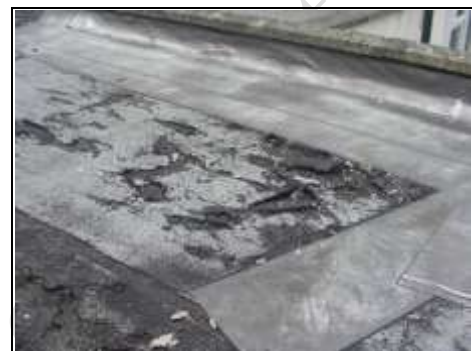
Deterioration to flat roof repaired with flashband

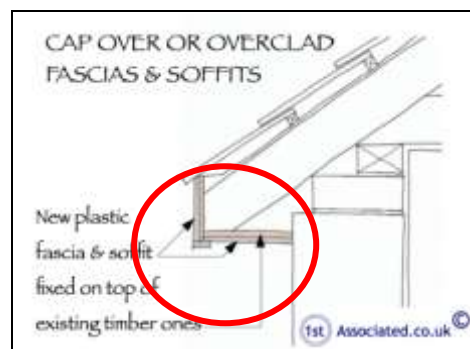
The plastic fascias and soffits around the property haven't got a vent and look to be overcladding on the original timber or asbestos fascias and soffits. We are not particularly keen on overcladding as it is normally put over timber already in poor condition which can then cause accelerated deterioration.

Overclad fascias and soffits

**ANTICIPATED COST:** If this is overcladding we would recommend complete replacement and removal of any asbestos if there is any. We would expect costs to be in the region of £2,000 - £4,000; please obtain quotations.

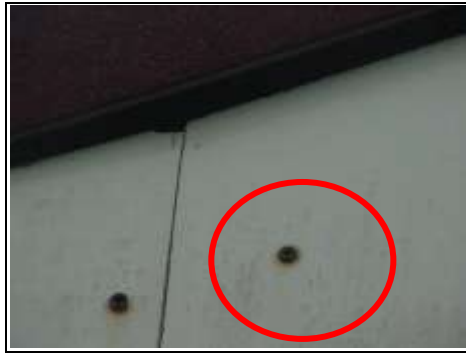
Rusting screws to fascia board

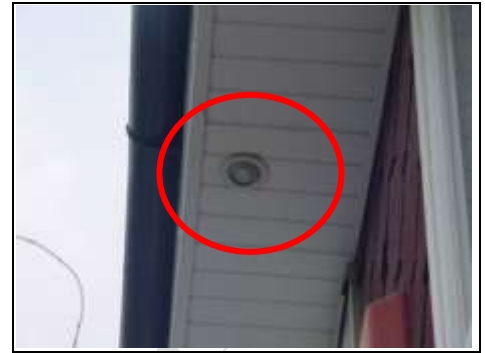
Lights in soffits which is slightly unusual

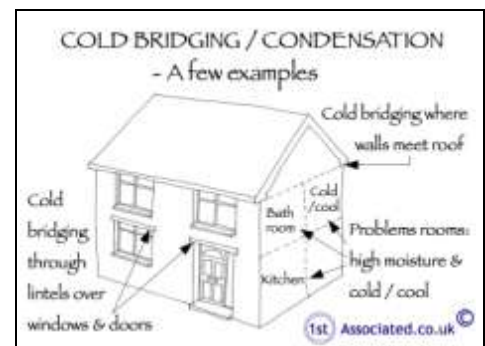
Cold bridging

**ACTION REQUIRED:** There are things you can do to help such as add large humidity controlled extract fans in the bathroom and the kitchen and any rooms that you use for drying.

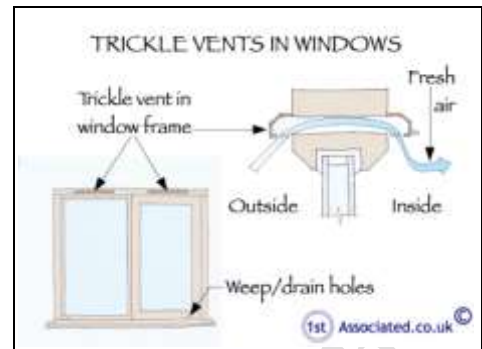
Trickle vents

**ANTICIPATED COST:** £200 - £300 per extract fan depending upon your electric wiring and configuration. Adding extracts is the very minimum we would recommend on this property, ideally we would recommend that ventilation is added to the soffits to vent the roof and also ventilation in the form of trickle vents are added to the windows.

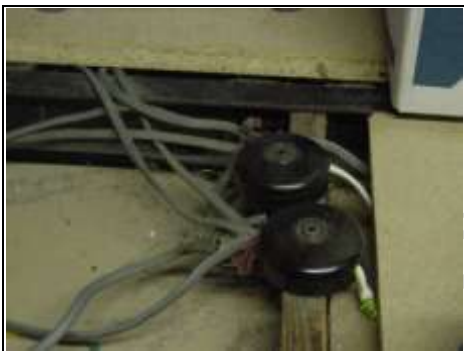
The electrics are dated and there are a lack of electric points, we noted many cable extensions being used.

Dated electrics

**ACTION REQUIRED:** The Institute of Electrical Engineers standards (IEE) recommend a test and report whenever a property changes occupancy. This should be carried out by an NICEIC registered and approved electrical contractor or equivalent.

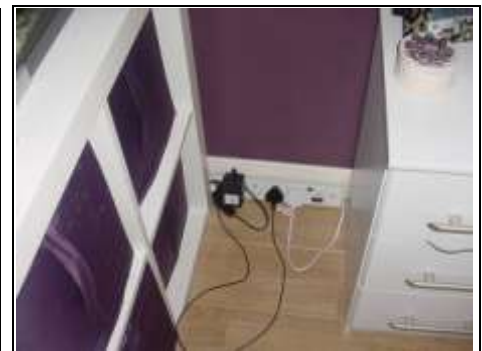
Overloading of electric points

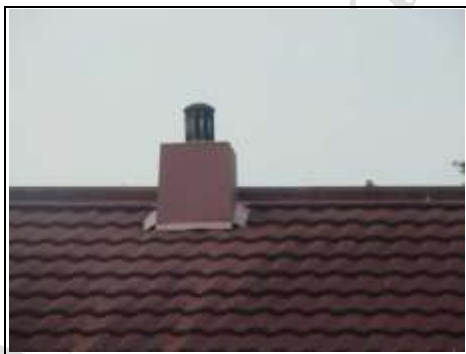
This chimney is metal finished and is probably best described as a mock or fake chimney with a main circular flue surrounded by a metal box. This can of course rust, from ground level it looked to be in average condition.

Metal chimney

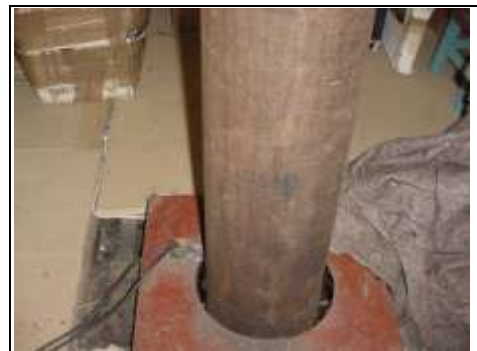
Central chimney which can rust

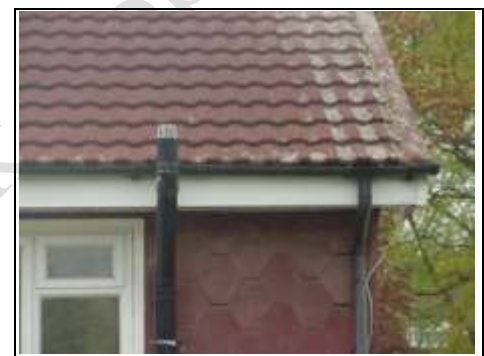
The main roof is shallow pitched proprietary prefinished metal profile sheet. From ground level, this looks in average condition considering the roof's age, type and style.

We do find that this type of roof weathers and you can almost get areas where the metal shines through.

Main roof

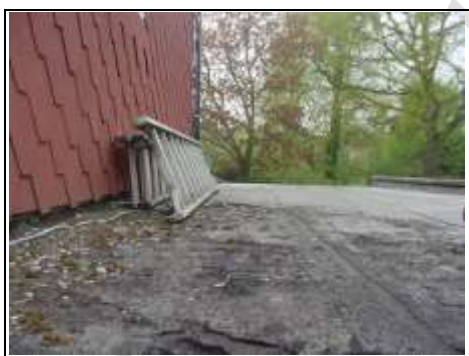
The flat roof over the garage is in a poor condition as are the parapet walls.

Flat roof

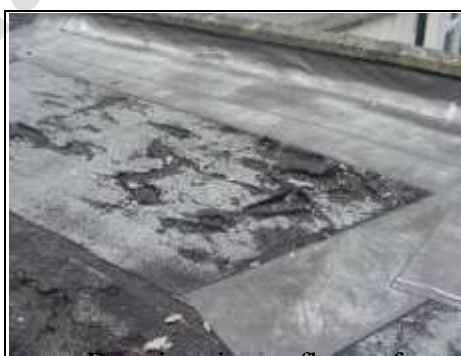
Deterioration to flat roof repaired with flashband

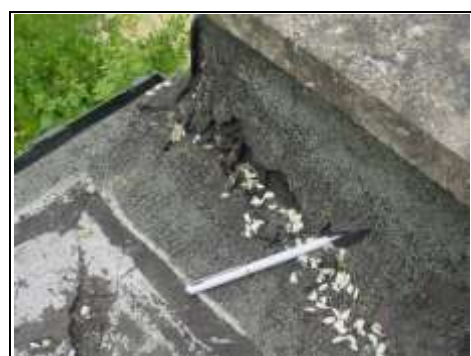
Felt has deteriorated to parapet wall

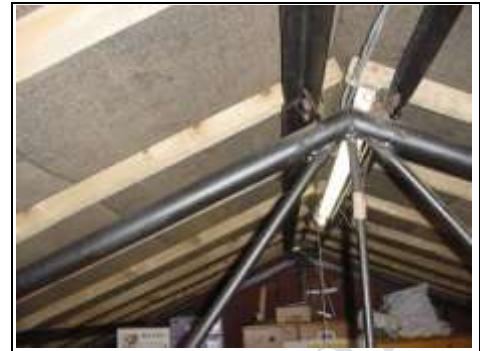
Top of metal truss and roof timbers

Our examination was limited by the general configuration of the roof, the floor boards and stored items. What we could see was generally found to be in average to above average condition for its age, type and style. We would normally expect to see rusting to the roof frame but in this case it looks as if the entire roof truss was treated when the property was re-roofed.

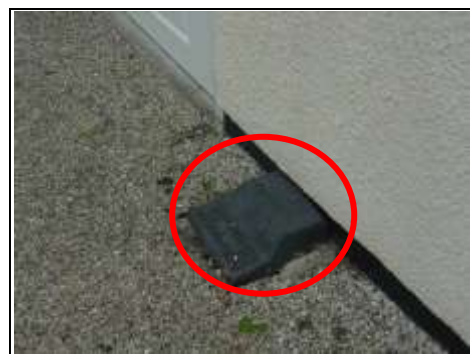
Why is there a gulley at front of the property?

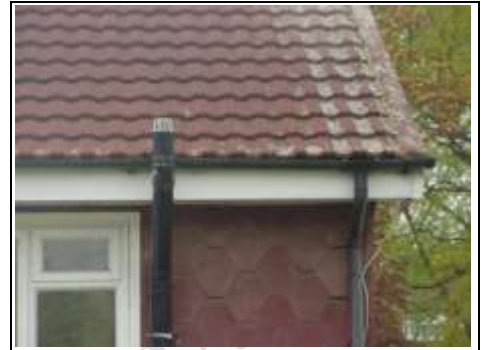
The property has a plastic soil and vent pipe to the rear which should be slightly higher above the fascia board, approximately 1m.

Soil and vent pipe

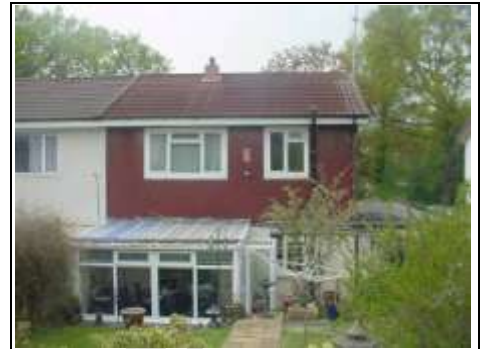
There are some mature trees relatively close to the property. The reason why we are mentioning these is because of the clay soil which can be affected considerably by trees and their root system.

**ACTION REQUIRED:** Trees located across the road  
Speak to your insurance company with regard to the trees; we believe this adds to the risk with the clay.

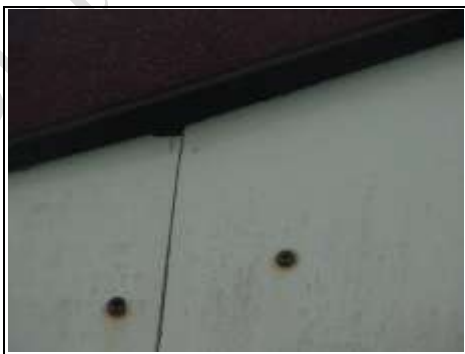
Rusting screws to fascia board

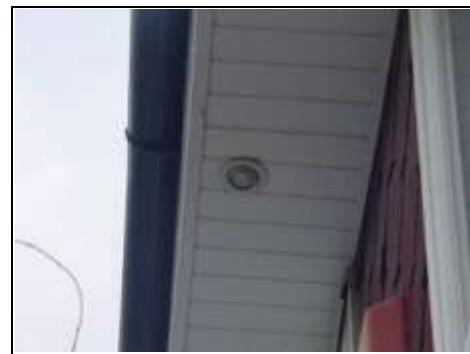
Lights in soffits which is slightly unusual

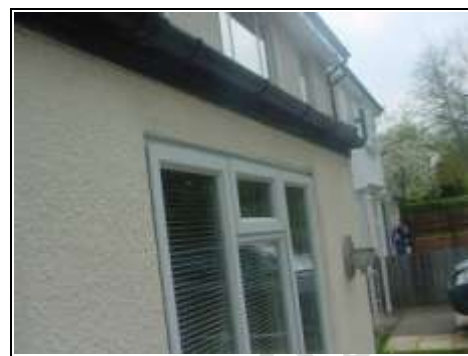
The property has plastic double glazed windows without trickle vents which generally look to be of an average quality. We would draw your attention to the fact that sealed double glazed units can fail, particularly as a result of poor workmanship during installation. Failure of the seal leads to condensation between the two panes of glass and simply replacing the affected units may not provide a satisfactory long-term solution. In this case we noted some of the seals on the conservatory have failed.

Plastic double glazed windows without trickle vents

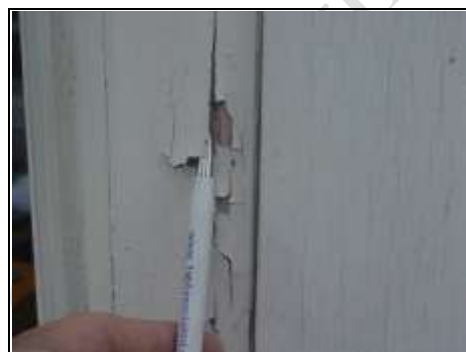
Generally there are plastic fascias and soffits and plastic windows with the exception of the rear of the garage where there is some paint flaking on the window and door areas which will need redecoration in the summer of 2013.

Paint flaking to rear of garage/utility room

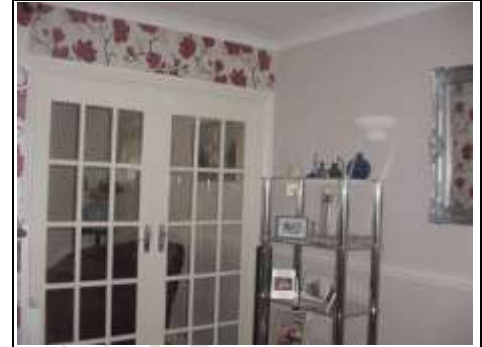
Glazed double door

**ACTION REQUIRED:** For the young, infirm or indeed anyone who could damage themselves on falling against a door such as this we would recommend that you change the glass to safety glass.

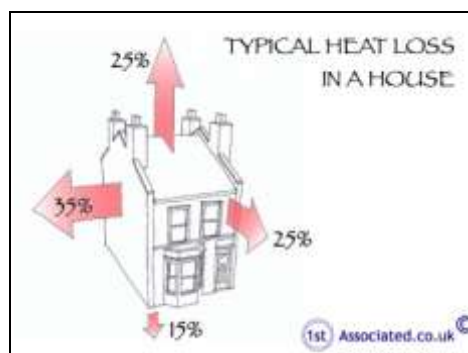
Some roof insulation was present although not to current Building Regulations requirements of 300mm. In this case there is approximately 200mm and it is boarded over in most areas. In this type of property you have to be very careful if you insulate not to create a condensation situation as this is when we feel you get most accelerated rusting and deterioration to the roof frame and the structural frame.

Typical heat loss

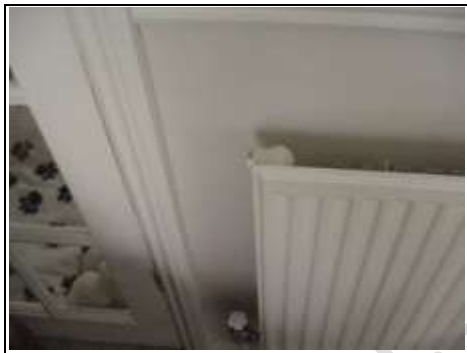
We noted that there are a fair number of single panel radiators. These may not warm the property to the heat that you desire. In most modern installations double panel radiators are used and often double panel convection radiators, which are more efficient, are utilised.

Single panel radiators

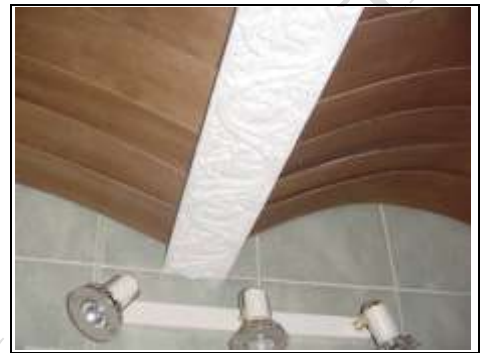
Unusual double concaved ceiling in bathroom

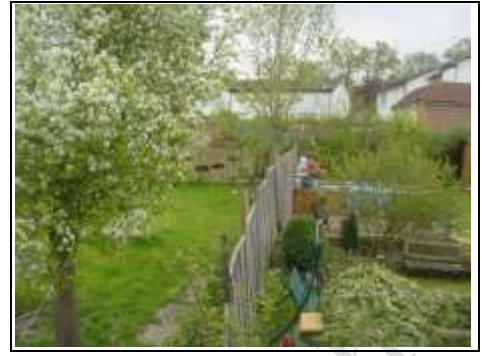
We noted the left hand fence which is normally yours is not in a good condition.

Left hand fence in poor condition
