RESIDENTIAL BUILDING SURVEY

XXXXXXXXXXXXX,
XXXXXXXXXX,
XXXXXXX,
Middlesex HA3 XXX

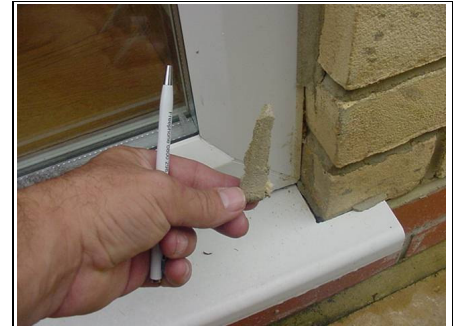
1.1 Cement has been used around the double glazed windows rather than a mastic seal. This is coming away.

Cement around windows

ACTION REQUIRED: These are general maintenance things that should be picked up on the builders snagging list.

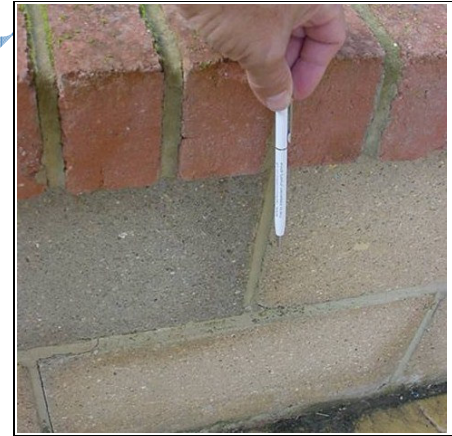
No weep holes to retaining wall

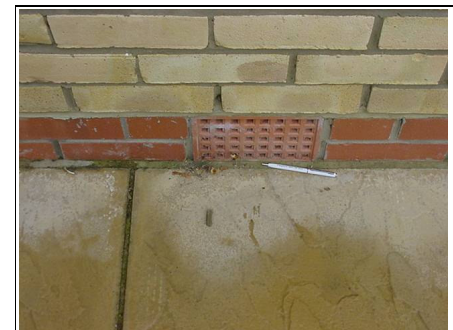
1.4 The airbricks acting as gutters to the ground floor properties.

Air bricks acting as gutters

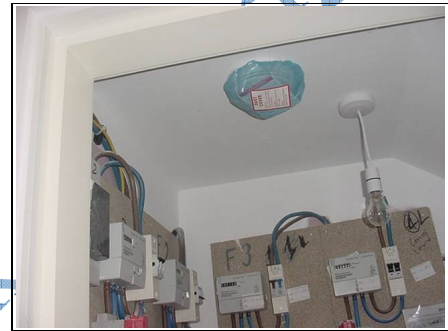
2.2 The fire detector under the stairs with the electrics has been covered up and therefore is not working.

Fire alarm covered up

ACTION REQUIRED: In summary the building is being occupied without the appropriate fire equipment. We are advised by the current owners lodger (the owner was not at home when we carried out the survey) that there is an Owners Management Company. We would recommend that your solicitor contacts them directly to ask what measures are being taking to solve this type of problem.

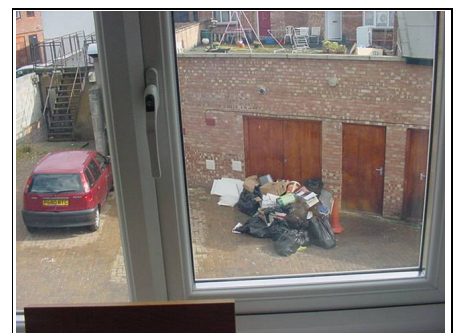
The view from the flats is not the best. Overlooking the entrance driveway it may get some noise. Also overlooking the back of the shops we noticed some fly tipping had taken place.

Fly tipping

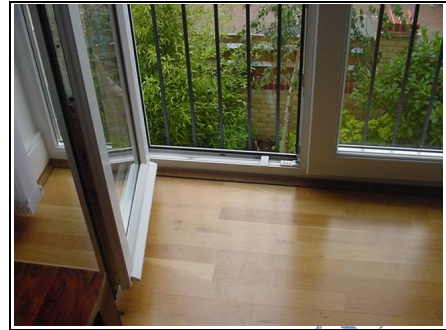
From speaking to one of the residents there is noise transfer in the property. Although the property should have been designed to modern standards it doesn't necessarily mean it has or that the system employed works.

Timber floor

We would add that the wooden floor that has been used in your property can equally cause problems.

ACTION REQUIRED: Before you move in we recommend that you speak to other people that live in the property (we could only find one person in on the day of our survey). It may be worth going round at a weekend) and ensure you are happy with the noise level.

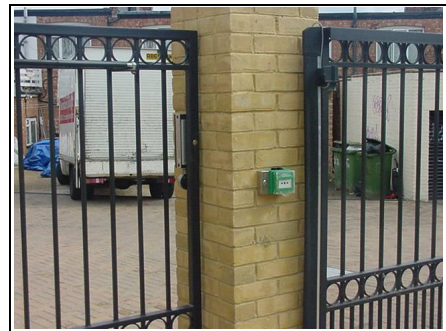
We were unable to open the main entrance door with the key, only by the fob, however we were able to lean through the security gates and press the opening device to open the main entrance gate to the grounds if you know where it is.

Entrance gate

ACTION REQUIRED: This is something an Owners Management Company would look into.

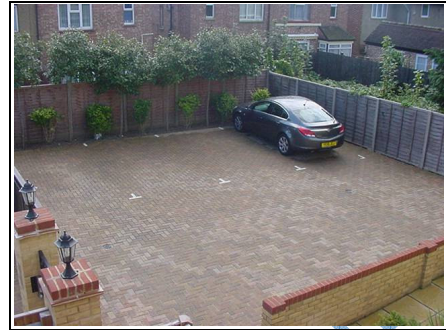
8.1 Parking is very limited; there looked to be four spaces. This all has a gated access. Is this satisfactory for you?

Car park

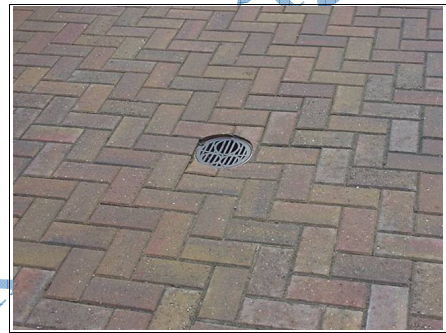
8.2 Whilst there are two drains in the car park the brick pave didn't look to be discharging towards the drain. Again this is something that the Owners Management Company would look into.

Drain in car park

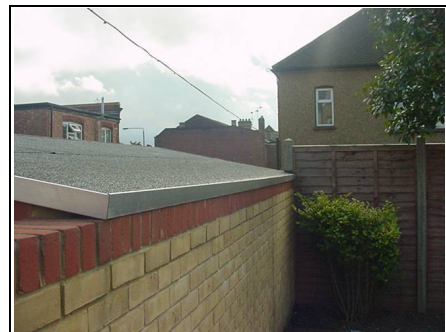
8.3 The lean-to is discharging against the wall rather than into a gutter.

Lean-to with no gutter

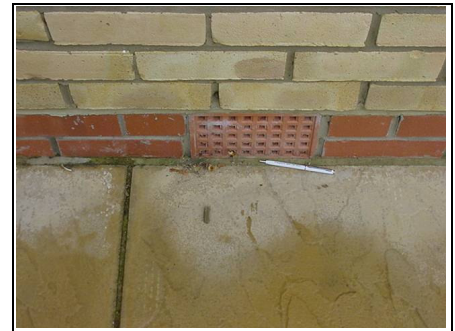
This has given us particular cause for concern due to the airbricks acting as gutters. Some work needs to be done to these to stop water getting in as we are concerned that the property has a suspended floor due to poor soil conditions. Unfortunately the last thing that you want with poor soil conditions is water pouring into the foundations.

Airbricks acting as gutters

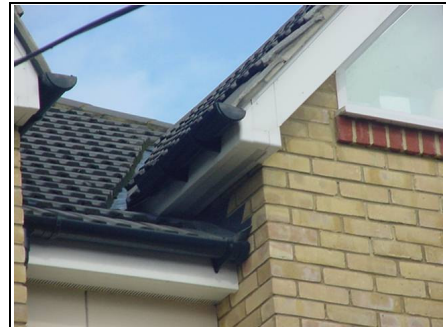
This is an awkward valley gutter detail which we suspect there will be problems with in years to come.

Awkward valley gutter detail

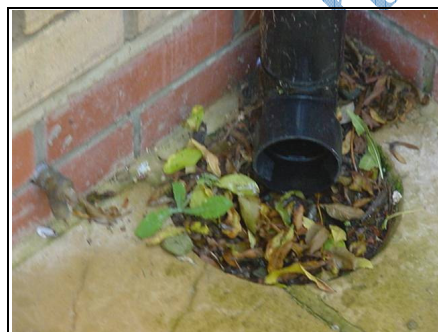
We were surprised to see that some of the downpipes were getting blocked this early in the autumn.

Blocked downpipes

ACTION REQUIRED: It will need regular maintenance to the gulleys at the bottom of the downpipes and we always recommend that annually the gutters and downpipes are cleared out and the joints etc.

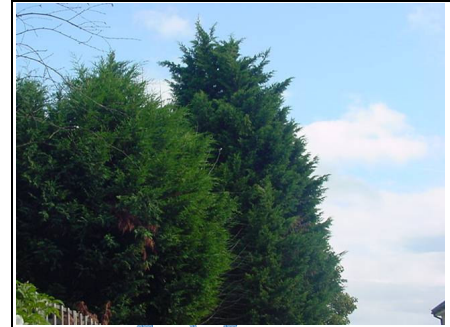
There are trees particularly to the rear of the property that may affect the sunlight/ possibly being within influencing distance of the main property as a whole although not your property.

Large conifers

ACTION REQUIRED: Someone from your management team needs to speak to the people about the trees and insure they will keep them maintained or agree that those trees overhanging the boundaries of this property are maintained.

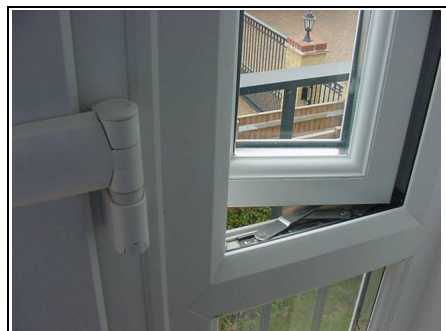
The property has plastic double glazed windows, which generally look to be of a reasonable quality with trickle vents. We particularly like the Juliet balconies although the window to the Juliet balconies have not been thought through properly as they are restricted on opening by the balcony and of course the view could be better.

Window hitting Juliet balcony

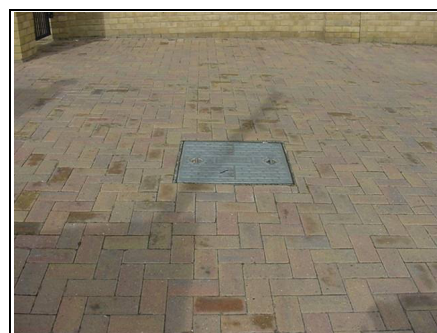
We started to lift this but the concrete started to come away so we didn't lift it any further. We are concerned that this manhole although it is outside the property it is in the driveway and it is the wrong quality of manhole cover is this suitable for heavy duty traffic?

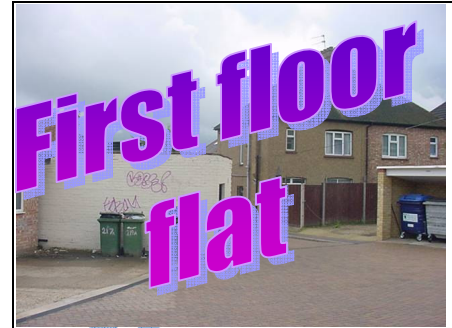
The property has very limited parking space. Please see our comments in the executive summary on parking.

Limited parking space
