SPECIFIC DEFECTS REPORT

Relating to Dampness

XXX Hackney, London. E5 XXX

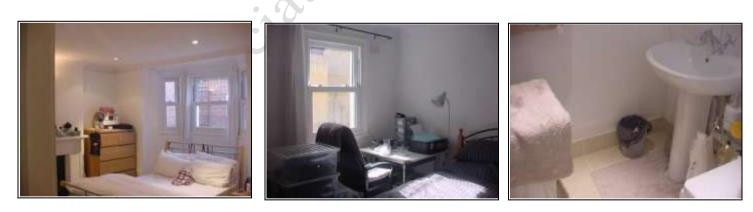
Lower Ground Floor (Basement)

On inspecting the property this leads us to believe that there is either no waterproof membrane (known as tanking) or there is a failed waterproof membrane to the lower ground floor (basement area) which is allowing damp into the property.

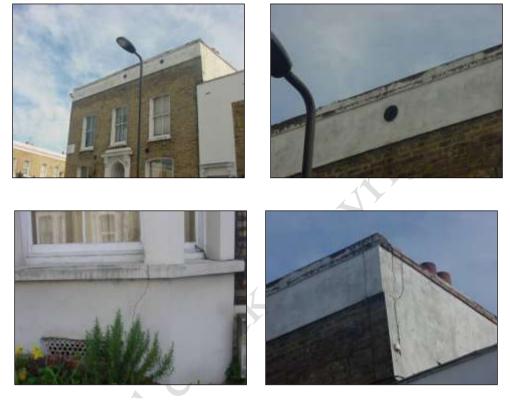
Tie-bars in end property of the row of houses showing that there has been problems with movement in the property generally

Cracking to next door neighbour's bay Cracking to the end gable of the window (Right hand side neighbour), all directions as you face the property
