RESIDENTIAL BUILDING SURVEY

Ifield, Crawley,
West Sussex, RH11

**Detached
Tudor
Property**

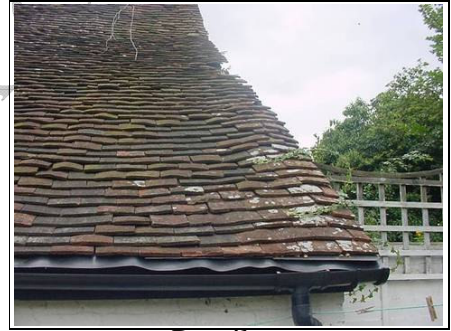
Where the old oak pegs have rotted away, and in some cases they have been replaced with ferrous nails, these have rotted or rusted.

Peg tiles

More immediately and to get you through the winter of 2011 you need to replace all the cracked and missing tiles with similar. You also need to get a supply of hand made clay peg tiles for future use.

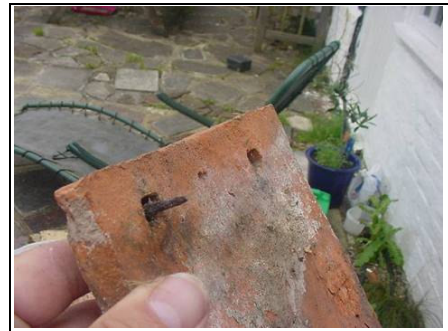
Close up of peg tile

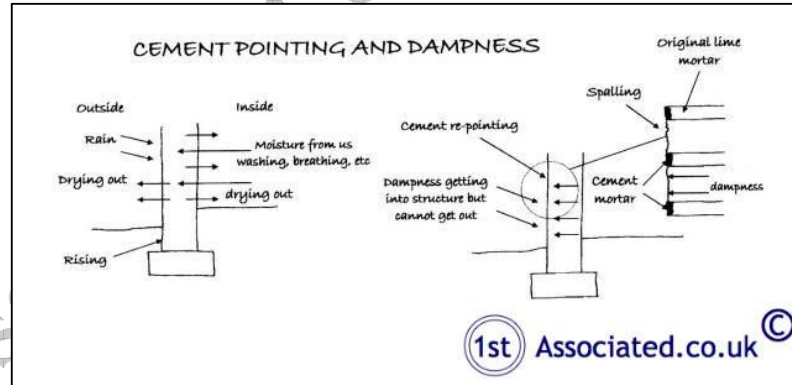
The chimney needs some work generally from repointing. You also need to check to see if it has been repointed in a cement mortar or lime mortar. It looks from ground level to be cement mortar.

Cement pointing

We would also recommend a lime coat or similar for the external of the building and you may also wish to look at how to treat the timbers rather than the black and white look which has become traditional (which was introduced by the Victorians). You may wish to lime wash the timbers as well for protection.

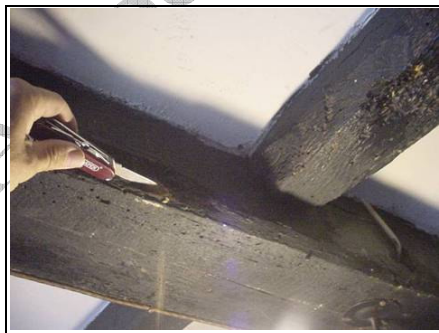
Internal spine beam with newish frass

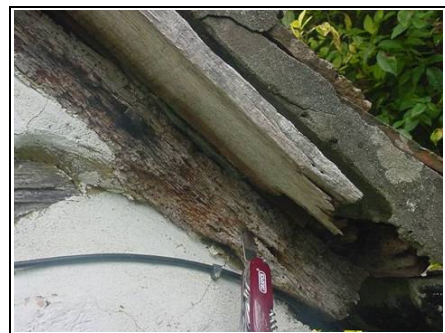
External timbers with woodworm which no longer looks to be active

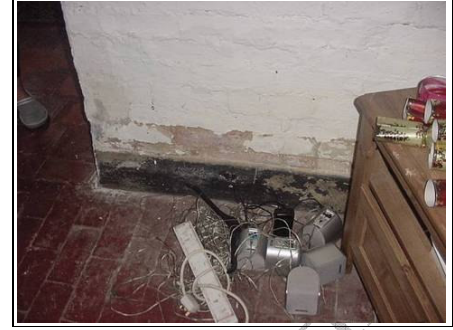
Lots of rising damp – paint coming off, we believe this to be a plastic based paint

ACTION REQUIRED: We would recommend that a French Drain is added around the property to lower the ground level which will lower the dampness.

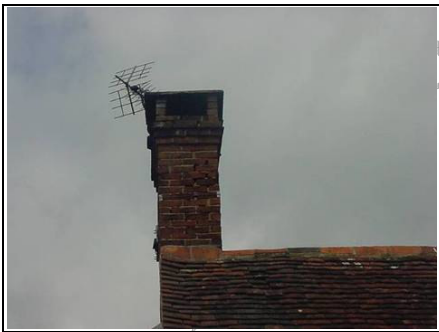
Chimney one

This chimney is brick finished with a tile on edge flashing. It would benefit from repointing and possibly re-building. The original structure is likely to be have been built without a chimney which is why the Listed building details identify the blackened timbers as the smoke would have risen into the roof. It may well therefore act as a separate structure to the main building, depending upon how it was built and how it was tied into the main structure.

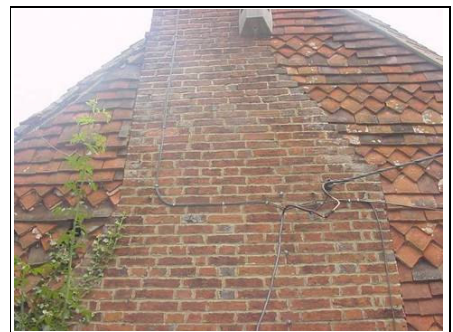
Chimney one – wrongly repointed in a cement mortar

ACTION REQUIRED: We feel the best way forward is to have a close look at the chimney from the top (using the tower scaffold that we have recommended you buy).

ANTICIPATED COST: We would set aside the sum of £750 to £1,500 to carry out repairs/rebuilding work. Please obtain quotations. Ultimately you will need to repoint the chimney in a lime mortar.

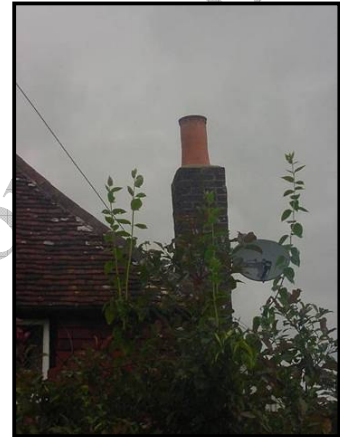
Chimney two

This chimney is brick finished with a lead flashing and one chimney pot. From what we could see from ground level, although our view was limited, it is in average condition for its age, type and style.

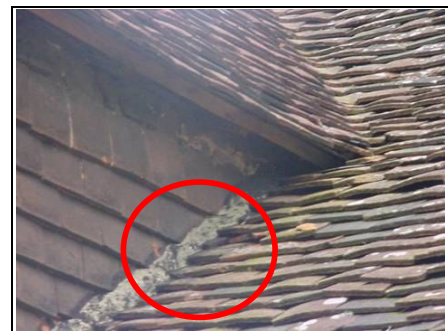
We can see some cement flashings. They may well be lime mortar judging from the colour. We would normally recommend a lead flashing but you do need to take guidance from your Conservation Officer with the local council on this as to what was authentic and it may be a lime mortar in this case.

Cement flashings rather than lead flashings

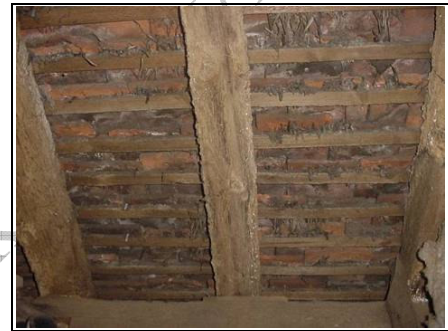
When we inspected the loft space we found there was no underfelt. It is therefore possible that during periods of heavy and prolonged driving rain some water penetration could take place through the roof coverings. At the time of our inspection this was not occurring.

No protective underlayer
(no sarking felt)

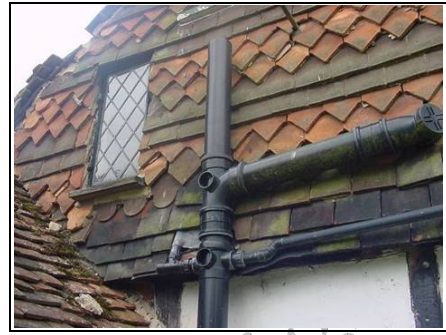
The property has plastic soil and vent pipes. There are some ugly soil and vent pipes to the rear of the property. Interestingly enough the soil and vent pipe is normally meant to discharge approximately one metre above the top of the roof. In this case it does not do, due to its position it would go over a window and this really is poor planning.

Plastic soil and vent pipe to the rear

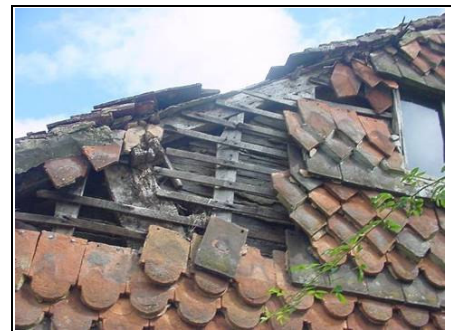
We noted vertical tiles coming off to left hand side of building.

Vertical tiles coming off to left hand side of building

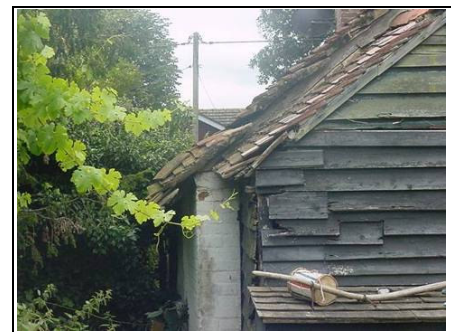
This shiplap boarding certainly has seen better days and needs tidying up, however you do need to focus mainly on getting the building wind and watertight before the winter of 2011.

Shiplap boarding deteriorating

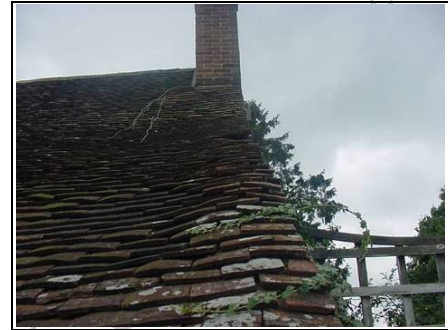
There are trees and vegetation growing close by the property. You need to cut all the ivy back and reduce the size of the trees but not remove them as this can cause problems with this age of property where it is built directly off the ground

Cut back all ivy

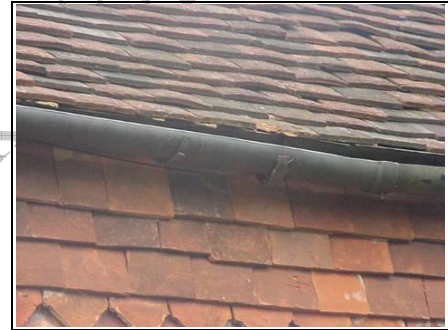
This gutter does not look to have a fascia board

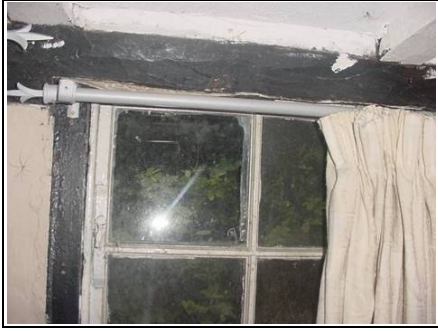
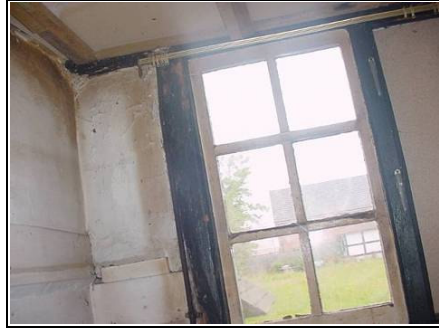
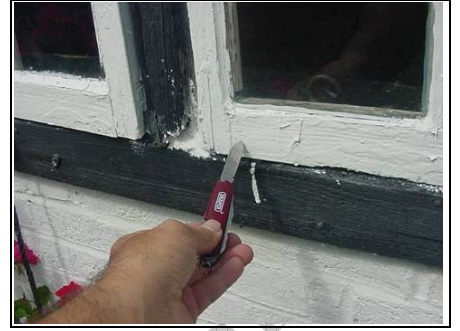
Variety of windows – all in need of redecoration

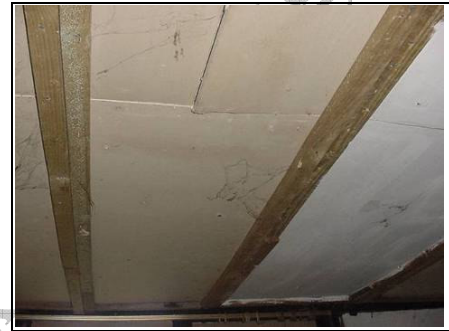
From our visual inspection the ceilings are likely to have originally been lath and plaster. We can see that they have been infilled with many materials including plaster, with some of it finished and some unfinished.

Infill to the ceiling

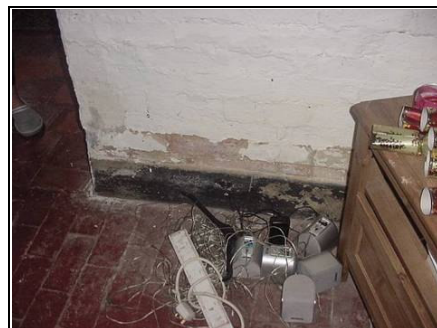
Lots of rising damp – paint coming off, we believe this to be a plastic based paint

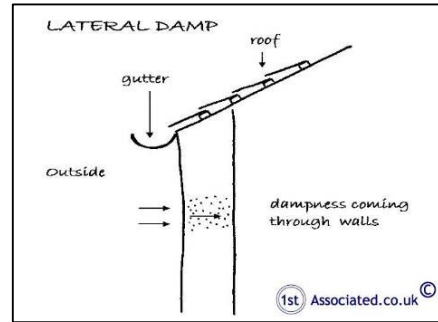
There is some lateral dampness. It is mainly to the walls on the ground floor, the vertical tiling is protecting the upper floor to some extent. Again, repointing is needed and you need to get this building breathing to reduce the dampness but you will never get rid of all of it.

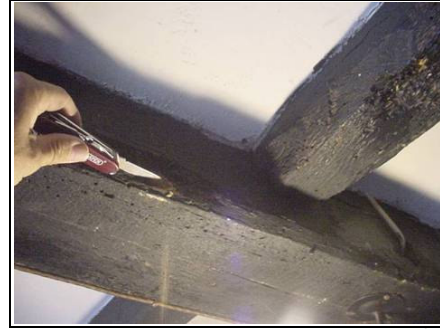
Woodworm with frass

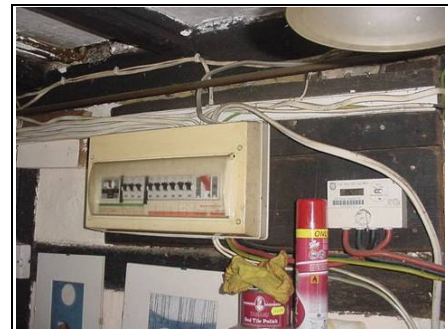
The electric fuses and consumer units were located in the kitchen. The fuse board looked dated and not the best currently available.

Fuse board

For the electrics we would recommend an NICEIC registered and approved electrical contractor or equivalent carries out an inspection, test and report to Institute of Electrical Engineers standards (IEE).

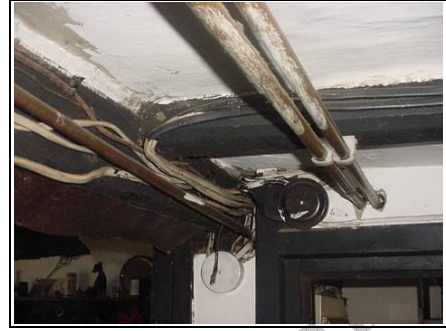
Surface mounted plumbing – plumbing could be better concealed
