JOB REFERENCE: XXXX

RESIDENTIAL BUILDING SURVEY

Bedfordshire

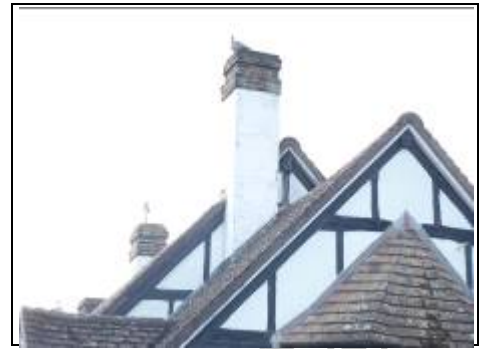
The left chimney looks to be in use. We noted the render around it is starting to crack. We believe it is likely to be cement render as we found this in the majority of the rest of the building.

Cracks to render

ACTION REQUIRED: We recommend that you repair this chimney as if water gets in behind the render then it can come away. At the same time check the other chimney. There is also other high level work that we mention in the next section.

ANTICIPATED COST: Set aside the sum of £2,500 - £5,000 for chimney and high level repairs; please obtain quotations.

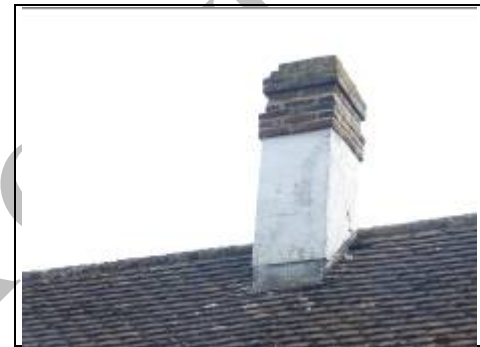
Crack to render of middle chimney

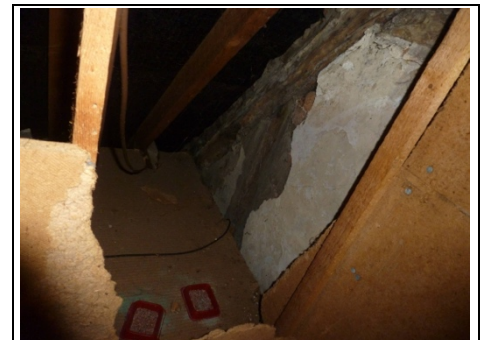
There are some timbers visible to the gable end that are starting to rot at high level. This may or may not be part of the original box timber frame. Within the roof space we could see some older timbers therefore care should be taken when examining this area. We would be more than happy to return and help if so required.

Old timbers in roof space

ACTION REQUIRED: Repair.

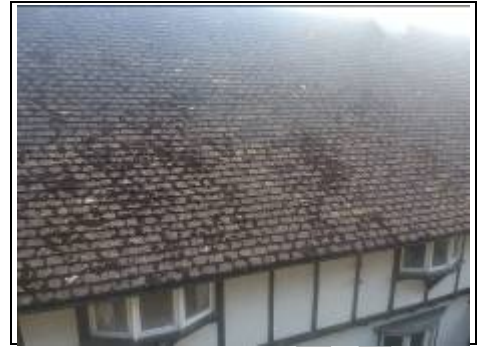
The main roof has a relatively steep pitch with a concrete tile. The tiles have more than the average amount of moss, as we often find in areas where there are large trees as they shelter the building from sunlight and also reduce air movement which tends to encourage moss. Moss then accelerates the deterioration of the tiles; it looks to have done this to the rear of the property. We can see this has been a concern for some time as there was a tile guard above the glass roof area to the rear which is starting to rust.

Moss on roof
~ Aerial View - 360 Photo ~

ACTION REQUIRED: Monitor roofs. The difficulty with carrying out work on these roofs is that when you move one tile you have to move a lot of tiles so sometimes these roofs bond themselves together far beyond what you would expect. We would however start to budget for roof repairs.

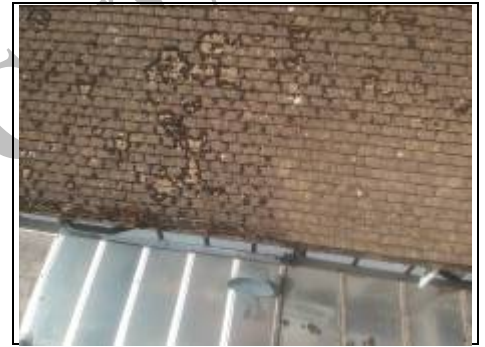
Moss
~ Aerial View - 360 Photo ~

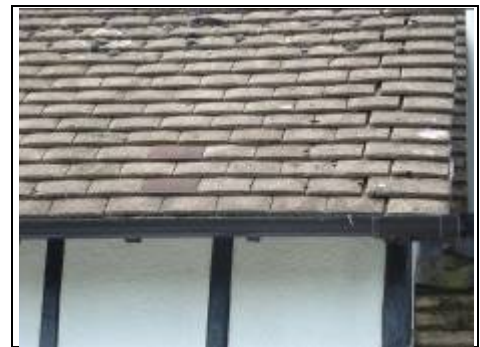
We can also see some opening up of the tiles.

Opening up of tiles

ANTICIPATED COST: Budget £2,500 - £5,000 for repairs. We would also identify a matching tile and ensure that you have a store of replacement tiles available. Please obtain quotations.

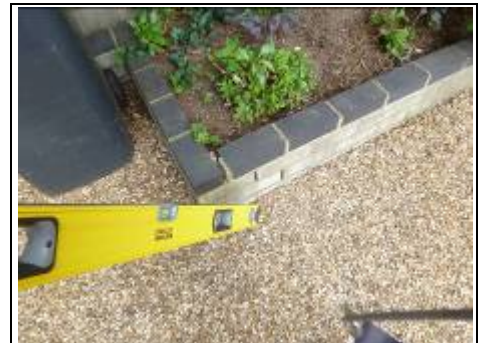
Small tree to front causing movement to dwarf wall

ACTION REQUIRED: We recommend maintenance of the trees as soon as possible.

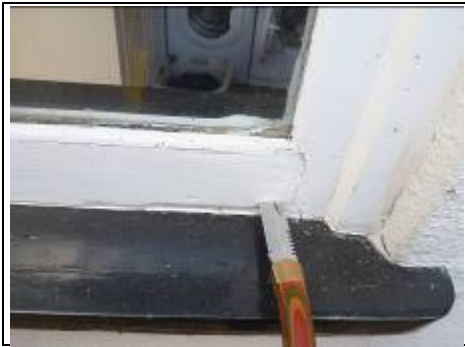
We found rot in the windows at ground floor level where we were able to knife test them. We suspect that there will also be rot at first floor level and also to the rafter feet which are very difficult to decorate. We normally find it is the ground floor windows that have problems and the upper areas have more problems.

Rot to garage window

ANTICIPATED COST: Budget £10,000 - £15,000 for timber repairs; please obtain quotations.

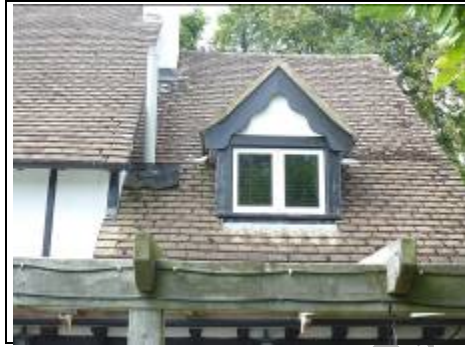
Deterioration to rear dormer

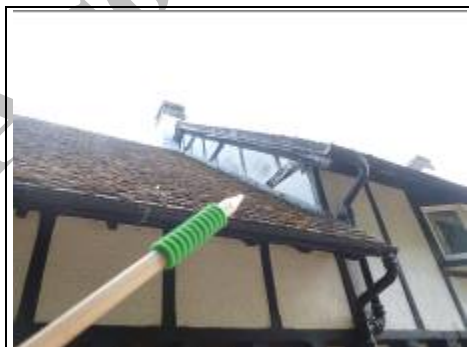
There is rot to the timber gable end which we have already mentioned in the high level work. With an older timber frame the quality of timber used was very good. Our concern is with a refurbishment post war the quality of timber may not be as good. We believe it is possible there will be considerable work required to the timber frame.

Rot to end timbers of gable end

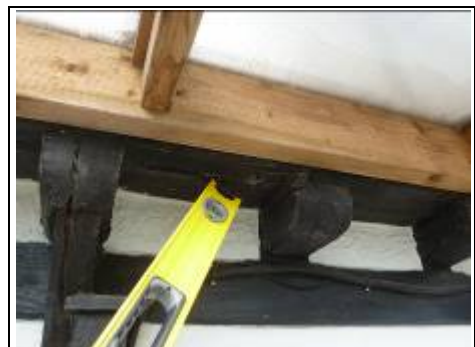
Rot starting to occur in jetty timbers to rear

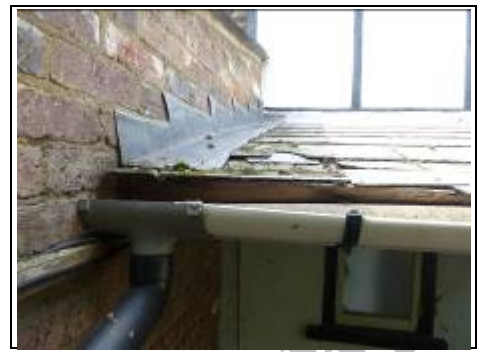
Tiles on end could be asbestos

ACTION REQUIRED: The only way to be one hundred percent certain with regards to Asbestos in a property is to have an Asbestos report with samples taken and the recommended action carried out.

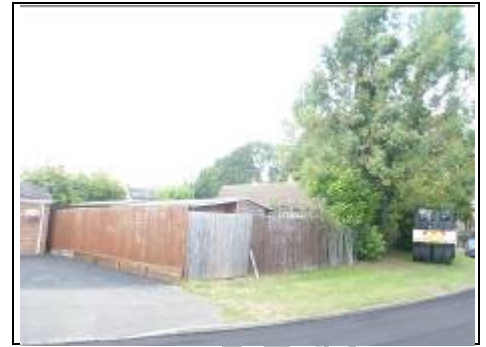
The rear of the left fence is in poor condition. Confirmation is required as to who owns this fence (we believe it is probably yourselves) and who has liability to repair it as it needs repairing).

Rear left fence in poor condition

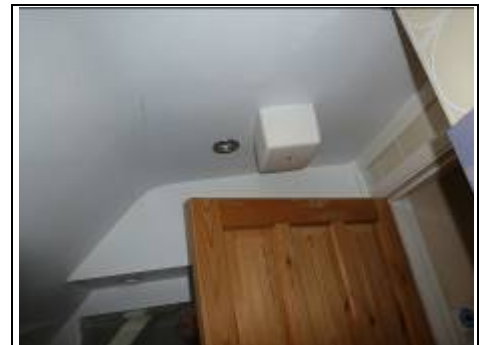
We noted an extract in the bathroom however it is still likely to have condensation as the ceiling is partly built in the roof.

Extract fan in bathroom

ACTION REQUIRED: We would recommend large good quality humidity controlled extract fans are added to the kitchen, the bathroom and any areas that are humidity generating for example areas that are used for drying clothes internally during winter months (we would assume that clothes will be dried externally during the warmer months). By large extract fans we mean 150mm.

ANTICIPATED COST: We would anticipate costs between £250 - £500 per extract fan depending upon the wiring required. We always recommend quotes are obtained before work is agreed/commenced.

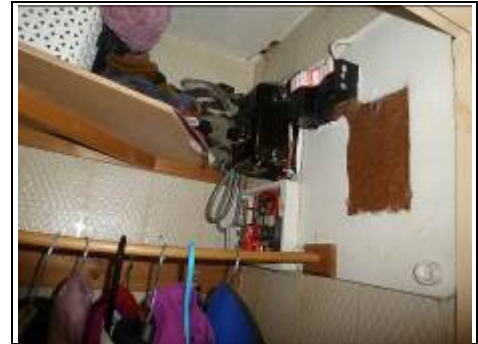
There is a 1970's-1990's fuse board in the kitchen cupboard. In in a timber frame building we would always recommend the most up to date fuse board therefore we would upgrade the fuse board to a modern fuse board which is in a metal casing to fire standards.

Old fuse board

ACTION REQUIRED: The Institution of Engineering and Technology (IET) recommend a test and report when properties change hands, to be carried out by an NICEIC registered and approved electrical contractor or equivalent.

ANTICIPATED COST: £250 - £500 for a test and report plus any work recommended; please obtain quotations. Expect costs in the region of £1,000 - £2,000 worth of repairs.

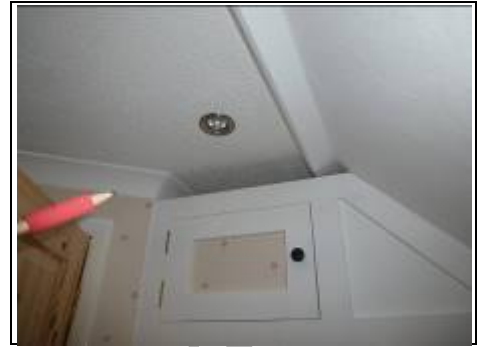
The property has ceiling lights which when we were in the left side of the roof did not seem to have proper covers. We are aware that some modern LED lights and low energy lights do not need covers. These lights are worth checking as there have been fires caused by these lights in the past (we would certainly recommend ensuring they are not covered with anything).

Older style light

ANTICIPATED COST: Cost depends upon the type of light you replace them with, if they need replacing. Please obtain quotations.

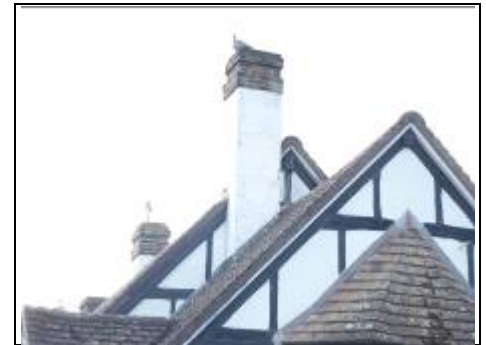
Cracks to render

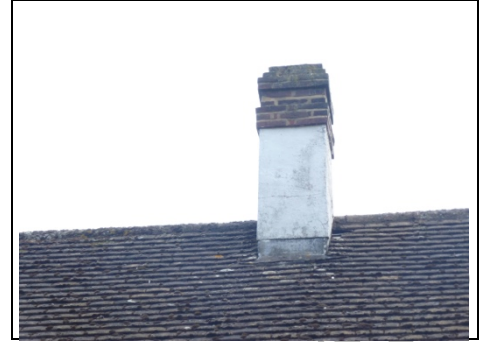
This chimney is render finished with a brick top and lead flashing. From what we could see from ground level it looked in below average condition considering its age, type and style with hairline cracking. The chimney looks to have had some repointing work to the top brickwork; ask the existing owners what work has been carried out and when.

Middle chimney front view
~ Aerial View - 360 Photo ~

ACTION REQUIRED: When carrying out work to the left chimney we would also recommend work to this chimney.

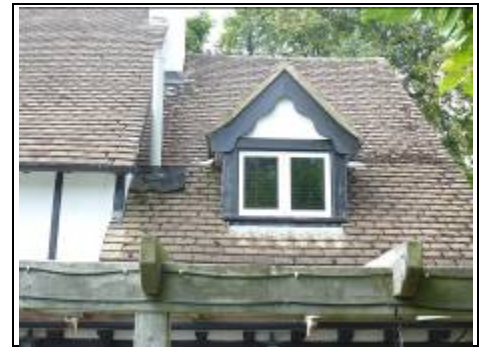
There is a dormer to the newer left extension. This looks in average condition. We would recommend redecoration in the summer of 2020 as we are recommending all the timber is redecorated.

Deterioration to rear dormer

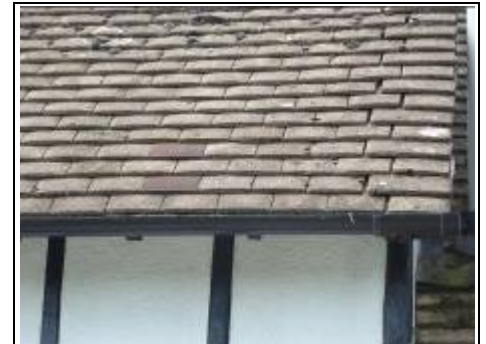
Opening up of tiles

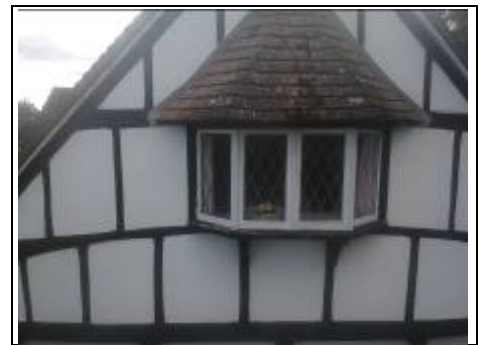
Oriel window deteriorating

Please see our comments with regards to repairs required to timber.

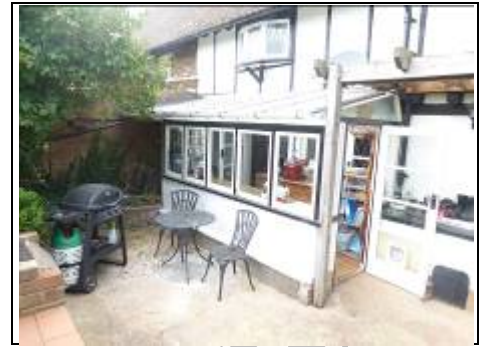
The rear canopy has a Georgian wire polished plate glass roof with flashband repairs. We believe the timber frame that it sits in needs repair. Care needs to be taken with these large sheets of glass.

Rear entrance/boot room roof

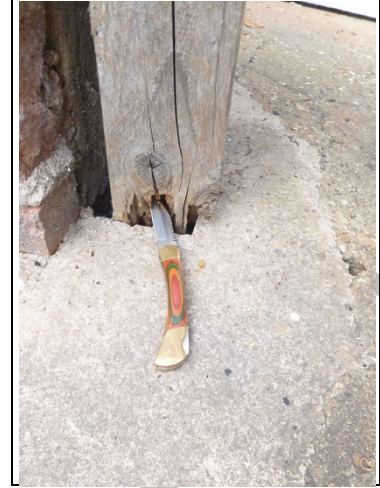
Rotten post

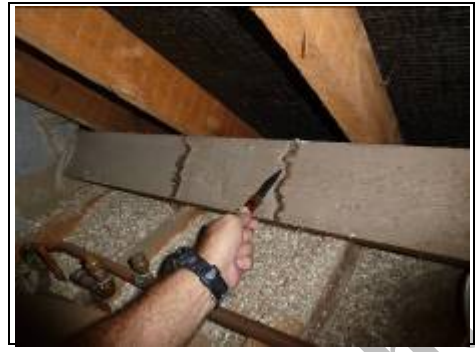
Dampness

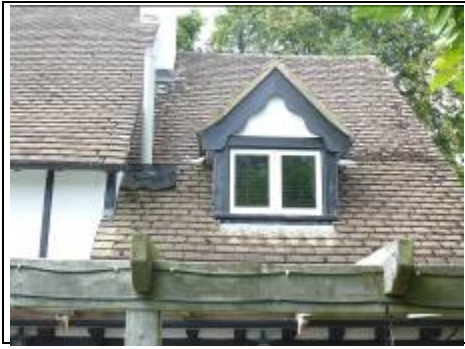
Deterioration to rear dormer

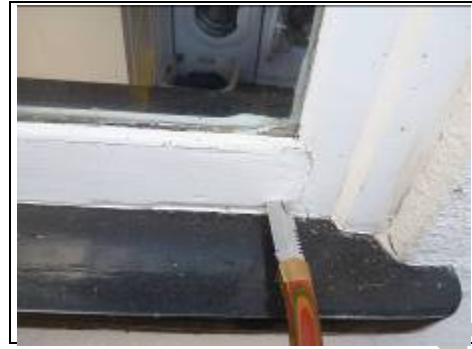
Rot to garage window

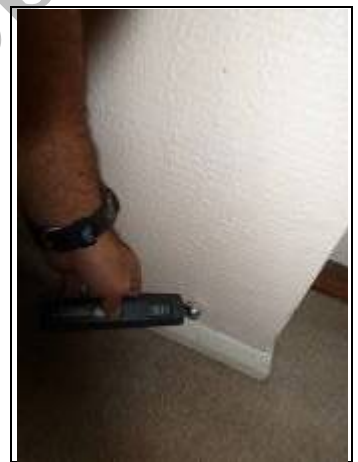
High damp meter reading

ACTION REQUIRED: Please see the Executive Summary.

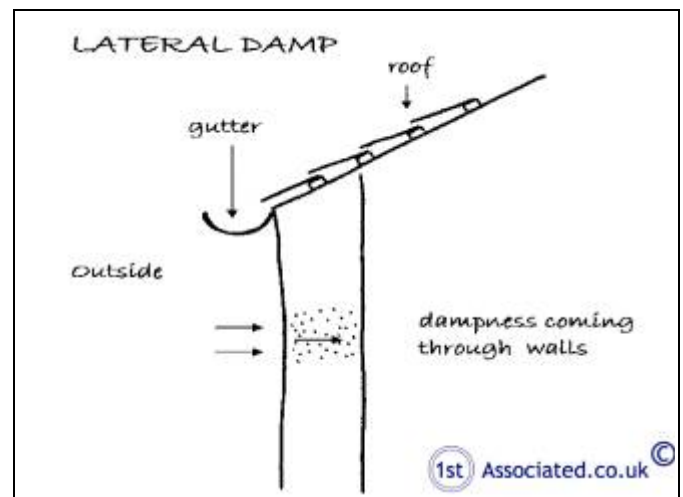
We used a resistance meter on the external walls. In this case we were unable to obtain readings in some areas due to the dry lining. This may indicate there is some original timbers present. Equally, it could indicate there is a more modern construction where it has been lined and insulation added.

Lateral damp

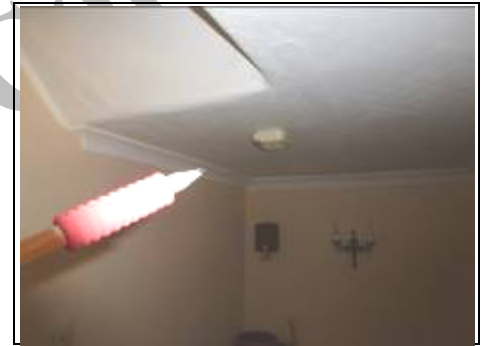
Some smoke detectors were noted, we were disappointed these were battery operated. The current Building Regulations require that they be wired into the main power supply. Obviously in a property of this age this is difficult, as it would mean having surface mounted wires or cutting wiring into the plaster.

Battery fire alarm

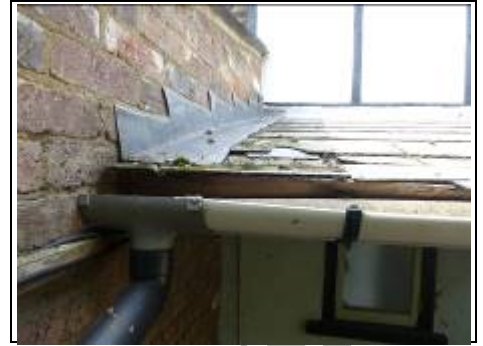
Tiles on end could be asbestos

ACTION REQUIRED: If you wish to confirm you are one hundred percent free of asbestos you need to have an asbestos survey carried out.
