JOB REFERENCE: XXXX

## RESIDENTIAL BUILDING SURVEY

Bedford  
Bedfordshire  
MK43 XXX

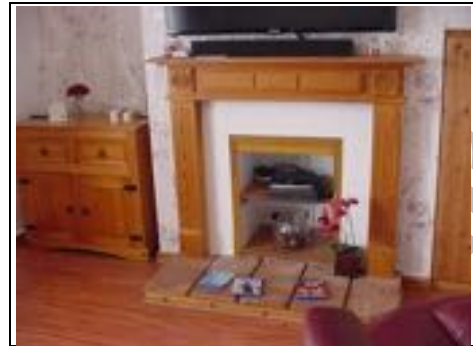
Front fireplace with asbestos flue

**ACTION REQUIRED:** The only way to be one hundred percent certain with regards to Asbestos in a property is to have an Asbestos report with samples taken and the recommended action carried out.

We would always recommend any asbestos is removed from a property as it can not only be dangerous, it can affect the value of the property.

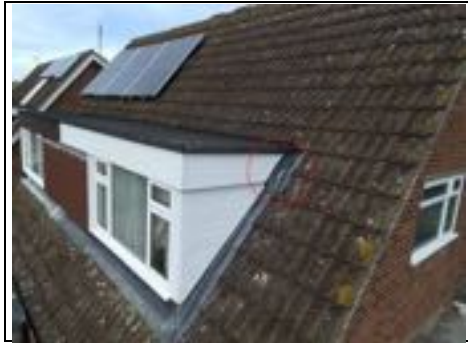
There is water sitting where the pitched roof meets the flat roof and we can see there has been a repair to the flashing.

Repair to flashing  
~ Aerial View - 360 Photo ~

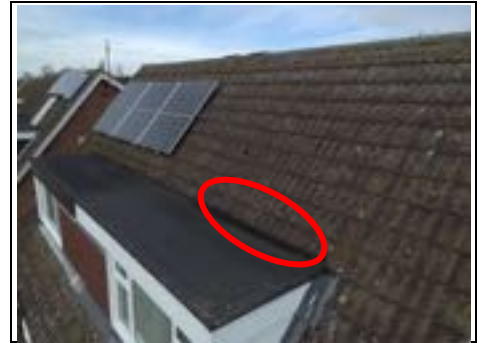
Water tipping/sitting on front flat roof  
~ Aerial View - 360 Photo ~

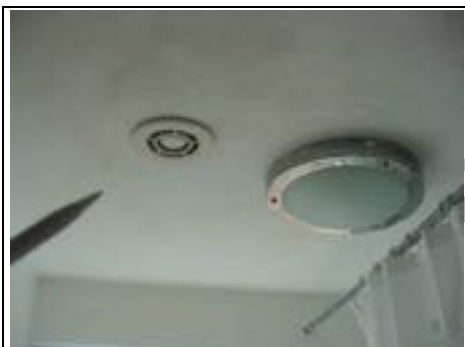
However this property has a fundamental problem with the extract fan within the bathroom discharging humid air into the roof space, this needs to be altered and the extract needs to go to external air as it normally would.

Bathroom extract

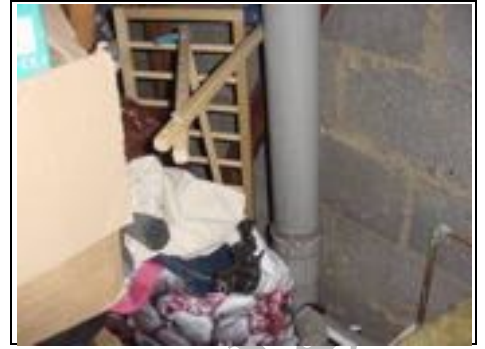
There are lots of stored items within the roof which unfortunately are adding to condensation problems. The stored items include general files, etc and also duvets and clothing, which we believe are acting like a sponge in the roof particularly as the extract fan is discharging humid air from the bathroom into the roof.

Clothes stored within roof space

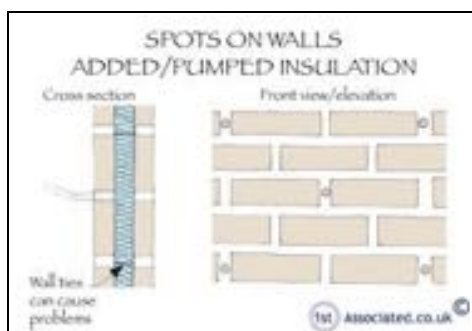
We noted spots to the brickwork which is likely be where insulation has been inserted or there is an outside chance it is wall tie replacement. We spoke to the person who had opened the house for us and they advised that they had contacted the owners and they thought it was wall insulation. However adding wall insulation is not as simple as just putting insulation in as there can be problems with wall tie deterioration and also dampness in the property.

Signs of pumped insulation to walls

Your legal advisor needs to check whether the insulation has a CIGA Cavity Insulation Guarantee Agency certificate to see if the wall ties were appropriate before the insulation was added as inserted insulation can cause deterioration of the wall ties. Contact CIGA at XXX, telephone XXX. If there is not a CIGA certificate then it does not mean it is necessarily a problem however ideally we would recommend opening up a small section of the wall to check the condition of the insulation and the wall ties.

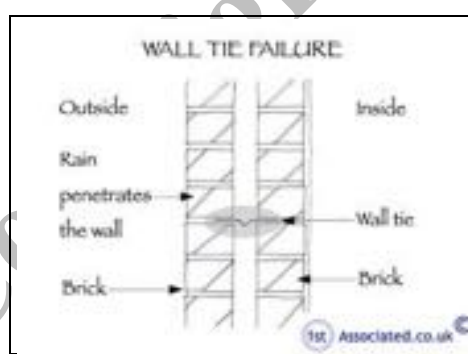
Wall tie failure

In a worst case scenario the wall ties will need to be replaced however having said that we cannot see any of the horizontal cracking that we would normally expect to see in a situation where the wall ties need repair.

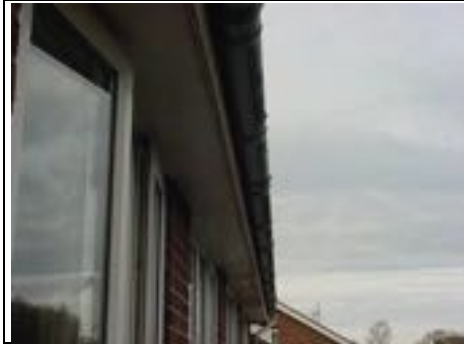
We have already mentioned fascias and soffits with regard to adding ventilation. We did note the fascias and soffits are in a dated/deteriorating condition.

Deterioration to fascias and soffits of the house

**ACTION REQUIRED:** We recommend that the fascias and soffits are redecorated ideally within the next few years during the warmer months when you could look at also adding ventilation to them.

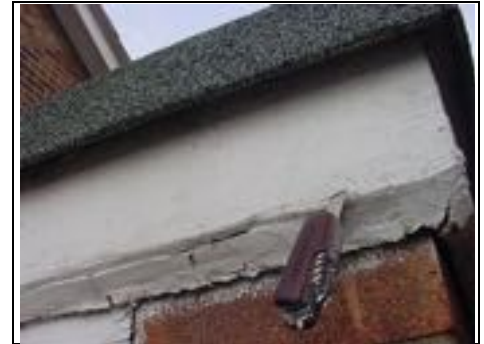
Rot to garage fascia

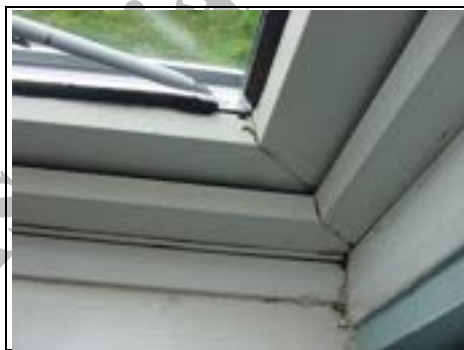
There is deterioration to the seals of the double glazed windows. We could also see black mould to some of the windows; see comments below.

Black mould to windows and rubber seals perishing

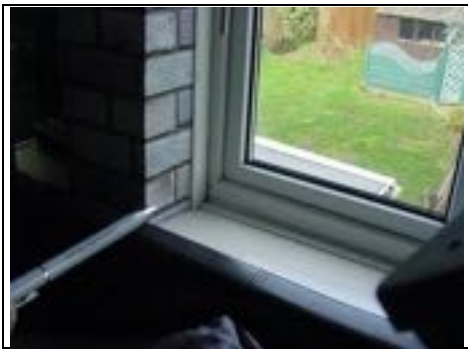
Black mould

**ACTION REQUIRED:** We would recommend large good quality humidity controlled extract fans are added to the kitchen, the bathroom and any areas that are humidity generating for example areas that are used for drying clothes internally during winter months (we would assume that clothes will be dried externally during the warmer months). By large extract fans we mean 150mm.

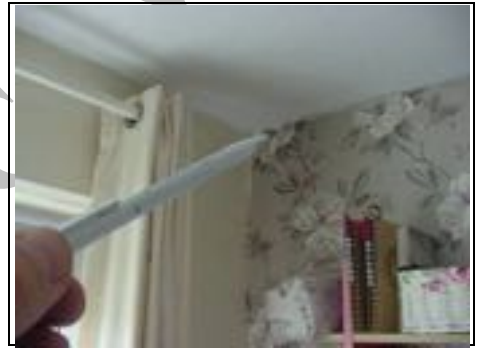
Black mould painted over in rear right bedroom

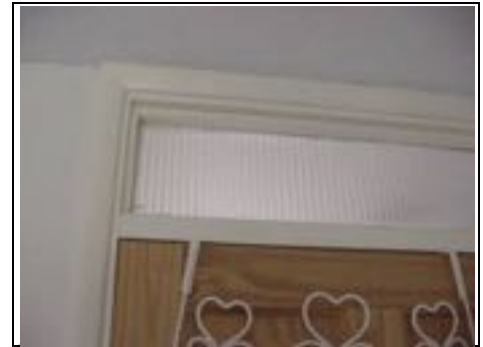
Fluted glass above doors not safety glass

**ACTION REQUIRED:** Check with the owners if this is safety glass or not. We would recommend replacing the glass with safety glass if it is not safety glass.

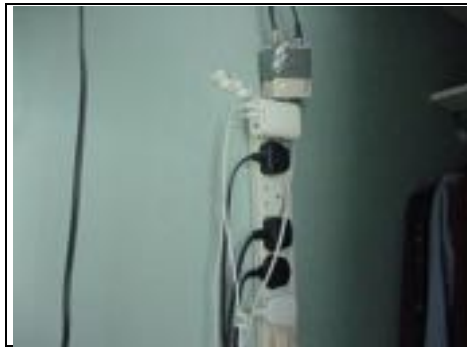
The electrics are dated with not enough socket points. We noted that the socket points are single and there are many extension cables on these.

Lack of socket points

We recommend an Institution of Engineering and Technology (IET) test and report to be carried out by an NICEIC registered and approved electrical contractor or equivalent.

**ANTICIPATED COST:** £500 - £1,000 for additional socket points. £250 - £500 for a test and report plus any work recommended; please obtain quotations.

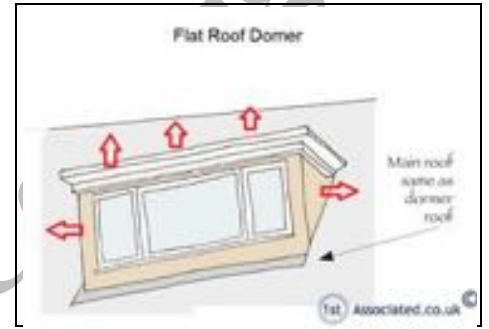
Dormer heat loss

**ACTION REQUIRED:** We recommend you upgrade to double panel convection radiators. We would recommend the radiator in the lounge is moved under the window. Originally windows had panels underneath as seen on a nearby property, some have glazed the panels and in your case brick has been put underneath.

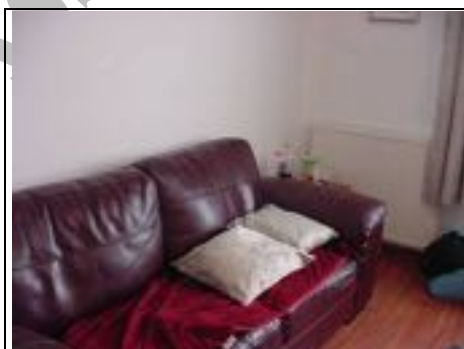
Lounge radiator

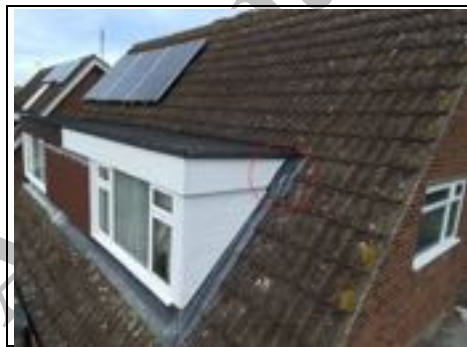
Generally we would comment for their age, type and style they are in slightly below condition. We would particularly draw your attention to water tipping/siting on the roof and we can see there has been a repair to the flashing.

Repair to flashing  
~ Aerial View - 360 Photo ~

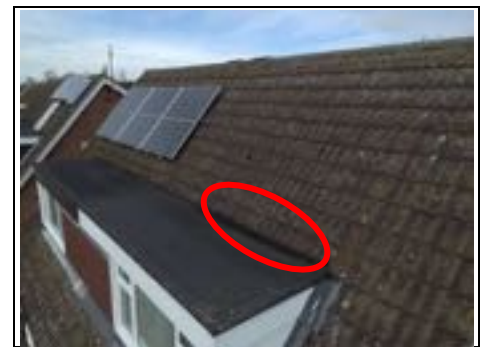
Water tipping/sitting on front flat roof  
~ Aerial View - 360 Photo ~

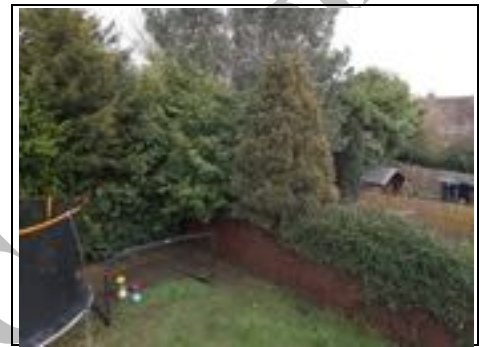
There are trees to the rear of the garden. As discussed you need to establish whose boundary this is and who carries out the cutting back of the trees as they look overgrown. We do not believe the trees are within what we would term as influencing distance but you do need to speak to your insurance company as they may have a different interpretation for insurance reasons.

Trees to rear  
~ Aerial View - 360 Photo ~

**ACTION REQUIRED:** We would recommend the trees are cut back and maintained.

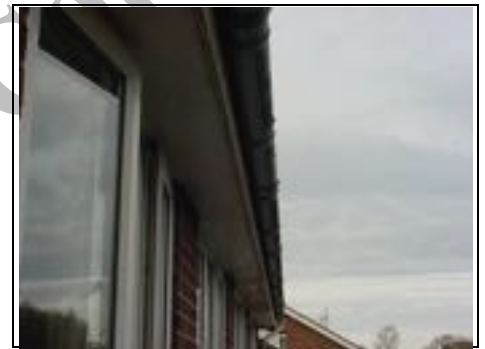
Deterioration to fascias and soffits

**ACTION REQUIRED:** Make sure gutters and downpipes are watertight before carrying out any work on fascias and soffits.

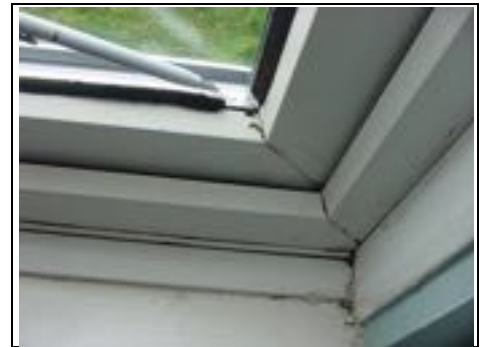
Black mould to windows and rubber seals perishing

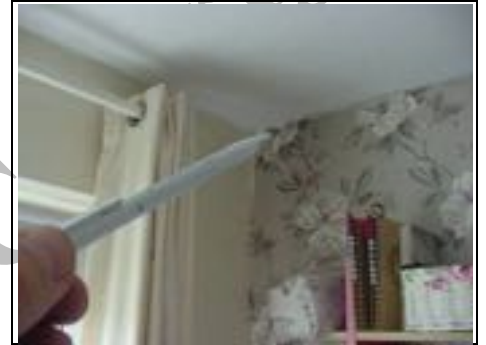
From our visual inspection of the ceilings and our general knowledge of this age and type of construction we believe that the ceilings are likely to be plasterboard or there may be some proprietary boarding as this was fairly common in this era of property. We noted an area of black mould which has been painted over in the rear right bedroom, there may also be other areas painted over.

Black mould painted over in rear right bedroom

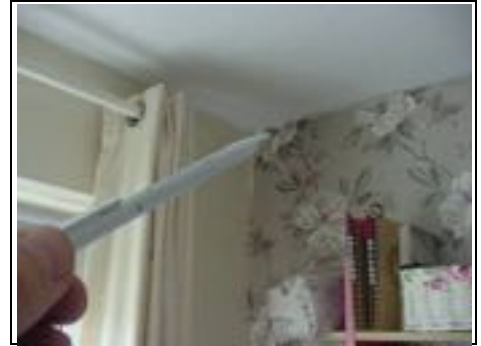
Black mould painted over in rear right bedroom

A way of helping to reduce condensation is to have good quality large extract fans with humidity controlled thermostats within the kitchens and bathrooms and also in any areas where you intend to dry clothes which are moisture generating areas.

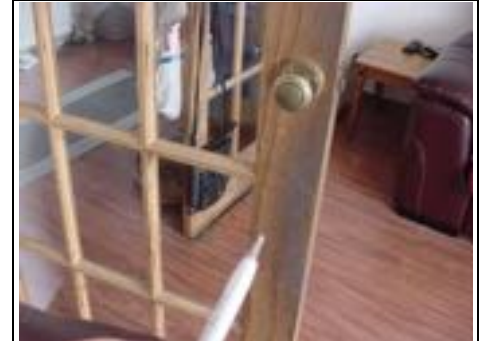
Glazed door worn

**ACTION REQUIRED:** Please see our comments in the Executive Summary with regards to glazed doors.

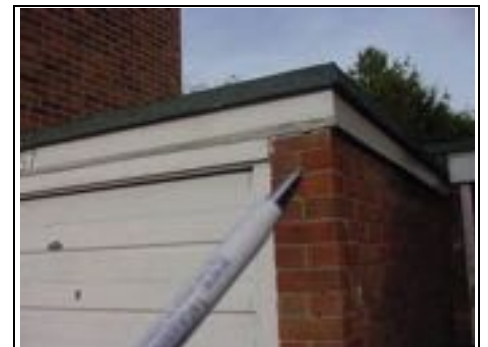
Rot to garage fascia

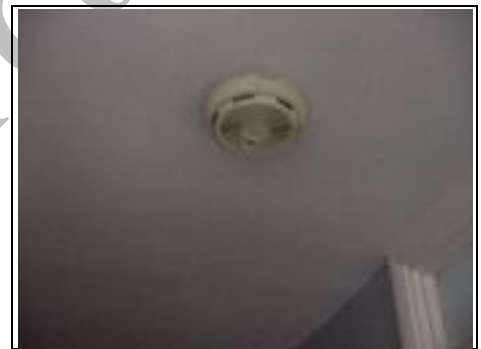
Alarm to be replaced

**ACTION REQUIRED:** We would recommend, for your own safety, that additional smoke detectors are installed. We would always recommend a hard wired fire alarm system and are also aware that some now work from a wireless signal which may be worth investigating. Whilst fire is relatively rare it is in a worst case scenario obviously devastating.

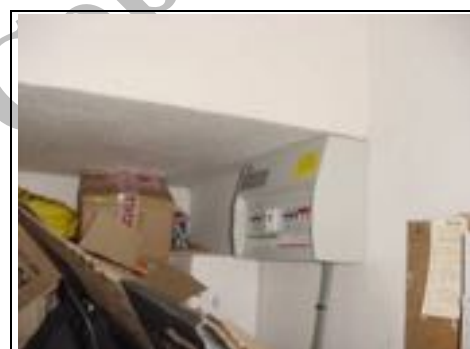
The electric fuses and consumer units were located in the cupboard from the dining room on left side. The fuse board looked 1980's/1990's and better are now available. We would recommend additional socket points are added; please see our comments in the Executive Summary.

Fuse Board

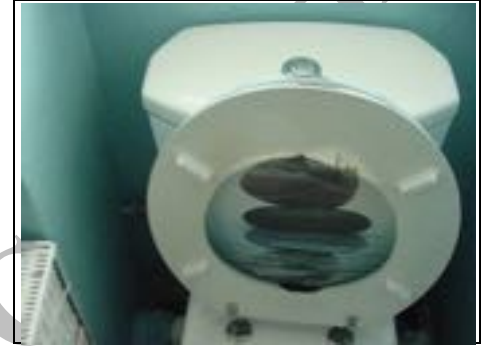
There is a separate WC adjacent to the bathroom. The toilet seat is damaged and we recommend replacement.

Damaged toilet seat

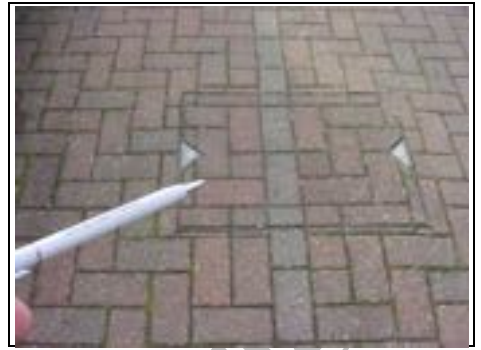
Manhole to middle of driveway

**ACTION REQUIRED:** We would recommend a closed circuit TV camera report of the drains particularly as you are looking at adding to the drains.

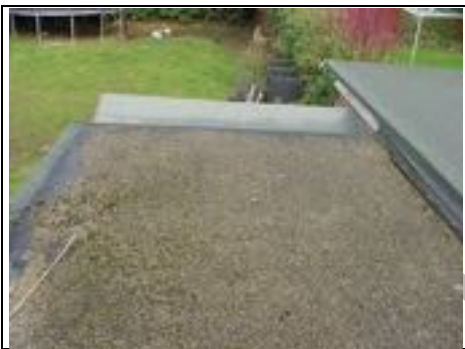
The garage has a flat roof covered in felt with a felt flashing. The water discharges to the rear of the property (in theory) however it is being caught by the shed on the rear. To the front of the property on the right side there looks to be water discharging as there is rot to the fascia board. If you re-roof we would recommend upgrading to a lead flashing as they are more pliable and tend to last longer.

Garage flat roof

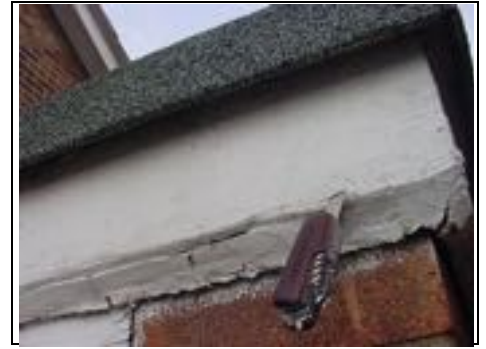
Rot to garage fascia

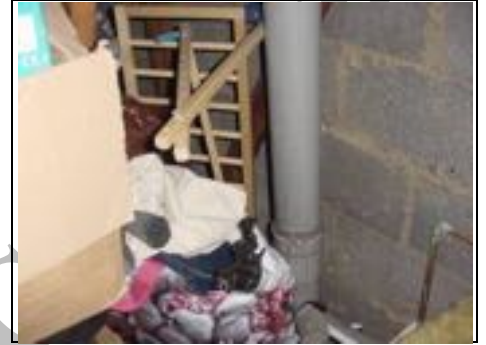
Stored items within roof
