RESIDENTIAL BUILDING SURVEY

British Iron and Steel Federation (BISF) Constructed House Wales

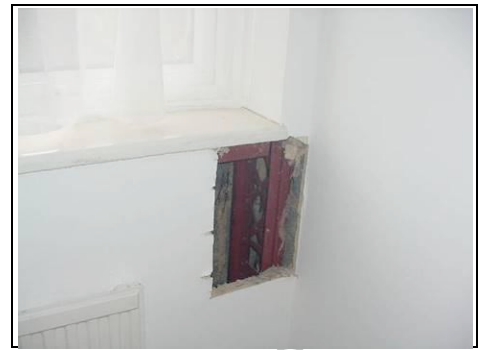
Example of opening up of a property
(Not your property)

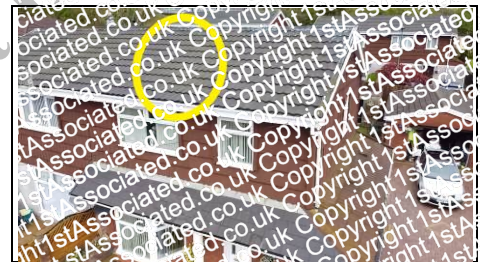
Area of roof not hidden
(highlighted in yellow)
Aerial view – 360 photo

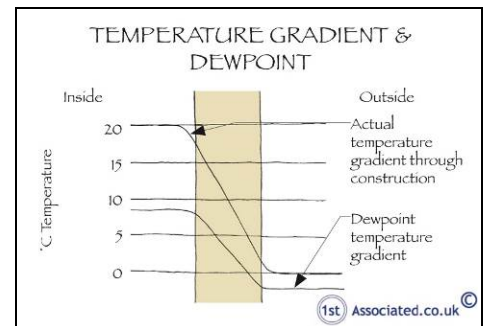
Interstitial condensation in a solid wall

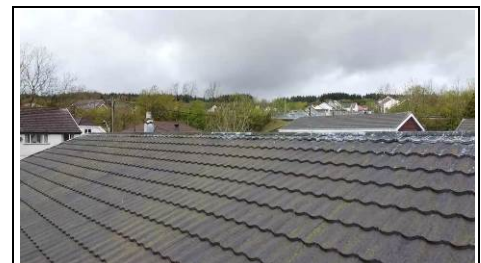
Pressed metal roof, a chimney would have once been present
Aerial view – 360 photo

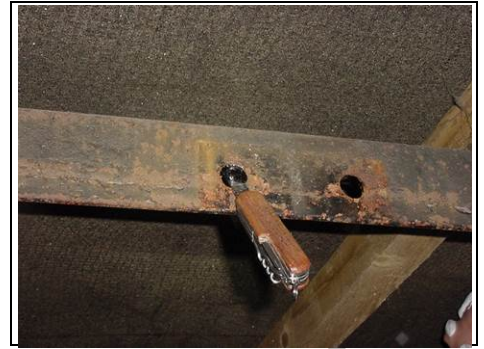
Area of roof space where we believe the chimney once was

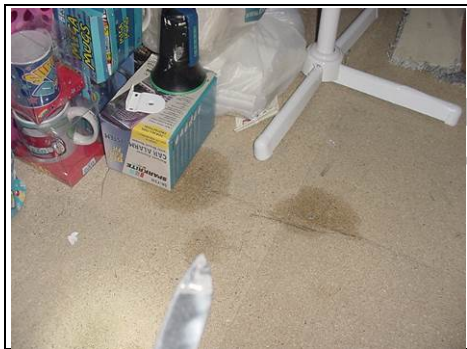
Damp stains in roof space, which we believe have been there a while

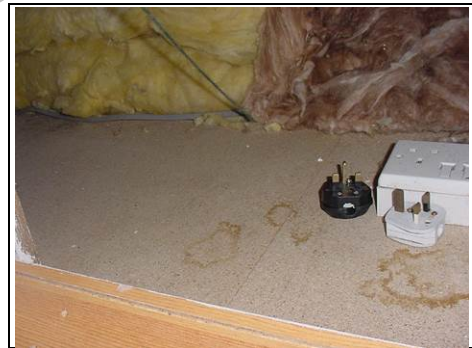
More staining in roof space

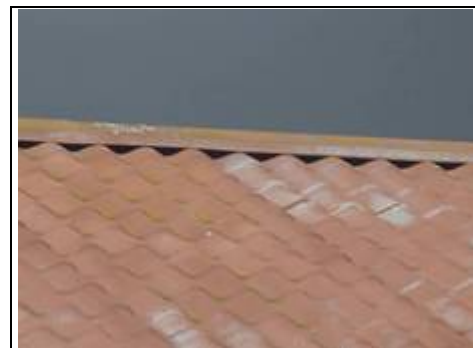
Example of weathering to pressed metal roof (Not this property)

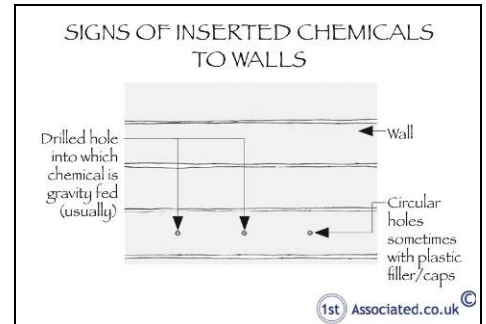
A lot of the pointing has weathered in the rear paving slabs

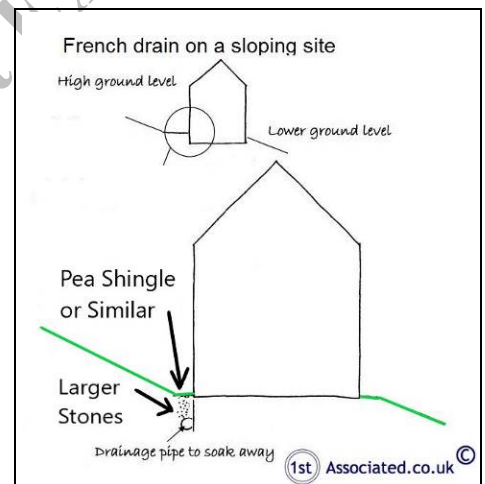
ANTICIPATED COST: Costs in the region of £750 to £1,500 if it is done properly and drained into the rear right manhole.

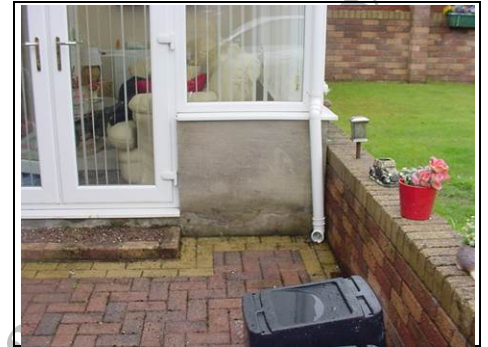
Downpipe by conservatory discharging in wrong area

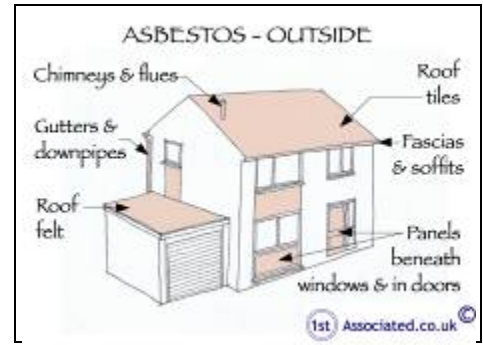
When this property was built asbestos was a common popular material which was used almost as commonly as wood. As mentioned it formed the original roof material and it also generally formed such things as the fascias and soffits (which have now been over-clad with plastic), the gutters and downpipes.

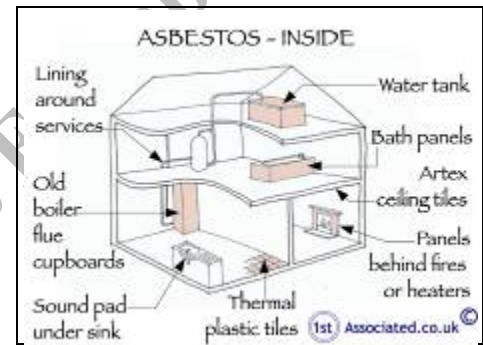
Internally, there are textured painted ceilings, the older style often contains an element of asbestos, although this does look to be quite modern.

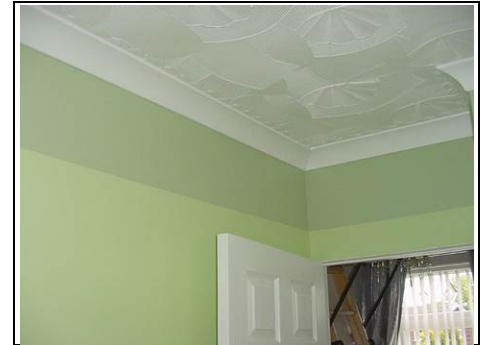
Textured paint in fan pattern

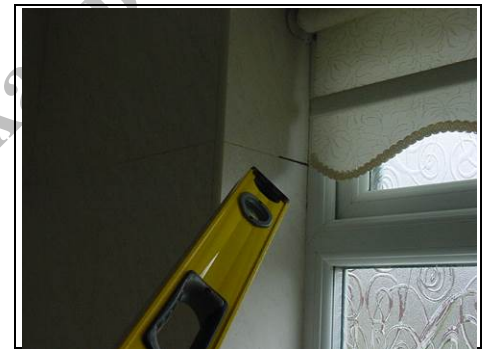
Very slight black mould in bathroom

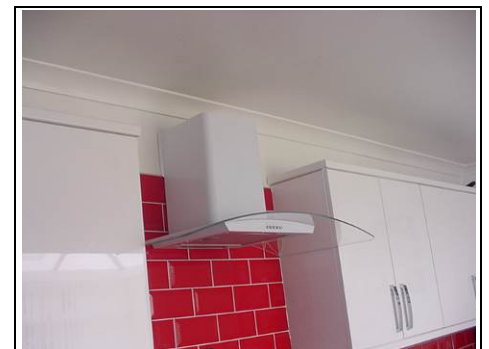
Kitchen air filter is not an extract fan

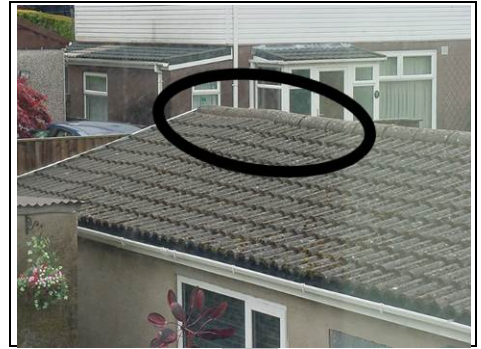
Dip in garage roof to the rear and there may be deterioration in this area

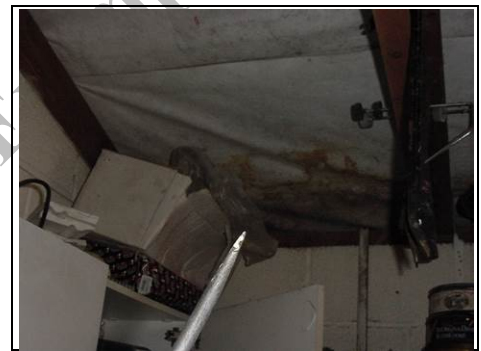
Dampness coming in through garage roof

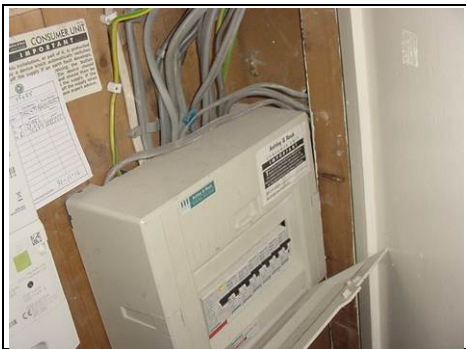
Dated fuse board under the stairs

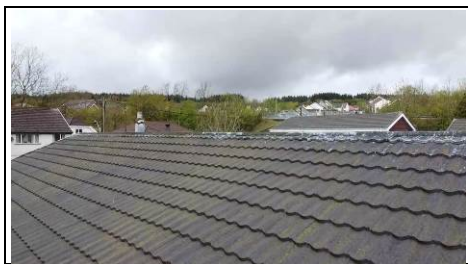
Pressed metal roof, a chimney would have once been present
Aerial view – 360 photo

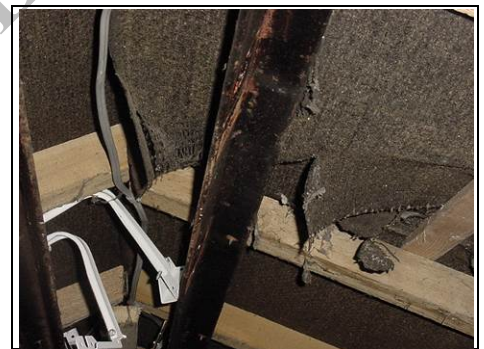
Protective underlayer not bedded particularly well which may have been an area affected by removing the chimney

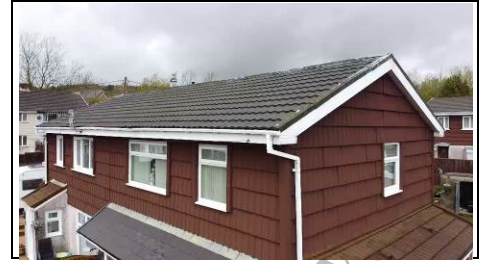
Pressed metal roof
Aerial view – 360 photo

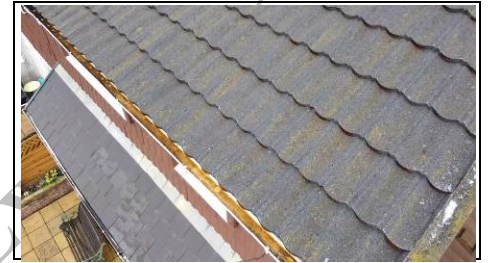
Close up
Aerial view – 360 photo

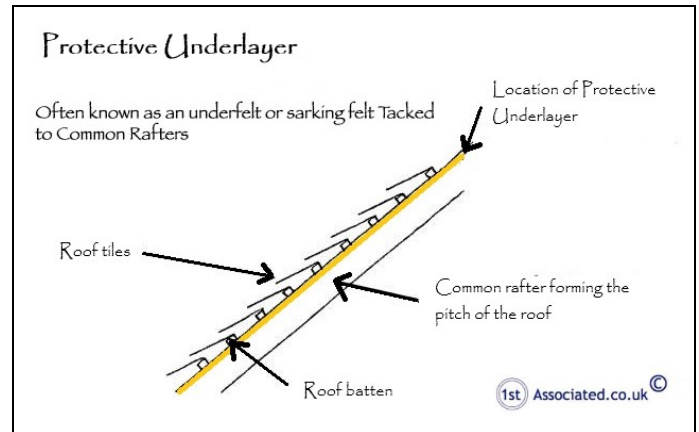
Protective underlayer

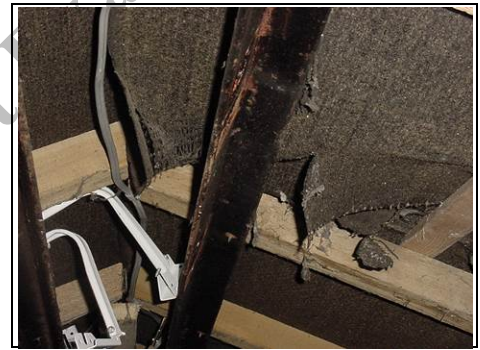
This photo shows the common rafters (the ones that form the pitch of the roof) and the dark area between is the underlayer, which is not bedded particularly well

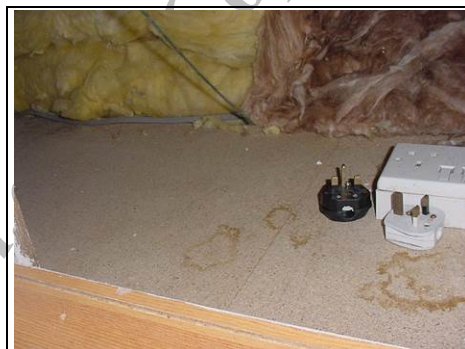
Staining in lined area

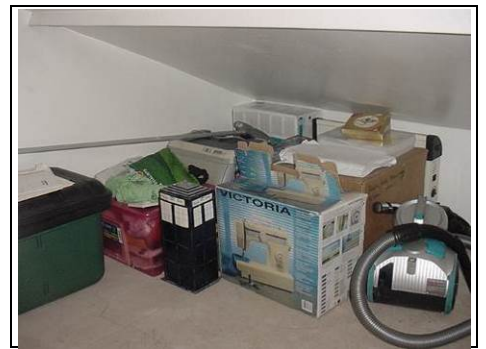
Stored items in lined area

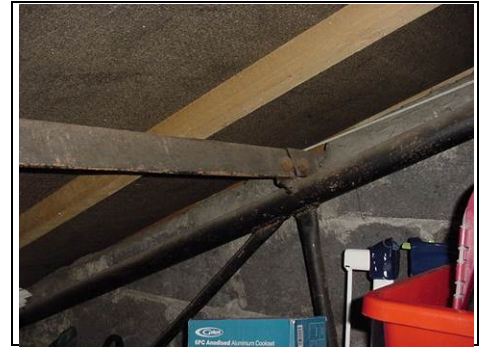
1. Structural cracking
2. Rusting
3. Distortion

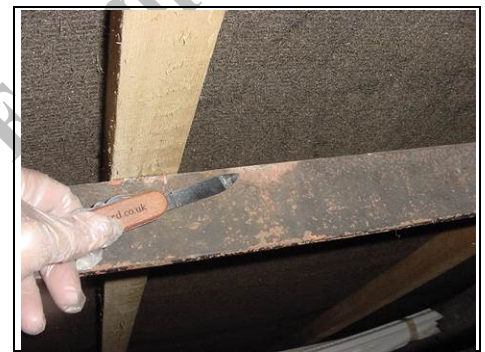
Rust where red oxide is showing through

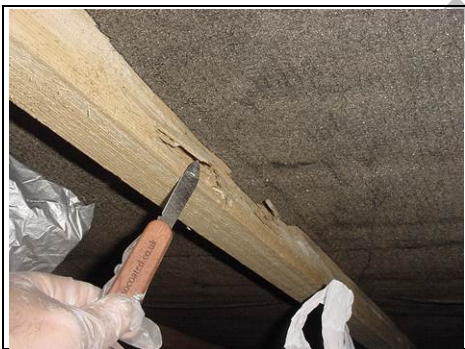
Damaged timber batten in the unlined area of the roof

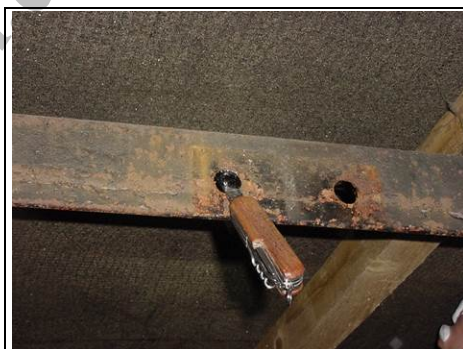
Holes in one of the brackets close to where we believe the chimney used to be

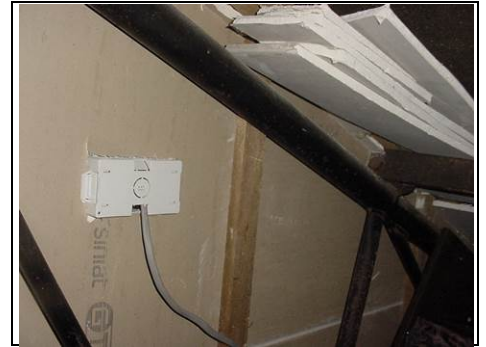
DIY electrics in roof space

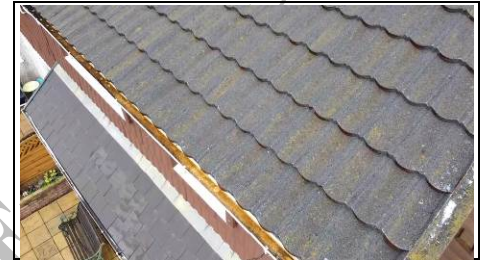
There may be some minor leaks but most people would be happy to live with these providing repairs are carried out within the next six to twelve months, with the exception of course of the garage gutters and downpipes.

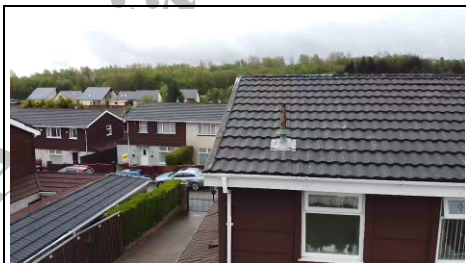
Top of internal soil and vent pipe to rear of property
Aerial view - 360 photo

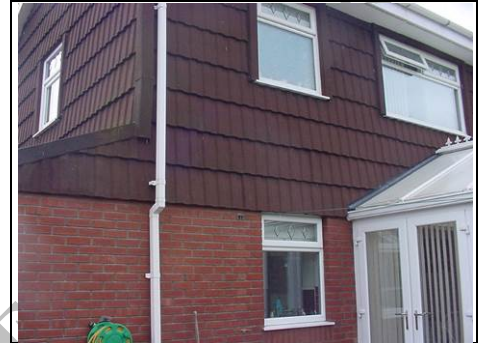
Pressed metal tiles to first floor and brick tiles to ground floor

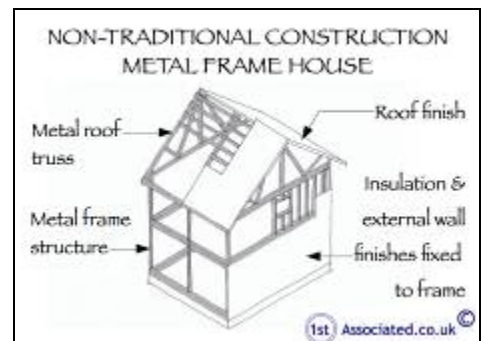
Non-traditional construction

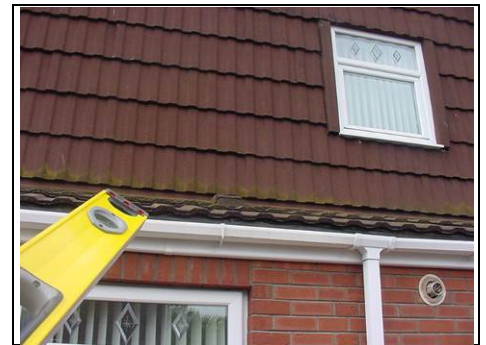
Vertical pressed metal wall tiles

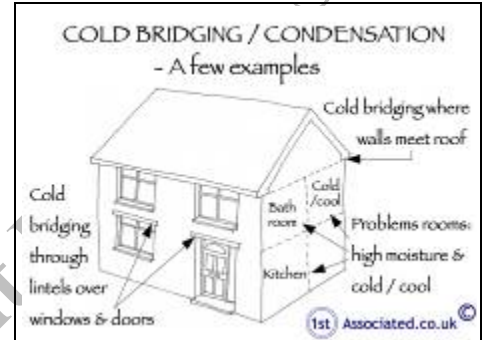
Cold bridging / thermal bridging

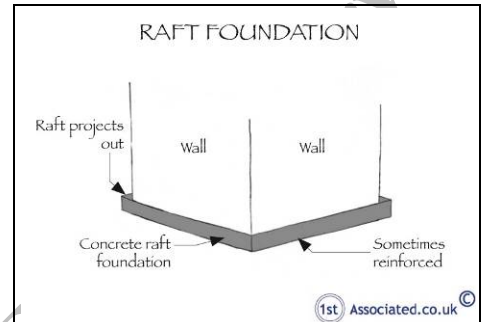
These were designed to allow spread of the weight allowing the building to float on the ground, with a thickening around the perimeter to hold the extra weight of the structural frame.

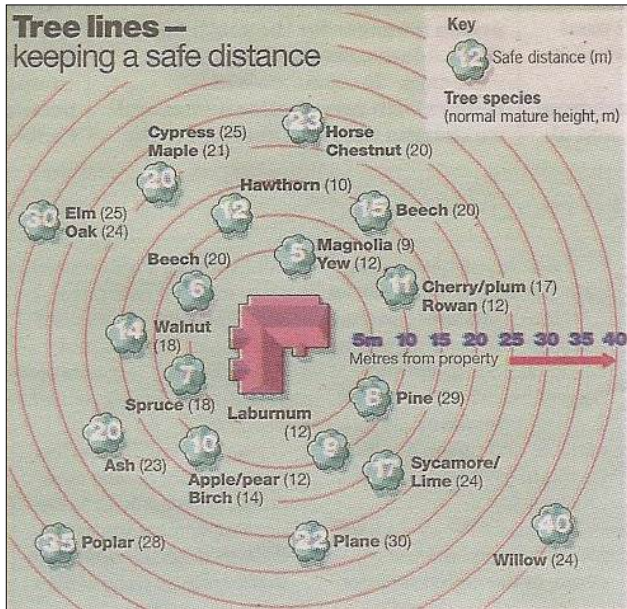
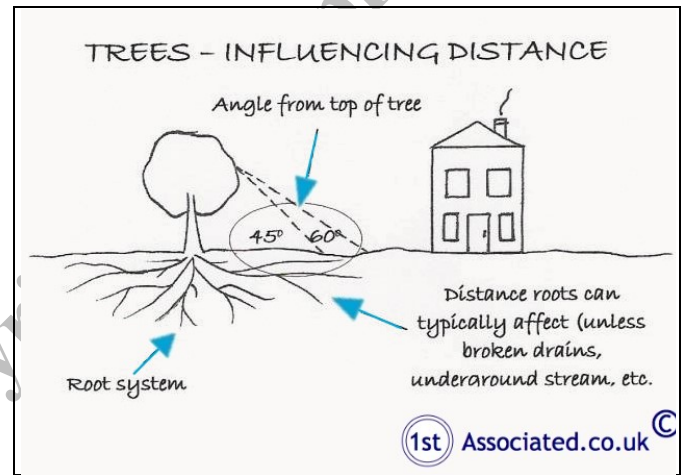
Influencing distance of trees to a property

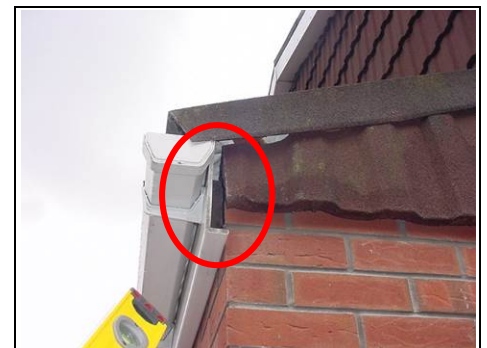
Plastic fascias and soffits over-cladding timber on the single storey roof

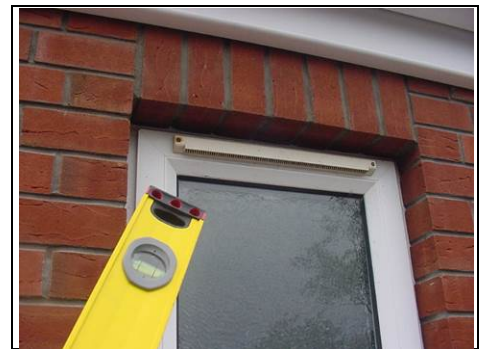
Only trickle vent in the windows is to the ground floor WC

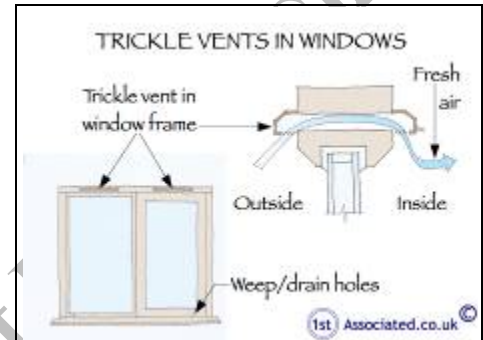
Trickle vents allow a trickle of air through, therefore stopping/reducing the likelihood of condensation occurring within the property.

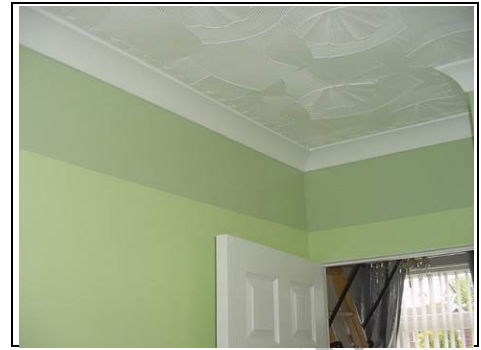
Textured paint in fan pattern

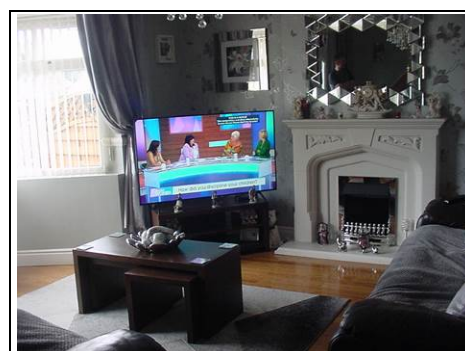
We note the chimney has been removed at roof level and also within the roof space. This type of chimney are not generally structural and its removal should not therefore affect the structure of the building.

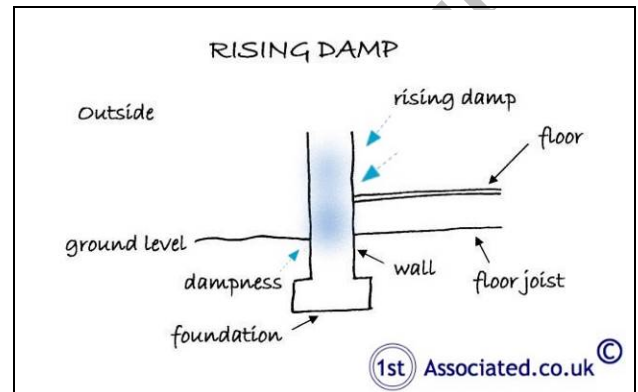
Rising damp depends upon various components including the porosity of the structure, the supply of water and the rate of evaporation of the material, amongst other things. Rising damp can come from the ground, drawn by capillary action, to varying degrees of intensity and height into the materials above. Much evidence points towards there being true rising damp in only very rare cases.

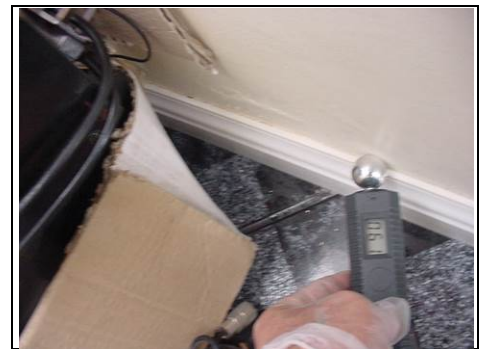
Slightly high damp meter readings in conservatory

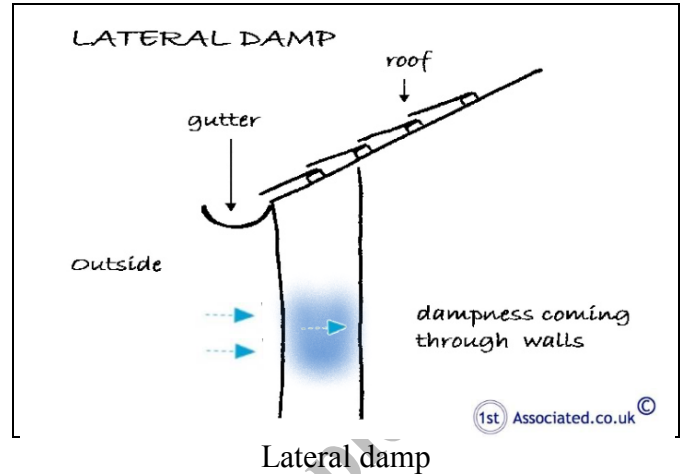
We used a resistance meter on the external walls. We have found dampness in line with what we typically see for this age, type and style of property.

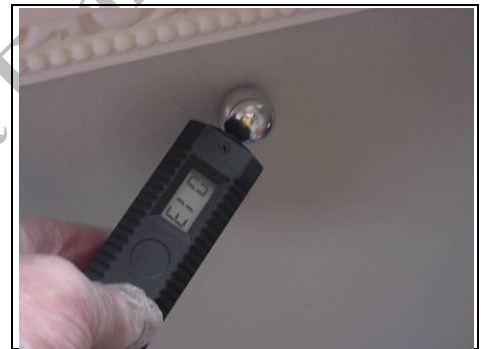
Condensation – higher than average chance

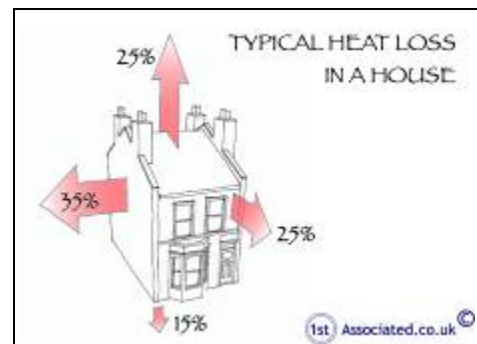
In this type of property you have to be very careful if you insulate not to create a condensation situation as this is when we feel you get most accelerated rusting and deterioration to the roof frame and the structural frame.

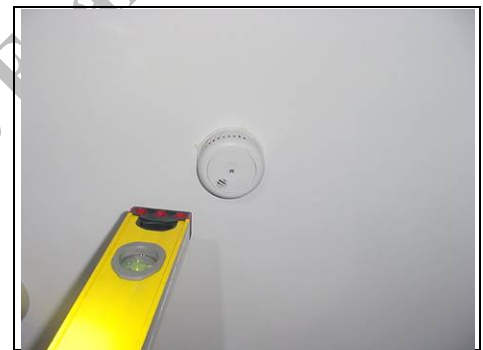
ACTION REQUIRED: We would recommend, for your own safety, that additional smoke detectors are installed. We would always recommend a hard wired fire alarm system and are also aware that some now work from a wireless signal which may be worth investigating. Whilst fire is relatively rare it is in a worst case scenario obviously devastating.

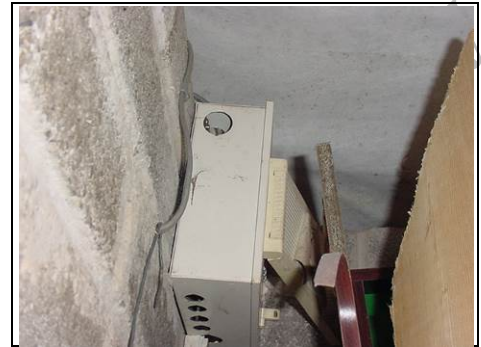
Dated fuse board in garage

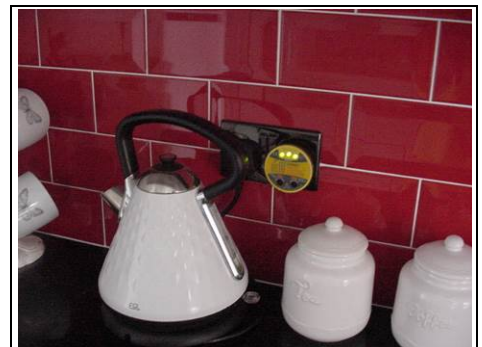
ACTION REQUIRED: As the property is changing ownership an Institution of Engineering and Technology (IET) test and report and any recommendations should be carried out by a NICEIC registered, or equivalent, approved electrical contractor or similarly approved.

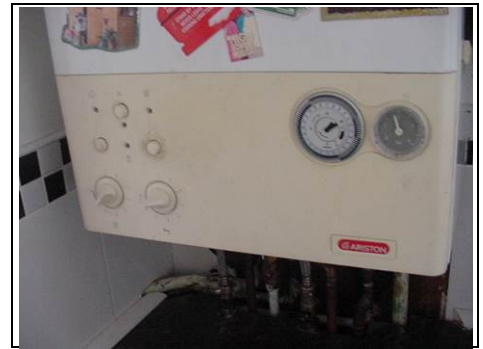
ACTION REQUIRED: Please see our comments in the Executive Summary.

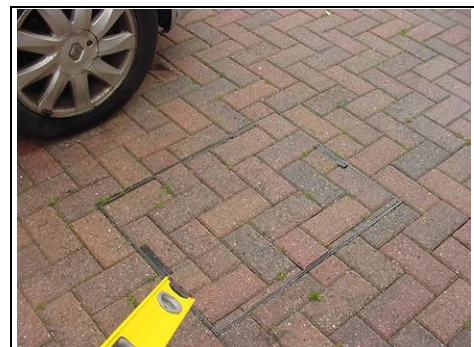
ANTICIPATED COST: A few hundred pounds; please obtain quotes.

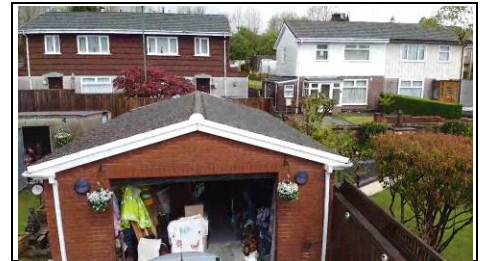
Rear right garage
Aerial view – 360 photo

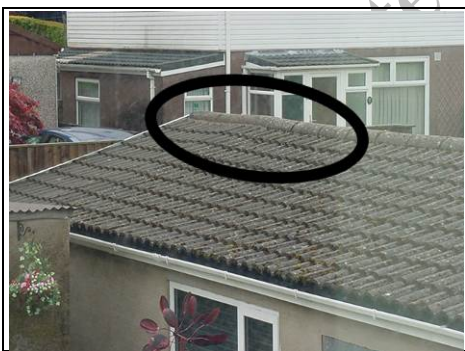
Undulating ridge to the rear and there may be deterioration in this area

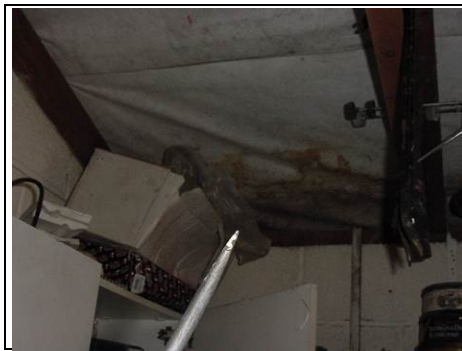
Dampness coming in through garage roof

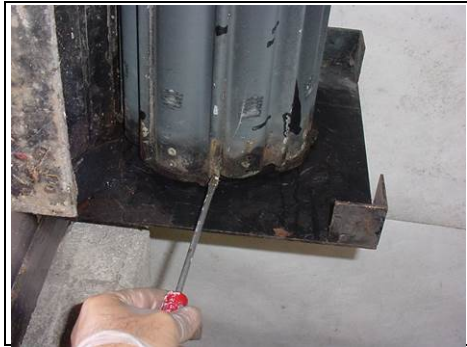
Rusting automatic garage door

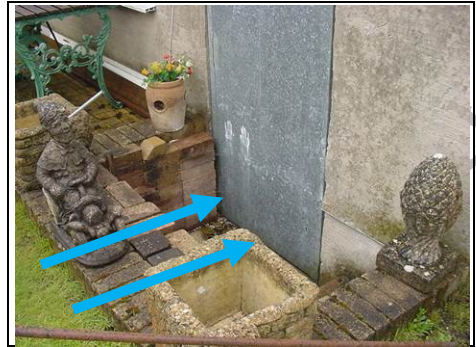
The garage is partially below ground and water will run into this area and then internally

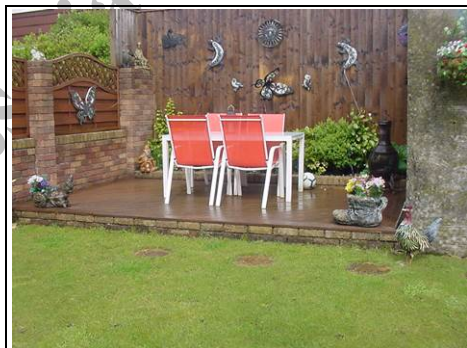
Decking to rear of garden

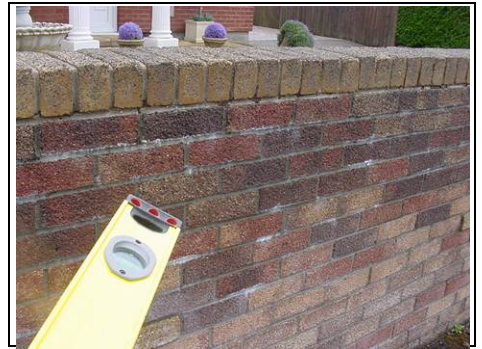
Efflorescence to front brick wall

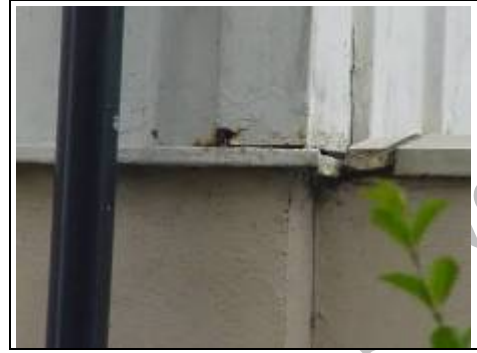
Rusting to profile metal cladding

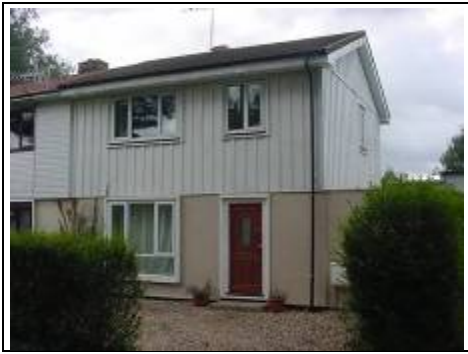
Metal frame house with profile metal sheeting at top and render at bottom. Roof has been changed.

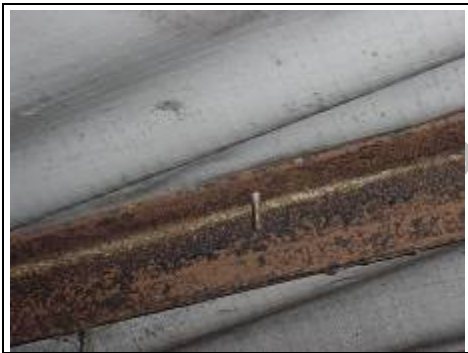
Example of rusting that we have seen in the roof of a metal framed building

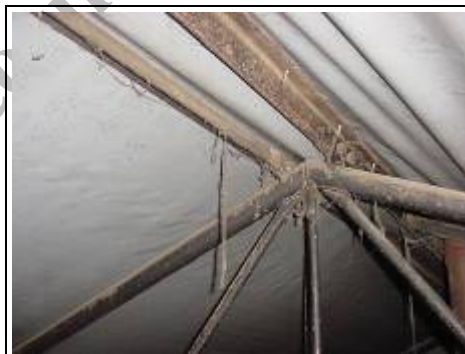
Example of tubular metal frame within the roof of a metal framed property

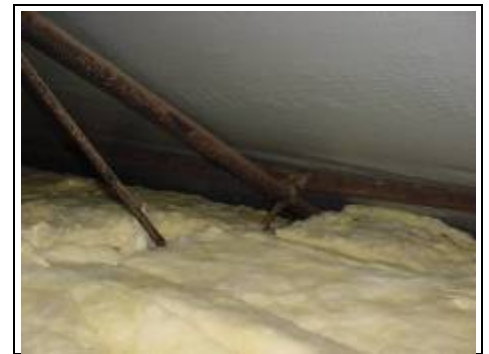
Example of over insulation of a metal framed property which causes condensation

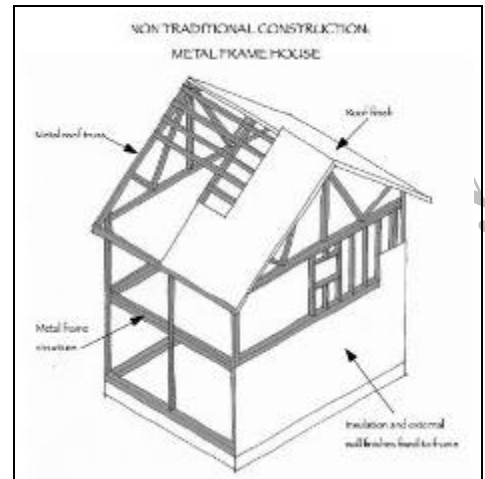
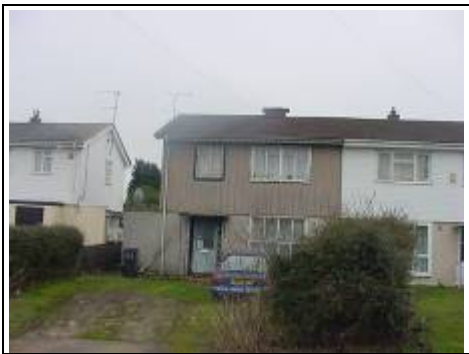
Original condition of non-traditional house with roof replacement

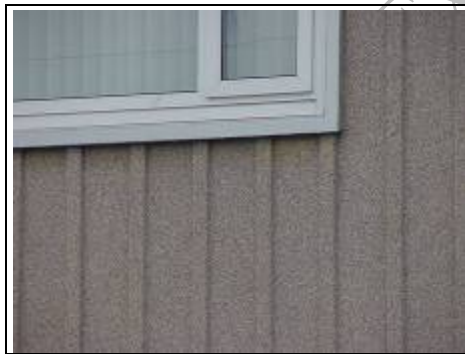
Close up of cladding on non-traditional house

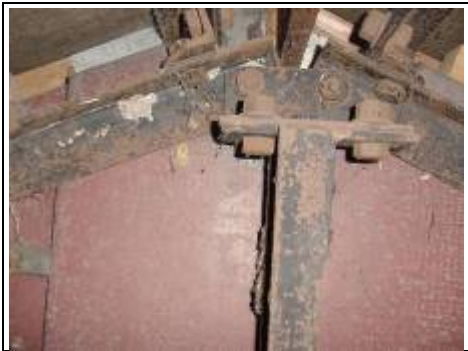
Rusting to a lightweight metal frame or damage or deterioration to the metal frame of a non-traditional house

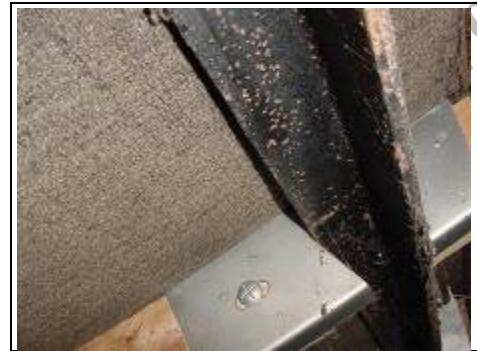
Some fixings replacements/repairs to a non-traditional house

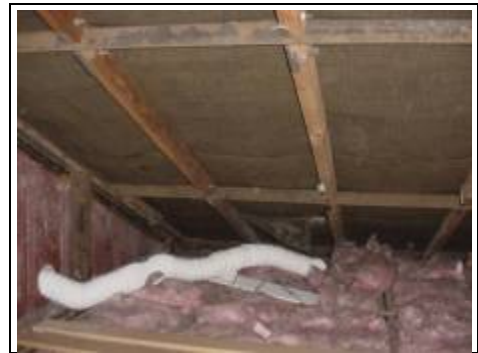
Extract vent to outside often discharges into roof which is essential that they do not in this type of roof

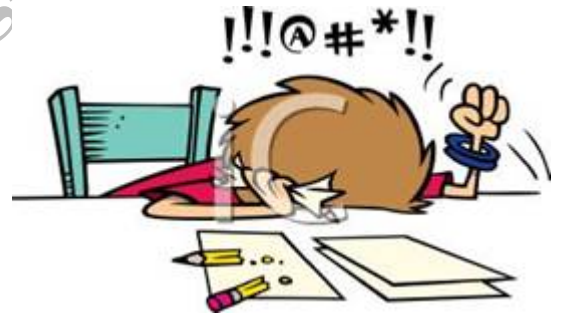
Non-traditional properties

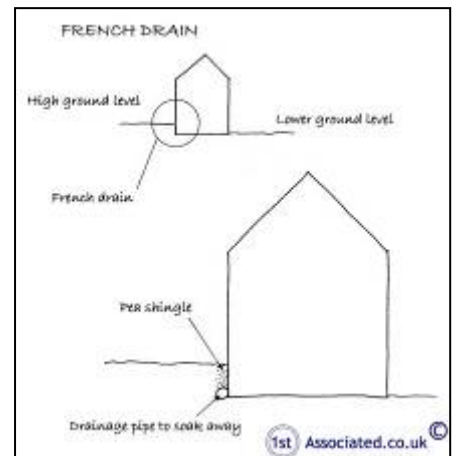
The French drain acts as an area where water soaks away quickly. We often recommend them close to building, but not next to the building, as this helps reduce the ground level and/or take any water that is directed at that area away. For example, where a patio has been put in place which aims any rainwater at part of the wall. As mentioned, whilst a French drain is a D.I.Y. job, it does need some understanding of how it works.

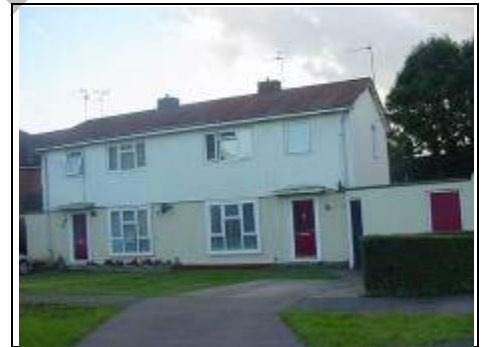
British Steel frame house (BISF)

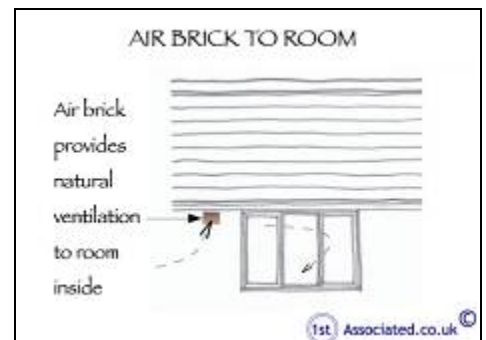
Airbrick provides ventilation

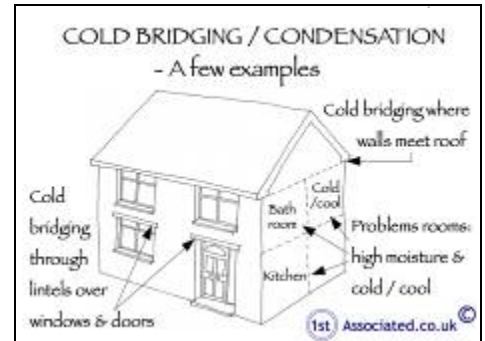
Cold Bridging isn't just about condensation on mirrors

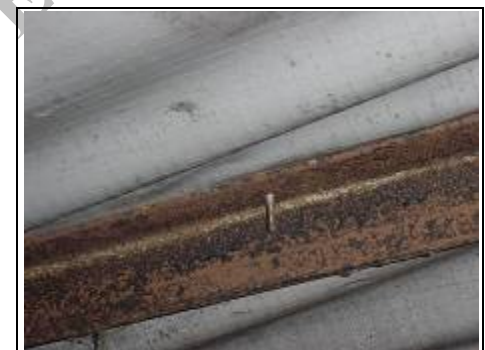
Rusting within the roof between the insulation and plastic protective underlayer

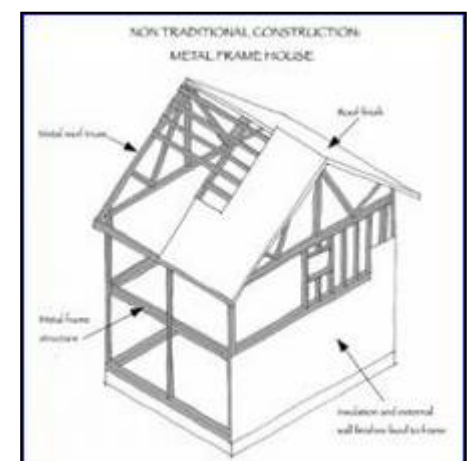
Metal frame non traditional construction

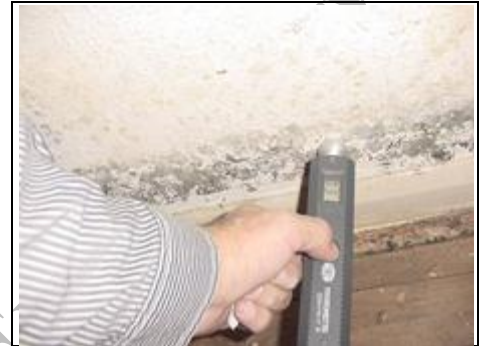
Black mould and high damp meter readings

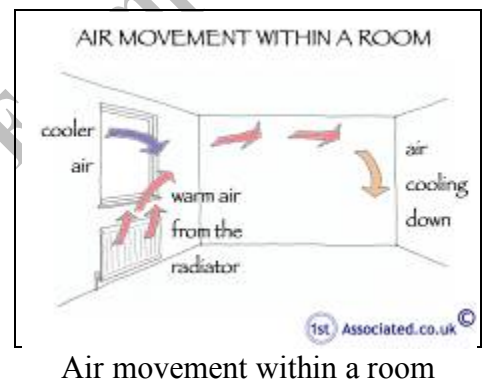
Where do we most commonly find Cold Bridging?

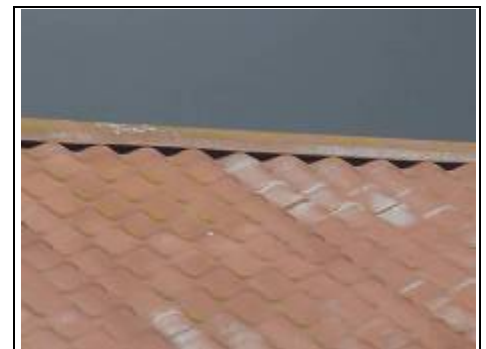
Our thoughts on this have very much changed as we used to say that cold bridging was typically found in properties from the 1960's/1970's. However we are increasingly finding it in a broader range of properties, particularly Victorian properties, where people are trying to live to modern standards of heating and insulation without understanding that the properties need to breathe as well. We have also found cold bridging in properties where extensions have been carried out and where the extension has been built to a different standard to the original property.

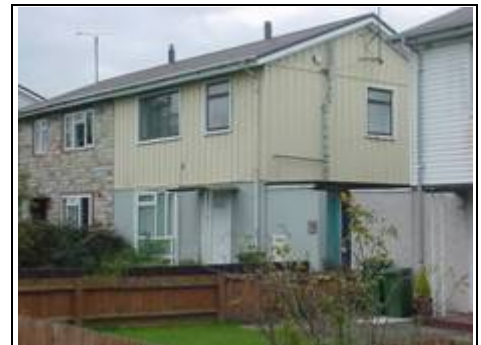
Non traditional BISF property

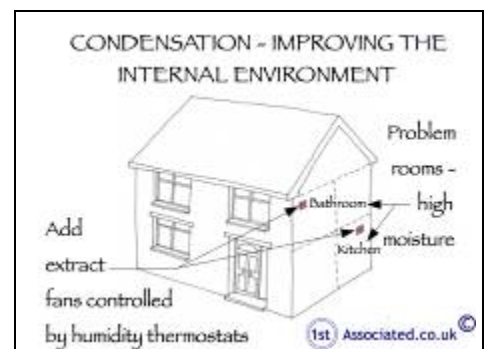
Sometimes it really is down to the design of the property. Where there are cold elements in it, such as a concrete structural frame or concrete lintels, when these are in contact with moist air condensation occurs. Sometimes this is impossible to stop but often it is possible to reduce it by having a better circulation of air with a better heat and coolness balance and the removal of any moist air.

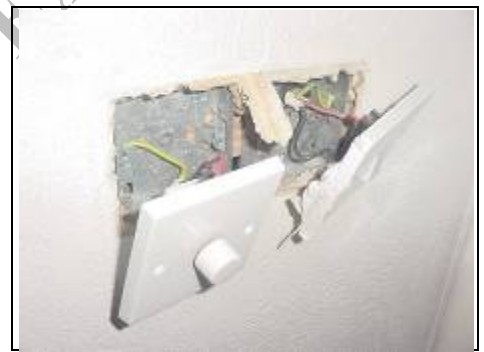
Removing electric points to view construction
