RESIDENTIAL BUILDING SURVEY

Pre-Cast Concrete Frame House Wiltshire

Mrs X

Prepared by:
INDEPENDENT CHARTERED SURVEYORS

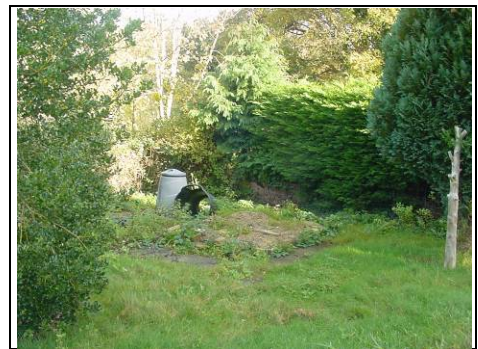
Rear garden, sloping away towards the road. Fences need repair.

The rear is a good sized garden, on a sloping site running towards X Lane. The boundary to the rear is a conifer hedge and dilapidated fencing, which needs repair. There is access to the rear on the right side of the property.

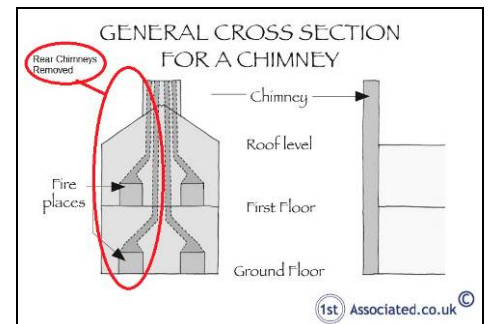
Front of chimney removed in roof space, black oval indicates where that part of the chimney once was

Chimney removed

We can see a crack to the rear of the chimney, where there looks to have been a leak coming in for some time as there is rot visible around the chimney.

ACTION REQUIRED: You can either repair the chimney externally and then add in new roofing timbers, which work many need scaffolding. Alternatively you may be able to carry out some form of repair internally on a temporary basis.

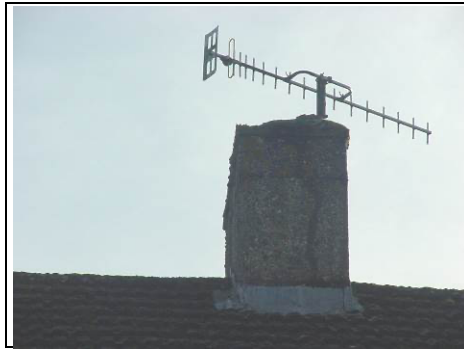
Crack to rear render

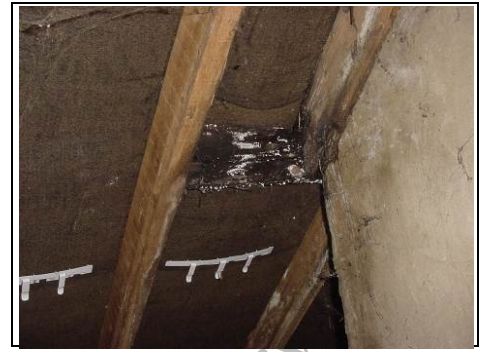
Rot around chimney

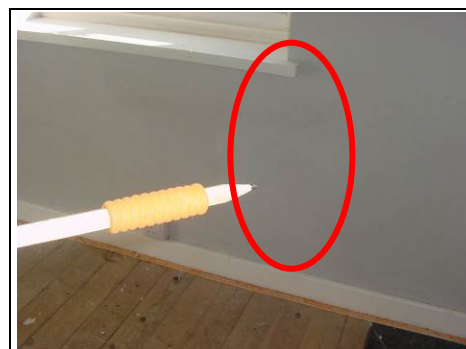
There are various cracked visible to the ceilings and walls. We feel these will continue in the property, as you have a mixture of different types of construction.

This mix of different materials often causes differential movement, in the form of cracking.

Front right bedroom crack to wall

ACTION REQUIRED: If you want to be 100% safe and as this is a one-off inspection, particularly bearing in mind we cannot actually see the pre-cast reinforced concrete structure, we would recommend the existing owners take out an insurance claim, advising that the cracking has been noted by a structural surveyor (this should cost them nothing other than time to write the letter/email).

This usually means that the insurance company will carry out a monitoring exercise (the Building Research Establishment recommend monitoring any cracks for a minimum of one year) to establish if there is any progressive movement.

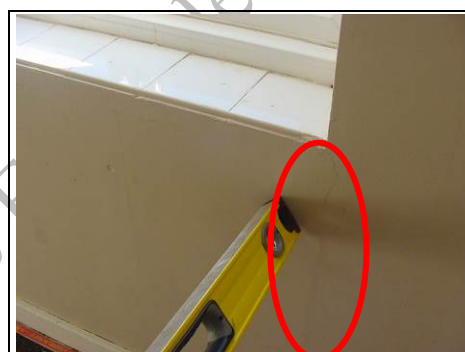
Crack below window

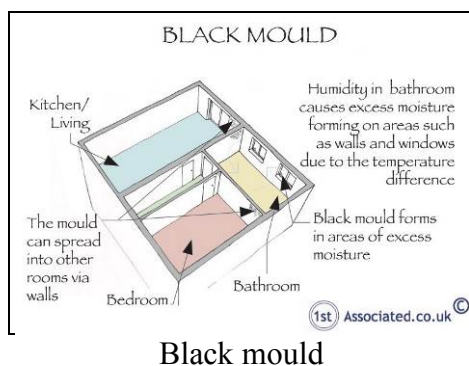
Talking more generally, this type of property is prone to getting condensation and black mould, both surface condensation and black mould that you will be able to see, but also, as discussed, it can get interstitial condensation, which is condensation inside the structure, which then makes the reinforcement of the concrete rust, causing deterioration.

Black mould

ACTION REQUIRED: We would recommend large humidity controlled extract fans are added to the kitchen, the bathroom and any areas that are used for drying clothes internally during winter months (we would assume that clothes will be dried externally during the warmer months). By large extract fans we mean 150mm.

ANTICIPATED COST: We would anticipate costs between £250 - £500 per extract fan depending upon the wiring required. We always recommend quotes are obtained before work is agreed/commenced.

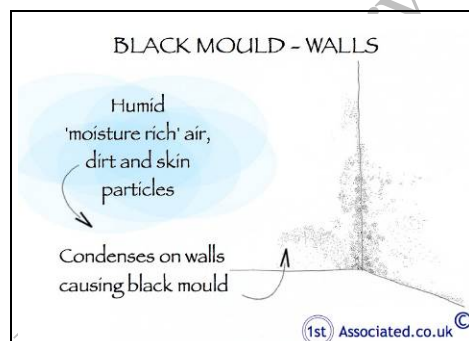
Black mould

We found vents in many of the ceilings and we believe condensation may be a problem in this property.

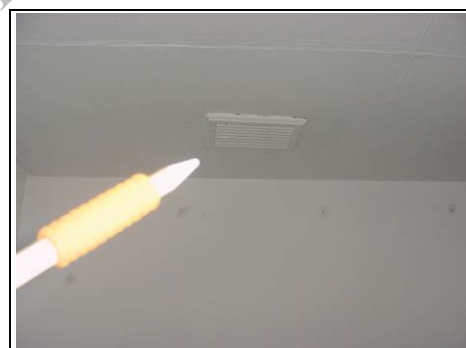
Vent in ceiling

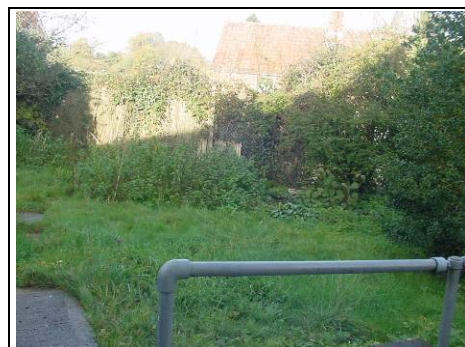
Vegetation and dilapidated fence to rear of garden

ANTICIPATED COST: £1,000 to £3,000, depending upon how much you do. We recommend you have concrete posts as these last longer and are stronger. Please obtain quotes.

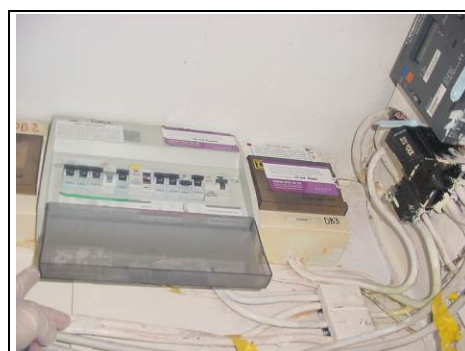
Fuse box

The electric fuse board is 1980s to 2000s and is located in the hallway. The Institution of Engineering and Technology (IET) recommend a test and report whenever a property changes occupancy. This should be carried out by an NICEIC registered and approved electrical contractor or equivalent.

ACTION REQUIRED: We recommend you replace the fuse box with a modern one in a fire resistant metal casing.

We also recommend an Institution of Engineering and Technology (IET) test and report to be carried out by an NICEIC registered and approved electrical contractor or equivalent.

ANTICIPATED COST: £250 to £500 for a test and report and plus any work recommended and £250 to £500 for a new fuse board; please obtain quotations.

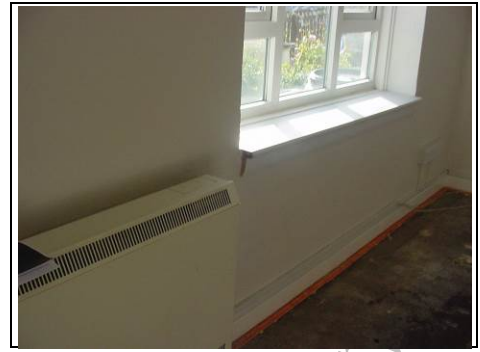
The property is heated via electric storage heaters. You may wish to upgrade to a modern electric radiator, or even LPG (liquefied petroleum gas) or oil via an oil tank.

Electric storage heater

ACTION REQUIRED: We recommend you upgrade the heating.

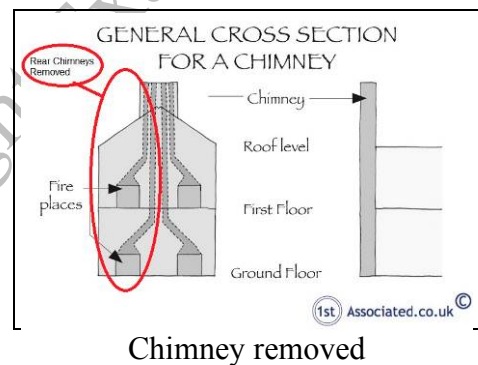
This chimney is render finished with a lead flashing. The chimney pots appear to be missing and there is a crack to the rear. Just as importantly, within the roof space we can see that the front part of the chimney has been removed. From what we can see of the external of chimney it is in below average condition considering its age, type and style.

We noted an aerial attached to the chimney which we are not keen on as it cuts into the render and de-stabilises the chimney.

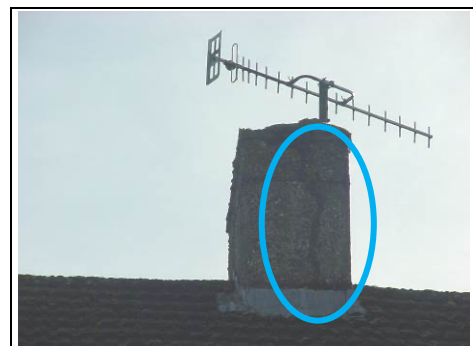
Crack to rear of chimney

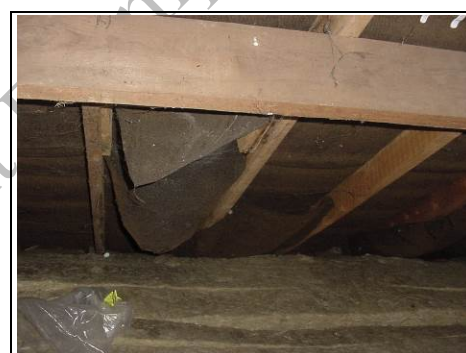
When we inspected the loft space we found a Hessian base Bitumen membrane. This type of membrane has been used since the 1960s. We generally found it to be in average condition, with damage in some areas which is what we typically find.

This photo shows deterioration to the underlayer with it hanging it down.

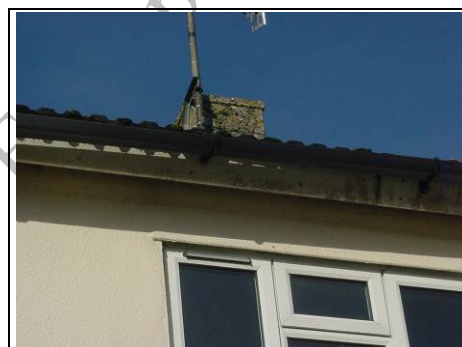
Awkward fascia detail

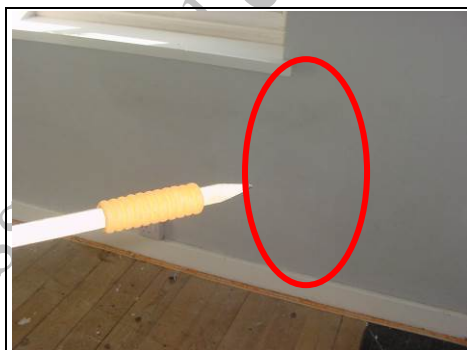
We noted cracking to some of the walls.

Front right bedroom crack to wall

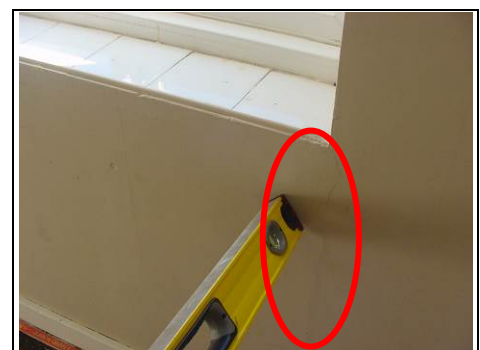
Crack below window

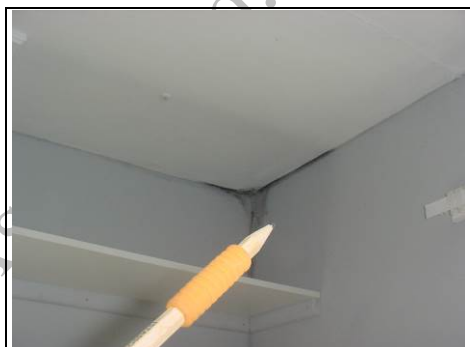
We noted vents in the ceilings and think this property may have a problem with condensation.

Blackness to corner of front right bedroom, possible condensation, possible roof leak

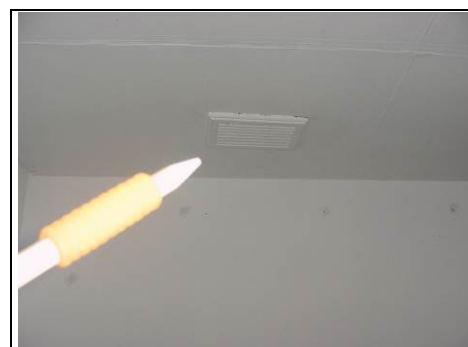
Vent in ceiling

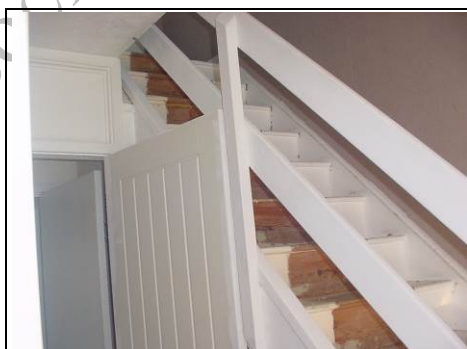
The staircase would not meet current Building Regulations, although there is no retrospective requirement to change it as far as we understand, however we would recommend it is altered from a safety point of view.

Staircase not up to modern standards

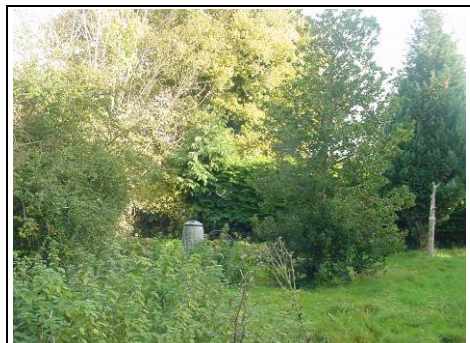
The rear garden is a good size, on a sloping site, running towards the Lavington Road, which was busy at the time of the survey. The fence to the rear is dilapidated and we recommend this is replaced from a safety point of view.

Overgrown garden

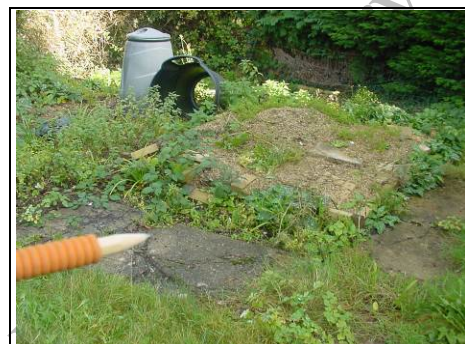
Area of hard standing with vegetation growth
