RESIDENTIAL BUILDING SURVEY

Non-Traditional Airey, Pre-Cast Concrete Panel construction House

Lincolnshire

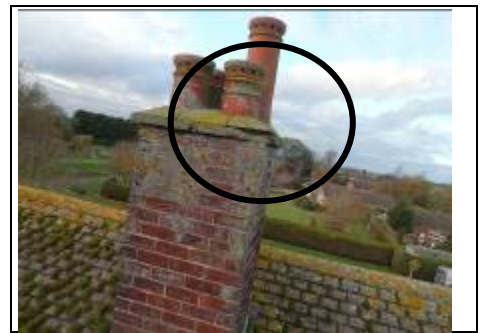
The chimney is weathered and in need of repair. We can see moss and damage to the very top of it where dampness will start to get in.

Chimney needs repair

ACTION REQUIRED: Repair and repoint and make watertight.

ANTICIPATED COST: £200 - £500 if this can be carried out without scaffolding. If scaffolding is required we would expect higher costs of double to treble this amount; please obtain quotations.

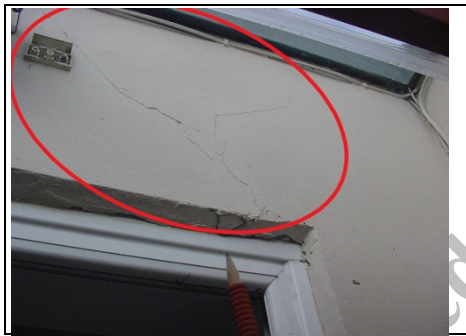
Cracking

ACTION REQUIRED: We would recommend your legal advisor asks for full details with regard to the conversion of the outbuilding. We have noted a few areas of concern:

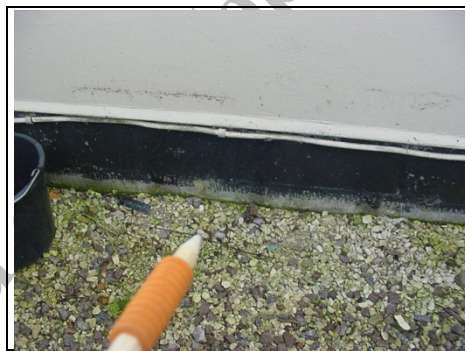
Water sitting to base of outbuilding

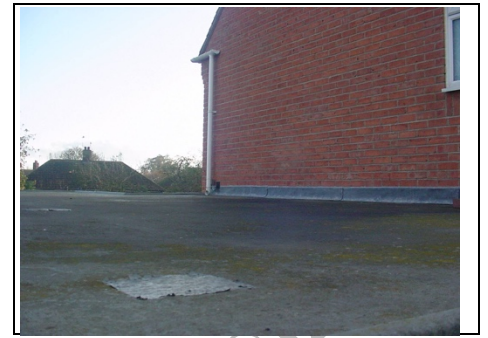
In this instance we can see the roof has blistered and also has water sitting on it. We spoke specifically to the owners about this and as with most owners of GRP roofs they say they have a guarantee. Our concern is that these roofs are problematic and we do not feel that they have been sufficiently tested in the British climate.

Repair on GRP roof and lead flashing where flat roof meets main building

ACTION REQUIRED: We would recommend you obtain a discount for the value of a new roof which we would expect to cost in the region of £10,000 - £15,000. You need to obtain quotations before you commit to purchase the property as part of the negotiation as it is difficult to remove this type of roof or get guarantees for it that are worth the paper they are written on.

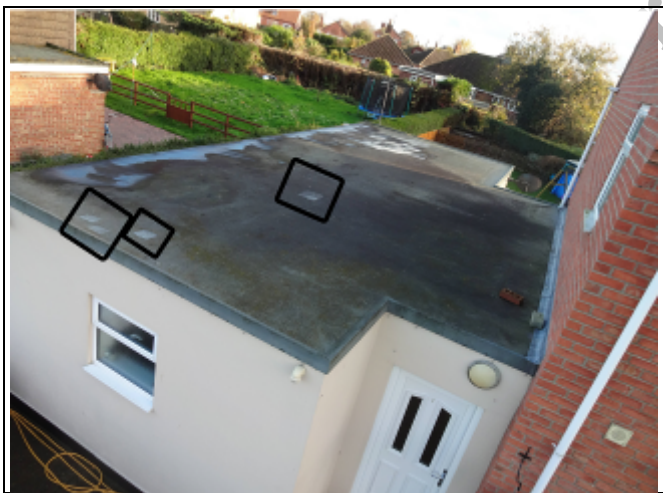
Patch repairs to GRP roof

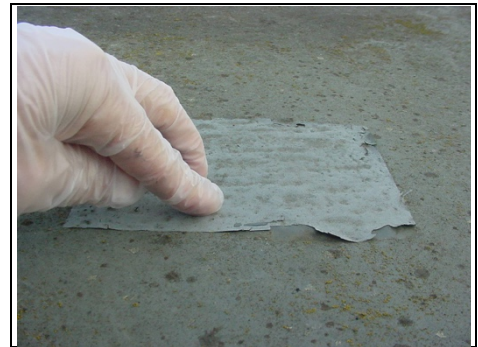
Close up of patch repair

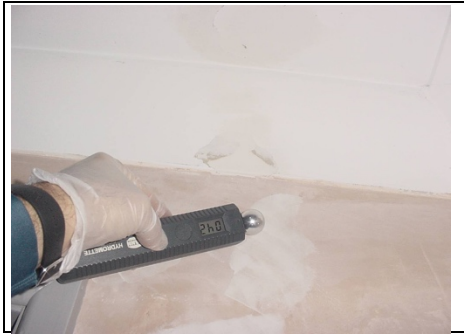
Damage

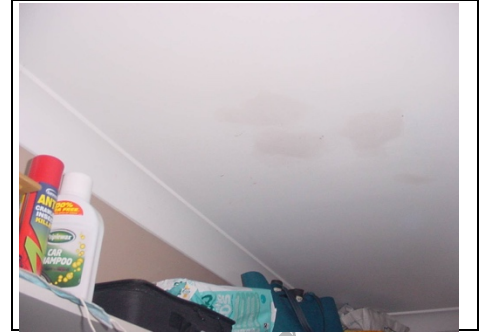
Patches to ceiling

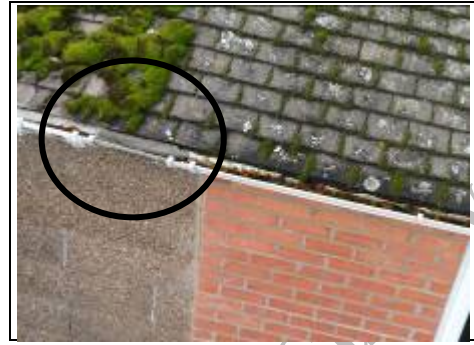
Asbestos gutter

Our insurance company requires us to advise we are not asbestos surveyors and advises us to recommend asbestos surveyors are instructed and that you have your own asbestos survey carried out.

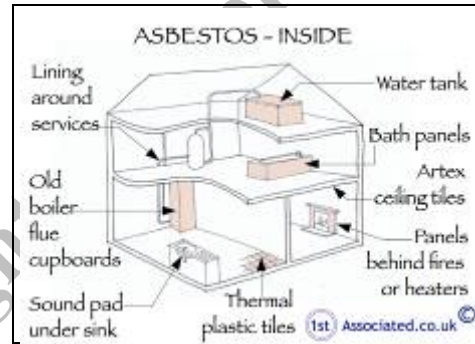
Asbestos - inside

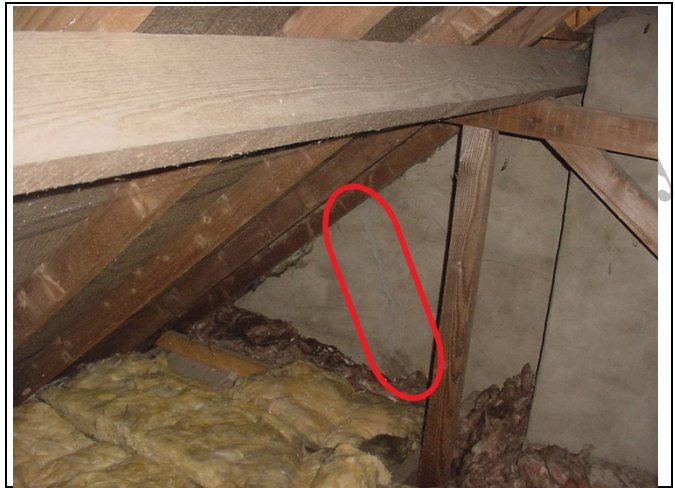
This is a semi-detached property and as such it has a shared wall. We can see a crack in this wall which we would like to record. There can often be differential movement where buildings are constructed in different ways as this property now is.

Crack visible in roof space

ACTION REQUIRED: As this is a one-off inspection we believe that caution is the best way forward. Ideally we would recommend the existing owners take out an insurance claim, advising that the cracking has been noted by a structural surveyor (this should cost them nothing other than time to write the letter/email). This usually means that the insurance company will carry out a monitoring exercise (the Building Research Establishment recommend monitoring any cracks for a minimum of one year) to establish if there is any progressive movement. Your future liability should be limited to the cost of the excess on the insurance providing the insurance company is happy for you to take over the insurance claim.

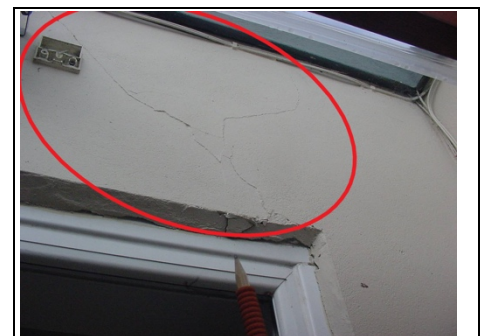
Outbuilding crack

Cracking

We have already mentioned the crack to the outbuilding. We would recommend the insurance claim covers this crack as well.

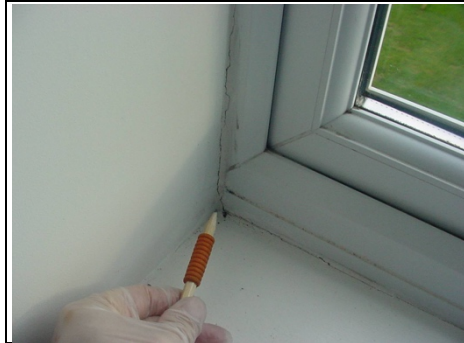
We noted some minor black mould in the bathroom and bedrooms. There is no extract fan in the bathroom and there is an extract in the kitchen however we would recommend this is upgraded to a humidity controlled extract fan.

Signs of black mould

ACTION REQUIRED: We would recommend large humidity controlled extract fans are added to the kitchen, the bathroom, downstairs cloakroom (which had washing machines in it at the time of our inspection) and any areas that are used for drying clothes internally during winter months (we would assume that clothes will be dried externally during the warmer months). By large extract fans we mean 150mm.

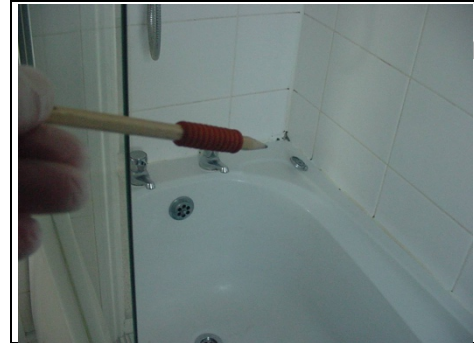
Black mould in bathroom

ANTICIPATED COST: We would anticipate costs between £250 - £500 per extract fan depending upon the wiring required. We always recommend quotes are obtained before work is agreed/commenced.

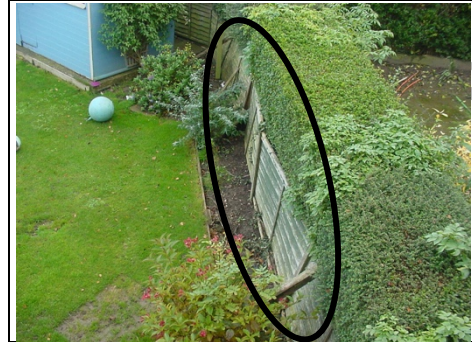
Right fence needs work

ACTION REQUIRED: Repair, strengthen and straighten and re-stain. We would recommend concrete posts.

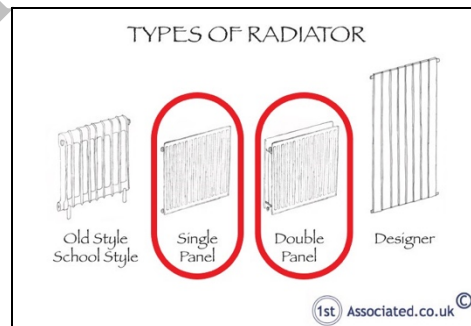
Replace single panel radiators with double panel convection radiators

ACTION REQUIRED: We recommend you upgrade to double panel convection radiators.

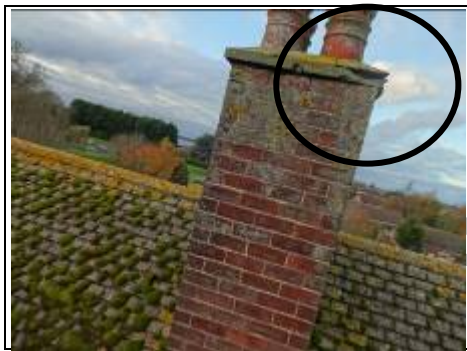
This chimney is brick finished with a lead flashing and two chimney pots. From what we could see from ground level it looked in below average condition considering its age, type and style.

Chimney needs repair

ACTION REQUIRED: Repair and repoint. Please see our comments in the Executive Summary.

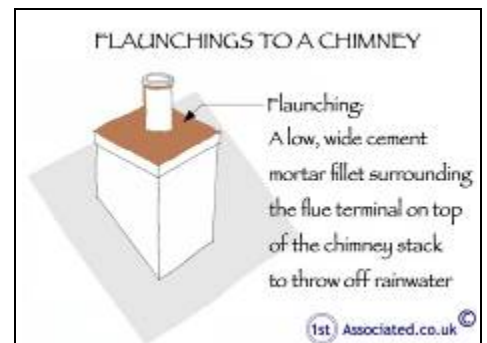
Flaunching

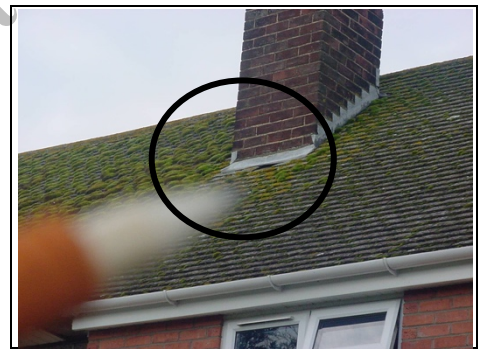
Tile missing at base of chimney

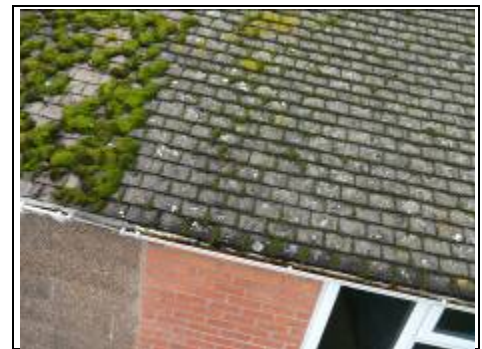
There is some slight moss on the roof although not as much moss as next door. Part of the problem here is that next doors moss will also get in your gutter. The moss can hold water against the tiles and cause them to have accelerated deterioration.

Moss

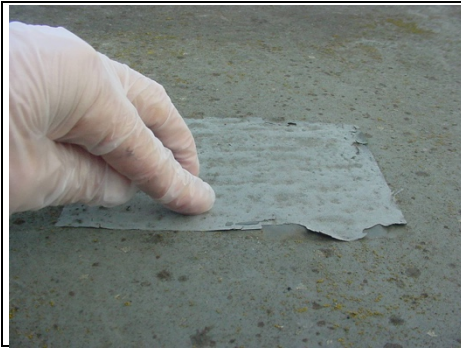
Close up of patch repair

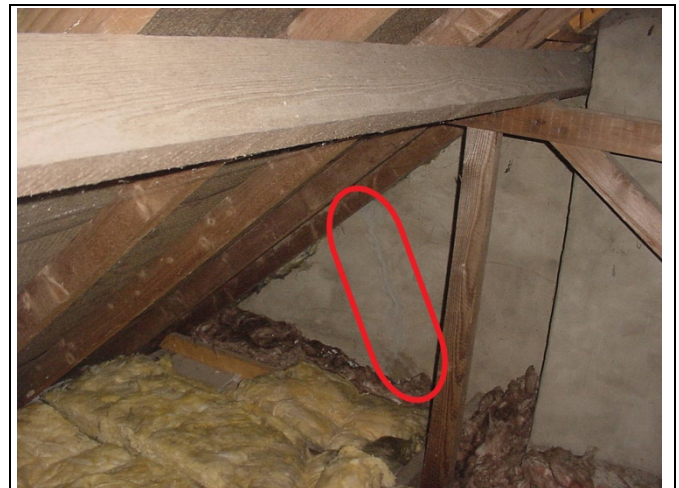
The property has one firewall finished with render located to the right hand side (all directions given as you face the property). The firewalls are also Party Walls. There is cracking to the fire wall; please see our comments in the Executive Summary.

Crack visible in roof space

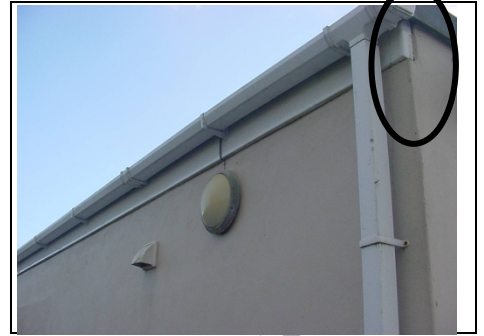
Fascia board set into render

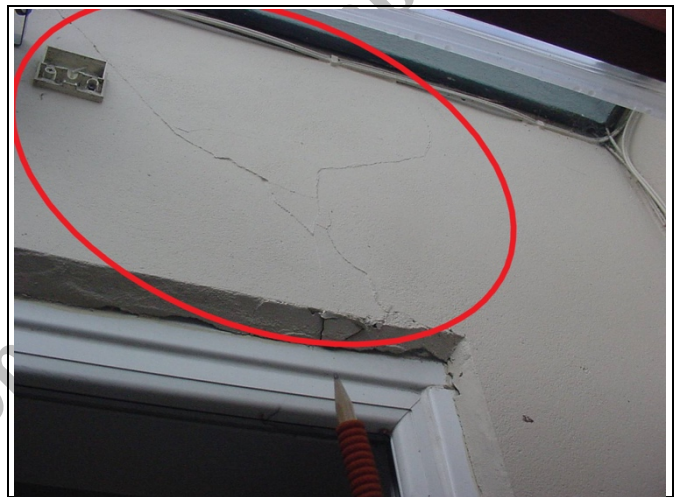
Crack in outbuilding

ACTION REQUIRED:
Please see our comments in the Executive Summary.

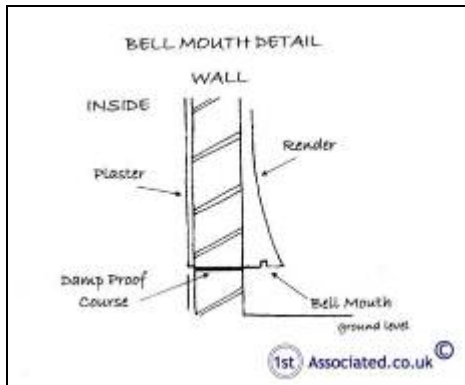
To the base of the render there was a bell mouth detail. There looks to be water sitting at the base of the property from the staining we can see on the left side.

Bell mouth detail

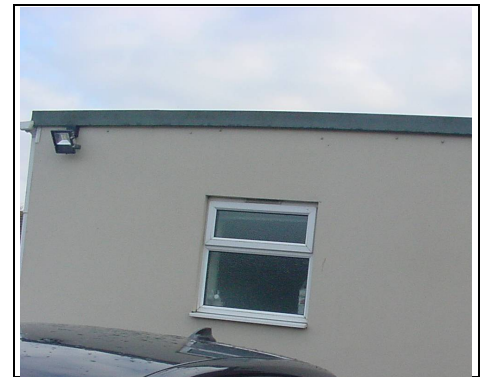
Outbuilding window with no trickle vents

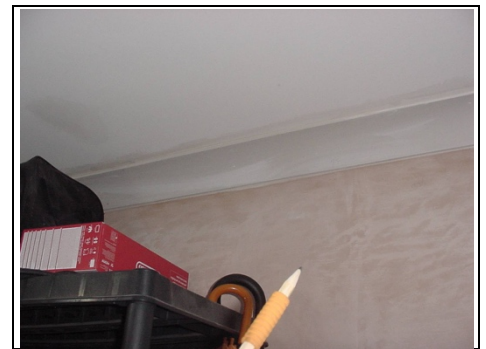
New plaster in store room

ACTION REQUIRED: The owner to specifically advise why they have replastered the walls in the outbuilding.

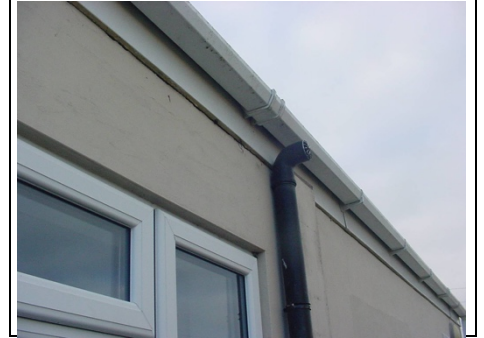
Flue can warp the plastic
