RESIDENTIAL BUILDING SURVEY

Dyke Pre Cast Concrete Construction House Shropshire

Ms X

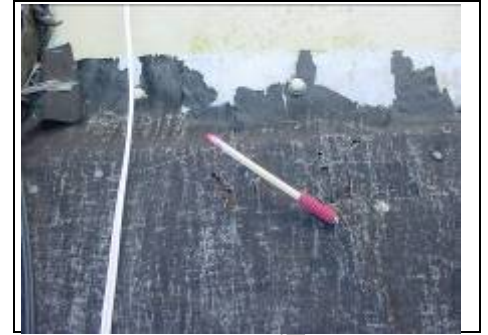
There are areas of the roof that are deteriorating and will be letting water into the roof structure/timber decking/concrete roof.

Deteriorating roof

ACTION REQUIRED: We recommend repairs to the roof. We believe you will probably need to start again with regard to the relatively small area of roof that has deteriorated.

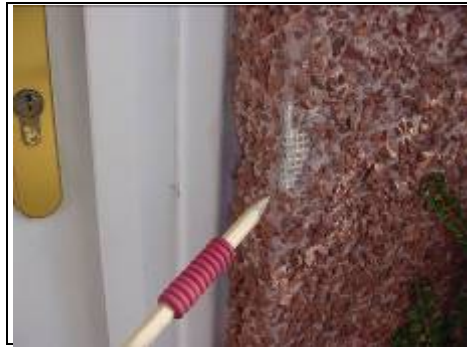
Render starting to deteriorate and reinforcement layer coming through

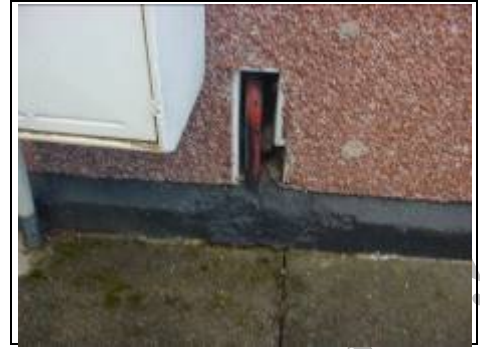
Insulation cut around pipe

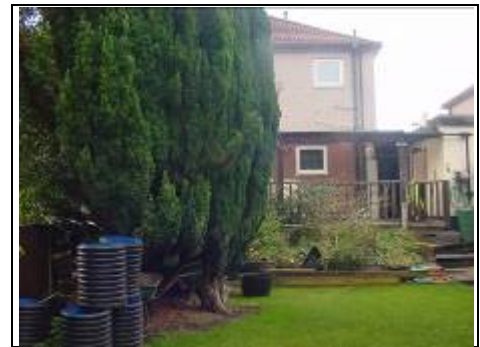
Trees near property

ACTION REQUIRED: We would recommend an arboriculturalist (not a tree surgeon) is asked to view the trees and give a ten year plan of maintenance.

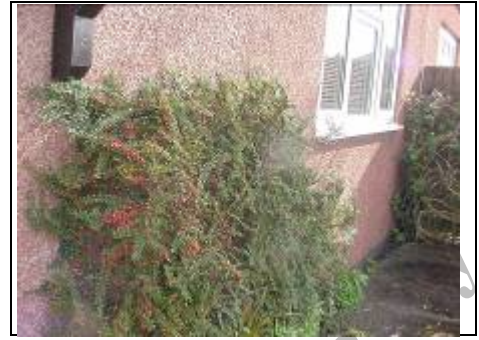
There are also bushes around the property which give us cause for concern as it means there is dampness to the base of the property which can affect the pre-cast concrete slabs.

Bushes to front

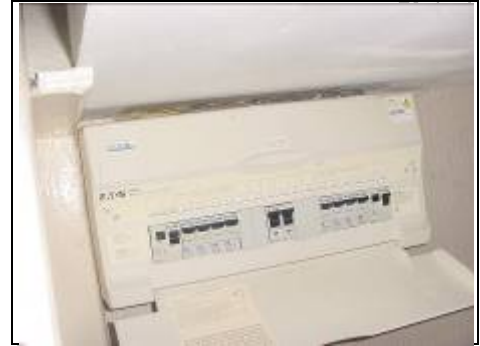
Dated electrics

ACTION REQUIRED: We recommend a new fuse board with a metal casing; modern standards require half hour to one hour fire resistant casing around a fuse board.

An Institution of Engineering and Technology (IET) test and report and any recommendations to be carried out by an NICEIC registered and approved electrical contractor or equivalent.

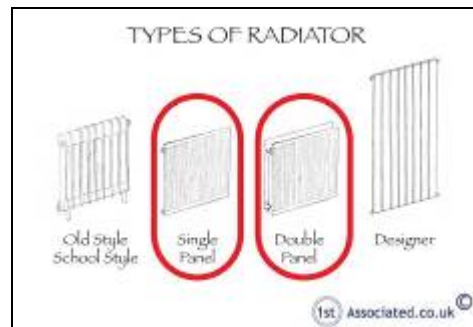
Replace single panel radiators with double panel convection radiators

ACTION REQUIRED: We recommend you upgrade to double panel convection radiators and move the radiators underneath the windows as this gives a better circulation of air and reduces the chance of condensation.

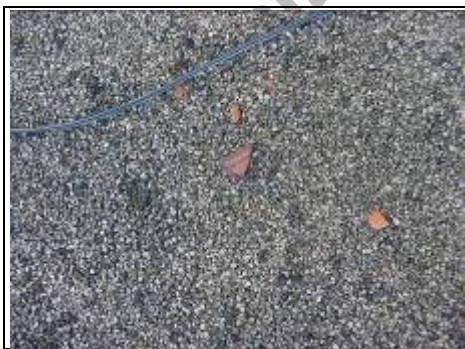
Broken roof tile on flat roof

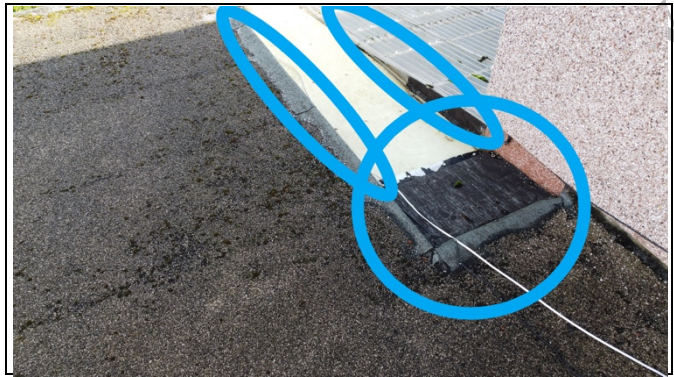
This roof is deteriorating and in need of replacement.

Link corridor roof
~ Aerial View - 360 Photo ~

ACTION REQUIRED: Replace link corridor area. Please see our comments in the Executive Summary.

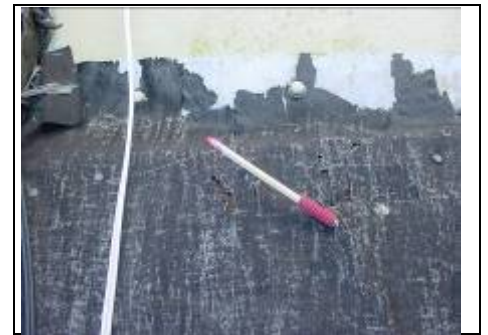
Deteriorating roof

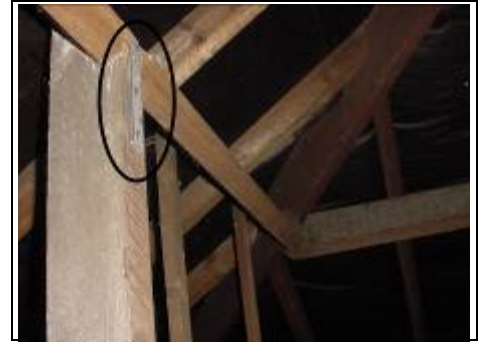
Metal brackets added to roof

ACTION REQUIRED: Your legal Advisor needs to check and confirm if the local authority/owner have carried out repairs retro-fits to the roofs. We would add that the only way to be one hundred percent certain is to have the roof cleared of all insulation, stored items, etc and checked.

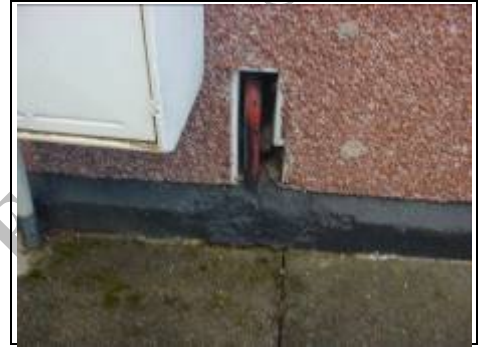
We have not been able to see the concrete walls with the exception of a very small area where it has been cut around a pipe. As mentioned elsewhere within this report we would normally open up the structure in three places of 1m wide openings which is our recommended practice.

Insulation cut a pipe

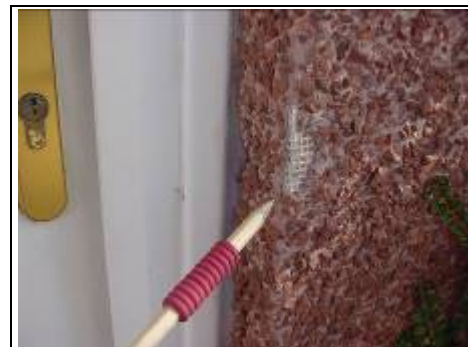
The external walls are finished in a thin render which has been applied to the insulation board. It has a reinforcement beneath it which can be seen (see photo below – render starting to deteriorate). We would comment that there is not a long term history in England of the use of this type of finish and the jury is still out with regard to how it will perform.

Render starting to deteriorate and reinforcement layer coming through

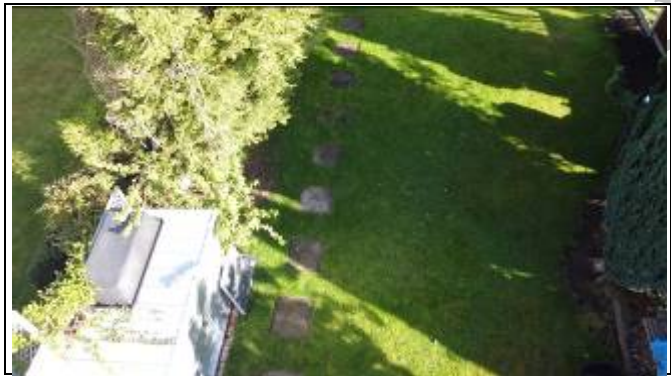
There are trees within what we would term as influencing distance but you do need to speak to your insurance company as they may have a different interpretation for insurance reasons.

Leylandii
~ Aerial View - 360 Photo ~

ACTION REQUIRED: Regularly maintain. Ideally we would recommend an arboriculturalist (not a tree surgeon) is asked to view the trees and give a ten year plan for maintenance of the trees.

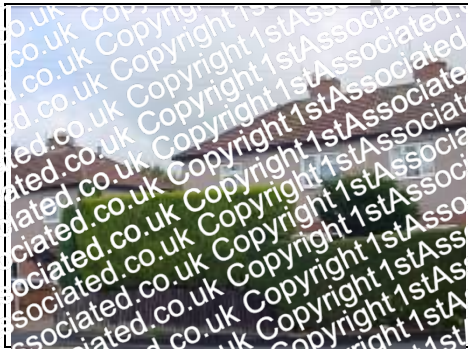
There is a garden and a driveway to the front. The front fence needs re-staining.

Fence to front needs re-staining
