RESIDENTIAL BUILDING SURVEY

Non-Traditional Pre-Cast Concrete House

South West England

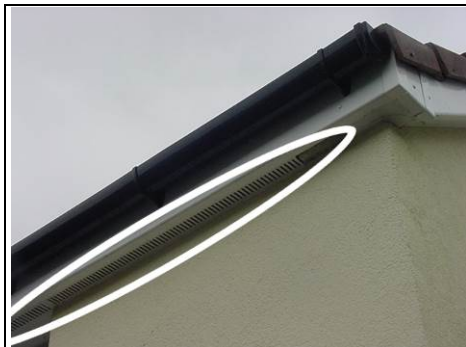
Plastic soffits with vents fitted in many short sections

We understand this is the third time the plastic fascias and soffits have been fitted. They were original fitted over the original ones, which had deteriorated from what we understand. They have been replaced but are in small sections.

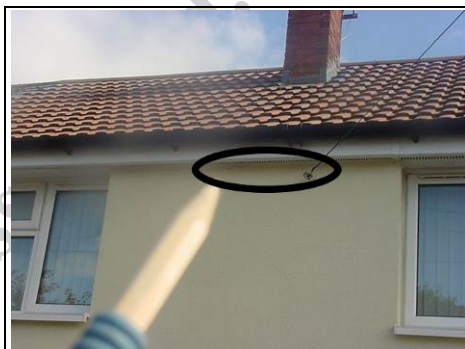
As we understand it from what you have told us, there has been damage to the external wall insulation when the soffits were being fitted and you are currently pursuing a claim against the Council with regard to this.

Damage to external wall

ACTION REQUIRED: We recommend you ask for a written report with regard to the External Wall Insulation (EWI) manufacturer's findings, together with them advising what they think is the best way forward, so they can give you a Guarantee and what they feel is the best way forward if they are not prepared to give you a Guarantee.

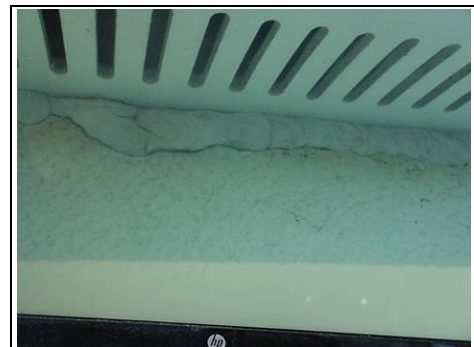
Close up of damage to render
(client's photo)

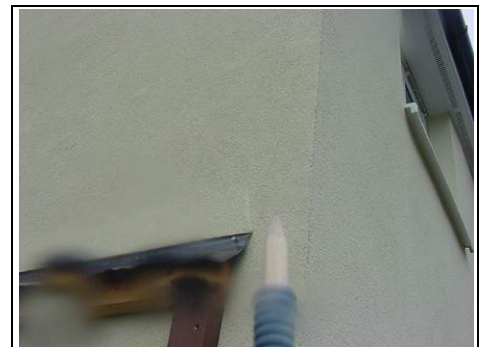
Slight hairline crack just above the flashing

To complete the lean-to as we see it, you will need to either to build a completely self-supporting separate structure, that is then abutted to the main building, and the insulation be replaced, subject to the manufacturer's agreement, or have a manufacturer approved detail that allows you go fix through the insulation.

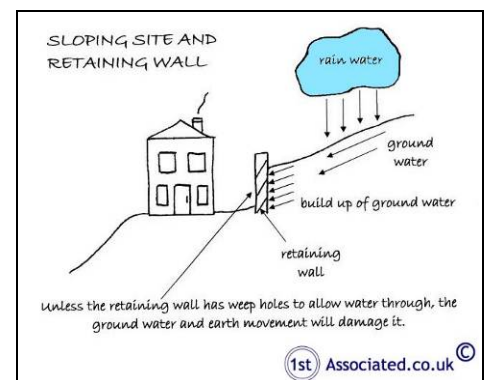
Retaining walls right side

The front retaining wall is helping to hold the driveway in place. The wall is part breeze block, which is not really the best material for a retaining wall as they absorb dampness and can deteriorate due to dampness. We noted cracking on this wall.

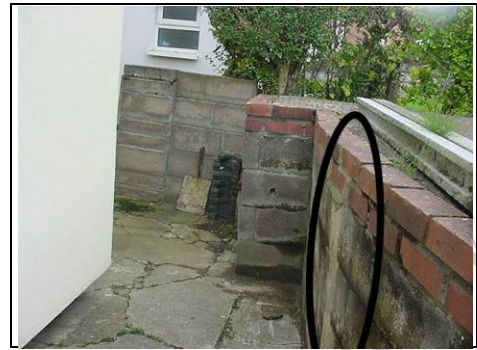
Crack to right side retaining wall around drop from front driveway it

ACTION REQUIRED: We recommend adding weep holes to the retaining wall. This will then relieve the pressure behind the walls and in due course repair the walls.

ANTICIPATED COST: A few hundred pounds to add weep holes. Then it will depend upon what you want to do. Please obtain quotations.

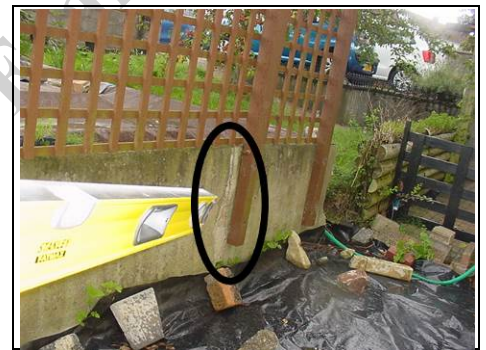
There is also a retaining wall to the left side, which is the garden side. It is built in a similar manner and we also noted a crack in this wall.

Crack in left side retaining wall

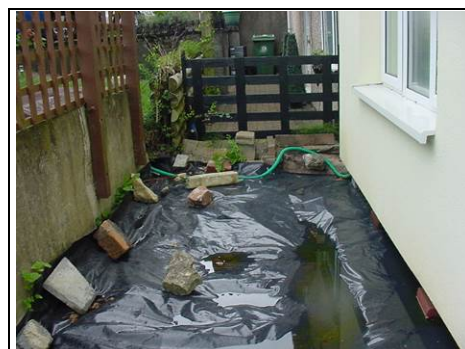
We feel the tarpaulin to the front of the property will cause dampness to get under the building, which in turn will lead to other problems, such as black mould and a poor health environment.

Polythene sheet/tarpaulin at front by base of the wall

ACTION REQUIRED: We recommend the tarpaulin is removed immediately.

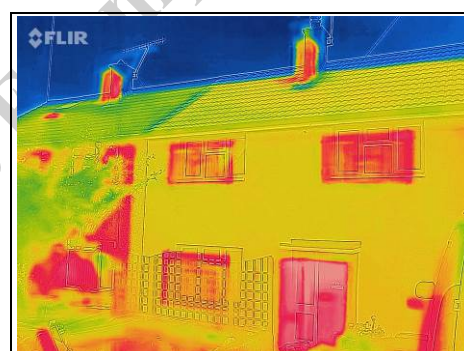
Front of the property with the red being heat coming through the windows and front door

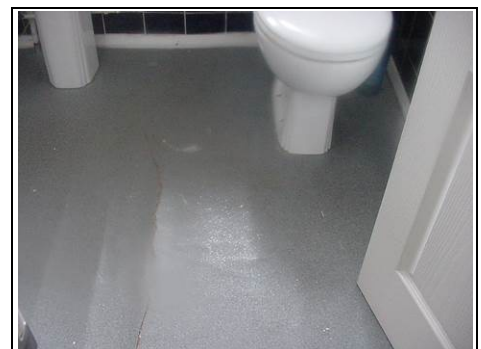
Bathroom floor

ACTION REQUIRED: We recommend you get a qualified plumber to check all the fixtures and fittings to see if any of them are leaking immediately and ask for a report, which we would be more than happy to comment on.

ANCICIPATED COST: Few hundred pounds for a test and report; please obtain quotes.

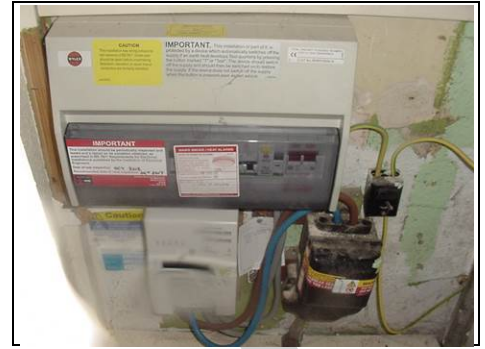
Fuse board

ACTION REQUIRED: We recommend you upgrade the fuse board to one in a fire resistant metal casing.

We recommend an Institution of Engineering and Technology (IET) test and report to be carried out by an NICEIC registered and approved electrical contractor or equivalent.

ANTICIPATED COST: £250 - £500 for a test and report plus any recommended work and £250 - £500 for a new fuse board; please obtain quotations.

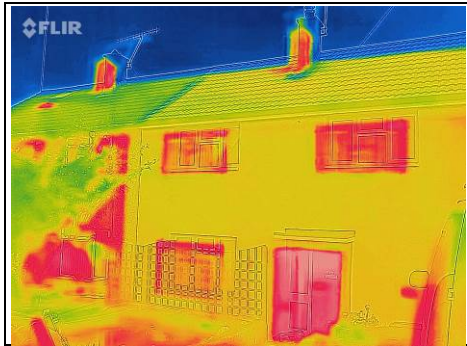
Front of property showing heat coming through windows and door

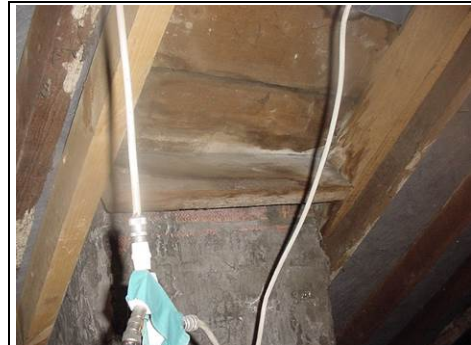
Water damage

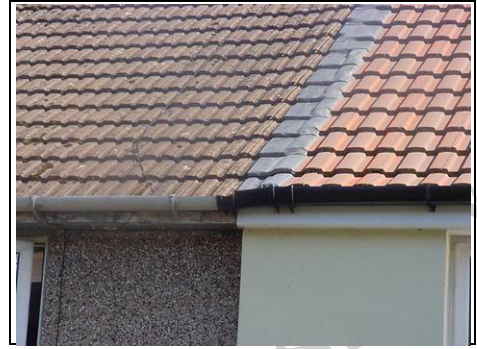
This needs to be monitored in case it leaks. There are many ways of joining new roofs to old, generally we would recommend a verge detail as opposed to a flashing detail like this where the roofs do not meet.

Junction in roof between your property and next door

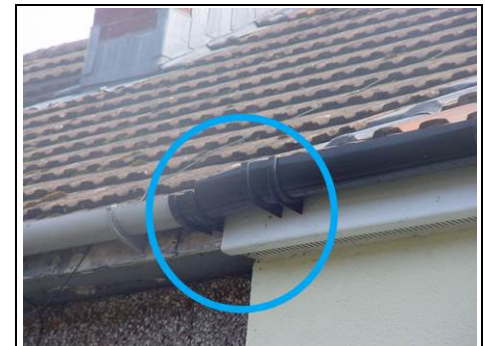
We noted an awkward detail to the front guttering where it joins with next door's gutter, which we think may leak. This is because of your property having the external wall insulation and next door's not.

Awkward detail to front where the guttering meets next door's gutter

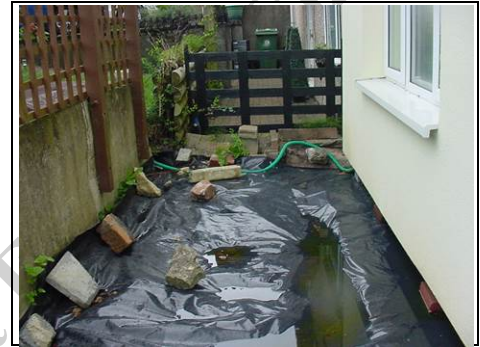
Our concern is that the polythene sheet/tarpaulin to the front will cause dampness under the property.

Polythene sheet/tarpaulin at front by base of the wall

ANTICIPATED COST: In the region of £1,500 to £3,000 for a French drain; please obtain quotes.

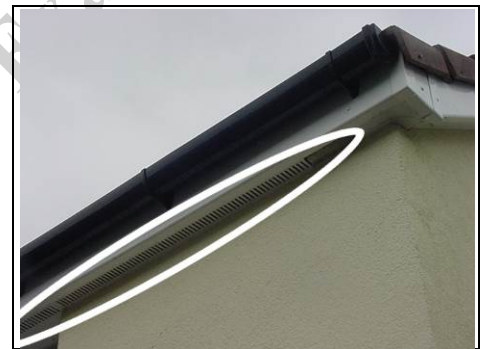
We also understand that the original timber fascias and soffits were over-clad. These vented soffits have been cut into smaller sections, indicating issues. They have also damaged the External Wall Insulation (EWI) caused when carrying out these works.

Vented soffits

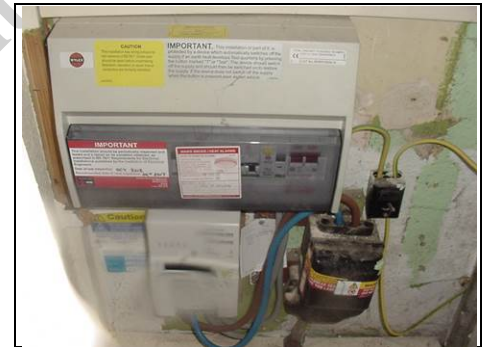
Fuse Board

ACTION REQUIRED: We recommend you replace with a fuse board in a fire resistant metal casing.

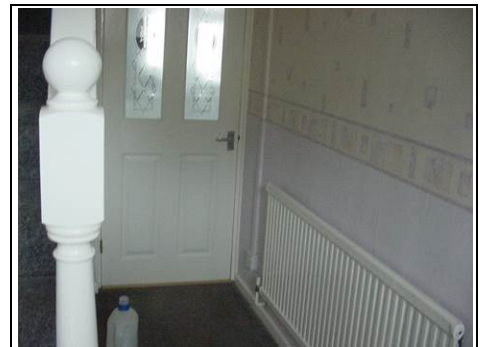
Single panel radiator in hallway

Replace single panel radiators with double panel convection radiators

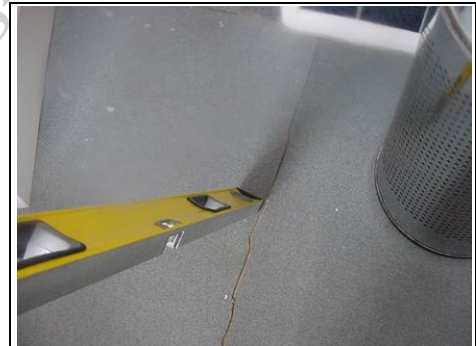
At the time of our inspection the bath panel was removed and there was damage to the floor and black mould to the wall.

Damaged floor

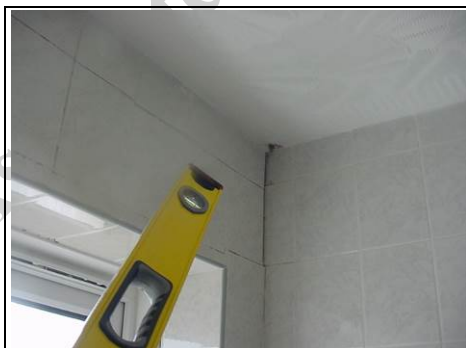
Black mould to corner of wall

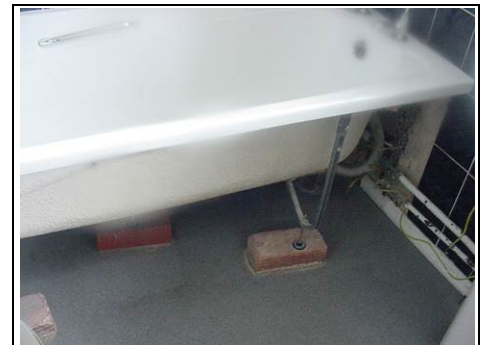
Bath panel missing

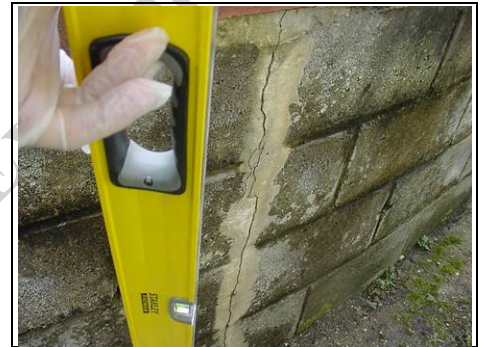
There are retaining walls, which we noted cracking to both sides.

Close up of crack

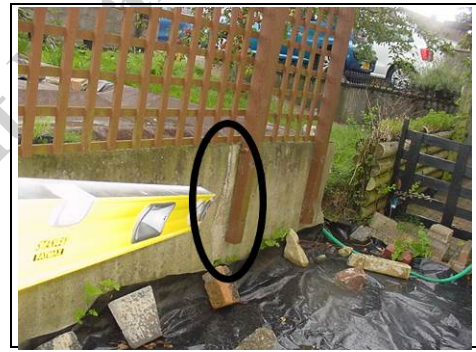
We noted a crack to the retaining wall to the left side.

Crack in front left side retaining wall

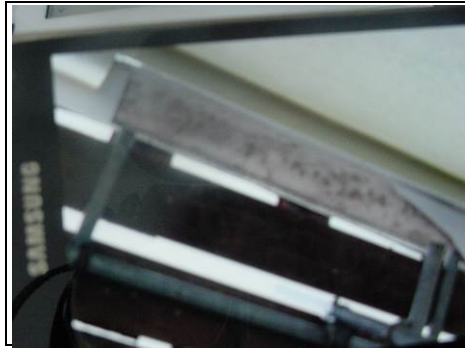
Deteriorating timber fascias board

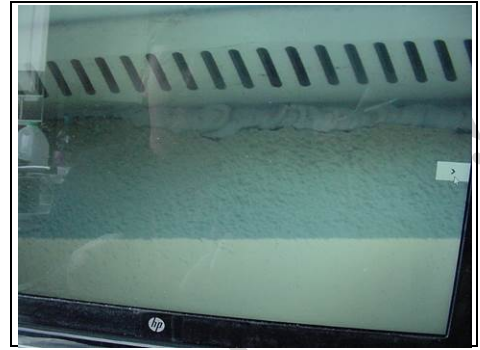
Damaged fascia board where mastic has been added

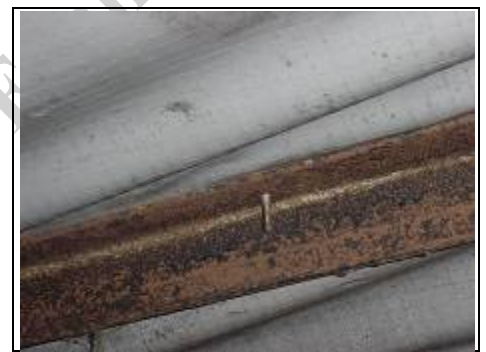
Rusting within the roof between the insulation and plastic protective underlayer

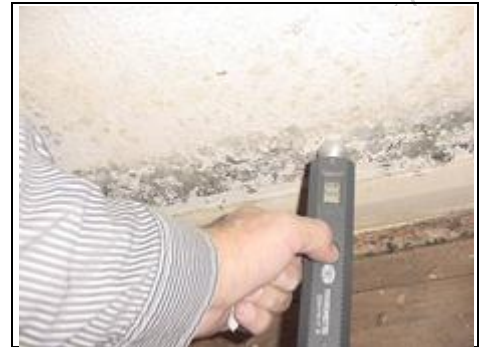
Black mould and high damp meter readings
