RESIDENTIAL BUILDING SURVEY

Non-Traditional BISF House Lincolnshire

Mr X

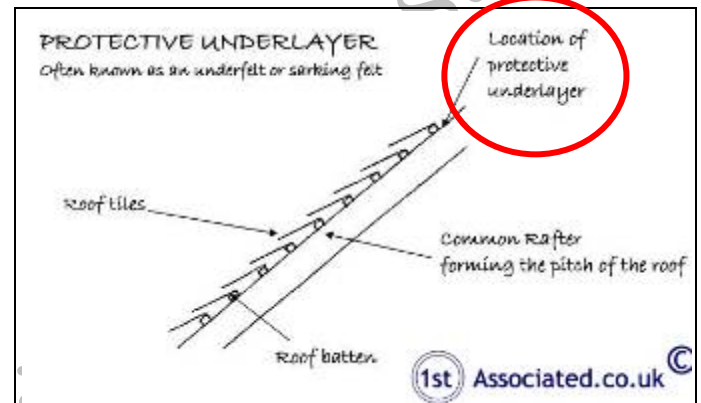
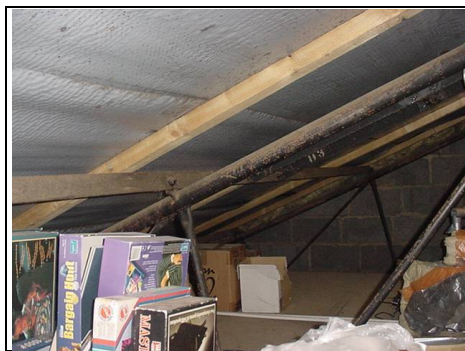
We examined the structural frame that we can see within the roof and found it to be in below average condition. We believe the plastic protective underlayer has helped accelerate deterioration.

Rust to metal frame

ACTION REQUIRED: We recommend that the metal roof structure is rubbed back, any structural defects treated, a rust stop paint added and the roof to be ventilated.

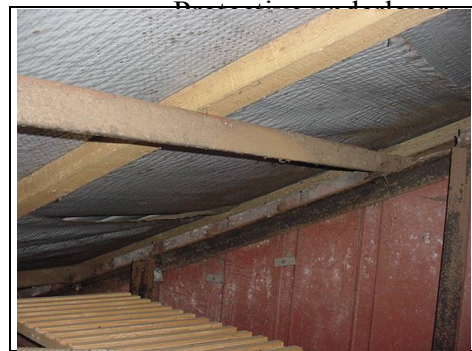
Rust to metal frame

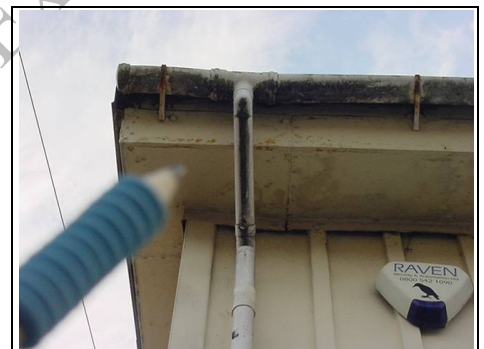
We can see that the gutters have been replaced; we cannot be one hundred percent certain whether the fascias and soffits are asbestos or not.

Fascias and soffits possibly asbestos

ACTION REQUIRED: The only way to be one hundred percent certain with regards to Asbestos in a property is to have an Asbestos report with samples taken and the recommended action carried out.

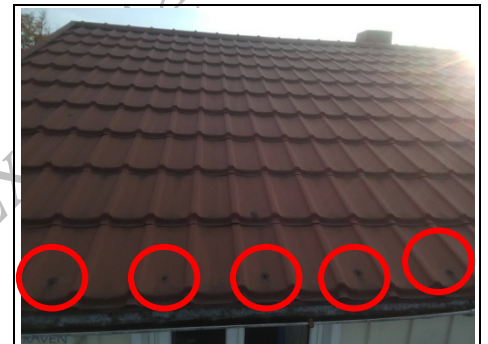
The anchor bolts are rusting to the pressed metal sheets. This type of problem is fairly common on commercial properties which use a similar detail however we have not come across it on this type of BISF house.

Rusting of anchor bolts

A close inspection needs to be carried out of the rusting anchor bolts and replace as necessary.

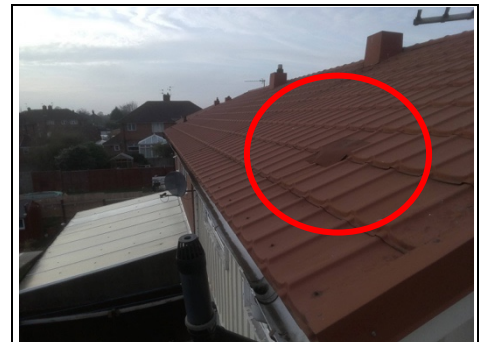
As discussed, the internal soil and vent pipe has been removed. This has a felt patch repair which needs to be carried out properly.

Felt repair where internal soil and vent pipe removed

ACTION REQUIRED: Repair felt repair with profile metal sheet.

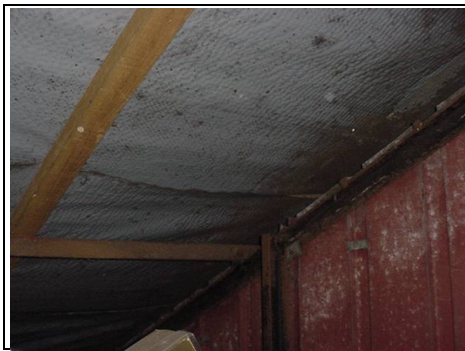
Within the roof we found a plastic based membrane. This type of membrane was used in the 1970's and tends to suffer from condensation. Today protective underlayers are a breathable membrane. Unfortunately having condensation in a house such as this means that the metal frame rusts.

Plastic underlayer

ACTION REQUIRED: We would recommend the roof is vented and that air movement is introduced. Unfortunately this is a difficult and awkward task as it will involve emptying the roof of stored items, removing the boarding that has been added, removing the insulation and rubbing back the metalwork, preparing it and applying a protective paint.

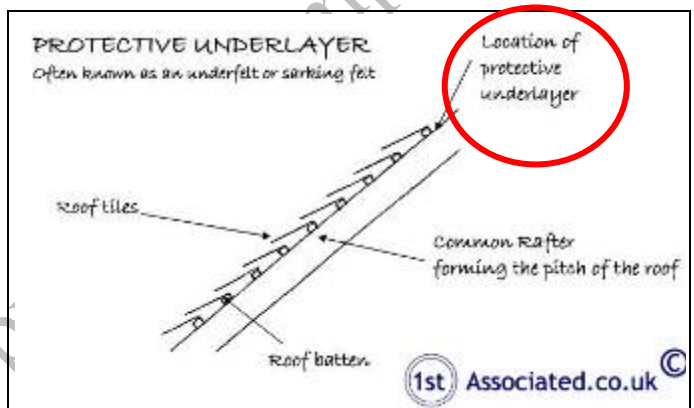
Protective underlayer

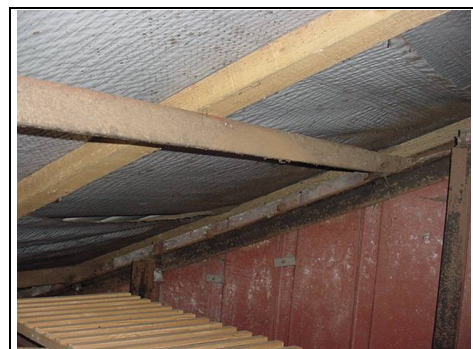
Within the roof where we could see the metal frame we could see that the rusting is above average.

Rust to metal frame

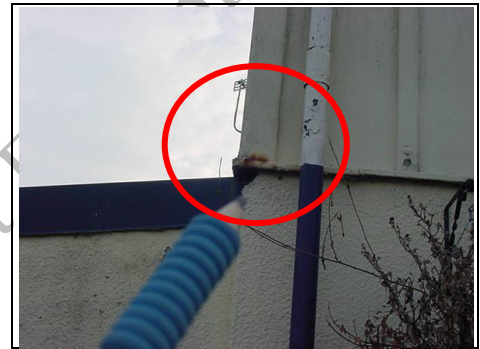
The profile metal sheeting is showing signs of deterioration. There is rusting occurring at the drip detail where the frame meets the main building. This can be for many reasons, for example leaking gutters and it can also be due to lack of maintenance and the paint being allowed to weather in these areas. We anticipate some deterioration for its age, type and style however this is above average.

Rust on sill between profile metal sheet and render

ACTION REQUIRED: Repair, prepare and redecorate.

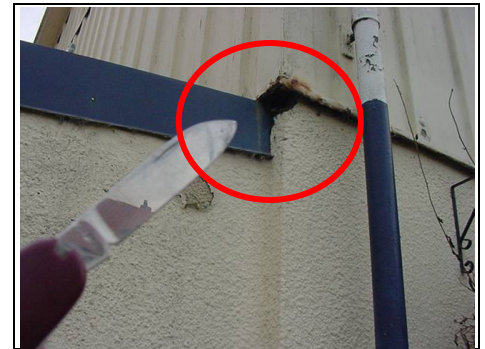
Rusting to sill detail to front left

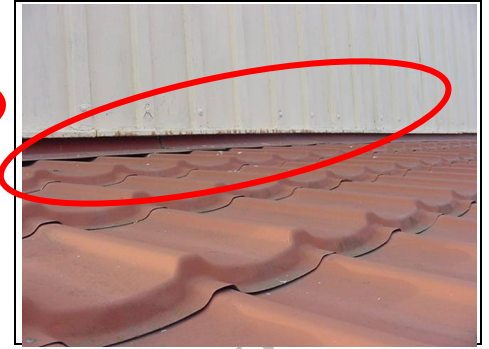
Rust to sill detail of single storey extension

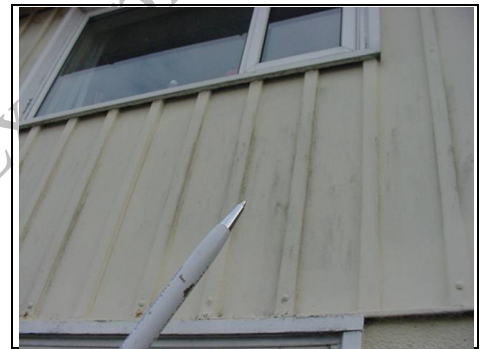
Blackening within panels

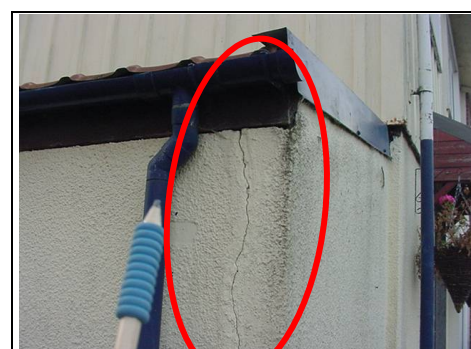
The cracks to the lean-to we are not overly concerned about as we believe this to be a traditional construction. We noted blockwork when we went into the store area.

Vertical crack to single storey lean-to

ACTION REQUIRED: Ideally we would recommend that you place an insurance claim, advising that the cracking has been noted by a structural surveyor. This usually means that the insurance company will carry out a monitoring exercise (the Building Research Establishment recommend monitoring any cracks for a minimum of one year) to establish if there is any progressive movement. Your future liability should be limited to the cost of the excess on the insurance.

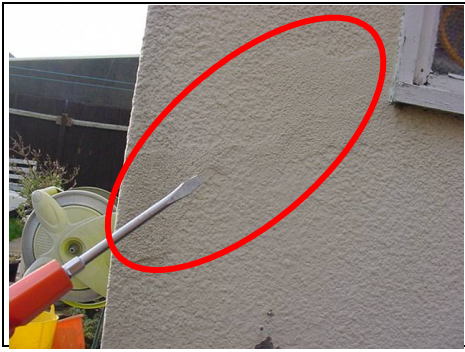
Repaired cracks on left side

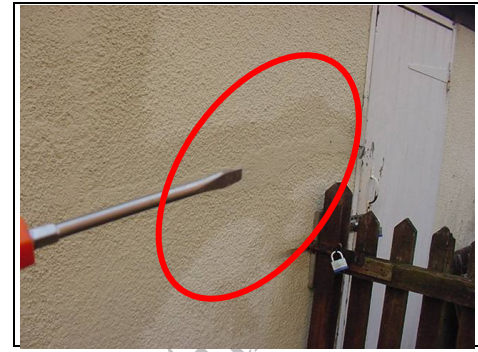
Repaired cracks on left side

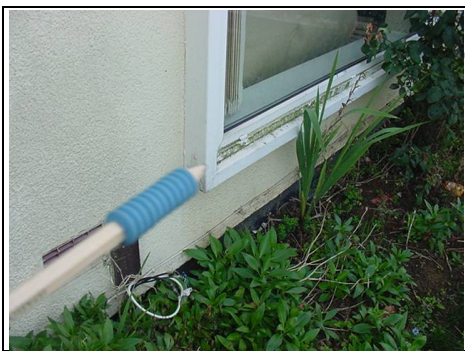
Moss sitting in surround around window sill

ACTION REQUIRED: Repair, prepare and redecorate. We would also add that the windows do not have trickle vents; it is good to have air movement in the property so either add trickle vents to the windows or replace them and/or add ventilation to the rooms.

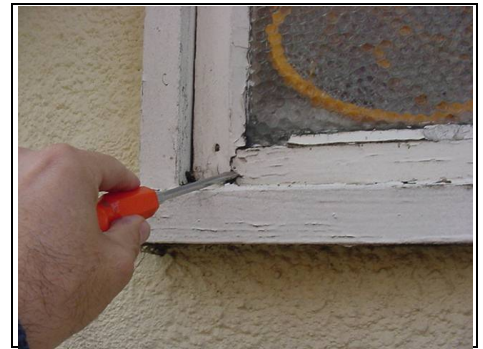
The property has older style plastic windows set within a metal frame. The paint to the metal frame is deteriorating. There is a timber window to the lean-to which is in need of repair and redecoration.

Timber window in need of work

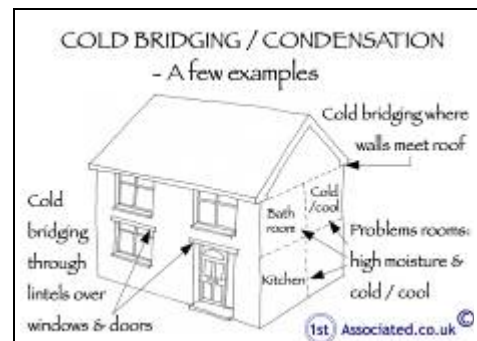
Cold bridging

ACTION REQUIRED: We would recommend large good quality humidity controlled extract fans are added to the kitchen, the bathroom and any humidity generating areas for example rooms that are used for drying clothes internally during winter months (we would assume that clothes will be dried externally during the warmer months). By large extract fans we mean 150mm.

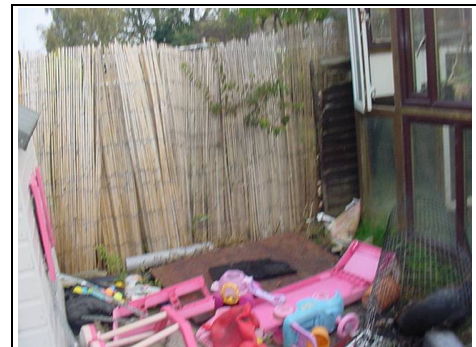
Generally, the fence to the left side is your responsibility. We noted the left fence is in need of repair.

Left fence

ACTION REQUIRED: Repair or replace.

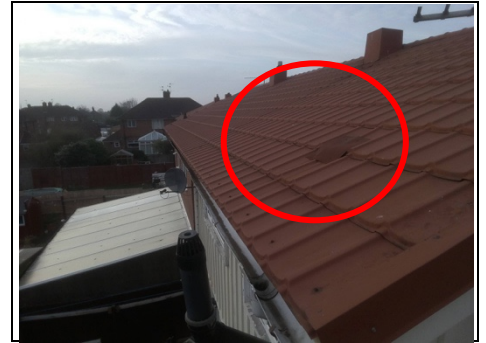
Felt repair where internal soil and vent pipe removed

ACTION REQUIRED: Repair felt repair with profile metal sheet.

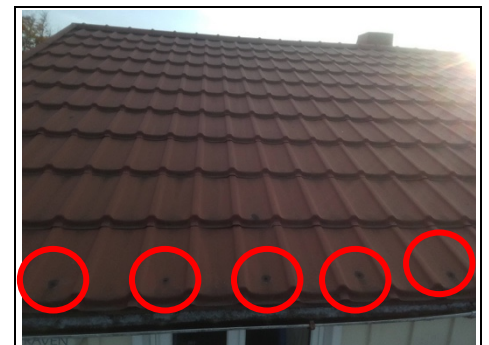
Rusting of anchor bolts

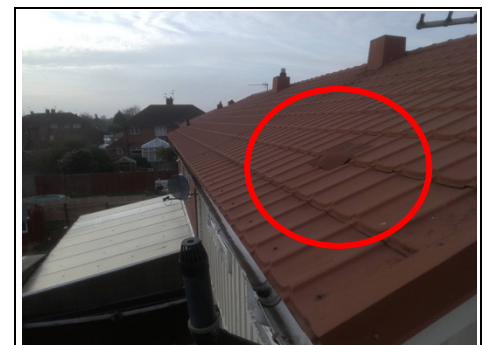
The internal soil and vent pipe has been removed. This has a felt patch repair which needs to be carried out properly.

Felt repair where internal soil and vent pipe removed

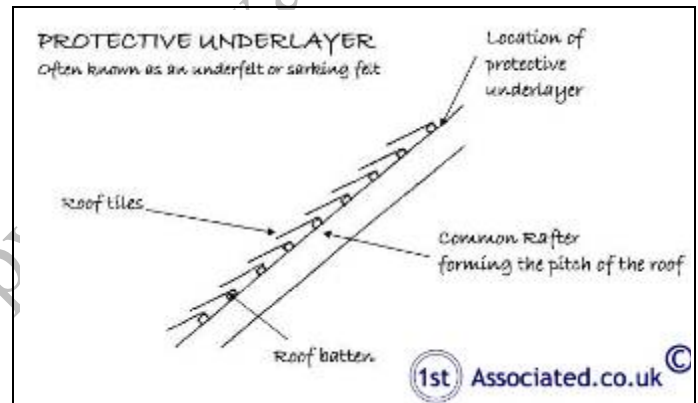
Protective underlayer

When we inspected the loft space we found a reinforced plastic protective underlayer. This type of protective underlayer was used in the 1970s/1980s and its use was generally stopped because it was susceptible to causing condensation unless the roofs are adequately vented, which they are usually not. In this case we would recommend improving the ventilation in the roof. If this does not stop the condensation ultimately the whole roof may have to be repositioned. We would however first of all reposition the water tanks in the roof to see if this helps.

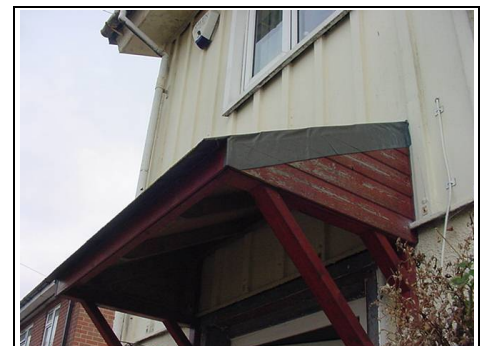
Canopy gallow brackets with flashband on side and timber needs redecoration

Entrance canopy

ACTION REQUIRED: Re-roof, repair, prepare and redecorate.

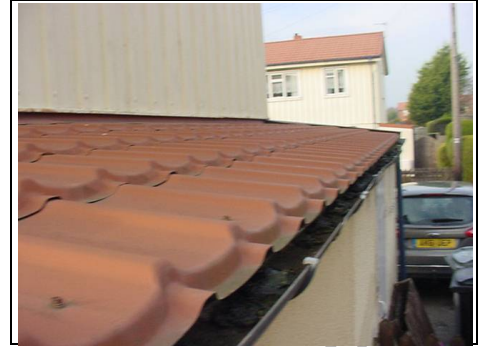
The roof is pitched and clad with pressed metal. From ground level, this looks in average condition considering the roof's age, type and style.

Single storey extension pressed metal tiles

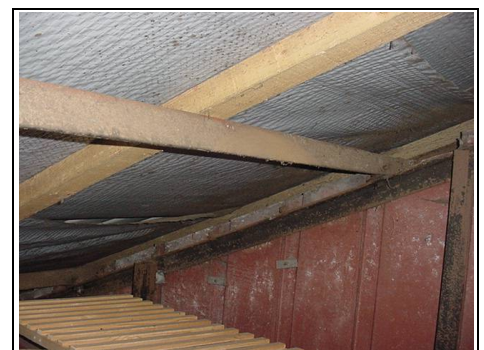
Rust to metal frame

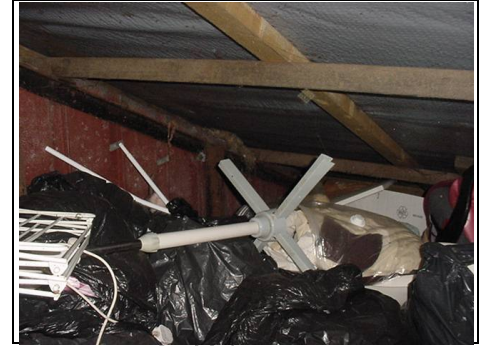
View of roof restricted by stored items

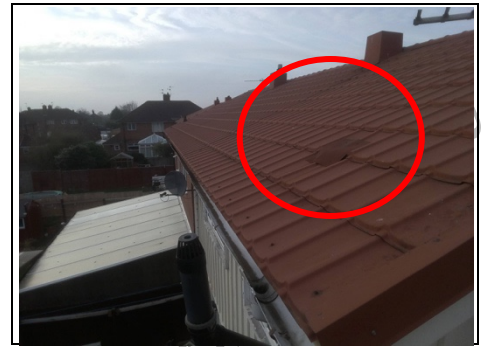
Felt repair where internal soil and vent pipe removed

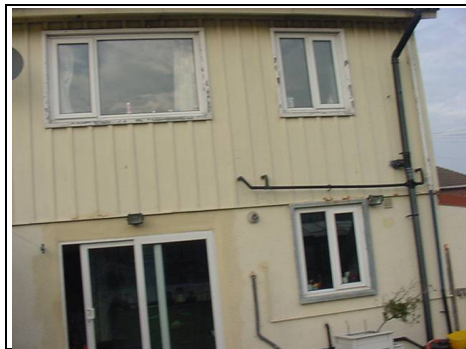
We would also comment that some of the pipework is to a DIY standard and would benefit from more support, with no support to 3-4m of pipework.

DIY standard pipework

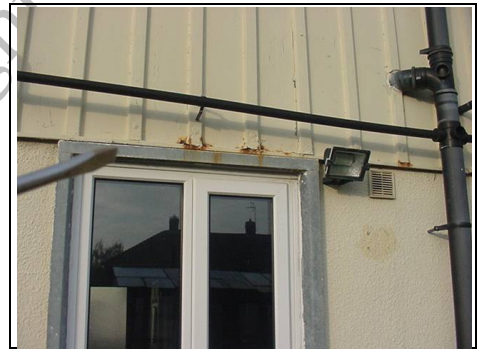
More support required to pipework

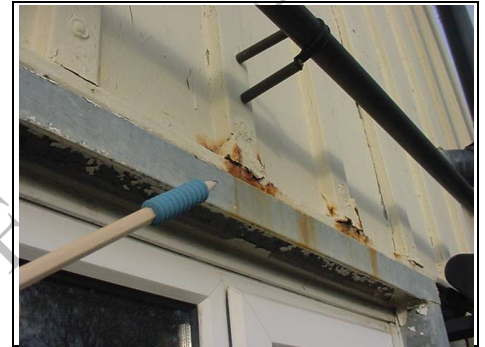
Rust where profile metal sheet meets the lower part of the building

ACTION REQUIRED: Redecorate.

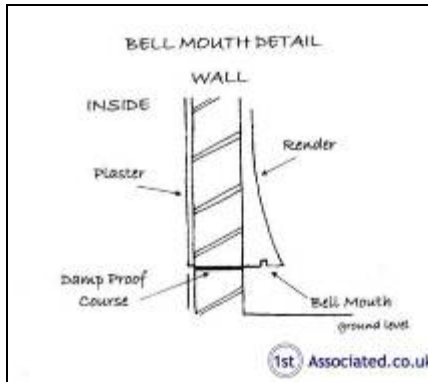
To the base of the render there was a bell mouth detail. This should in theory be 100mm to 200mm above ground level. We recommend the ground around the property is reduced to do this.

Bell mouth detail

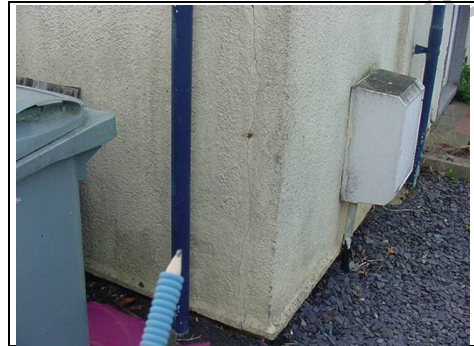
Bell mouth detail

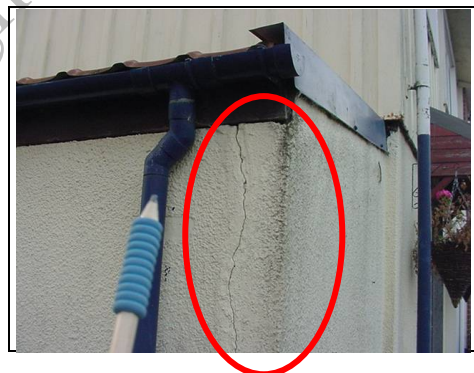
Vertical crack to single storey lean-to

ACTION REQUIRED: Please see our comments in the Executive Summary.

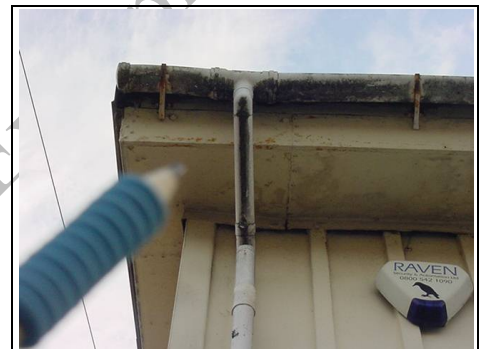
Rusting at high level to fascias

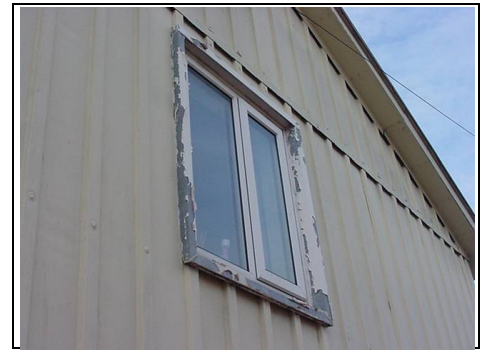
Deterioration to left window surrounding metal frame

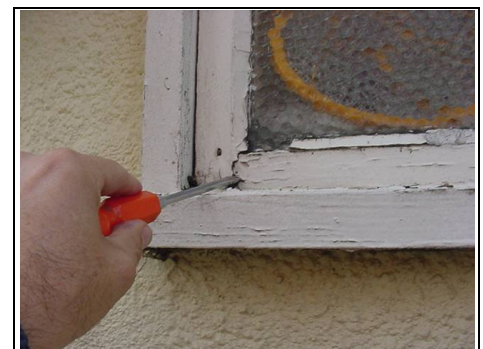
Timber window in need of work

ACTION REQUIRED: Please see our comments in the Executive Summary.

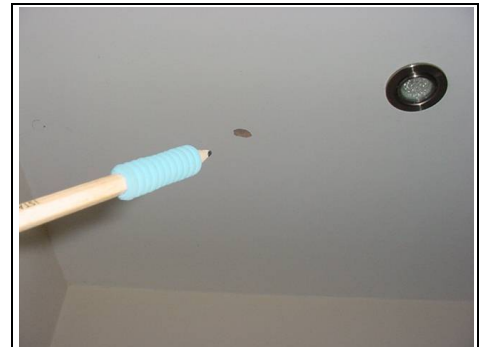
We noted popping to some of the plaster. This is where the nail heads have not been put into the plaster correctly and the plaster over the top pops which leads us to believe that probably the plaster has been tacked onto the original ceiling. We have not been able to check what this is.

Popping to plaster ceiling

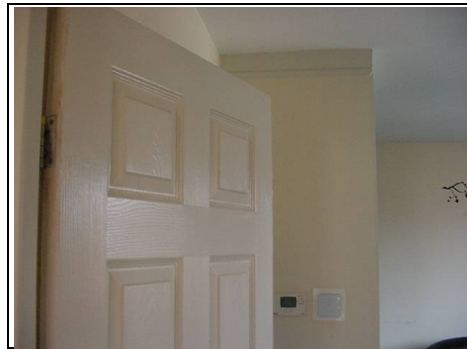
The property has hollow core doors (sometimes referred to as egg box doors, as this is what the internal of them looks like when they are opened up). These can damage very easily.

Hollow core door
