Victorian Example Residential Building Survey

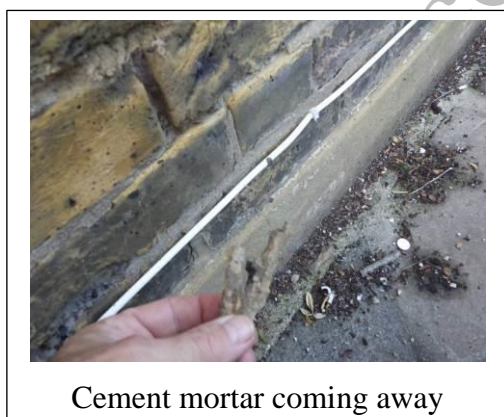
We would draw your attention to the cement mortar re-pointing that has been carried out on the exterior of the property that we feel is not appropriate to this building. Originally, it would have been built with a lime-based mortar which allows the building to breathe.

This was fairly common particularly in properties like this that were updated in the 1960's/1970's from what we can see from such things as the replacement of the slates with a concrete tile.

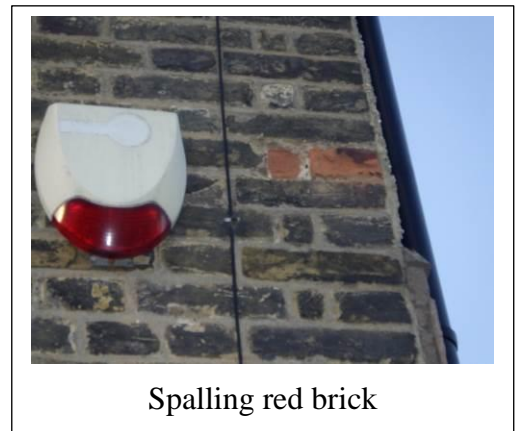
The use of cement mortar causes deterioration to brickwork and does lead to the face of the bricks deteriorating and also leads to dampness and cracking.

ACTION REQUIRED: We would recommend repointing with a lime mortar. If you recall, the cement mortar was falling out in many areas and we think a stiff brush would remove a fair amount of it. We would initially concentrate on the base of the property which should help considerably. Care needs to be taken as we feel some of the bricks are starting to deteriorate/shale.

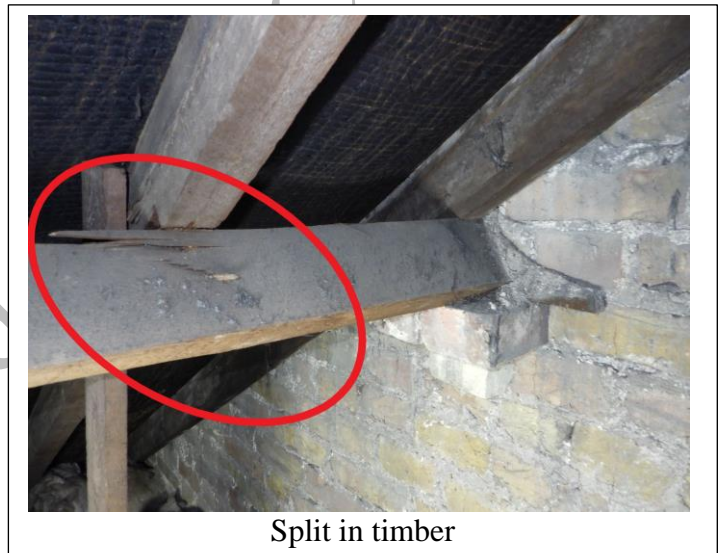
We noted a split in the roof timber which indicates to us that there has been some movement to the gable end. It is very difficult to confirm how long ago it is but to us it means it is essential that you have an insurance claim placed by the existing owners.

ACTION REQUIRED: Ideally, we would recommend the existing owners take out an insurance claim, advising that the cracking has been noted by a structural surveyor (this should cost them nothing other than time to write the letter/email). This usually means that the insurance company will carry out a monitoring exercise (the Building Research Establishment recommend monitoring any cracks for a minimum of one year) to establish if there is any progressive movement. Your future liability should be limited to the cost of the excess on the insurance providing the insurance company is happy for you to take over the insurance claim.

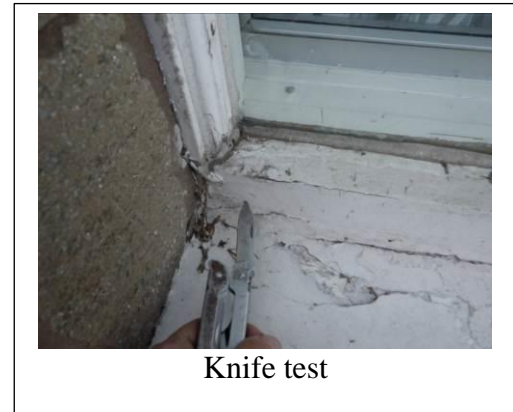
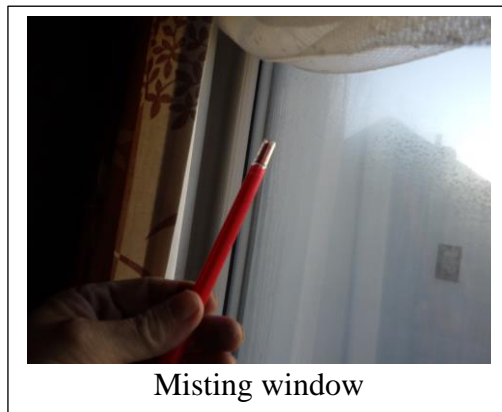
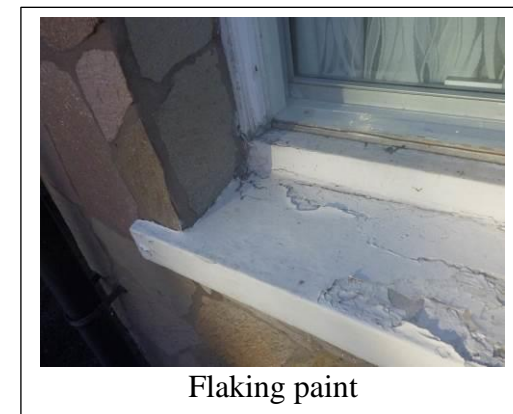
The property has a mixture of timber and plastic double and single glazed windows. The windows have paint flaking and we noted the high level windows look to be in poor condition.

Where the windows are double glazed we noted that some of the seals on the plastic windows looked to be starting to go and we can see them misting over for example the rear left window.

ACTION REQUIRED: Budget to repair and make good and/or replace the sealed windows.

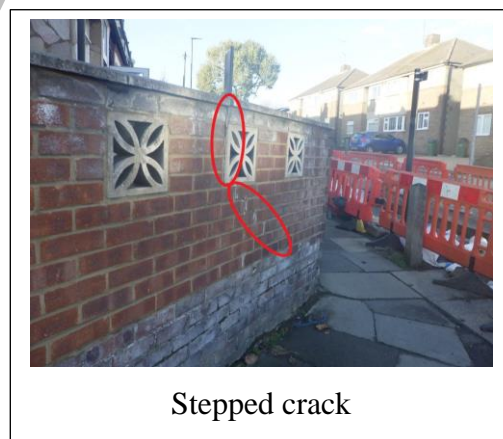
As mentioned, we noted cracking to the boundary wall. As you have pedestrians walking around the outside of it we would recommend repairs are carried out sooner rather than later.

ACTION REQUIRED: It may be a case of repairing it or it may be a case of partial rebuilding; you need to speak to a bricklayer.

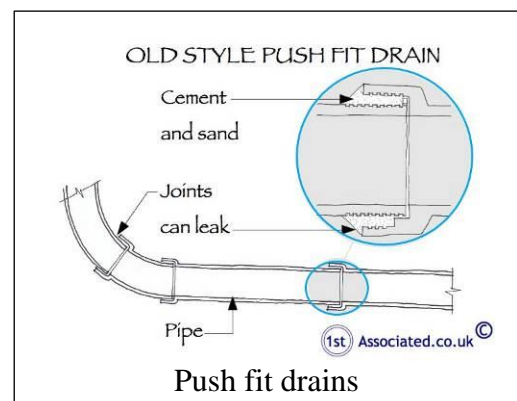
As we discussed, there is not a manhole within the curtilage of the property. The only manhole we have seen is in the rear private road, which we have not had access to. In years gone by, in older properties such as this, drainage was often push fitted together rather than bonded together and they can leak.

ACTION REQUIRED: Please see our earlier comments.

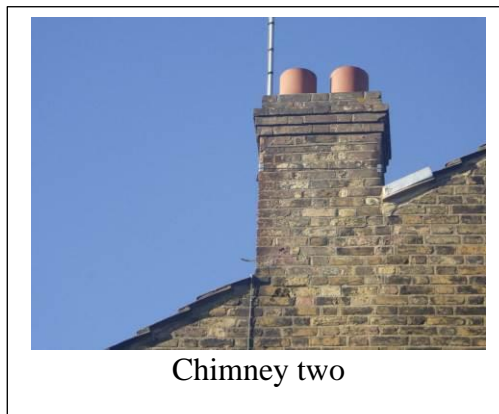
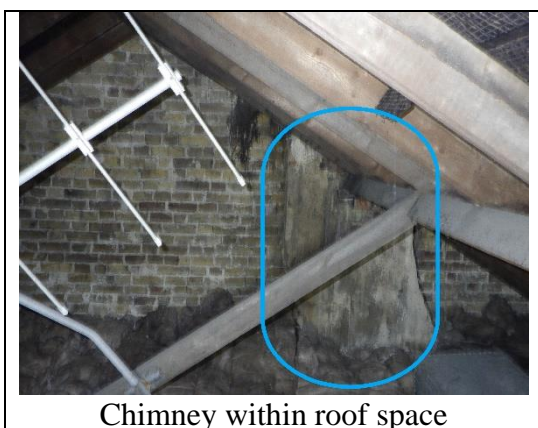
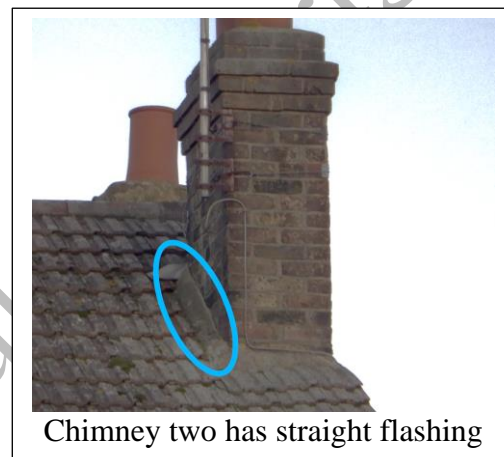
We noted an aerial attached to the chimney which we are not keen on as it can de-stabilise the chimney.

ACTION REQUIRED: Periodically inspect the chimney.

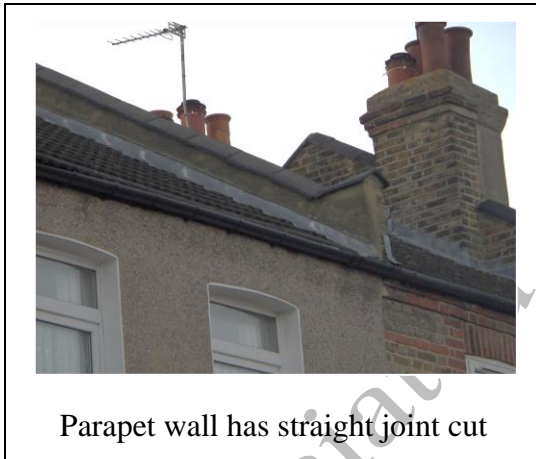
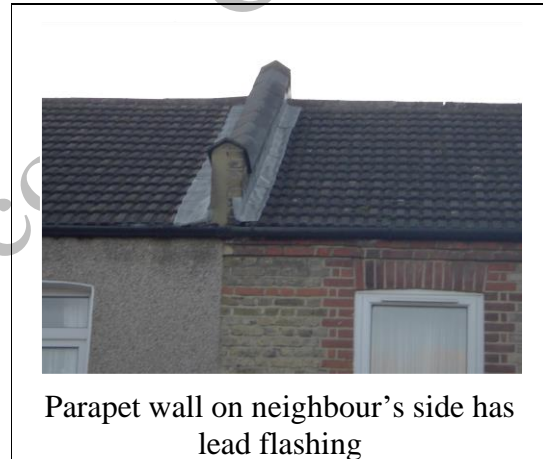
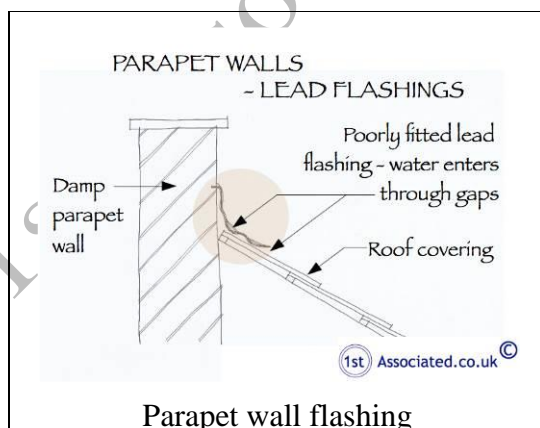
Movement?

We would comment the flashing has a poor quality straight cut rather than being stepped. It was either not originally laid very well or there has been some movement. Please see our comments with regards to the existing owners taking out an insurance claim that you then take over with regard to possible movement in the property.

ACTION REQUIRED: Please see our comments in the Executive Summary.

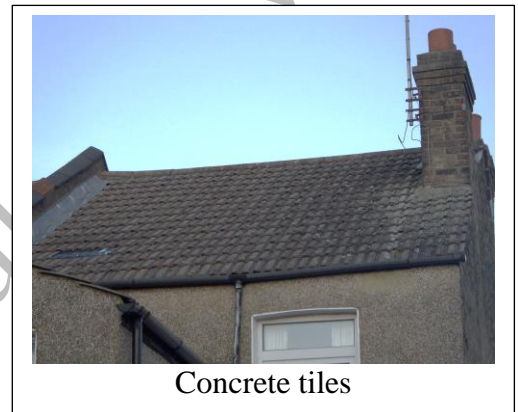
Concrete tiles

There are glass roof tiles. Early glass tiles are prone to leaking and are not as good as a modern day roof window.

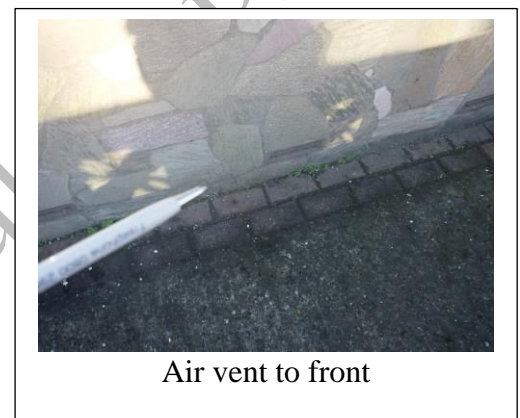
Air vents are essential to have a through flow of air as this helps to reduce the chances of wet rot, dry rot and woodworm. In this case, we noted air vents to the front of the property but no air vents to the rear.

ACTION REQUIRED: We would recommend further vents are added and we would also open up the floor to check its condition.

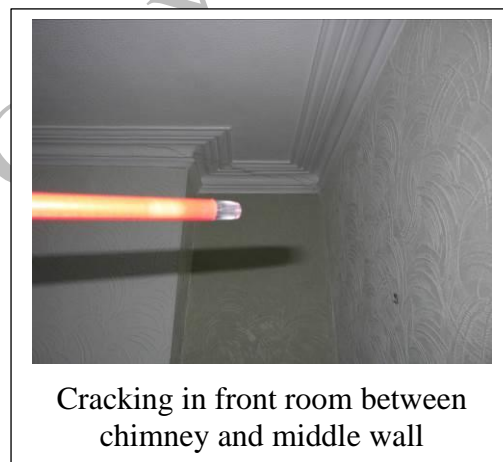
Cracking in front room between chimney and middle wall

ACTION REQUIRED: Please see our comments in the Executive Summary and the defects that we found in the roof.

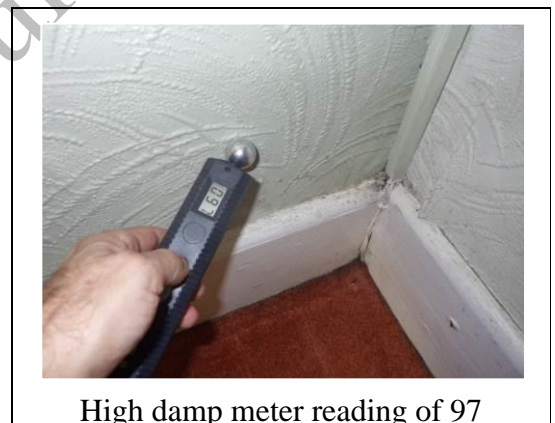
A visual inspection and tests with a moisture meter have been taken to the perimeter walls. In this particular case, we have found significant rising damp.

High damp meter reading of 97

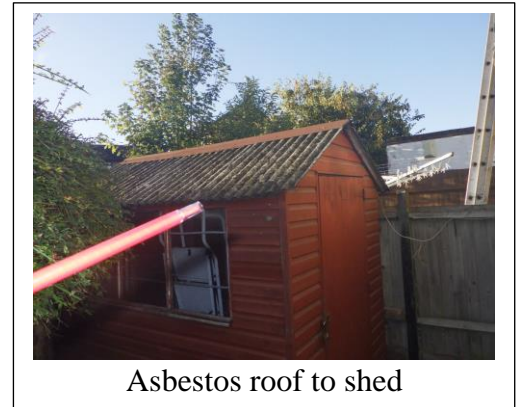
In a property of this age there may well be some asbestos. In this case, we have noted asbestos to the shed roof.

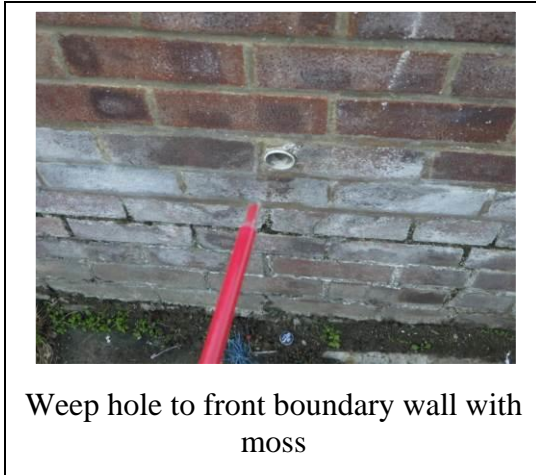
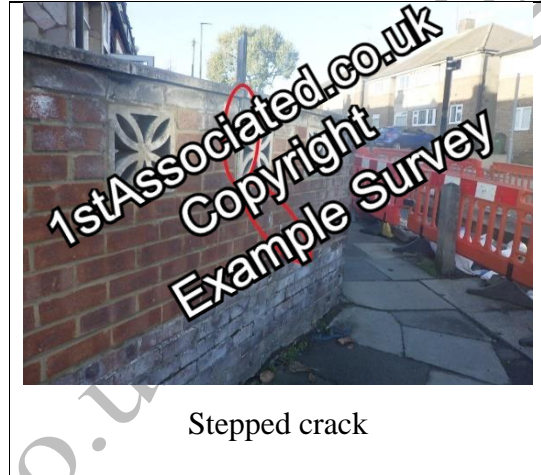
There is cracking to the boundary wall. In this case, we assume that the wall is the boundary wall but you should not assume anything; your legal advisor to check and confirm.

ACTION REQUIRED: Your Legal Advisor to check whose boundary is whose. There is normally a 'T' marking which boundary is yours on the Deeds which you can obtain from the Land Registry.
