Georgian/Regency Example Residential Building Survey

LATE 18TH CENTURY SASH WINDOW

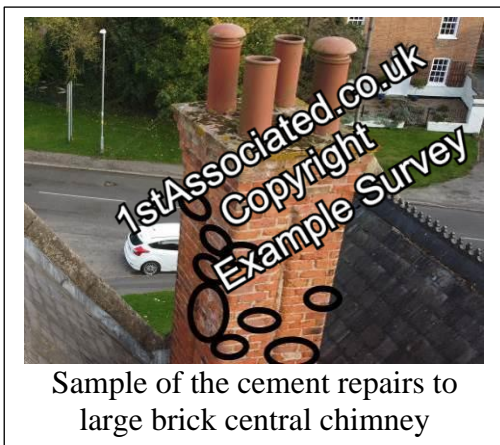
There is a large brick built chimney which sits centrally in the valley gutter between the left and right roofs. This chimney is heavily spalling and in need of repair/rebuilding. We often find as chimneys are exposed they get badly affected.

Sample of the cement repairs to large brick central chimney

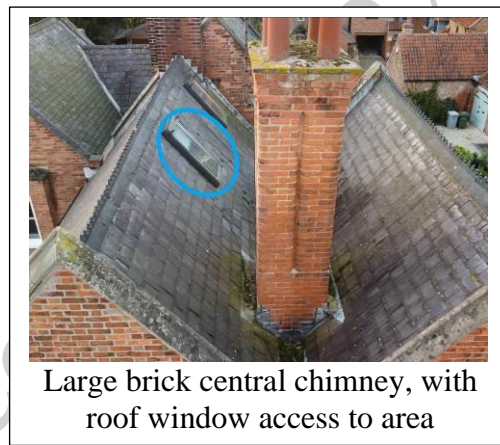
Large brick central chimney, with roof window access to area

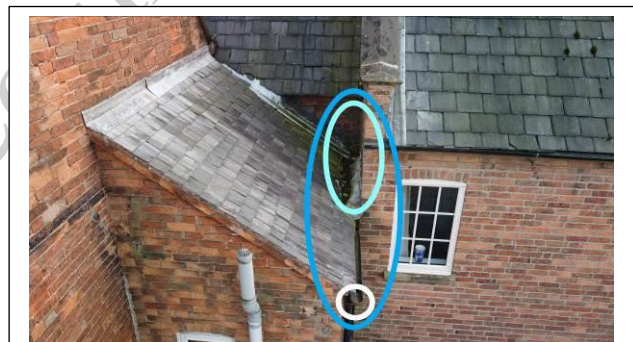
We think the high level awkward valley gutter may be affecting your next door neighbour. We recommend you visit them and have a chat.

High level rear awkward valley gutter against wall, which looks to be affecting the next door neighbour

Key for above photo, showing a sample of the problems	
Dark blue oval	High level valley gutter against neighbour's wall
Light blue ovals	We believe is where the main problems is around the wall
White circle	Where end cap of guttering is missing, which we think is fairly critical in this particular instance

ACTION REQUIRED: As already mentioned, we recommend some form of eye-bolt is fitted that allows harnessing to be carried out so these areas can be looked at properly, also using ladders and crawler boards, etc.

We recommend starting off with basic cleaning of these areas and repairing of any damaged areas, such as putting the gutter end on.

We always think that lead is the best way forward for repairing valley gutters. We would take as many pictures as possible and speak to someone who is good with lead work.

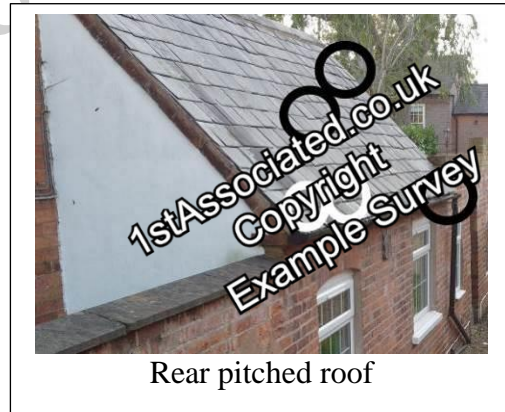
There are also a number of tingles to the rear pitched roof and as mentioned we think there will be problems where the awkward valley gutter is. We think it very likely there will be some rot to the rafter feet in this area.

Rear pitched roof

Key for above photo, showing sample of problems	
White circles	Sample of the tingle repairs
Black circles	Slipped or damaged slates
Blue oval and arrow	Awkward valley gutter

ANTICIPATED COST: In the region of £2,500 to £5,000 to repair/replace slates. Please obtain quotes before you legally commit to purchase the property.

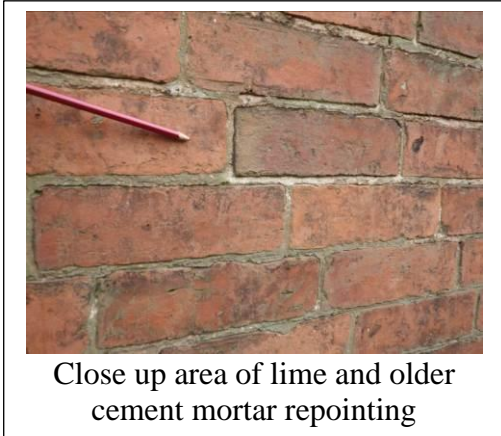
Close up area of lime and older cement mortar repointing

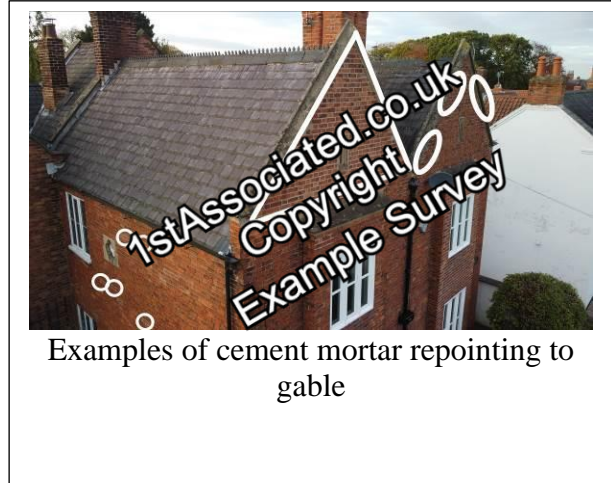
Examples of cement mortar repointing to gable

Key for above photo showing samples of problem areas	
White triangle	Work carried out in cement mortar
White ovals	Areas of repair in cement

The use of cement mortar causes deterioration to brickwork and does lead to the face of the bricks deteriorating and also leads to dampness and cracking.

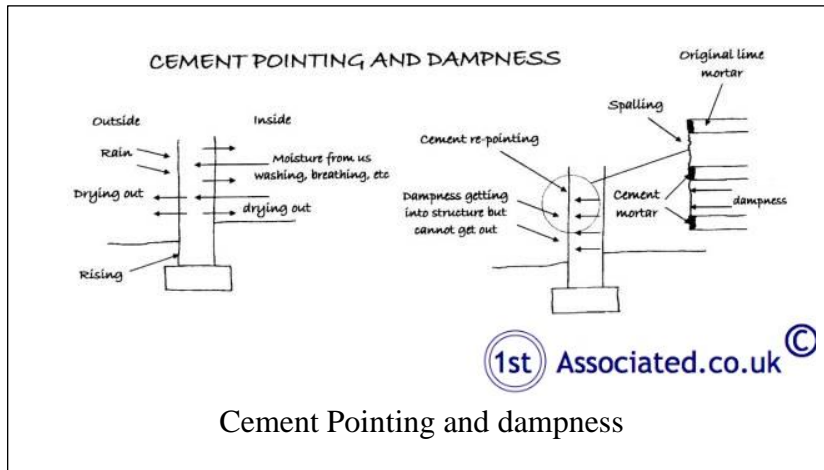
Wrongly repointed areas

The following are a few areas we noted have been wrongly repointed in cement, some of are highlighted in white in earlier photos:

ACTION REQUIRED: Find the oldest/most experienced bricklayer/mason you can who is skilled in using lime mortar to replace cement mortar with lime, ideally during warmer/summer months, known as the lime season.

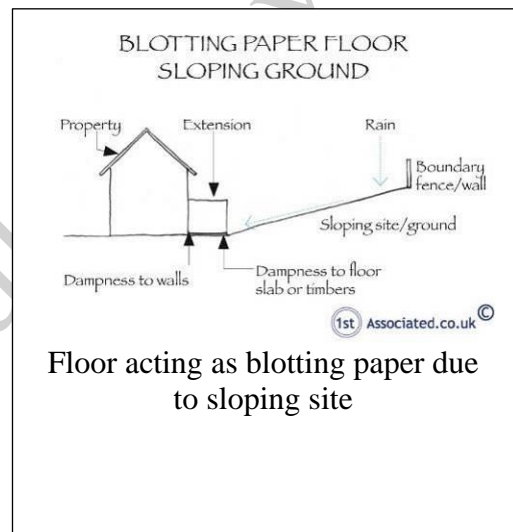
Floor acting as blotting paper due to sloping site

ACTION REQUIRED: There are two gullies in this area, however we would recommend a French drain/land drain is added which will help reduce some of the effects of the sloping site and water discharging against the property. If you can have two of these it will be even better.

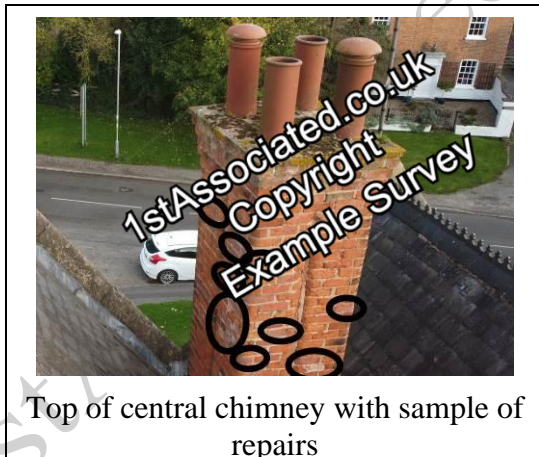
This large chimney is brick finished with a lead flashing and four chimney pots. From what we could see from ground level it looked in below average condition considering its age, type and style. We have circled a sample of spalling brickwork, often more are found when you are actually on the roof and have a close up view.

Top of central chimney with sample of repairs

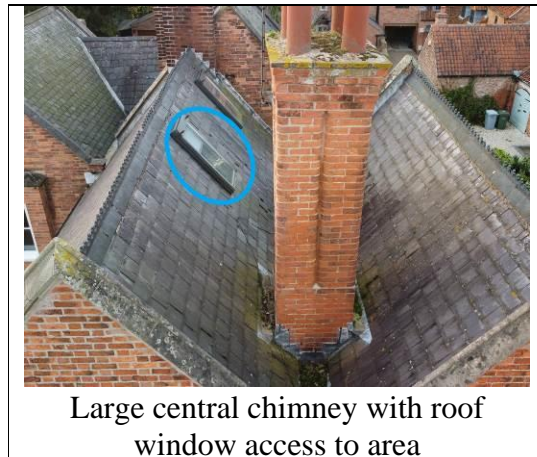
Large central chimney with roof window access to area

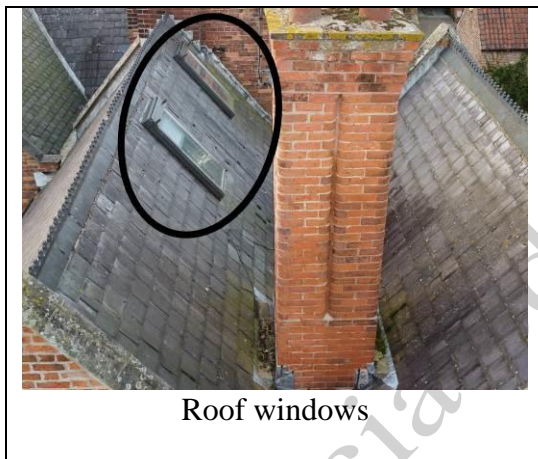
Roof windows

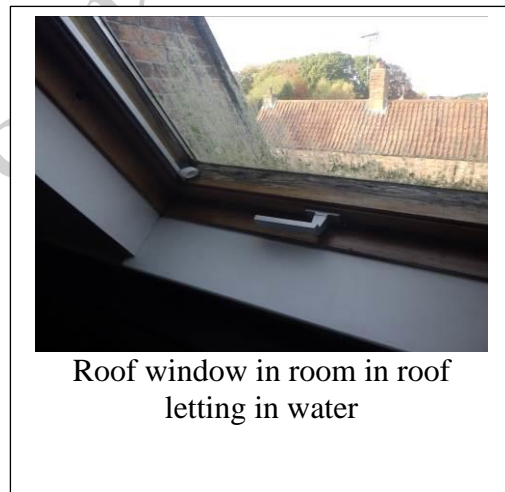
Roof window in room in roof letting in water

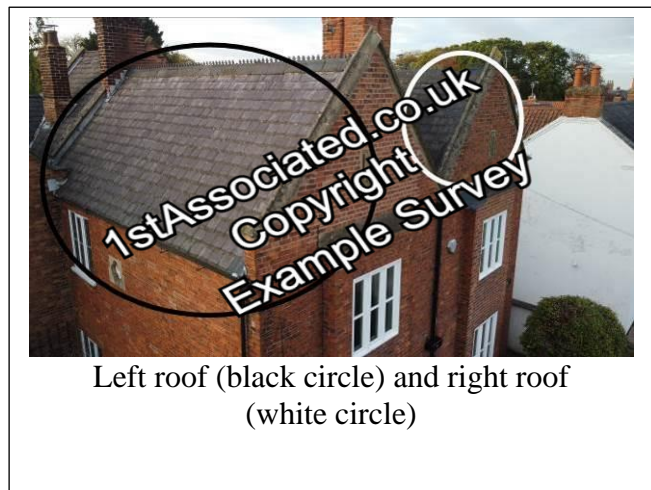
Do not underestimate the amount of work that will need to be carried out to the high level roofs. We believe they are letting water in. They have been patch repaired a great deal using tingles.

Left roof (black circle) and right roof (white circle)

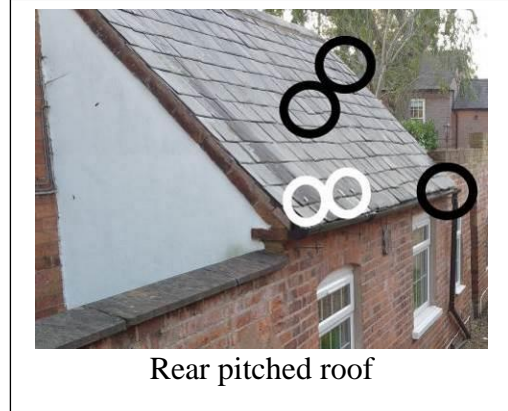
We can see that slates are uneven and there are quite a number of tingles.

Key for above photo, showing sample of problems	
White circles	Sample of the tingle repairs
Black circles	Slipped or damaged slates
Blue oval and arrow	Awkward valley gutter

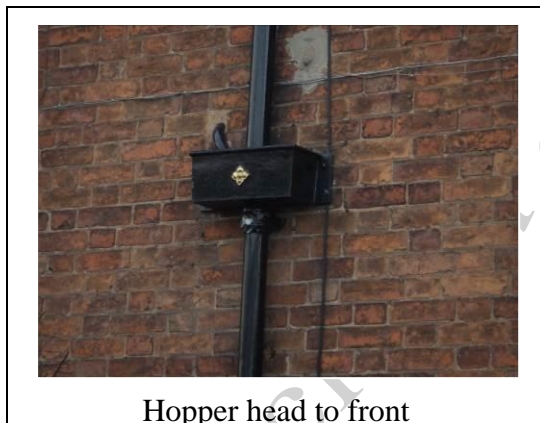
Hopper head to front

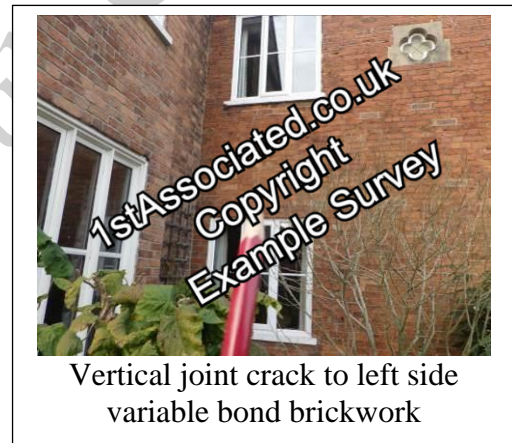
Vertical joint crack to left side variable bond brickwork

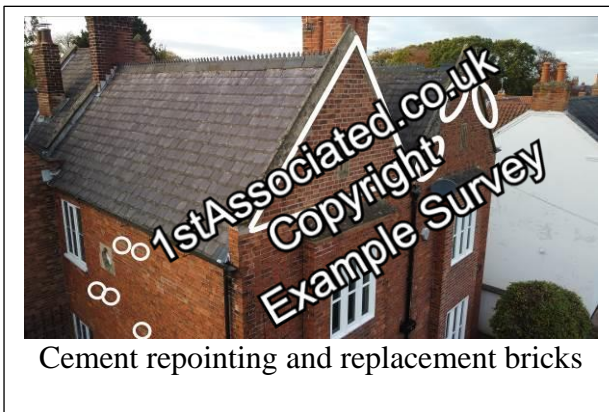
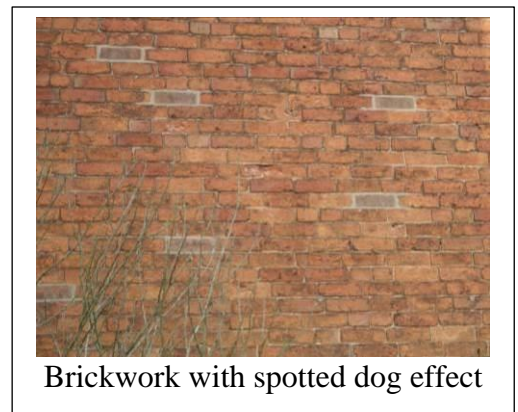
In this case many of the bricks have been repointed incorrectly using cement mortar, some replaced with different bricks causing a spotted dog effect, all of which can be repaired but they are fairly difficult and time consuming repairs and you need to find the right person to work on this over time.

Variable, or local, bond brickwork

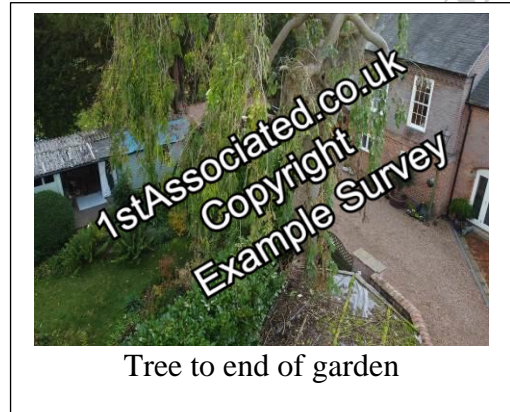
Tree to end of garden

Take advise from someone who knows how to maintain trees. We generally recommend an arboriculturalist (not a tree surgeon) is asked to view the tree and give a ten year plan for maintenance of the trees. We would also ask them whereabouts fruit trees, etc, would be good to plant in the garden to help the water travelling down.

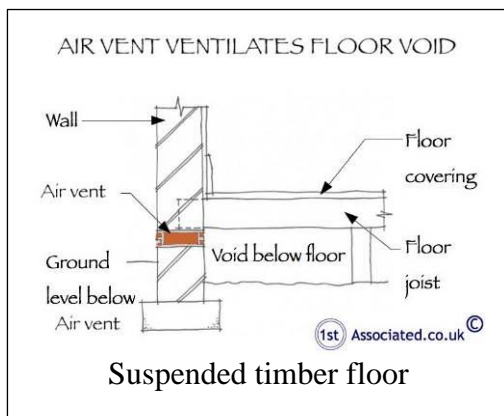
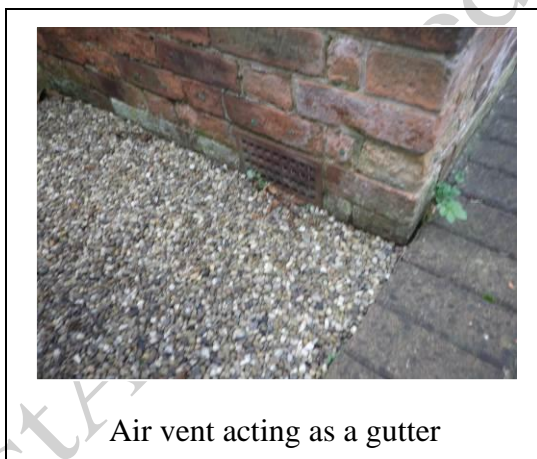
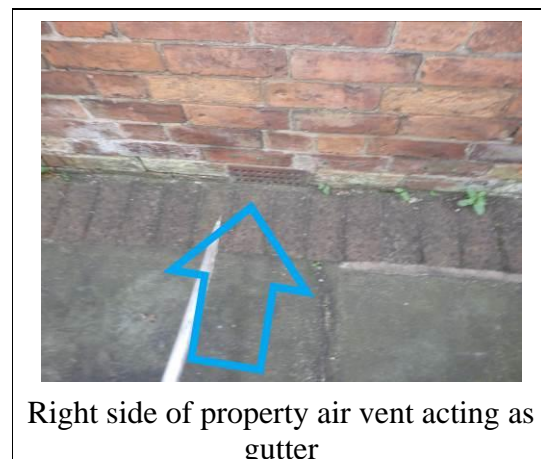
Air vents are essential to have a through flow of air as this helps to reduce the chances of wet rot, dry rot and woodworm. In this case, the air vents are acting as gutters.

ACTION REQUIRED: Please see our comments in the Executive Summary.

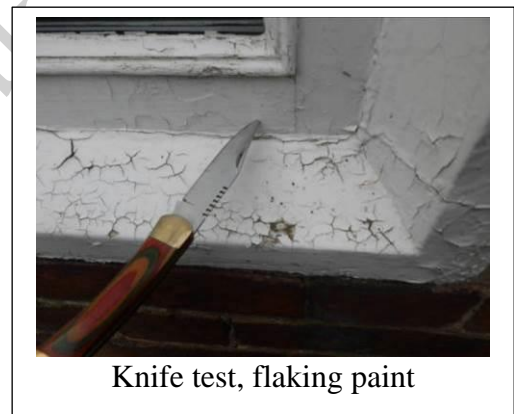
Knife test, flaking paint

ACTION REQUIRED: Repair, prepare and redecorate.

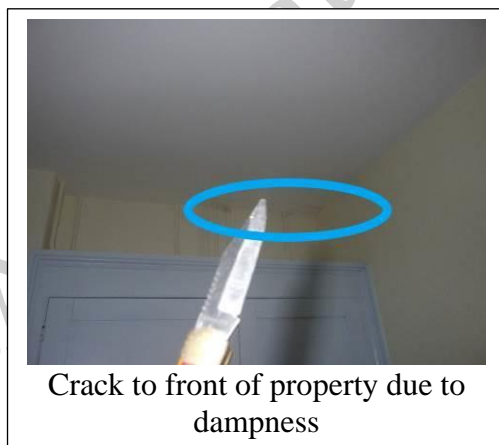
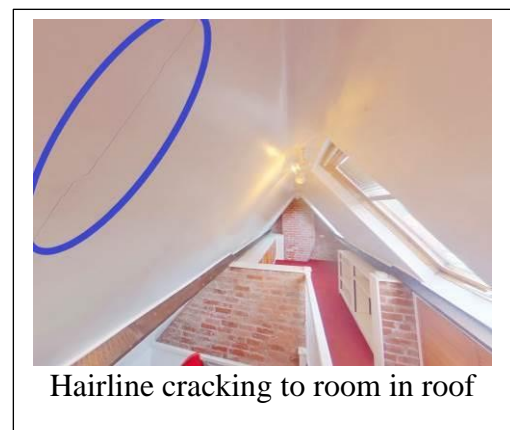
We noted some internal cracking in the room in the roof, which is a crack in modern plaster. This is often caused by dampness, which we think is the case in this instance, sometimes differential movement where different materials are moving at different rates.

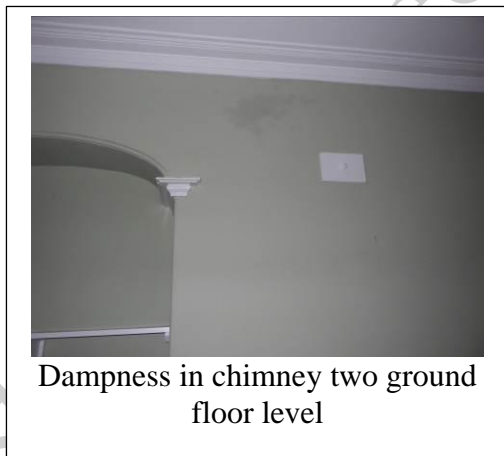
We noted dampness coming in the around the chimney breast of rear chimney number two both at ground and first floor level.

Dampness in chimney two ground floor level

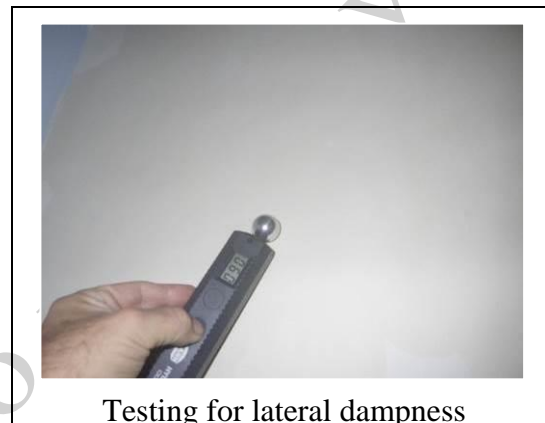
Patches of dampness
