Modern Example Residential Building Survey

GENERAL INTRODUCTION

Firstly, may we thank you for your instructions of XXX we have now undertaken an independent Building Survey (formerly known as a Structural Survey) of the aforementioned property. This Survey was carried out on XXX.

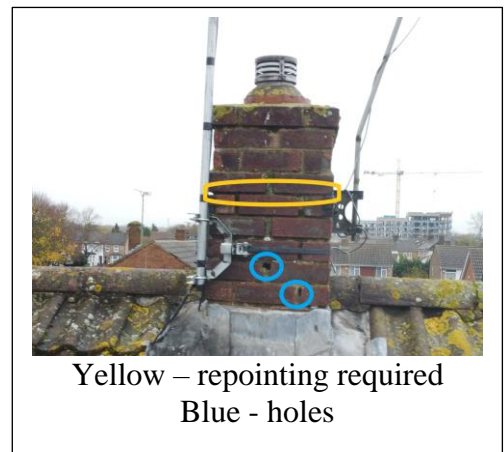
Yellow – repointing required
Blue - holes

ACTION REQUIRED: Repair and repoint.

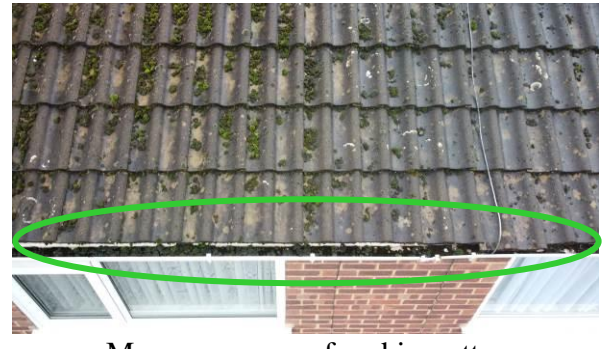
There is some moss on the roof particularly to the rear. The moss can cause accelerated deterioration and also blocks gutters. There looks in turn to have then been overflowing of the gutters which may discharge down the walls of the property making them damp and less energy efficient than dry walls.

Moss on rear roof and in gutter

ACTION REQUIRED: We recommend removing moss with a soft brush and trowel, we do not recommend high pressure cleaning or chemicals are used on the roof tiles as they can damage the tiles.

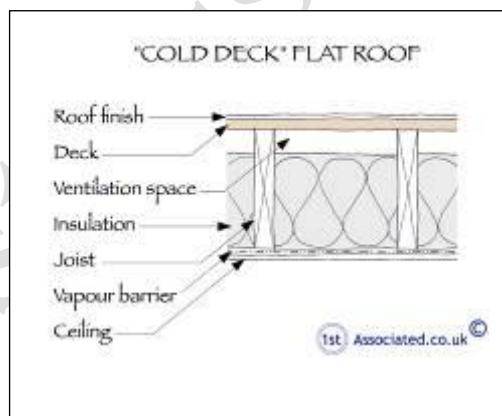
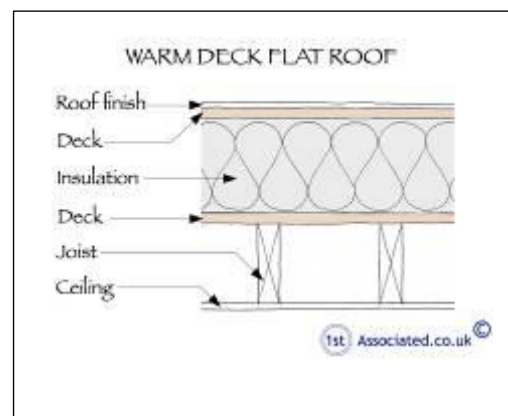
We think that the rear flat roof will have a minimum amount of insulation and as such thermal efficiency of the roof could be improved by adding insulation although it is fairly difficult to retrospectively fit. However, insulation could be fitted when the roof is re-roofed. We would also advise that we much prefer to see a lead flashing than a felt flashing. It is likely to currently have what is known as a cold decking with a small amount of insulation. In modern properties it is common to use a warm decking.

ACTION REQUIRED: We recommend re-roofing with a cut to fall insulation and detailing such as lead flashings, etc.

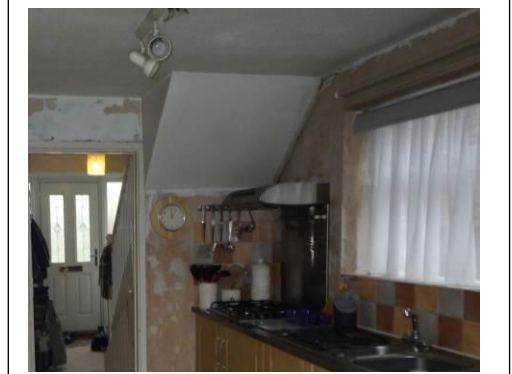
Air filter over cooker but no extraction in kitchen noted

Ensure that any humidity generating areas have good extraction. We would recommend large good quality humidity controlled extract fans are added to the kitchen, the bathroom and any areas that are humidity generating for example areas that are used for drying clothes internally during winter months (we would assume that clothes will be dried externally during the warmer months). By large extract fans we mean 150mm.

ANTICIPATED COST: We would anticipate costs between £250 - £500 per extract fan depending upon the wiring required. We always recommend quotations are obtained before work is agreed/commenced.

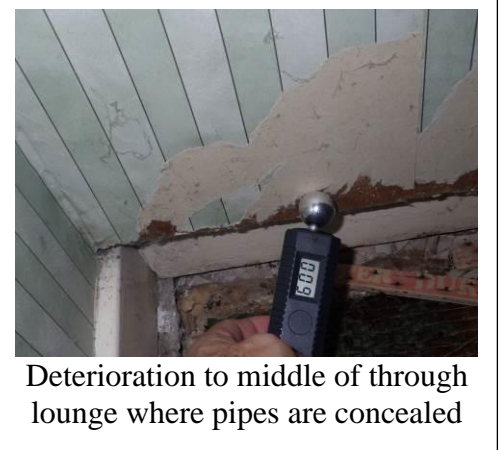
Deterioration to middle of through lounge where pipes are concealed

ACTION REQUIRED: You need to open up this area to see what is going on and forward photographs to us to comment further.

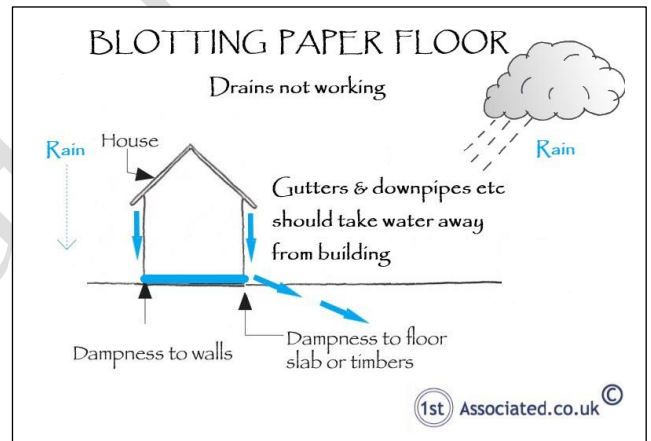
We believe the water table level in the area may be higher than we typically find. When looking at historic maps it looks like the area was quite marshy. We believe that due to this the ground floor slab could be acting like blotting paper absorbing moisture in the surrounding grounds.

In addition to this, it looks like the drains to the front have been blocked and this can lead to further dampness getting in the property. It also should not be discounted there may be leaking supply pipes.

Mould next to building on rear left side

ACTION REQUIRED: You need to carry out further investigation with regard to whether there are any leaking drains or pipes in the area.

We would recommend that ground levels around the property are lowered (a DIY type job). Also, we would recommend cutting the bush away to the front as you would also be able to see whether the vertical crack on the inside of the property is also on the outside and also it would allow sunlight and air movement to get around the property better.

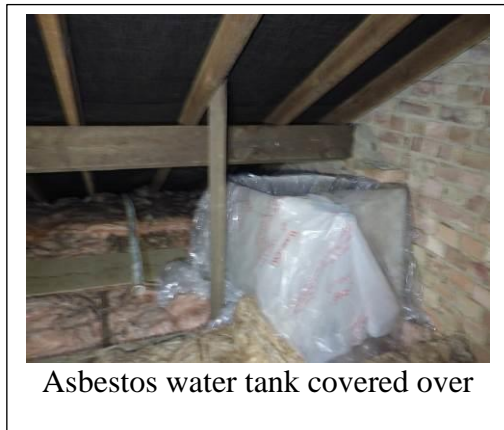
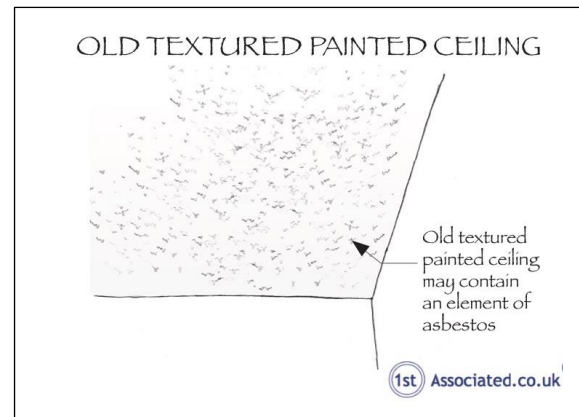
There is a disused asbestos water tank in the roof space and there looks to be textured paint used throughout the property which contains asbestos.

ACTION REQUIRED: The only way to be one hundred percent certain with regards to asbestos in a property is to have an asbestos report with samples taken and the recommended action carried out. This needs to be carried out as soon as possible as this would put some people off buying the property.

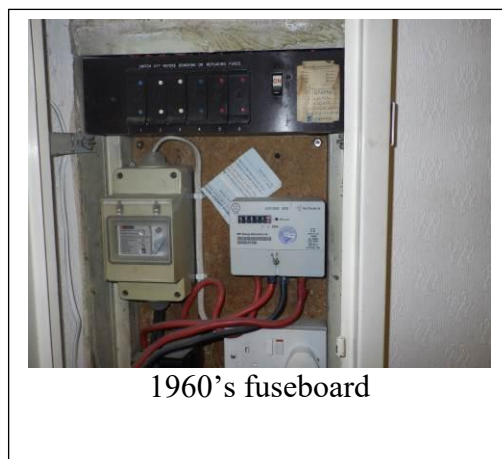
The fuse board is 1960's and better are now available. We noted an above average level of extension leads being used which generally means there are a lack of socket points.

ACTION REQUIRED: We recommend a new fuse board with a metal casing; modern standards require half hour to one hour fire resistant casing around a fuse board.

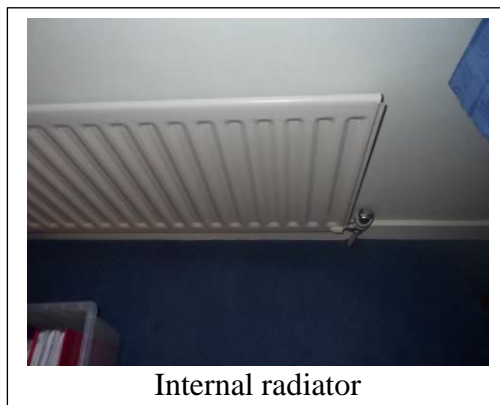
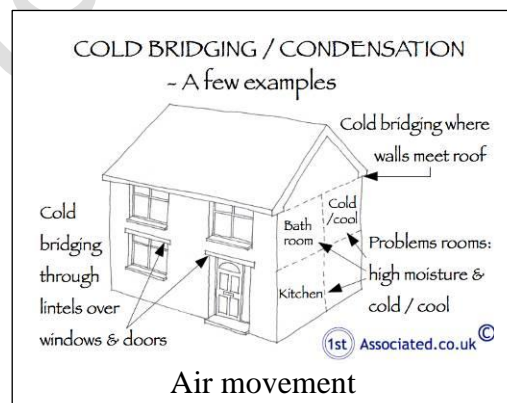
We noted the radiators in some areas are internal/not under the windows which is the usual position. This is often carried out on cheaper central heating systems to save the labour and piping costs of positioning the radiators underneath the windows. However, it then reduces the air movement in the room which can lead to black mould.

Single panel radiators

ACTION REQUIRED: We recommend you move the radiators underneath the windows as this gives a better circulation of air and reduces the chance of condensation.

ACTION REQUIRED: We would recommend upgrading the radiators to double panel radiators. We would also recommend the system be tested and overhauled and that a regular maintenance contract be placed with an approved heating engineer.

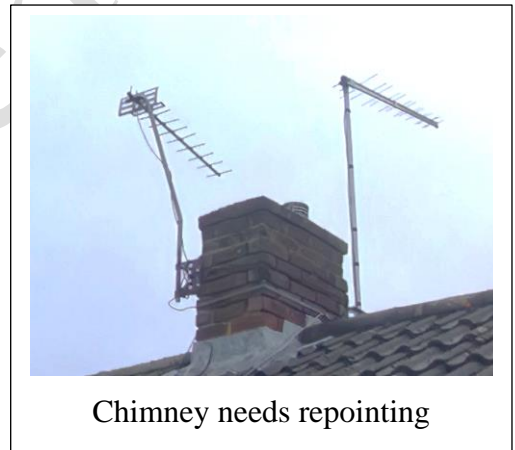
This chimney is brick finished with a lead flashing and one chimney pot. From what we could see from ground level it looked in slightly below average condition considering its age, type and style.

Chimney needs repointing

ACTION REQUIRED: Repoint. Please see our comments in the Executive Summary.

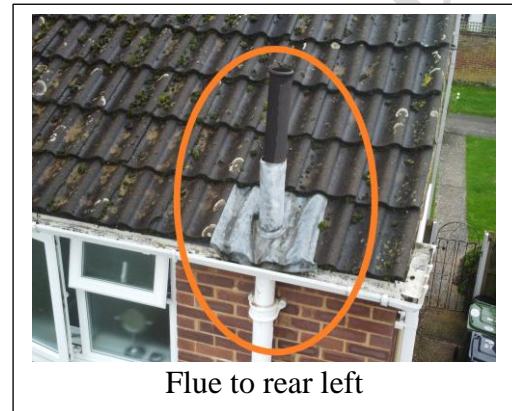
The property has a cast iron flue with a lead flashing to the rear left. The cast iron is rusting and it looks like the lead needs making good. Also, note the moss to the rear roof.

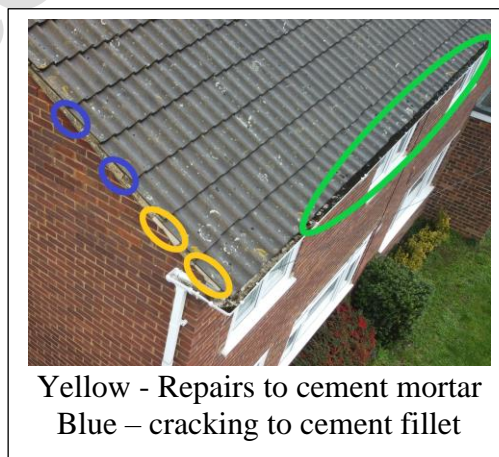
The moss was particularly bad on the rear of the roof.

Yellow - Repairs to cement mortar
Blue – cracking to cement fillet

ACTION REQUIRED: Please see our comments in the Executive Summary.

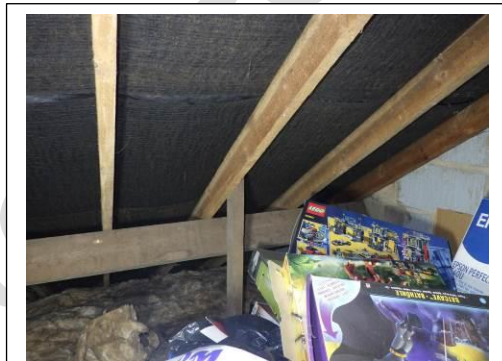
When we inspected the loft space, we found a Hessian based bitumen membrane. This type of membrane has been used since the 1960s. We generally found it to be in average condition with damage in some areas/areas that were not fitted particularly well, which is what we typically find.

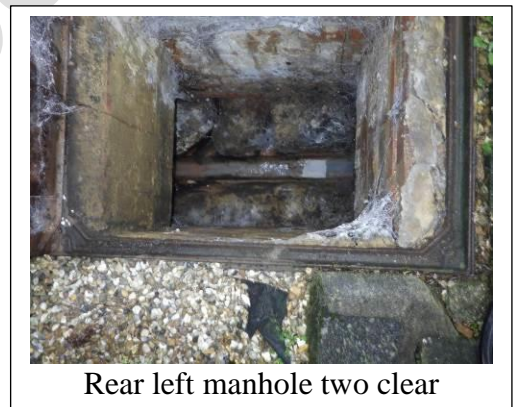
Rear left manhole two clear
